E.E.S. REPORT C-3599-A(2)  
30 MARCH 1950

UNITED STATES NAVAL  
ENGINEERING EXPERIMENT STATION

ENDURANCE TEST OF  
PHILIPS MODEL 1/4D EXTERNAL COMBUSTION ENGINE

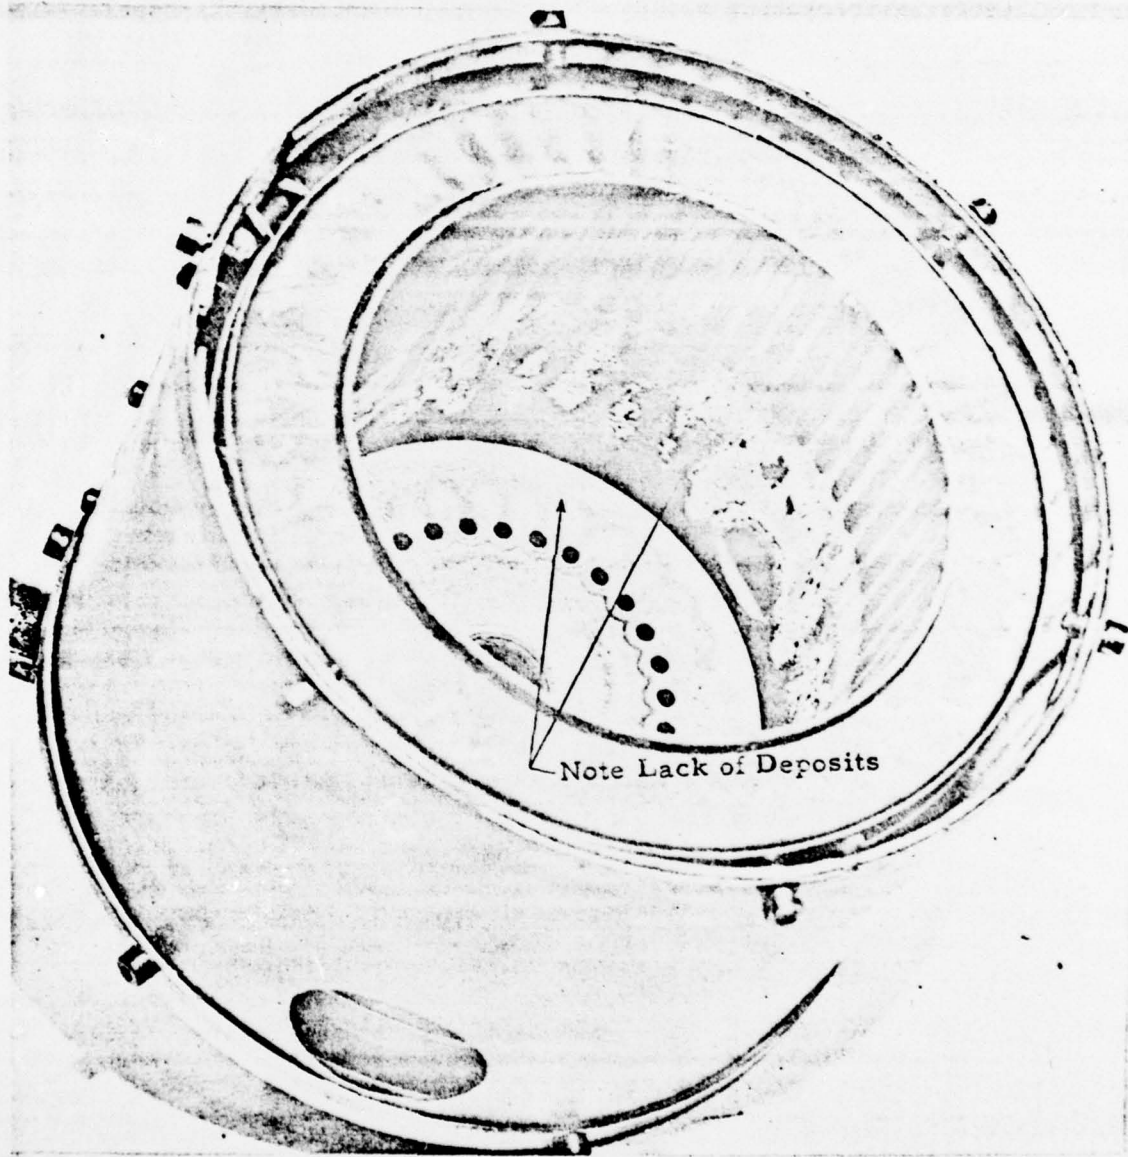
PHILIPS MODEL 1/4D ENGINE BURNER HEAD  
FOLLOWING 500 HOURS OPERATION ON UNLEADED GASOLINE

16. Inspection of the burner and heater heads following 500 hours operation with Amoco water white (lead free) gasoline showed them to be free of appreciable deposits, Plates 7 and 8. Cleaning of the parts was considered unnecessary. A second inspection of these surfaces following 30 hours subsequent operation with 80 octane leaded motor fuel again showed them to be satisfactorily clean, Plates 9 and 10; cleaning was again considered unnecessary.

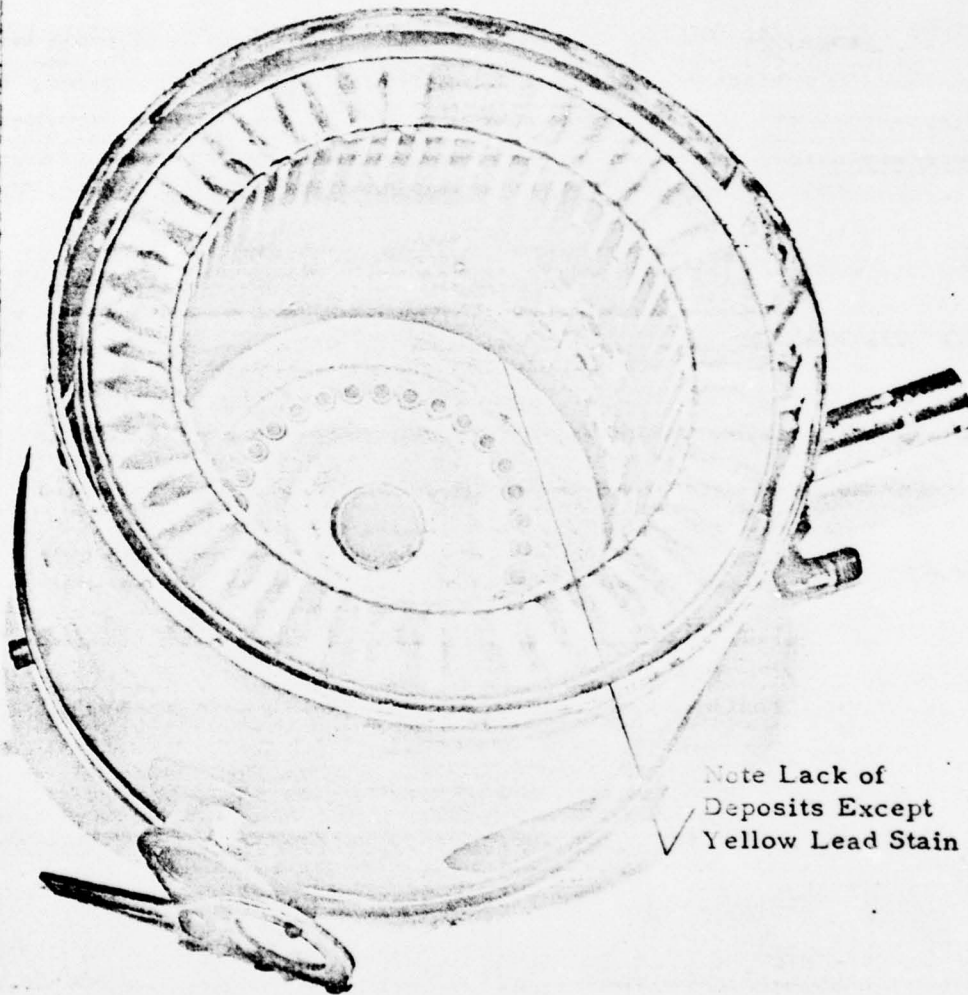
PHILIPS MODEL 1/4D ENGINE BURNER HEAD  
FOLLOWING 30 HOURS OPERATION ON 80 OCTANE GASOLINE  
AND 500 HOURS OPERATION ON UNLEADED GASOLINE

✓ Note Lack of  
Deposits Except  
Yellow Lead Stain

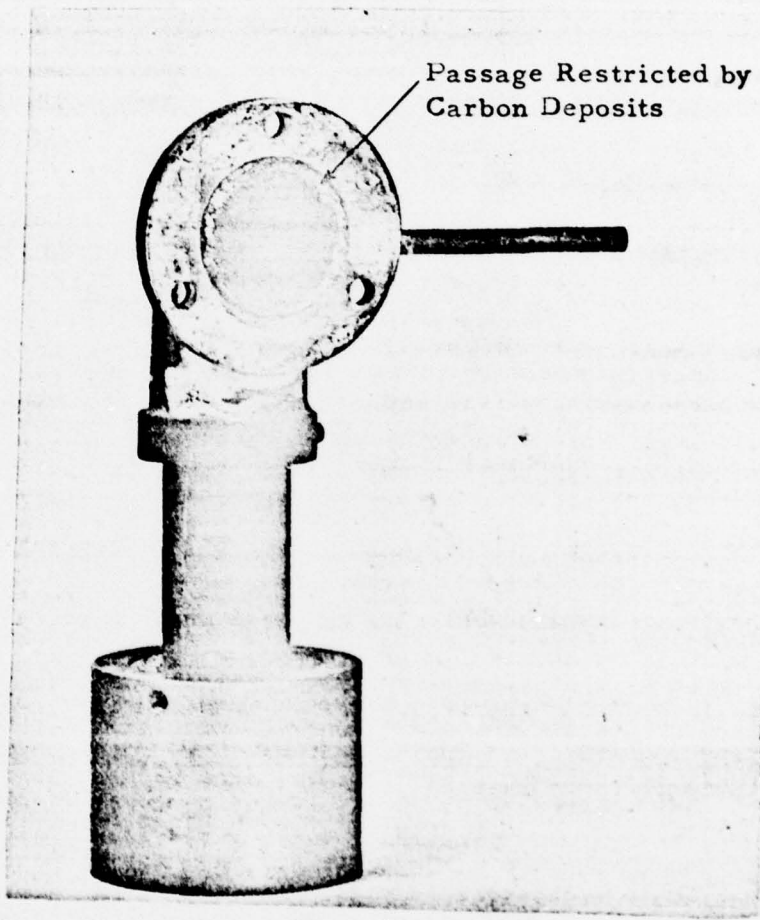
PHILIPS MODEL 1/4D ENGINE  
GASOLINE-AIR MIXTURE VENTURI TUBE  
250 HOURS OPERATION

(c) Heavy carbon deposits in the gasoline-air mixture venturi, Plate 11, prevented proper combustion after 250 hours operation. The deposits were removed by scraping. Similar but considerably lighter deposits were removed after 431 hours operation of the engine; it was uncertain whether the deposits affected engine operation on this occasion.

30. The build-up of carbon deposits in the gasoline-air mixture venturi tube, Plate 11, appears to be an inherent fault of the combustion system used on this engine. The tube is hot during operation, because of heat conduction from the burner head. Its inner surface is wetted by a coarse spray of gasoline. This creates a favorable condition for carbonization of the gasoline. It is necessary that the tube operate at a high temperature in order to gasify the fuel before it reaches the combustion chamber.

31. The above-described carbon deposits definitely interfered with proper engine operation on only one occasion, after 250 hours operation, although the deposits were cleaned out after 431 hours operation during attempts to correct low heater head temperatures. In the latter case, however, the difficulties appeared to have been caused by nozzle fouling. The carbon deposits are not regarded as a serious problem in this engine. Removal of the deposits is a simple operation and very little disassembly is required.

Passage Restricted by  
Carbon Deposits

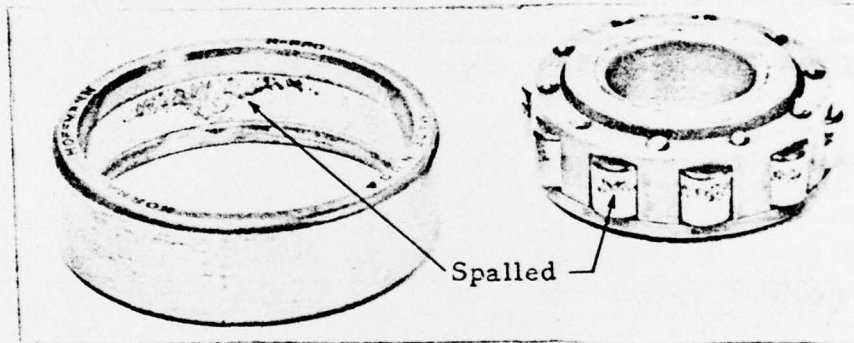
PHILIPS MODEL 1/4D ENGINE  
MAIN ROLLER BEARING  
597 HOURS OPERATION

(g) The crankshaft main roller bearing failed after 597 hours operation, Plate 13.

(a) The main roller bearing had failed by spalling, Plate 13.

(c) The main roller bearing failed by spalling after 597 hours operation, Plate 13.

35. The crankshaft main roller bearing that failed after 597 hours operation, Plate 13, was installed new immediately prior to shipment of the engine to this Station, according to information supplied by Mr. R. L. Adams of the Philips Laboratories. He further advised that while considerable difficulty with this bearing had been experienced during the earlier development work on the engine, the trouble had apparently been corrected by use of a narrower bearing and by the elimination of needle bearings in the engine.

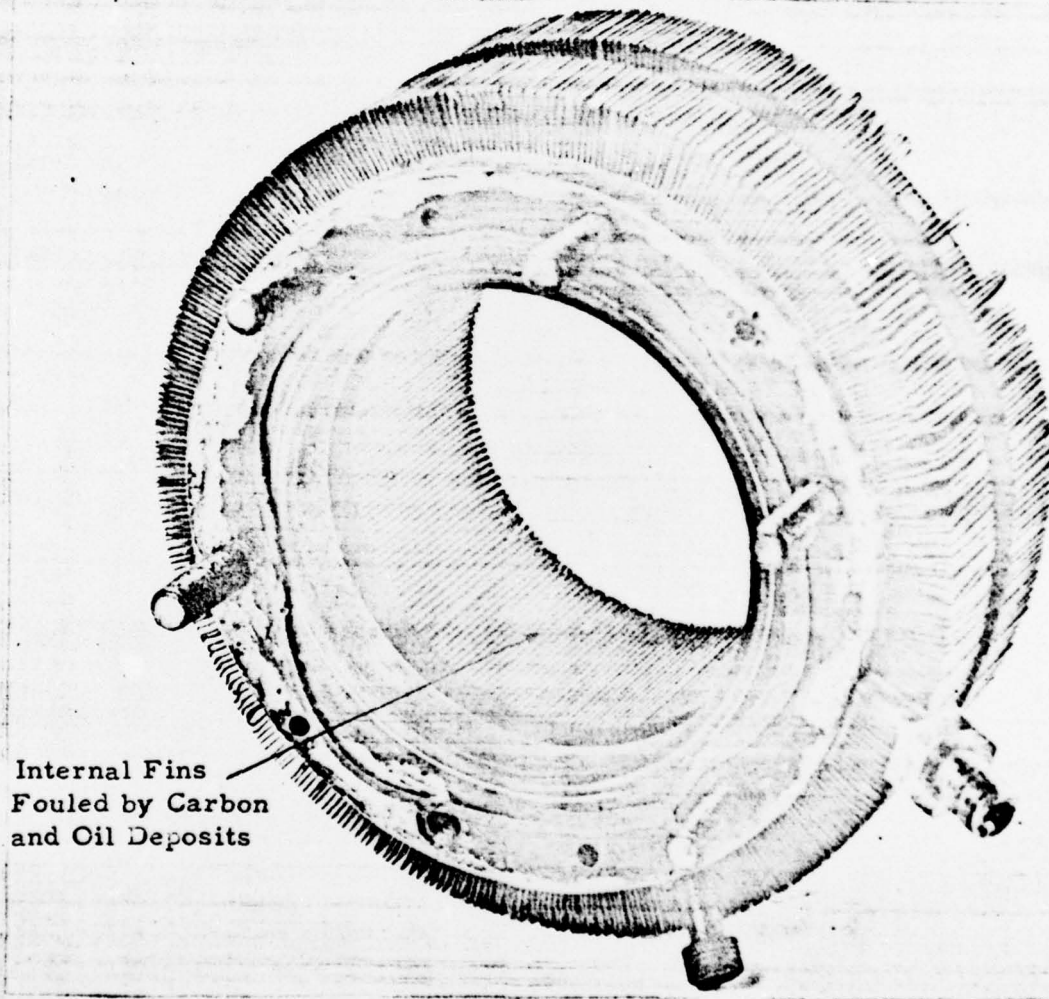
PHILLIPS MODEL 1/4D ENGINE  
COOLER BLOCK  
597 HOURS OPERATION

(b) The internal fins of the cooler were coated with an oily carbonaceous deposit, Plate 16. It is estimated that the flow restriction due to the deposit was 10 percent or less.

36. Fouling of the internal fins of the cooler, Plate 16, at the post-trial disassembly, appeared to be moderately serious. This was the apparent cause of the increase in temperature of the cooler during the latter part of the endurance run, Plate 5. It is pointed out, however, that in spite of this fouling and the main bearing failure, the engine still developed more than its rated power, 124.5 watts, when secured at the end of the endurance run, Plate 5.

Internal Fins  
Fouled by Carbon  
and Oil Deposits

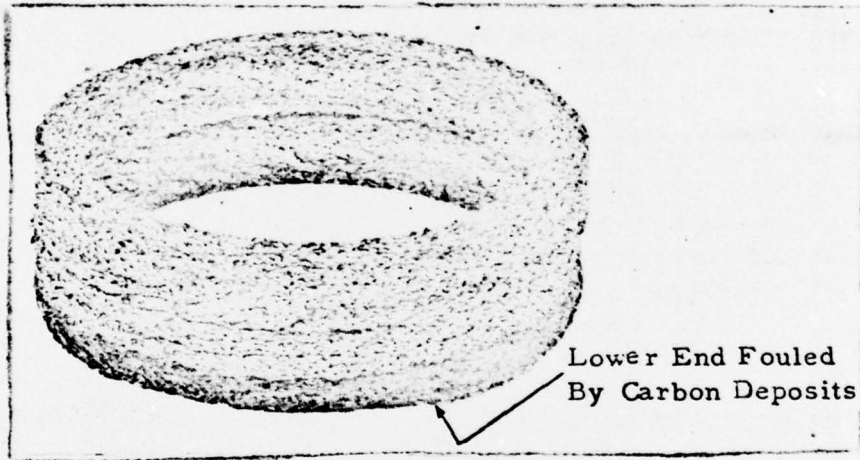
PHILIPS MODEL 1/4D ENGINE  
REGENERATOR  
597 HOURS OPERATION

(c) The lower quarter of the regenerator was blackened by carbon and oil deposits, Plate 17. The balance of the regenerator appeared to be relatively clean, although it was dulled and heat-colored.

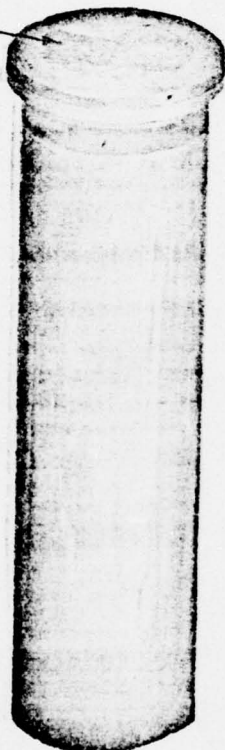
PHILIPS MODEL 1/4D ENGINE  
COMPRESSOR PISTON  
597 HOURS OPERATION

(d) The tappet surface of the compressor piston was indented and pitted from contact with the crankpin bearing, Plate 18.

37. The excessive wear and indentation of the compressor piston tappet face, Plate 18, was due to the inadequate hardness of that surface. According to the contractor's drawing of this part, cold rolled steel without any hardening procedure was specified.

Tappet Surface  
Pitted and  
Indented

(h) The tappet face of the compressor piston be made of a suitable hardened material to withstand wear and resist indentation.
