**PRECIPITATION STATIC ELECTRICITY AND  
SWEPT-STROKE LIGHTNING EFFECTS ON  
AIRCRAFT TRANSPARENCY COATINGS**

R.C.Twomey  
Douglas Aircraft Company  
McDonnell Douglas Corporation  
3855 Lakewood Boulevard  
Long Beach, California 90846

DECEMBER 1977

TECHNICAL REPORT AFFDL-TR-77-141

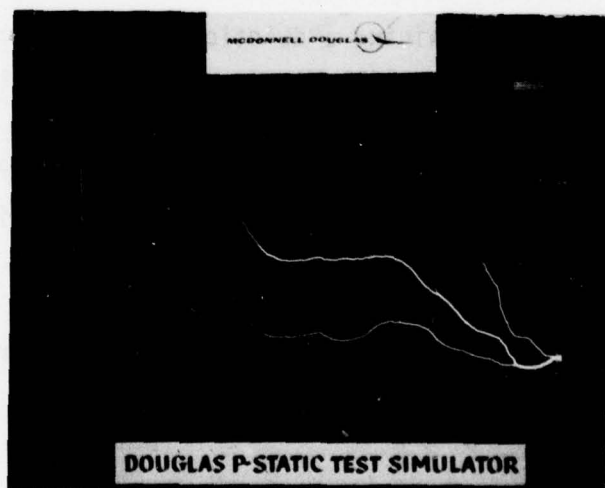
Figure 12. Typical Discharge Pattern on -505A Specimen.

Figure 12 is a photograph of a typical static electric discharge on the acrylic surface of the -505A specimen. The relative current density of the discharge branches can be judged by the photographed intensity of the various branches. Fifty-nine discharges were allowed before the specimen was dismantled from the test simulator for detailed damage assessment. Some of these flashes were weaker and less extensive in area than the single discharge of Figure 12, while some were more intense and with more sub-branches.

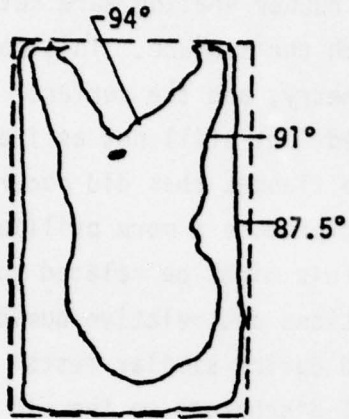
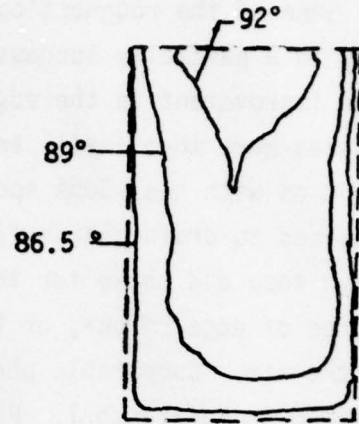
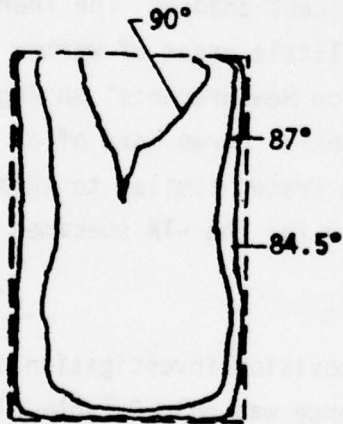
Figure 14. Isothermal Traces on  
-505A Specimen After  
Static Electric  
Discharges.

first exposure, and second exposure thermographs are shown in Figure 14. Note that the isotherm lines on the traces do not represent the same temperature for each Thermovision run. The important, easily derived information from the traces is that no significant change in the heating pattern took place. This observation translates to the conclusion that a large number of surface flashes apparently did not induce damaging current into the gold conductive coating of the -505A specimen.

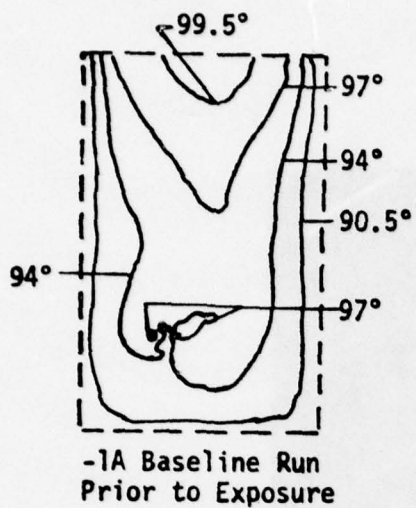
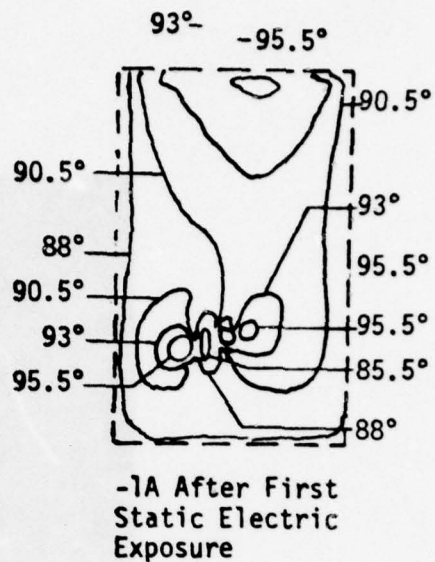
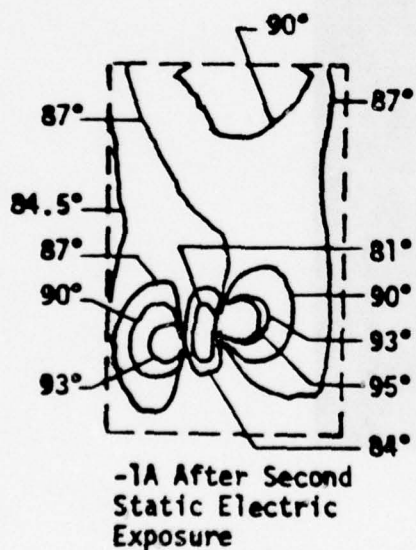
Figure 16. Isothermal Traces on -1A Specimen After Static Electric Discharge.

The visual inspection yielded no indication of damage. Resistance measurements (Table I) also indicated no significant change. The Thermovision inspection did show a change in the two little areas of warmer temperature discussed under "Initial Thermovision Measurements" on Page 23. They appeared to be more accentuated and the central cores were of a slightly higher relative temperature. Isotherm traces similar to those previously discussed for Figure 14 are presented for the -1A specimen in Figure 16.

a continuing slight deterioration in the homogeneity of the resistance coating in this area of the specimen. Figure 16 also shows the isotherm tracings for the specimen after the second static electric discharge series. Although there had been a very noticeable change in the isotherm plot between the baseline run and the last run, it is doubtful that these changes would degrade the ability of the resistive coating to perform a satisfactory anti-icing function if it were a part of an actual aircraft windshield. However, there is the unanswered question of whether the continuous cycling of heating current, as would be encountered in an actual windshield, would cause the discharge induced changes in the resistive coating to further change and develop into an unsatisfactory condition.

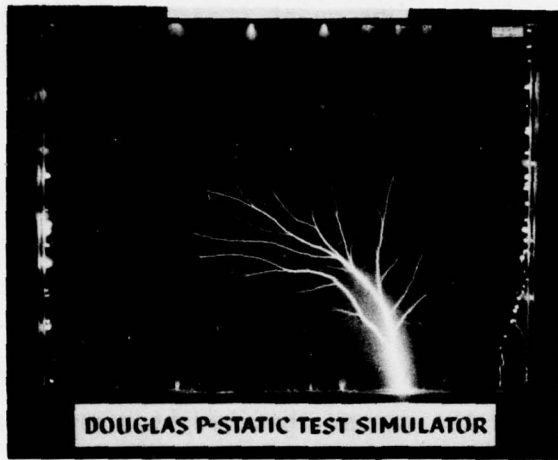
Figure 20. -1B Specimen Undergoing Static Discharge After Lightning Exposure.

Figure 20 is a photograph which shows a large oak tree discharge as well as sparking along the right and left edges adjacent to the bus bars. The bus bars are the straight vertical lines bordering the open area of the transparency. Note the forked line in the lower right corner. (This corresponds to the lower left during the Thermovision tests.) The area that was hot to the touch and bubbled during the post-exposure heating is at the lower left edge in Figure 20.

After this P-static discharge exposure the damage was very visible. The action of the internal sparking had caused the flaws in the coating and in the bus-coating interface to be colored a faint pink. Examinations of the specimen before and after this P-static exposure indicated that the static discharge did not significantly increase the extent of the previous damage, but caused a visual enhancement of the existing damage. Attempts to photograph this damage were not too successful. Figure 21 is a photograph of the lower left edge of Figure 20 as viewed from the opposite side of the specimen. The bus bar is the solid line about 0.3-inch wide along the lower part of the photo.

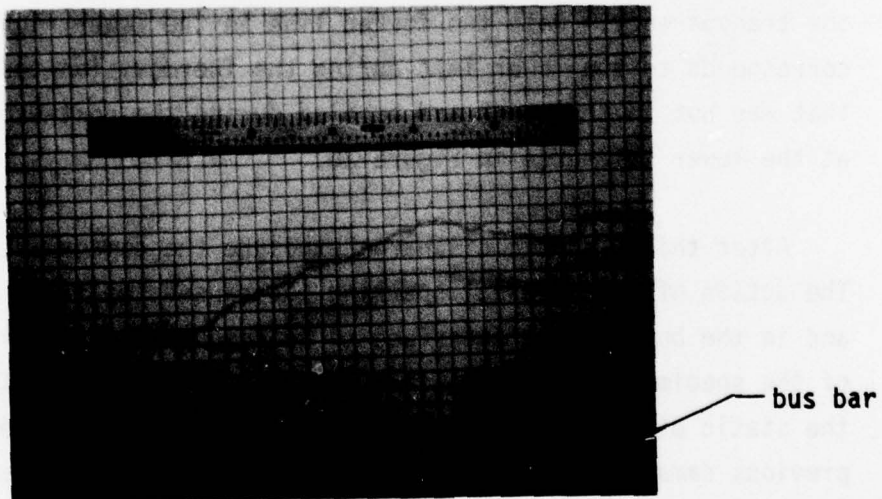
Figure 21. Static Enhanced View of Lightning Damage to -1B.

The open circuit condition of the now defunct -1B specimen did not allow further testing in the manner that had been previously planned. However, it was decided to see how it would react in the P-static simulator. As hoped, the high voltage caused sparking in the internal voids in the coating caused by lightning and subsequent heating current.

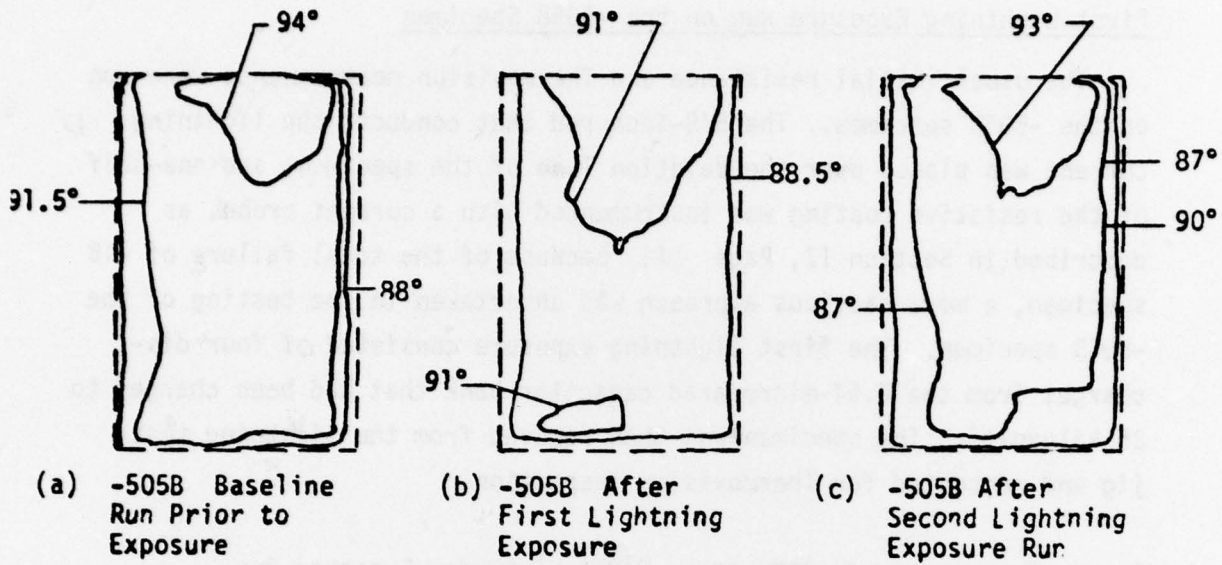
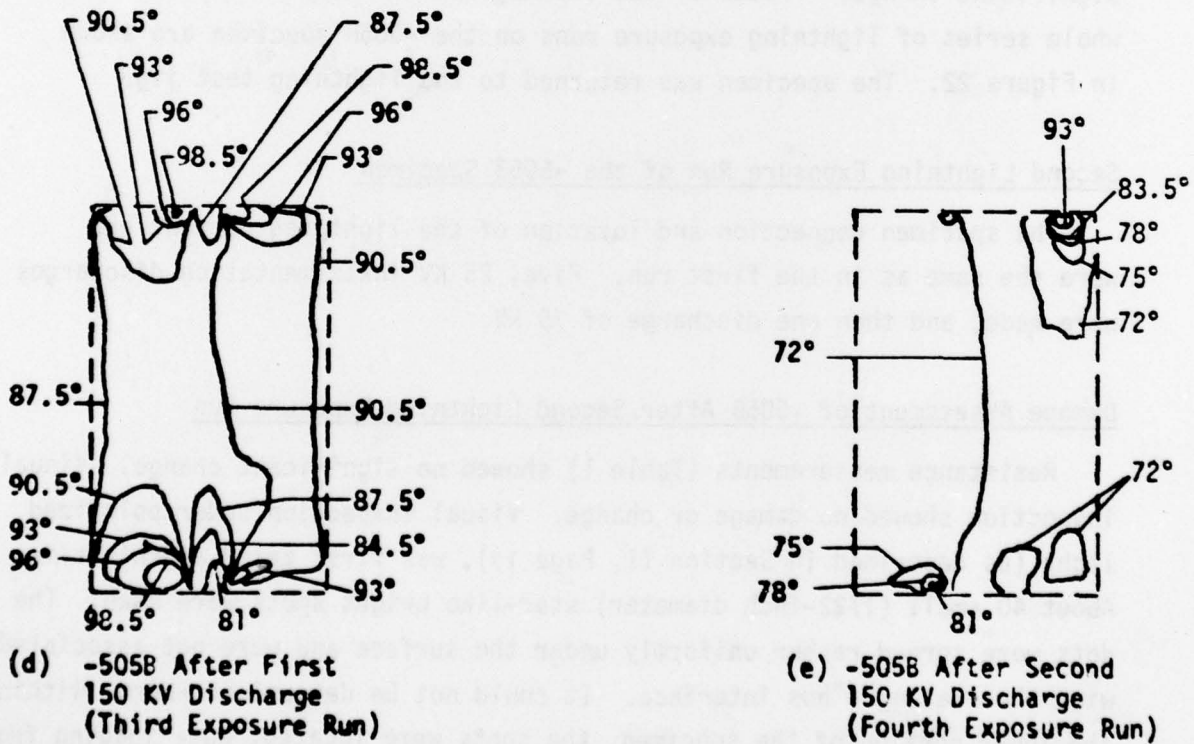
Figure 22. Isothermal Traces on -505B After Lightning Exposure.

Resistance measurements (Table 1) showed no significant change. Visual inspection showed no damage or change. Visual inspection under polarized light (as described in Section II, Page 17), was first tried at this time. About 40 small (1/32-inch diameter) star-like bright spots were seen. The dots were spread rather uniformly under the surface and were not associated with the coating - bus interface. It could not be determined where, within the inner portion of the specimen, the spots were located, but, judging from

the degree of parallax observed, the spots were probably not in the resistive coating. These spots could not be seen in unpolarized (normal) light. Their number and intensity did not seem to change as the specimen heated.

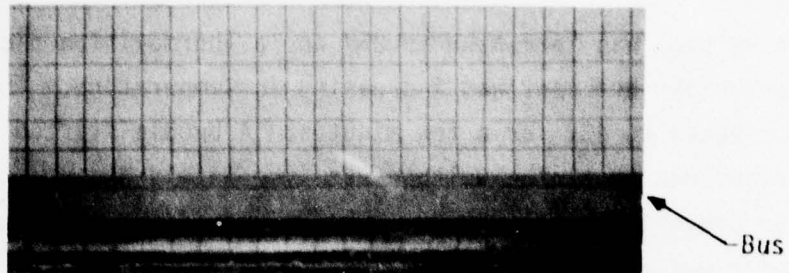
(a) Photo of undamaged coating/bus interface area.

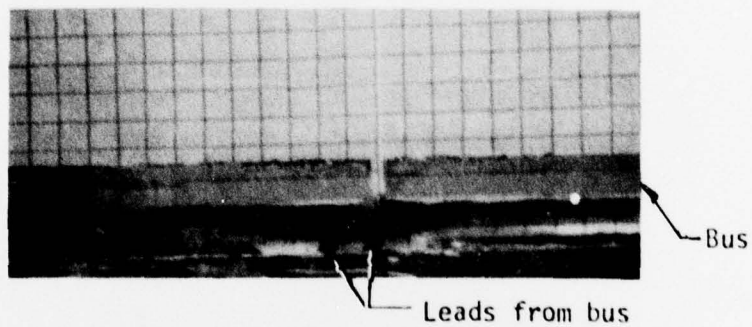
Figure 23. Damage to -505B After First 150 Kv Discharge.

Resistance measurements (Table 1) showed only a minor (1 ohm) increase in the upper coating, which was farthest from the excitation rod. The lower, fully excited coating showed a significant resistance increase from 39 ohms to 54.5 ohms.

(b) Photo showing damage to coating/bus interface.  
(Background grid is 0.2-inch on a side)
