1. Report No. USCG 16732/73429 ✓		2. Government Accession No.		3. Recipient's Catalog No.	
4. Title and Subtitle Marine Board Casualty Report SS FROSTA (Norwegian) and M/V GEORGE PRINCE; collision at Mile 120.8 AHP, Lower Mississippi River on 20 October 1976 with loss of life				5. Report Date 18 April 1978

SS FROSTA (NORWEGIAN), M/V GEORGE PRINCE;
 COLLISION IN THE MISSISSIPPI RIVER ON 20
 OCTOBER 1976 WITH LOSS OF LIFE

Subj: SS FROSTA (NO) JXLS and M/V GEORGE PRINCE, O.N. 236825; collision
at Mile 120.8 AHP, Lower Mississippi River on 20 October 1976
with loss of life

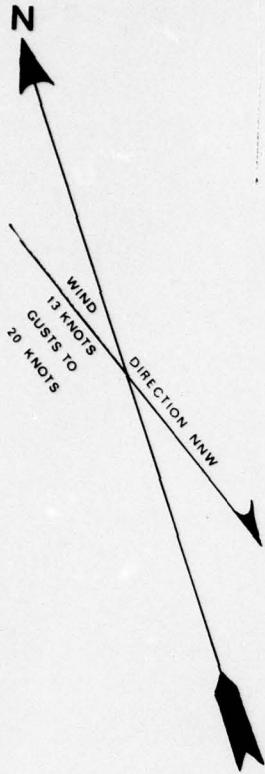
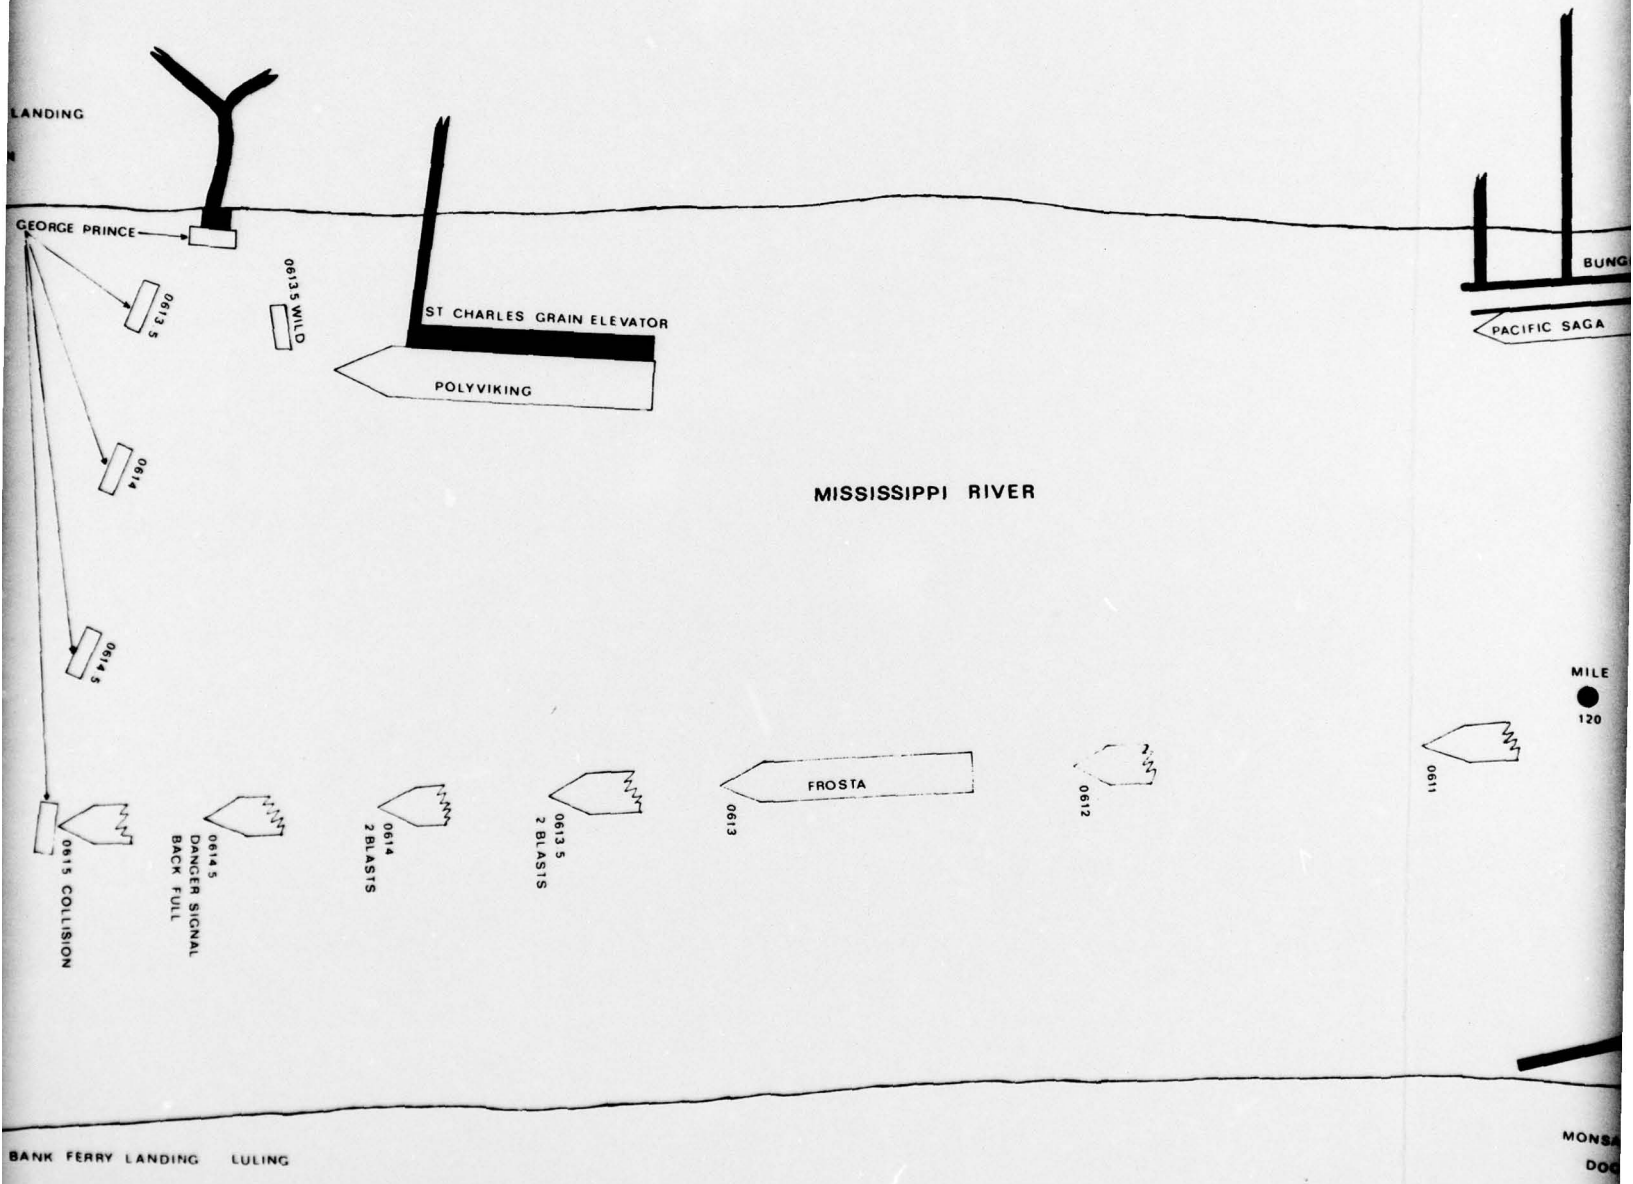
SS FROSTA struck M/V GEORGE PRINCE on the port side in way of the deck house which placed the center of impact some 38 feet 3 inches forward from the stern. The blow caused SS FROSTA to penetrate the port hull, opening the port engine room to free communication with the river. SS FROSTA's bow opened the port hull to a depth of about 3 feet.

The momentum of SS FROSTA carried M/V GEORGE PRINCE upriver for a short distance until it capsized by rolling to starboard. As the ferry capsized, it was driven under by SS FROSTA with a second point of contact between the two occurring between an unknown portion of SS FROSTA's hull and the bottom aft portion of M/V GEORGE PRINCE's starboard hull.
