USAAVRADCOM TR 78-2

AD A 054906 FIELD EVALUATION OF THE SHOCK PULSE TECHNIQUE TO UH-1H SERIES HELICOPTERS

5 JUNE 1974

FINAL REPORT

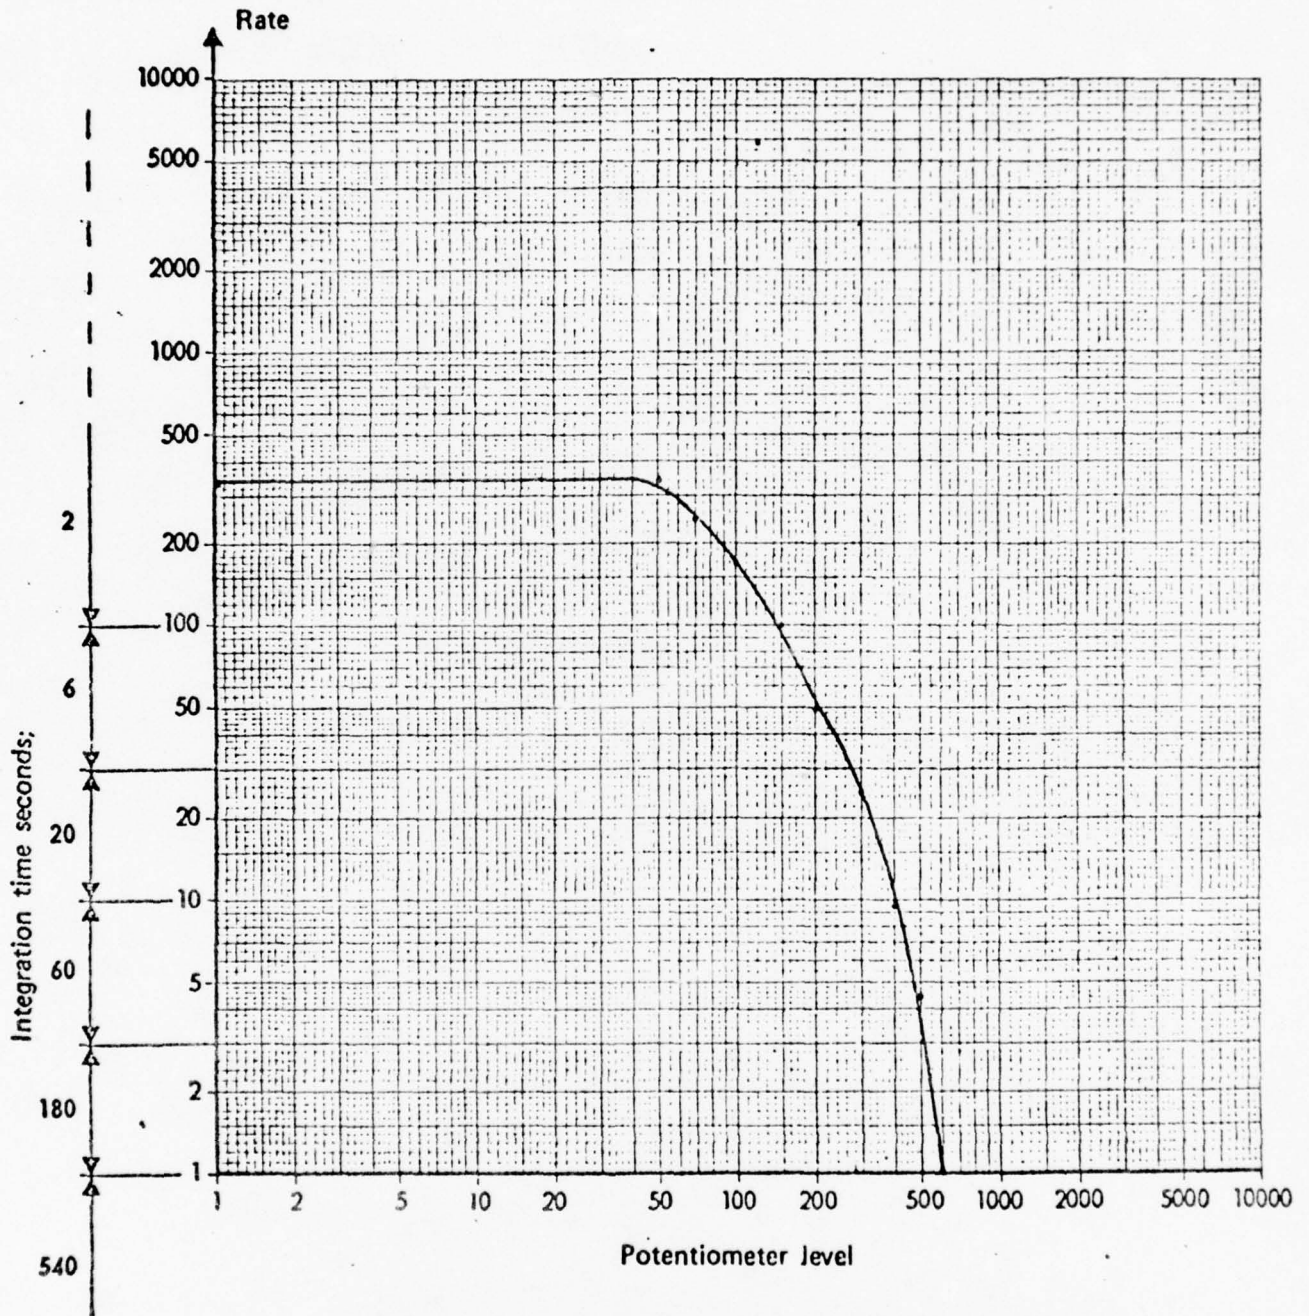
FIG. 2

BEARING SERIAL #A20-67523 REMOVED FOR PHYSICAL ANALYSIS.

404 hour since overhaul: 806 since new. "General condition good."

Corrosion evident in outer race adjacent to most balls, scratches across race adjacent to corrosive area.

SKF analysis showed shock level of 600 with shock rate of 340. Bearing damage appears to be caused by normal wear and use exposed to the general environment. Damage could not be considered excessive. Considering the teardown analysis of the bearing correlated with the MEPA-10A depiction, we would consider the depiction in rate and level would be approaching an unacceptable condition.

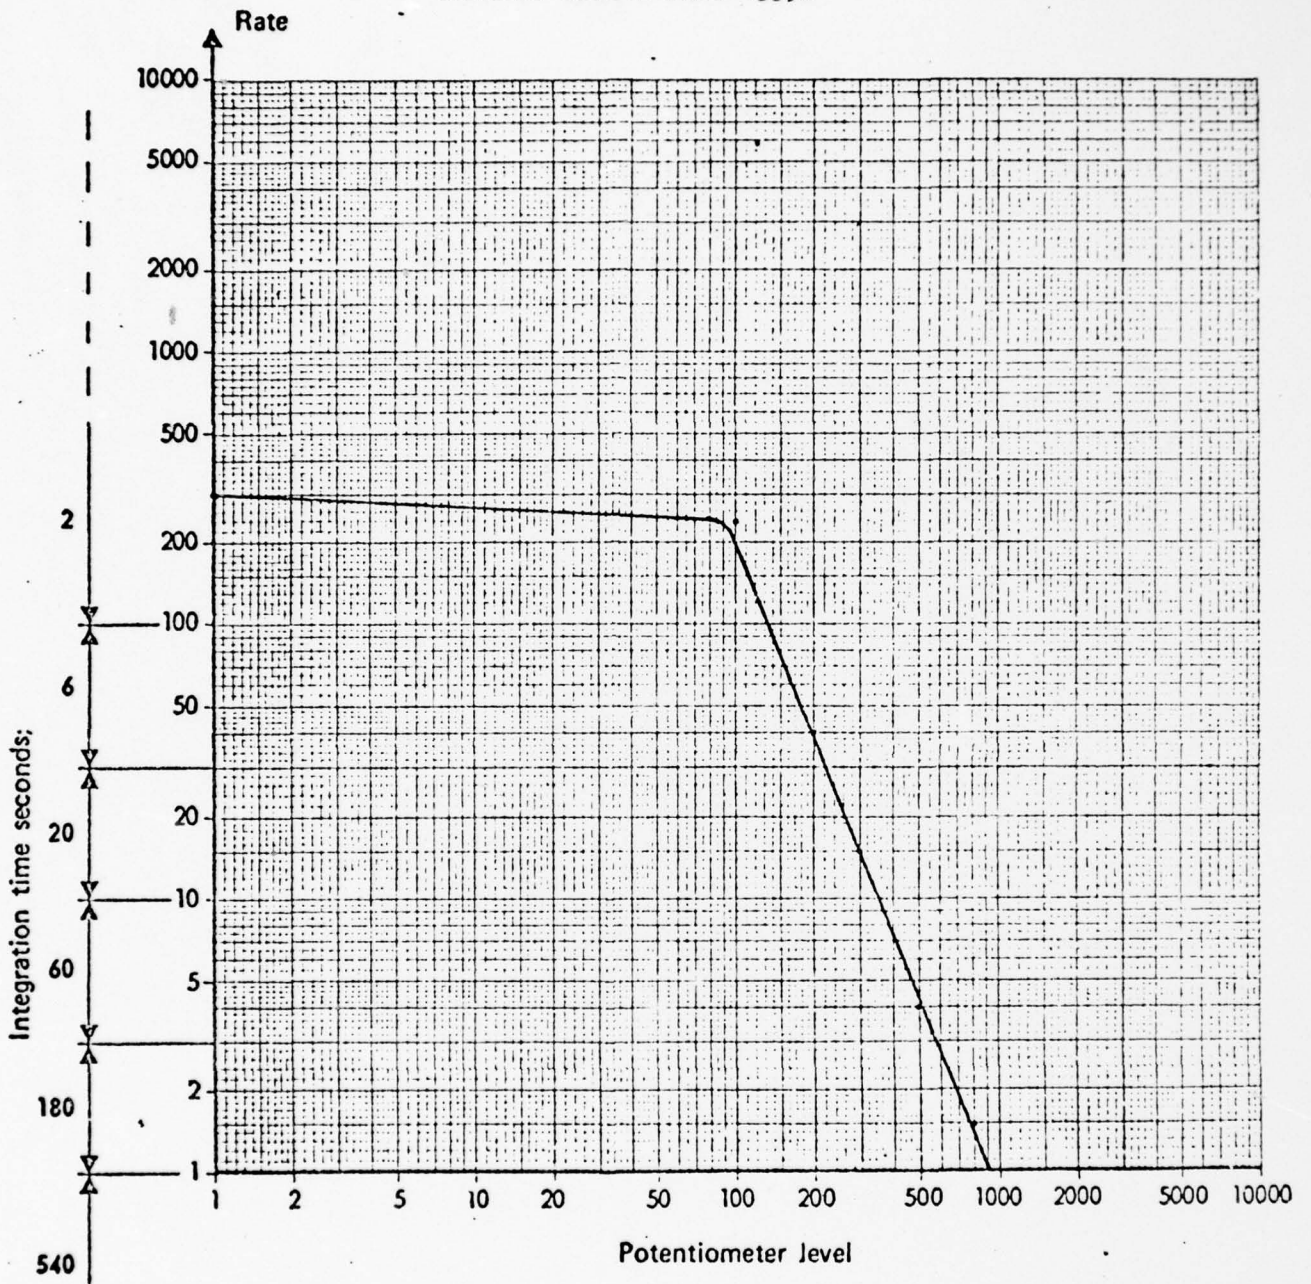
FIG. 13

REMOVED FOR ANALYSIS, EXCESSIVE POTENTIOMETER LEVEL EXHIBITING HIGH RATES.

The outer race of this bearing showed evidence of corrosion and pitting.

No damage was apparent in the inner race, however, one ball had corrosion.

The MEPA-10A shock analysis of this bearing showed high levels of damage. The level reached of 900 is in the higher 20% of the readings taken of all hanger bearings tested. Rate level of 300 is not excessive considering the bearings tested. Reviewing the MEPA-10A depiction, this bearing would fit in a classification showing damage requiring action.

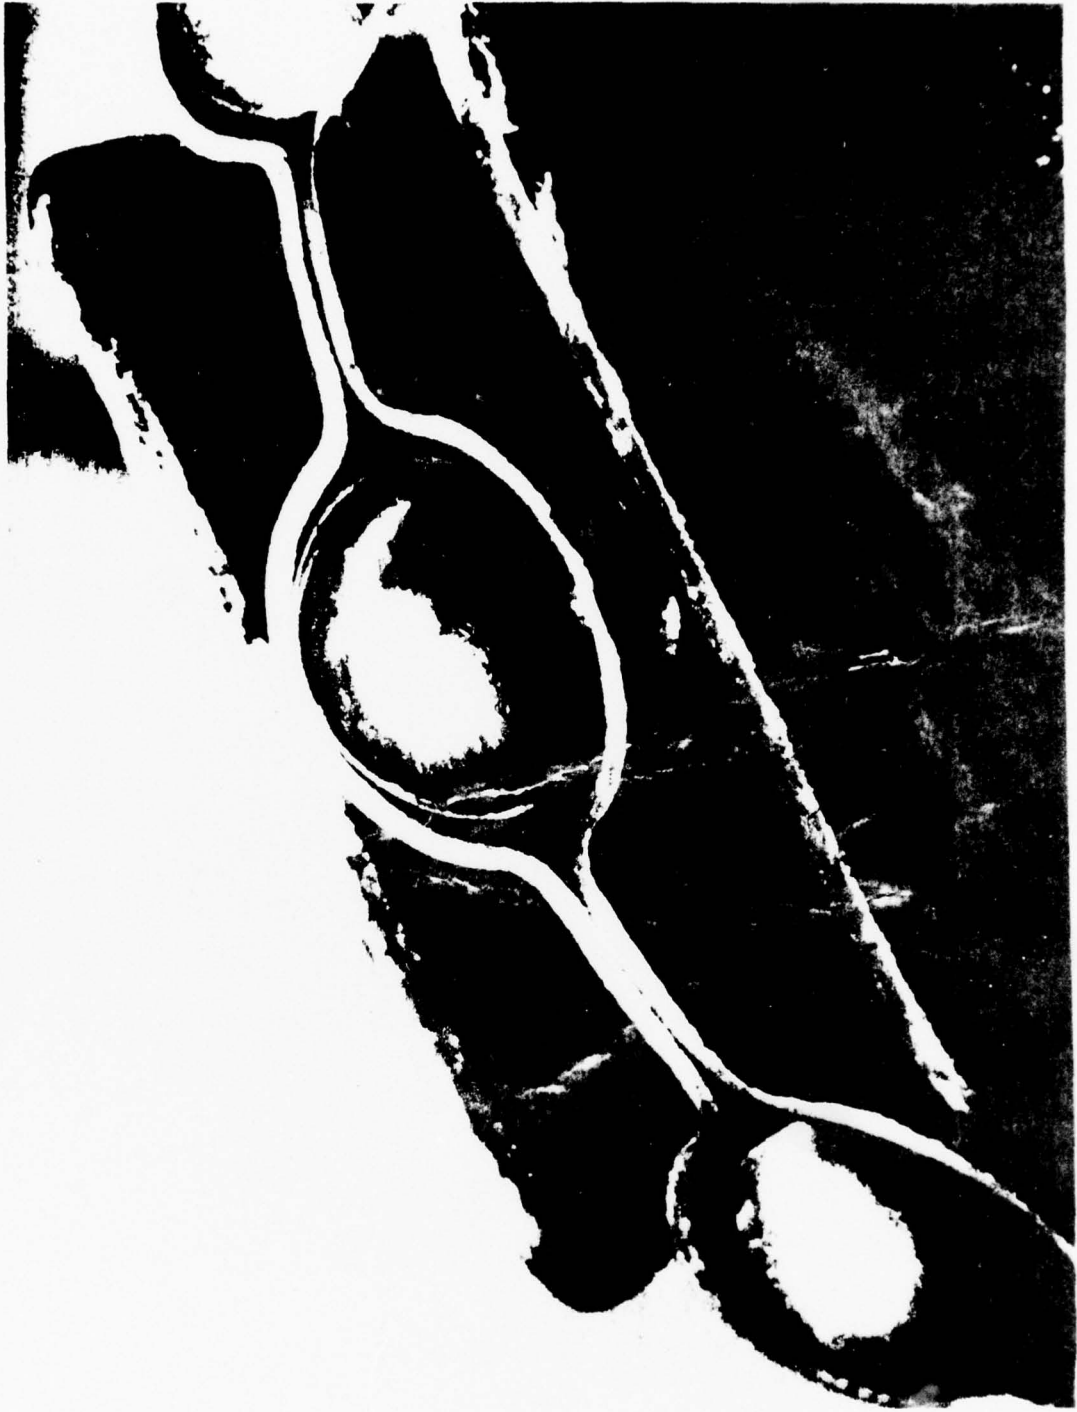
FIG. 13C

A20-43391 - Corrosion on Ball:

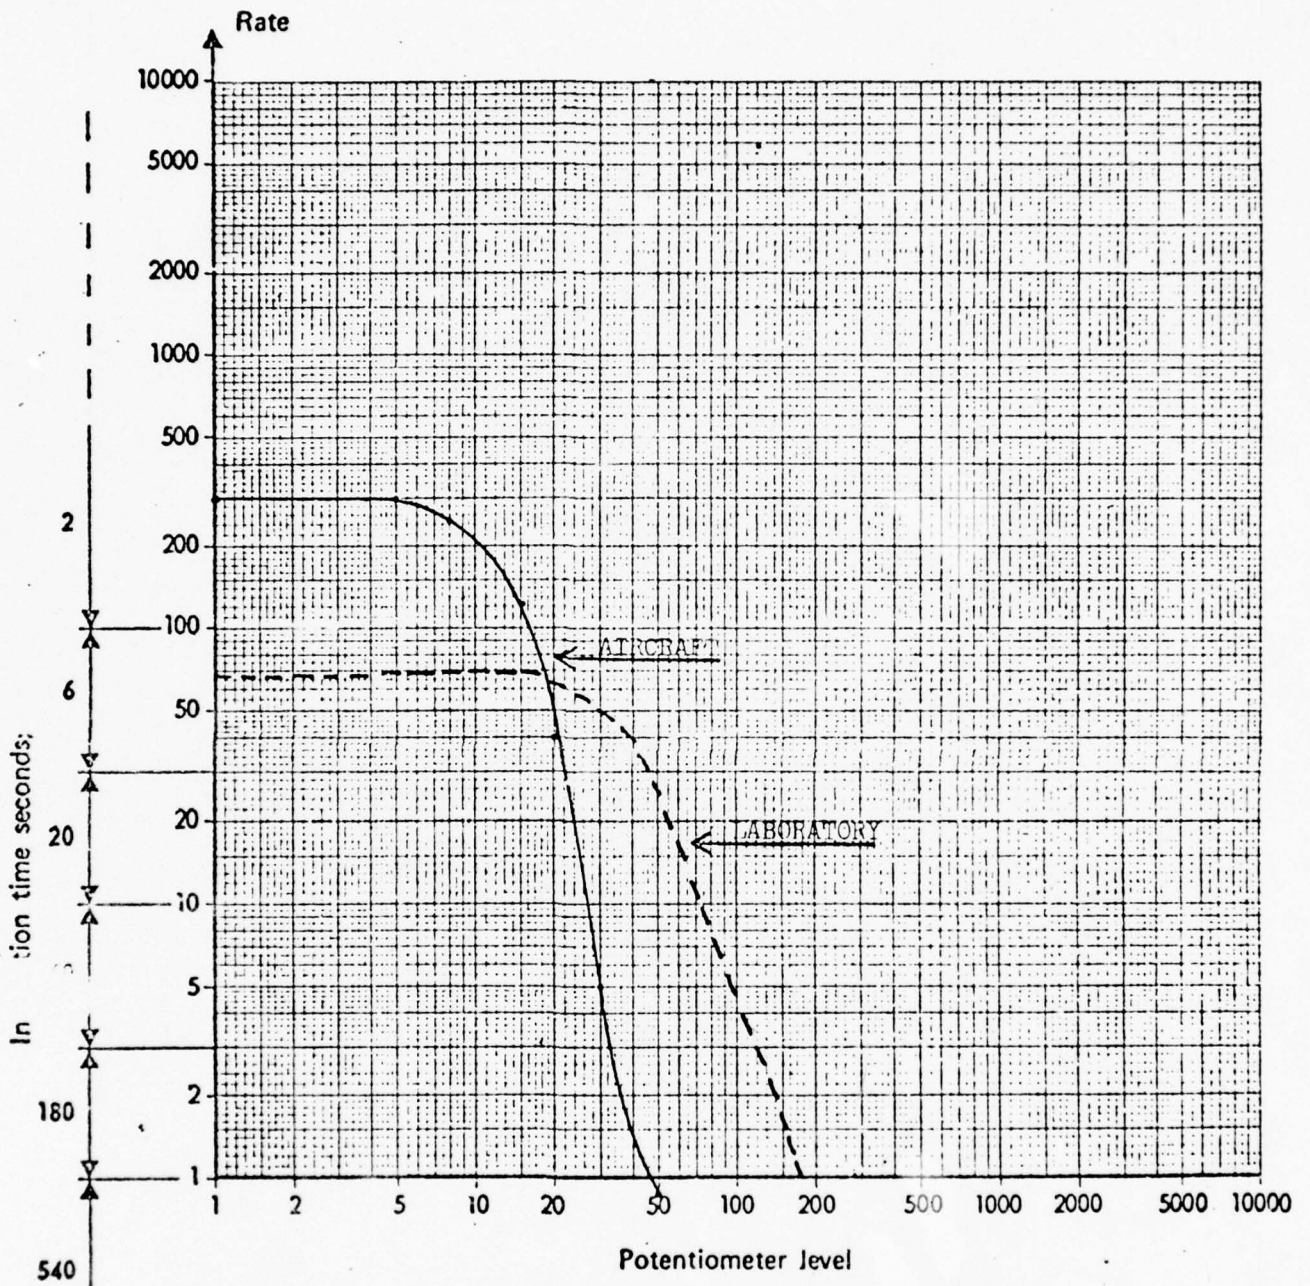
FIG. 14

Of interest, is the data presented in Figure 14. According to the plotted data, the bearing would be classified as satisfactory. However, the bearing was removed by an aircraft technical inspector due to "excessive play." Also shown is data collected from the same bearing on the laboratory bench set-up. The data still appears satisfactory and the teardown analysis did not show significant damage level.

GRAPH OF BEARING #A2037362 WHICH WAS REMOVED FOR ANALYSIS BECAUSE OF EXCESSIVE PLAY DISCOVERED BY AN AIRCRAFT TECHNICAL INSPECTOR - ONE GRAPH MADE ON AIRCRAFT, THE OTHER IN LABORATORY AT APPROXIMATELY THE SAME RPM. (14 DEC 1973).

Very light pitting was evident in both the inner and outer race. No defects were found in the balls according to the Bell Helicopter report and no pictures were taken of the bearing.

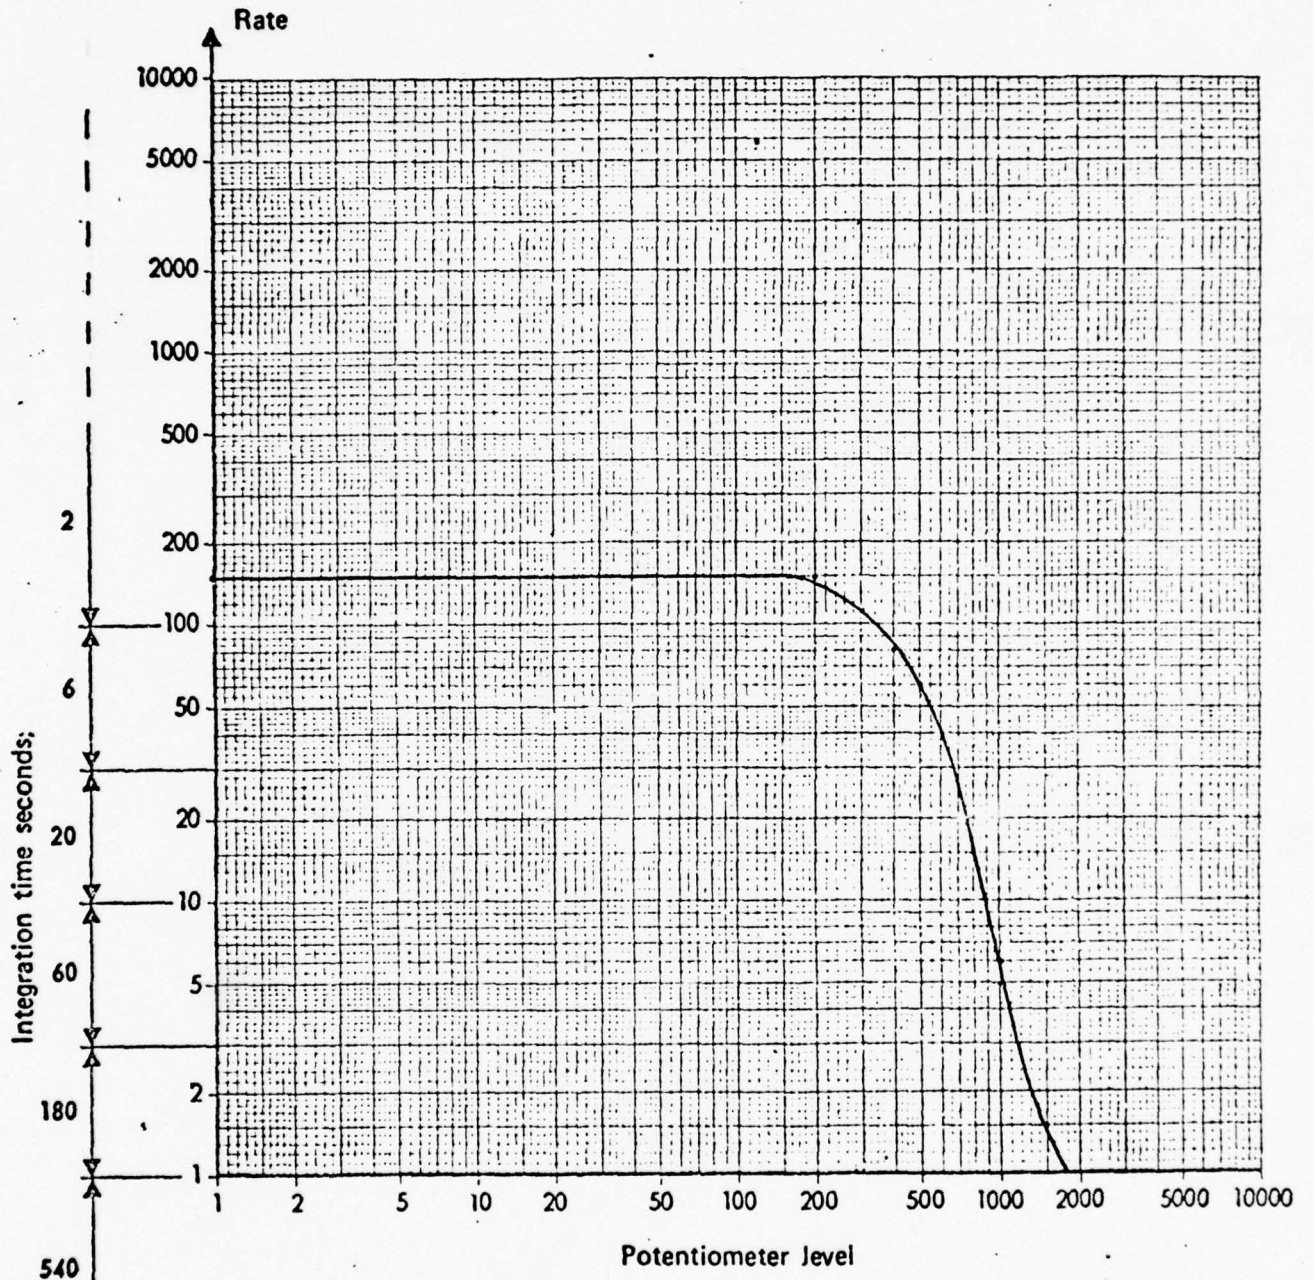
FIG. 15

BEARING SERIAL #A20-64495 REMOVED FOR PHYSICAL ANALYSIS/EXCESSIVE POTENTIOMETER LEVELS NORMAL RATES OF SHOCK.

Both the outer and inner race of the bearing showed evidence of corrosion and pitting. Corrosion was also apparent on several of the balls of this bearing.

The MEPA-10A analysis revealed an excessive potentiometer level of approximately 1800. We would consider a level this high cause for replacement.

The pictorial evidence of damage on the outer race and balls appears to definitely warrant a replacement of this assembly.

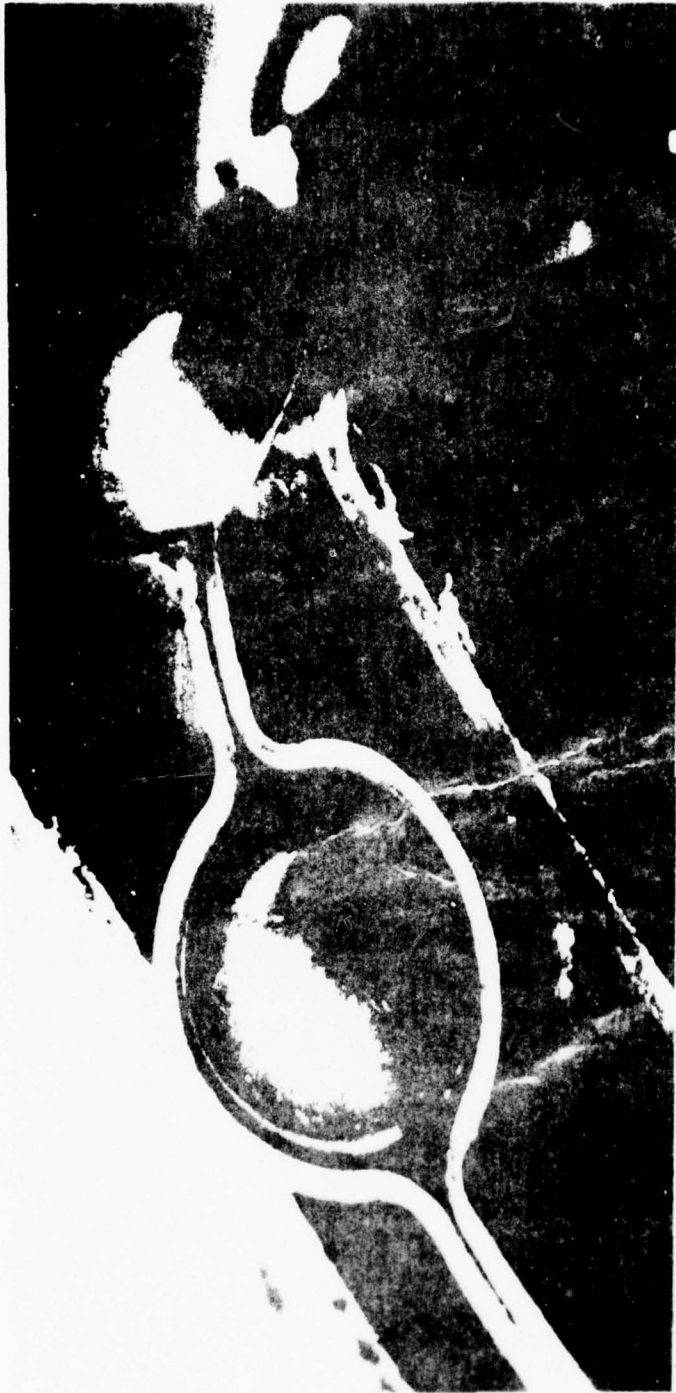
FIG. 15B

A20-64495 - Corrosion
Damage on Ball Bearing.

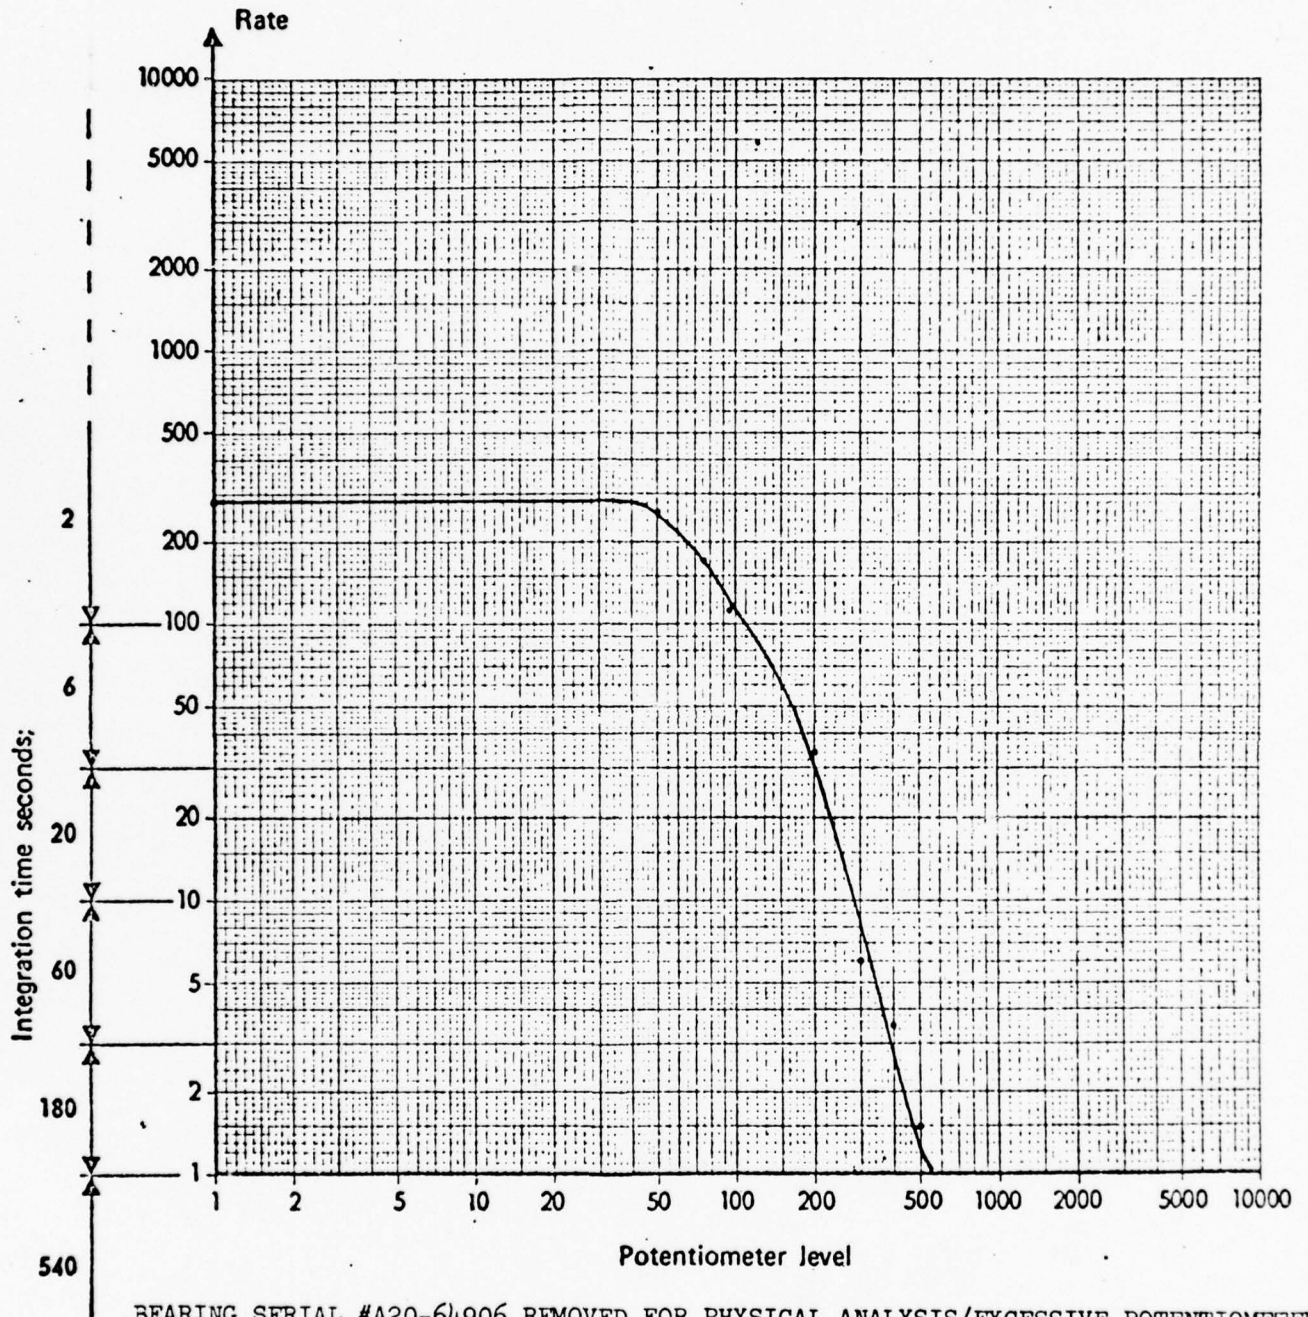
FIG. 16

BEARING SERIAL #A20-64906 REMOVED FOR PHYSICAL ANALYSIS/EXCESSIVE POTENTIOMETER LEVELS.

Pitting was evident in the outer race of this bearing as well as corrosion and pitting on one ball of the rolling element. No defects were found in the inner race of the bearing.

The MEPA-10A shock depiction had a level of 550 and rate of 290. This rate and level while higher than the mean level measured, would not be considered excessive but would be considered approaching an unacceptable condition.

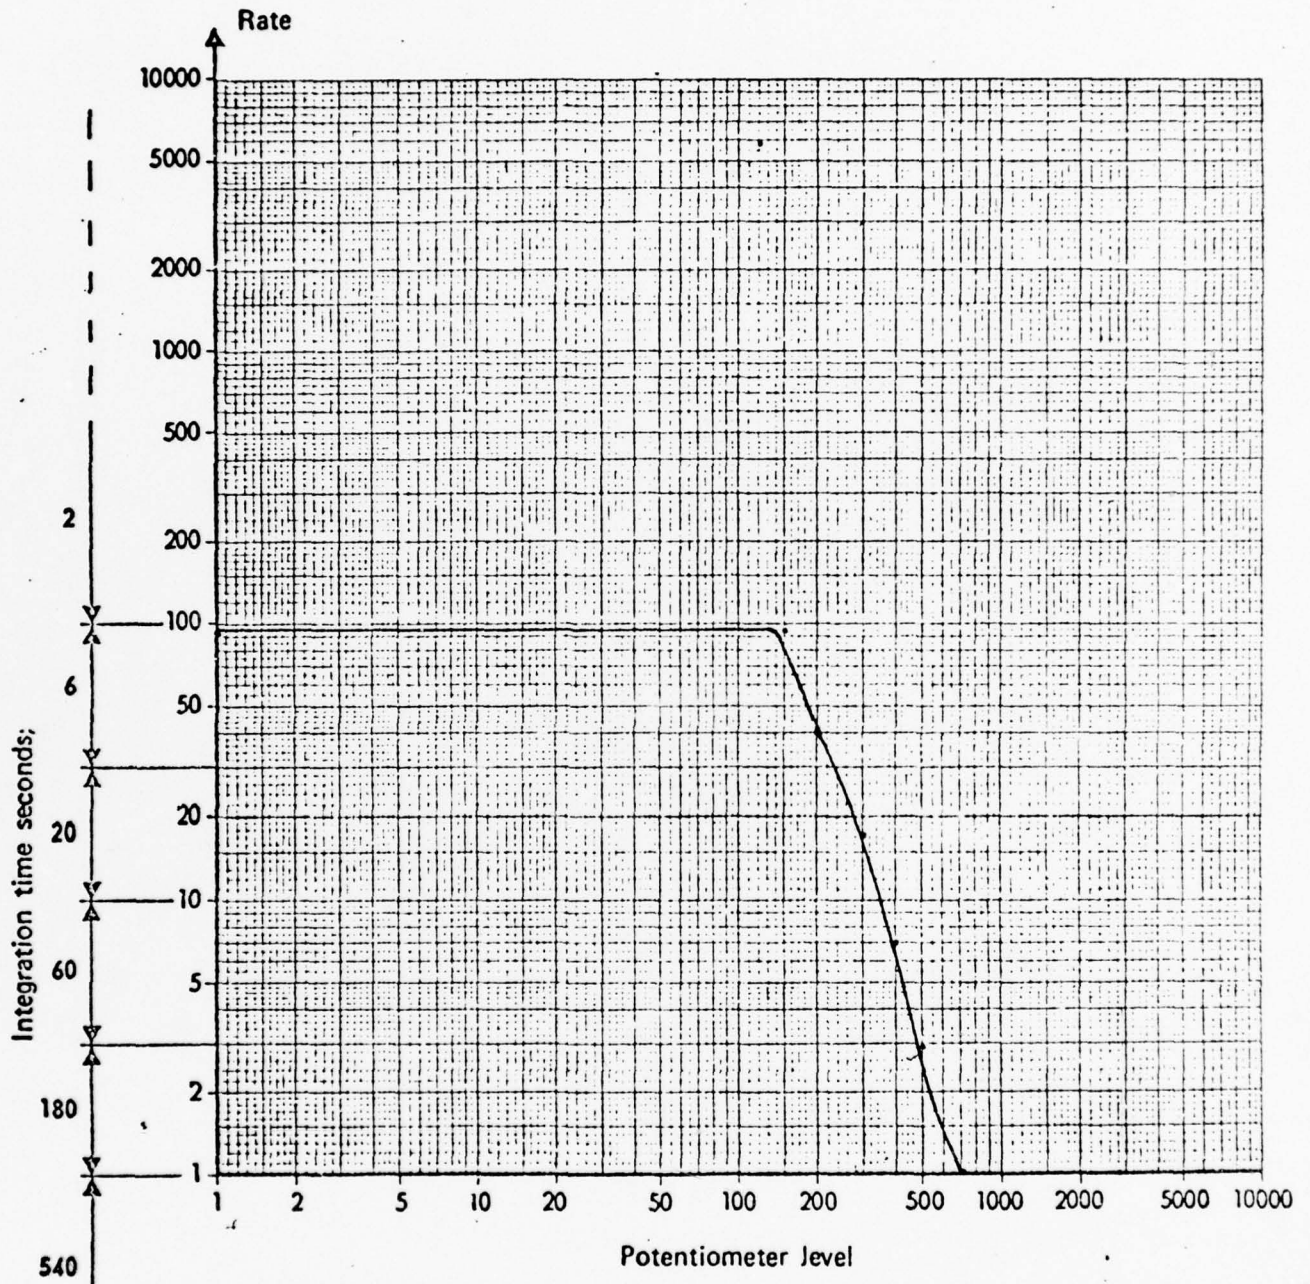
FIG. 17

RATE APPEARED LESS THAN NORMAL WITH POTENTIOMETER LEVEL IN EXCESS OF NORMAL. BEARING WAS NOT REMOVED FOR PHYSICAL ANALYSIS.

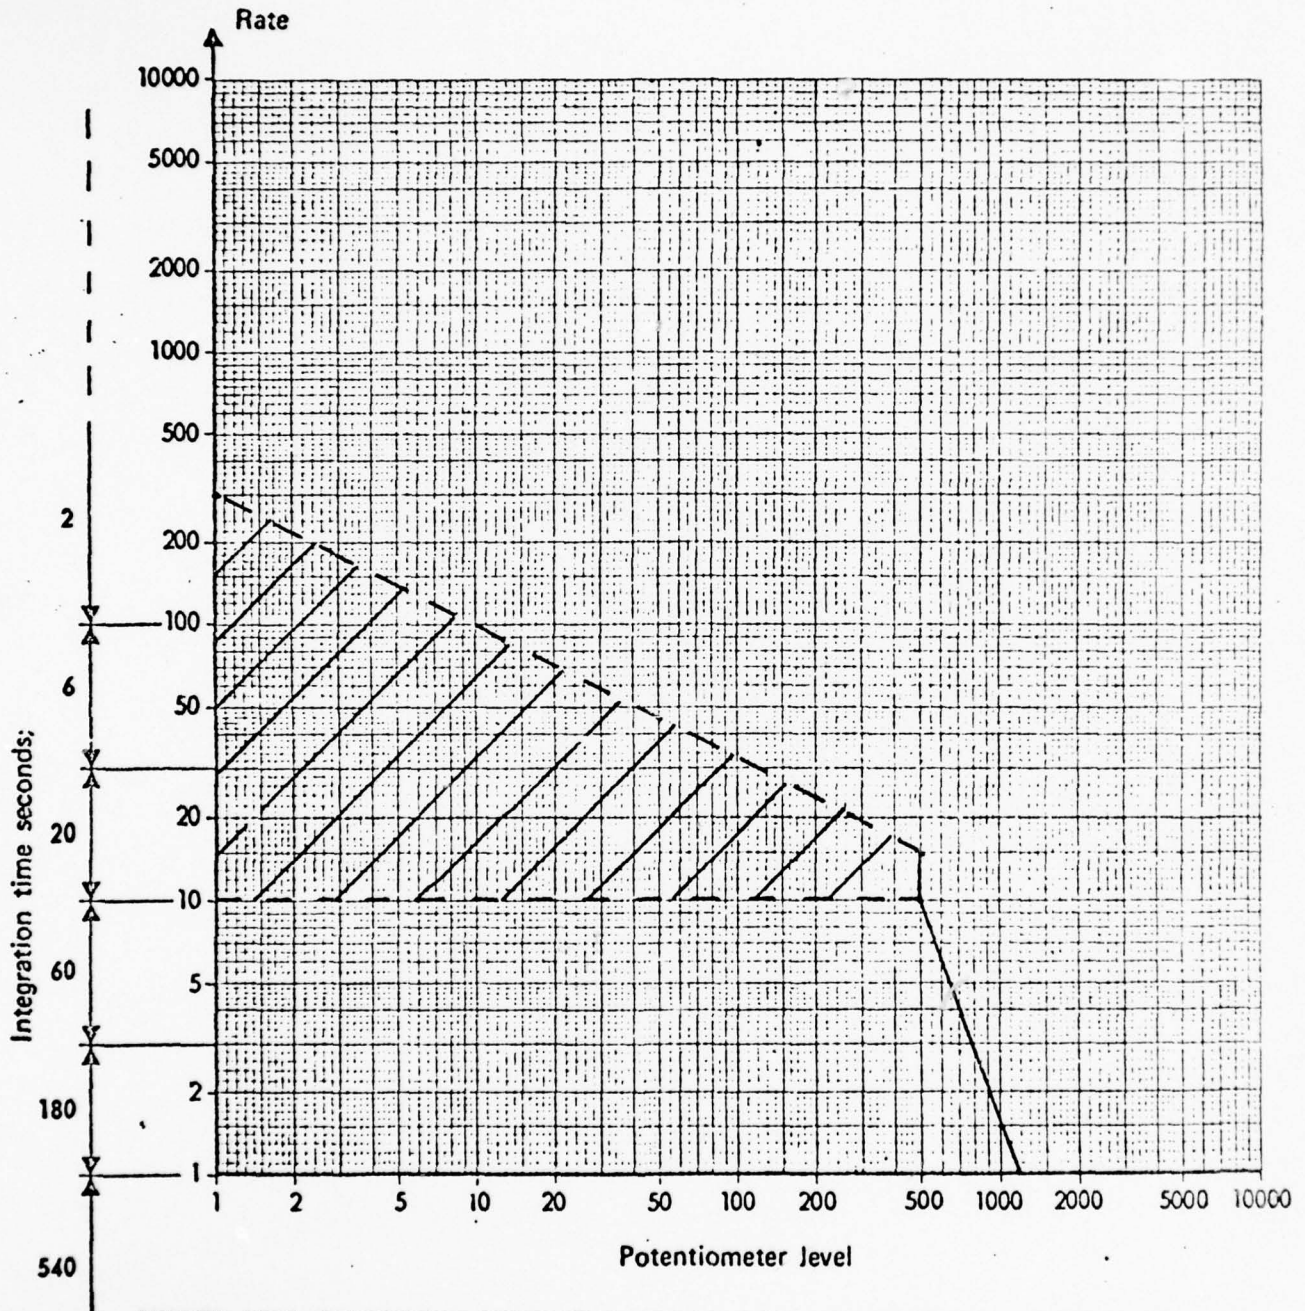
FIG. 19

Hanger Bearing Serial #A20-11446 (Fig. 10) was removed for analysis because of the high potentiometer level of 1200 plotted and the excessive needle swing present in plotting the curve. This was the only hanger bearing which manifested such excessive needle swing on the MEPA-10A shock analysis. Reviewing the teardown data from BHC, a general good condition is reported with the only damage being corrosion in two places

in the outer race. The inability to plot a smooth curve for this hanger bearing cannot be explained at this time. It is the only assembly tested which appears not to correlate with the teardown evidence. On several occasions, needle swing was found in plotting a portion of the curve in the analysis of gearbox assemblies. The swing in these cases was minimal and usually confined to between two or three points on the curve, not the entire curve. More data should be collected to determine how this needle swing affects curve plotting and whether temperature or low electric power supply could be the cause of excessive swing. The slight needle swing found in some of the gearbox assemblies, it is felt, could be because of the multiple bearing and gear assemblies present in the quills as well as accelerometer placement.

SHADED AREA REPRESENTS EXCESSIVE NEEDLE SWING ON MEPA-10A - BEARING REMOVED FOR ANALYSIS.

Teardown analysis yielded a bearing condition described as "general condition good, bearing feels smooth."

Some corrosion is evident in two places in the outer race. The teardown data indicates a bearing in normal condition.

The MEPA-10A analysis shows an excessive needle swing in rate depiction ranging from a rate of 10 to 300. The potentiometer level of 1200 would be considered high and excessive when compared to the other bearings evaluated. It was for this reason the assembly was removed for analysis. The cause of excessive needle swing in measurement of shock rate is not known. The plot of this bearing was not made up of defined points which the curve developed through, and thus differs from other bearings which exhibited some needle movement. Teardown information would lead to the conclusion that the bearings was in a serviceable condition.

The ability of the MEPA-10A to plot a curve of shock emission which did not have the erratic nature seen in this curve is desirable, in order to confirm the bearing condition. Possible reasons for the excessive needle swing includes an ambient air temperature below 30°F and the possibility of a less than sufficient power source.

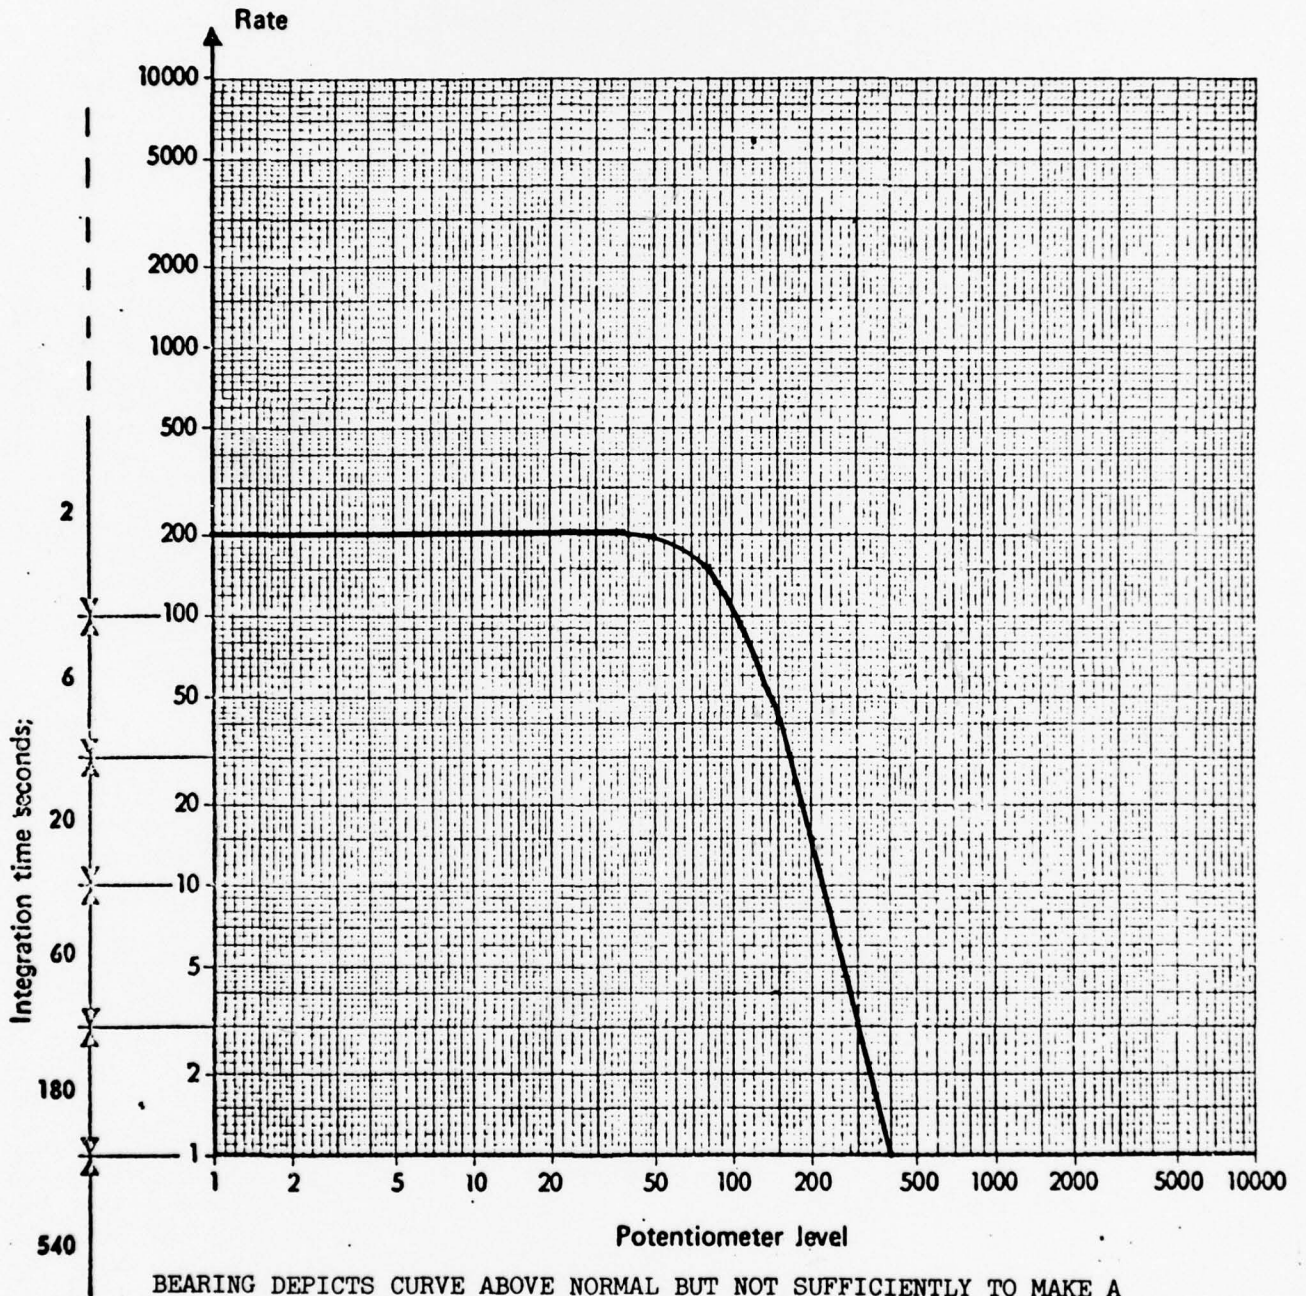
FIG. 26

BEARING DEPICTS CURVE ABOVE NORMAL BUT NOT SUFFICIENTLY TO MAKE A DETERMINATION THAT THIS BEARING IS EXCESSIVELY DAMAGED.

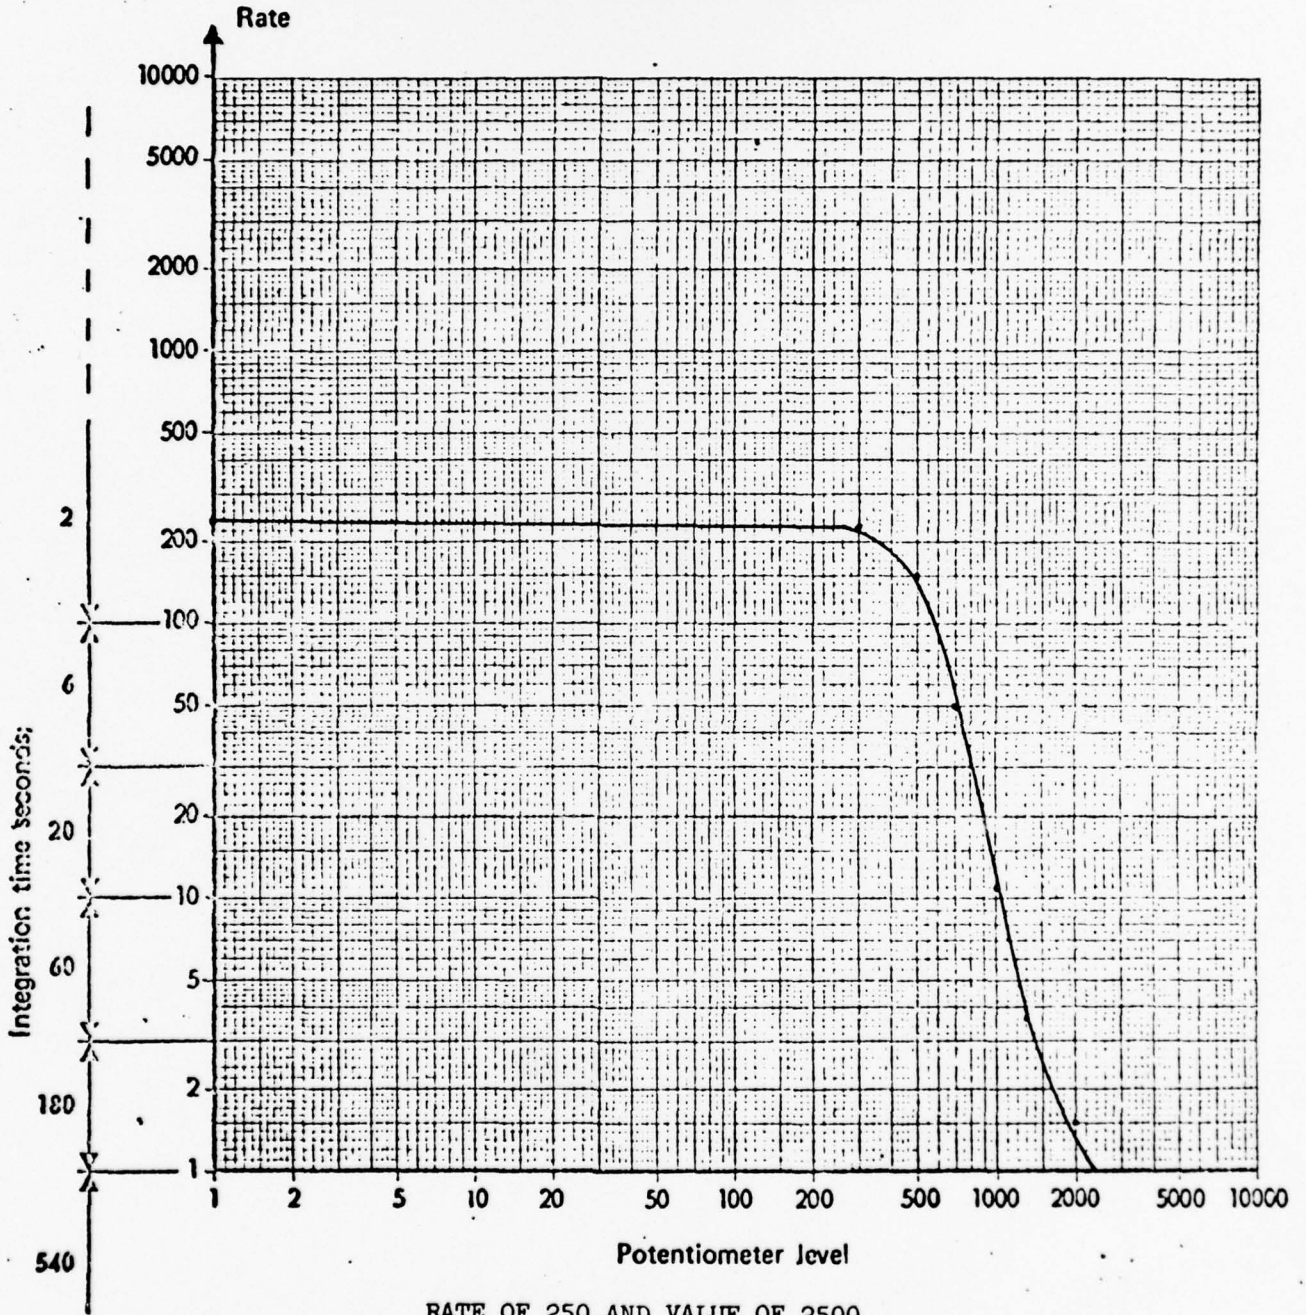
FIG. 29

RATE OF 250 AND VALUE OF 2500
BEARING-REMOVED FOR ANALYSIS

Both corrosion and pitting are evident on the outer race of this bearing. No defects were noted on the inner race, however, the rolling element also had evidence of corrosion and pitting.

The potentiometer level of 2500 reached was the second highest of all bearings tested although the rate attained was not excessive at 250. The plot of the curve derived from the MEPA-10A shock analysis system would warrant the conclusion that this bearing would be considered excessively damaged when compared to the normal amount of shock emission of all bearings tested. Pictured damaged in the outer race would seem to indicate a bearing which was damaged to the point overhaul is warranted.

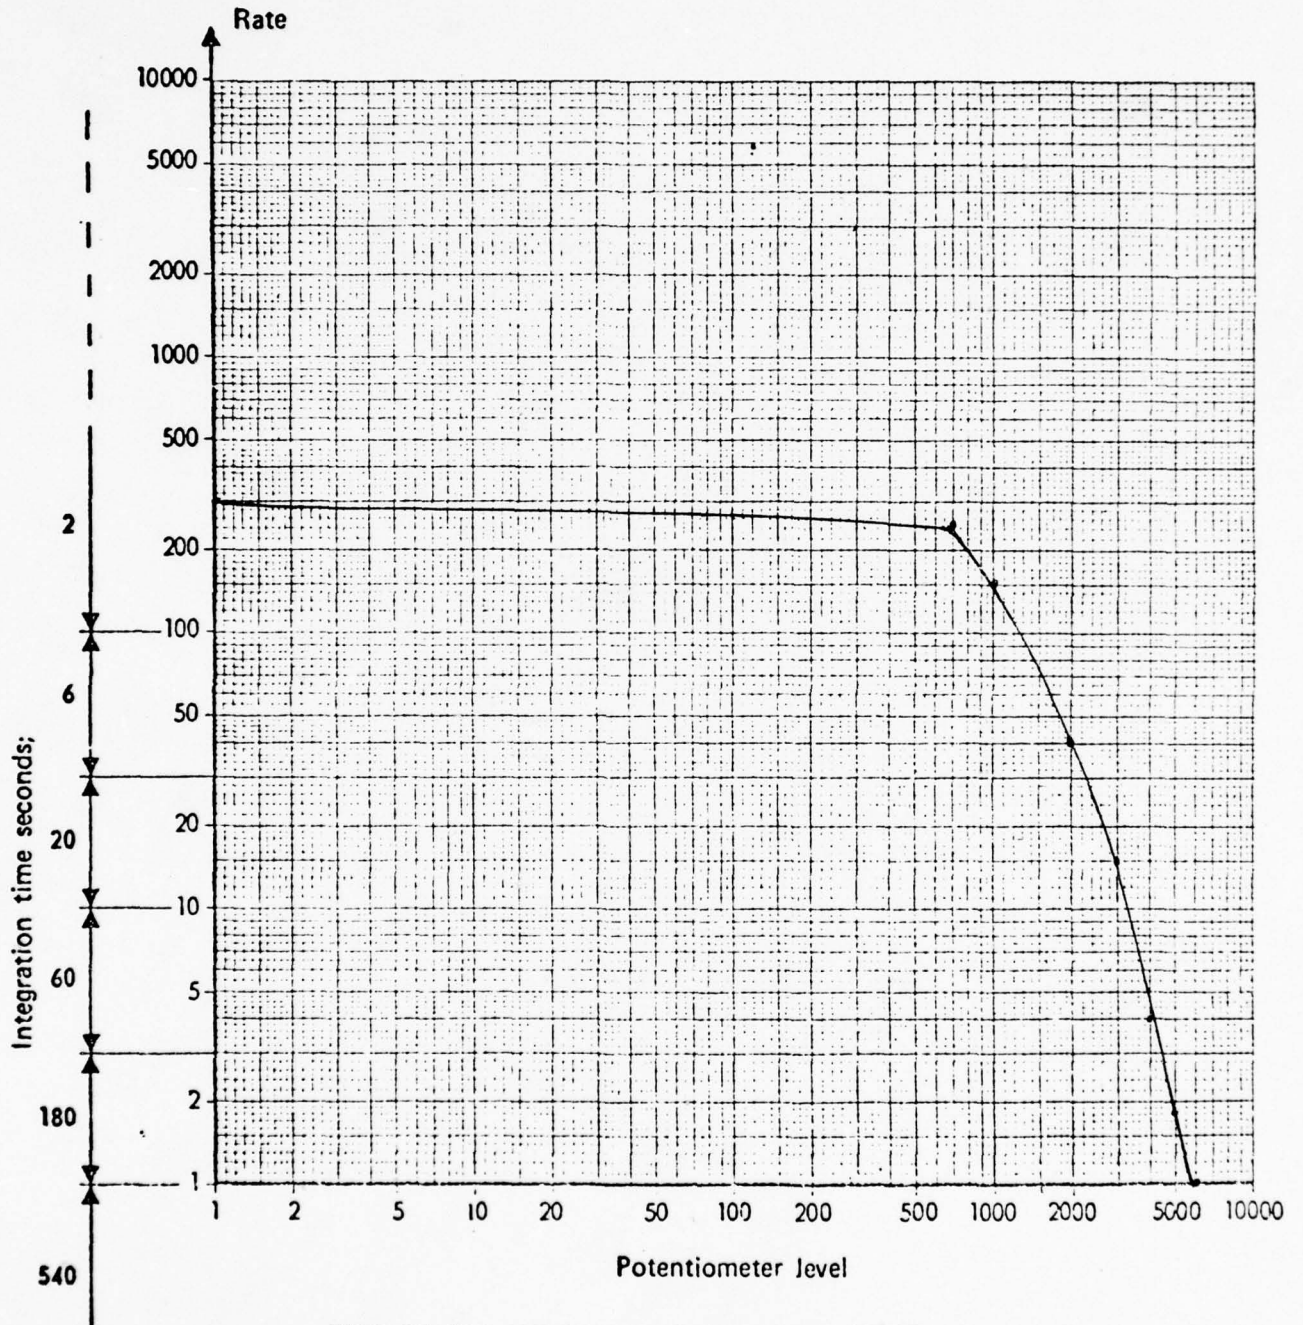
FIG. 30

RATE OF 300 AND VALUE OF EXCESS OF 6,000
BEARING REMOVED FOR ANALYSIS

The teardown report stated "bearing rotated roughly before tear-down." Corrosion and pitting was in evidence in all the bearing elements, inner and outer races as well as rolling element damage. Damage can be clearly seen in the teardown photos and this bearing must be considered as excessively damaged.

The MEPA-10A shock profile showed the highest potentiometer level recorded on this bearing. A level of 6500 should be considered excessive and with the photo and teardown data reviewed, this bearing must be placed in a severely damaged category.

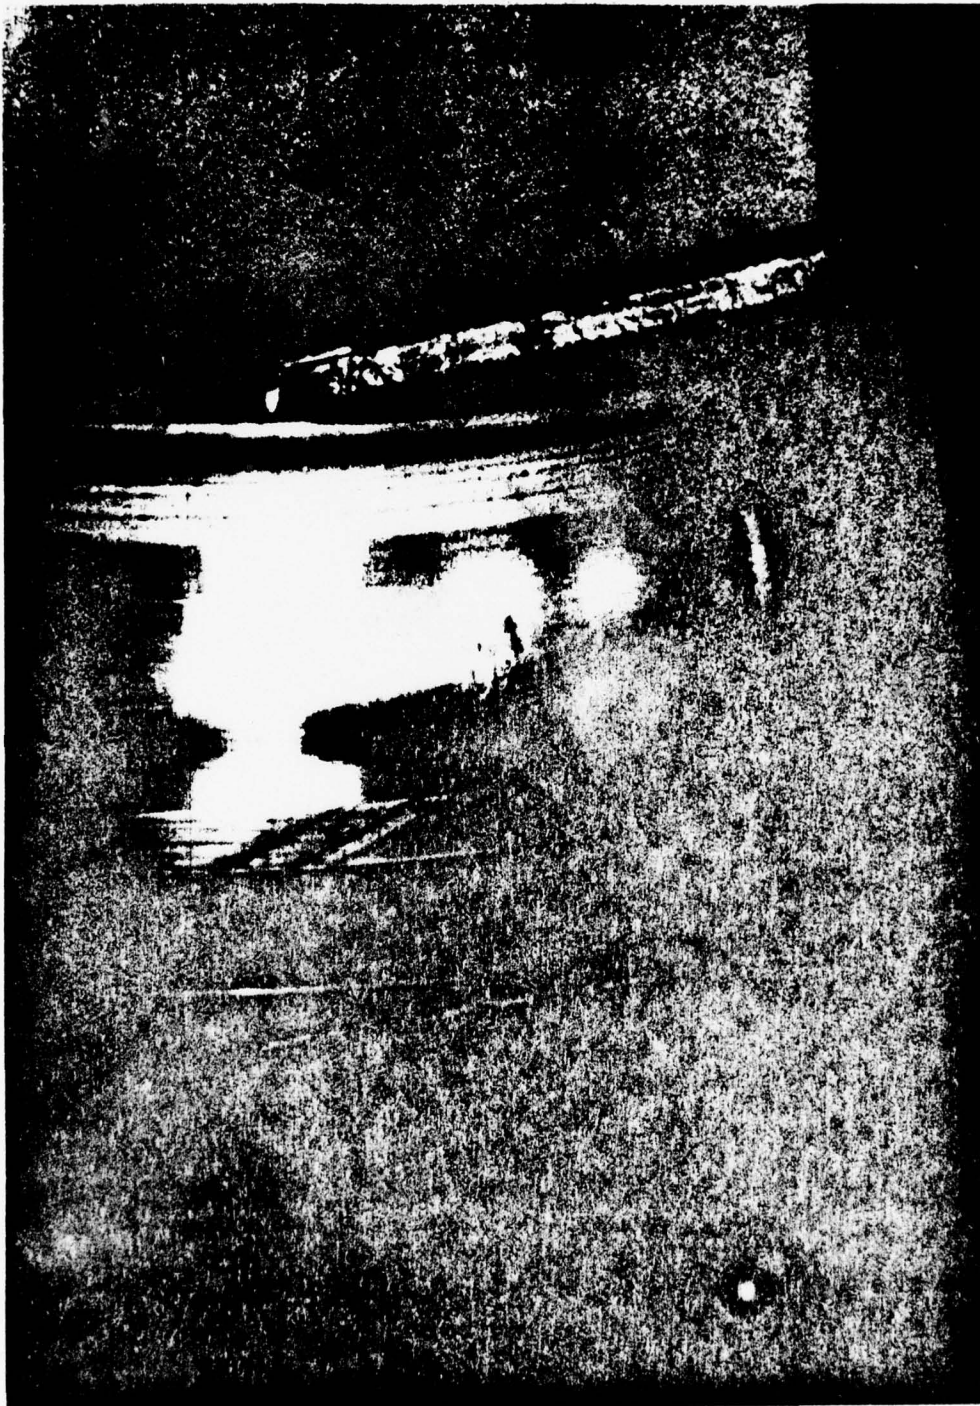
FIG. 30B

A20-31225 - Corrosion and
Pitting on Outer Race.
