USAAVRADCOM TR 78-2

AD A 054906 FIELD EVALUATION OF THE SHOCK PULSE TECHNIQUE TO UH-1H SERIES HELICOPTERS

5 JUNE 1974

FINAL REPORT

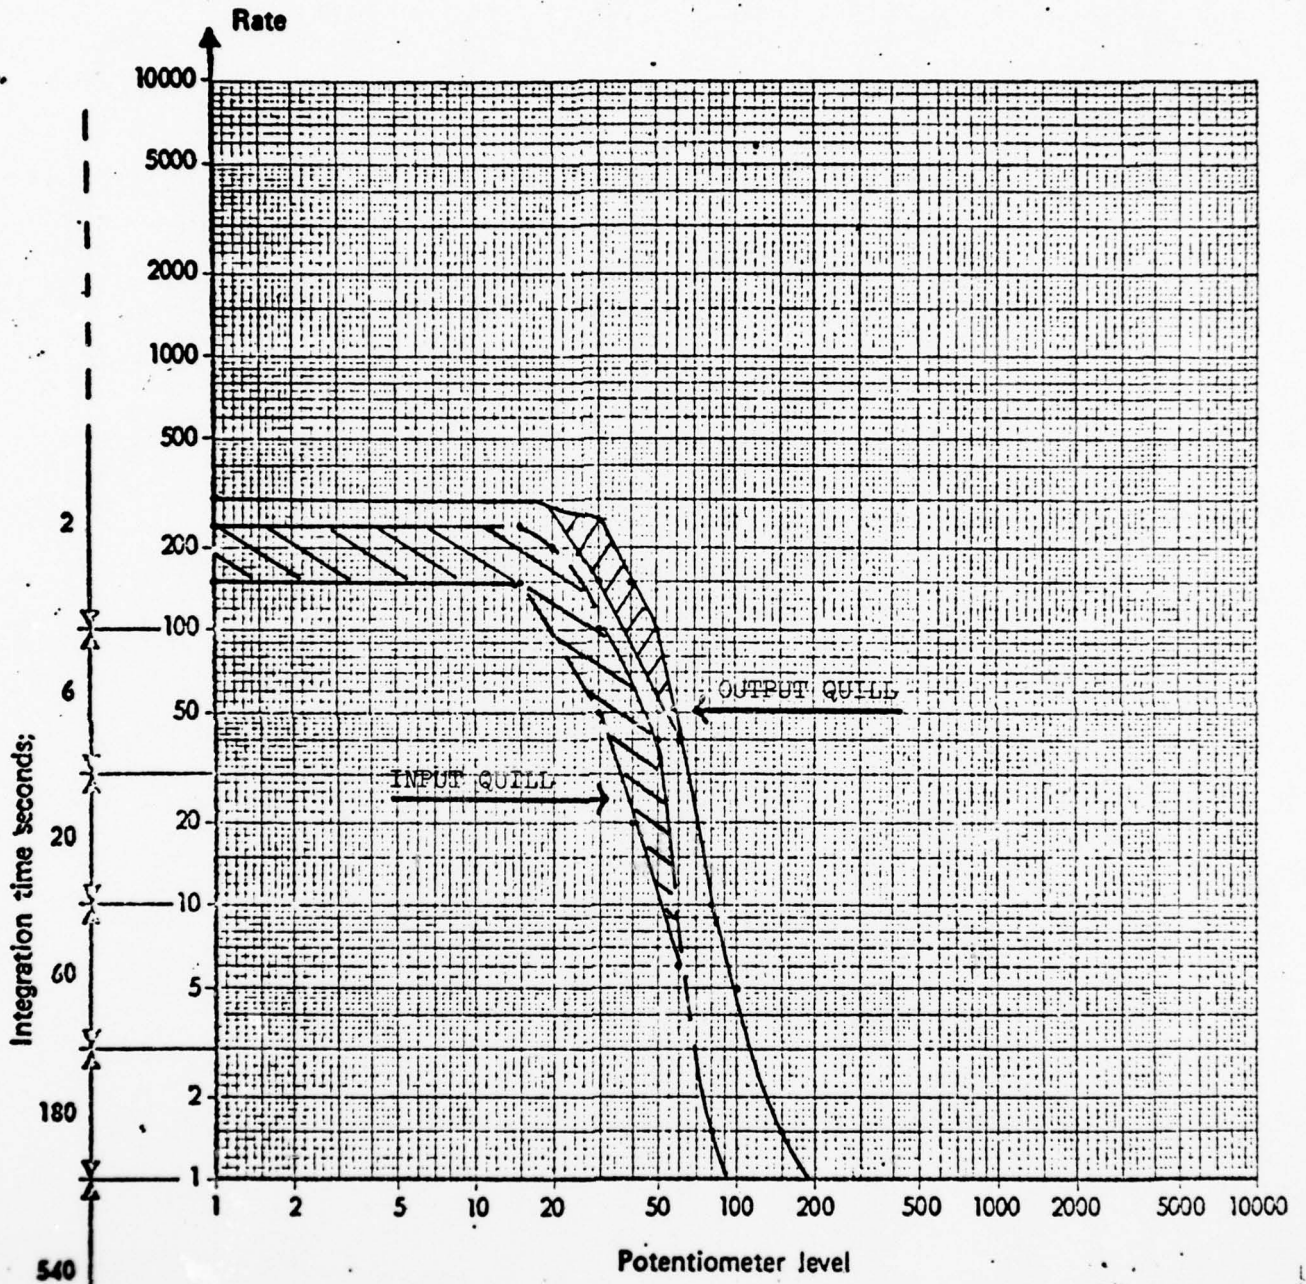
ONE CURVE DEPICTS INPUT DRIVE QUILL, THE OTHER OUTPUT DRIVE QUILL.
GEARBOX REMOVED FOR TEARDOWN ANALYSIS.

Shock emission profiles for both input and output quill packages had some needle swing which was the main reason for removing this gearbox for teardown. There is little difference in the curve shapes of both bearing assemblies and neither had abnormally high rate or potentiometer level. The needle swing in rate analysis was felt could have masked curve irregularities related to bearing damage.

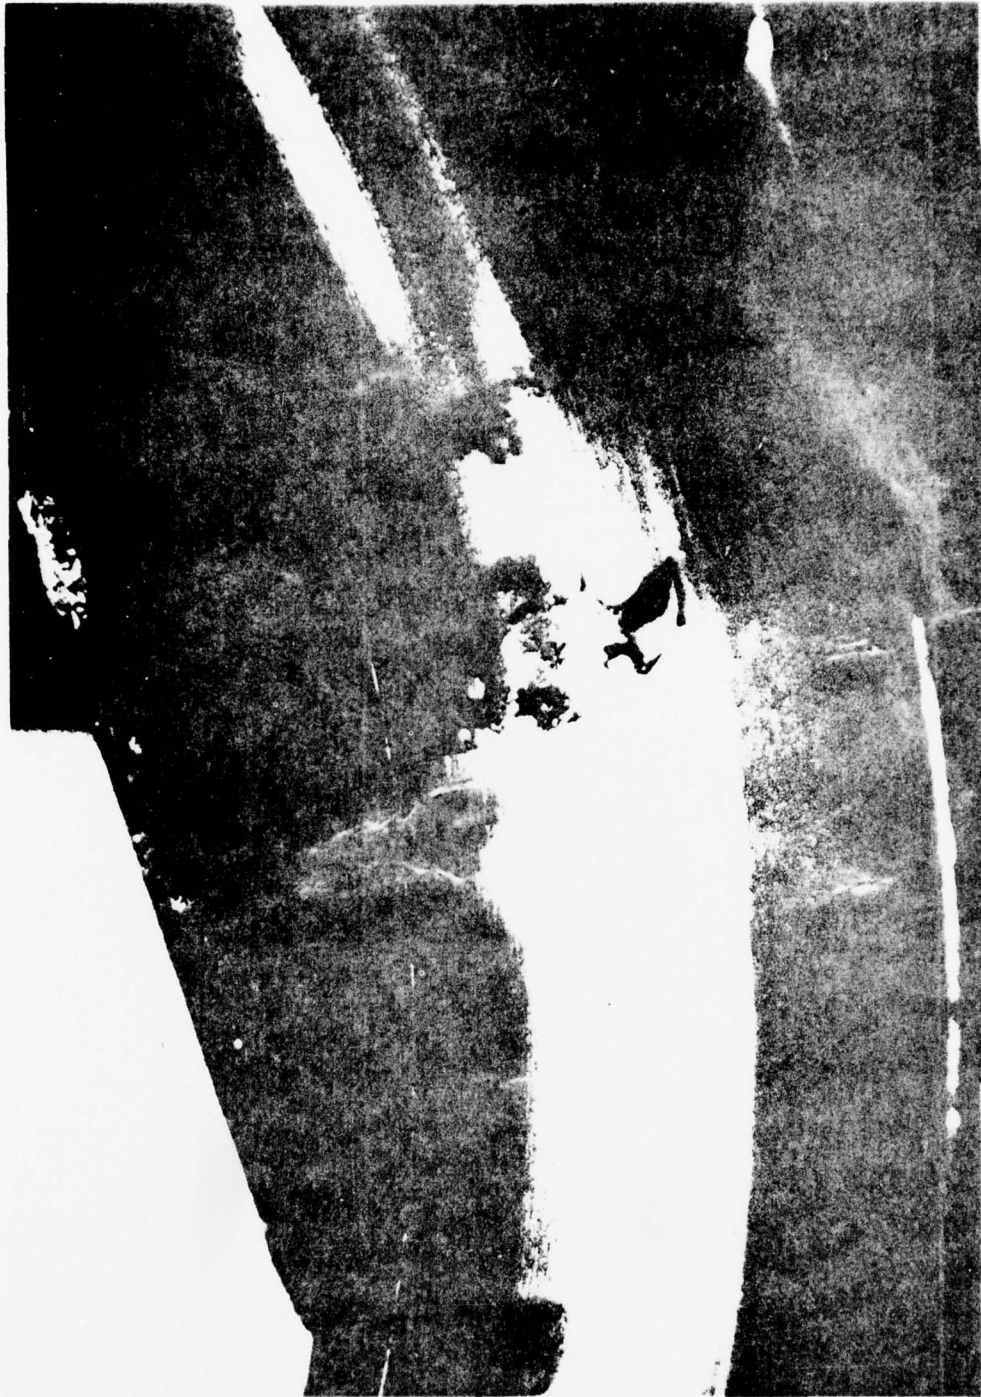
ABB-1101 - Output, Inner Bearing
Corrosion Damage on Outer Race.

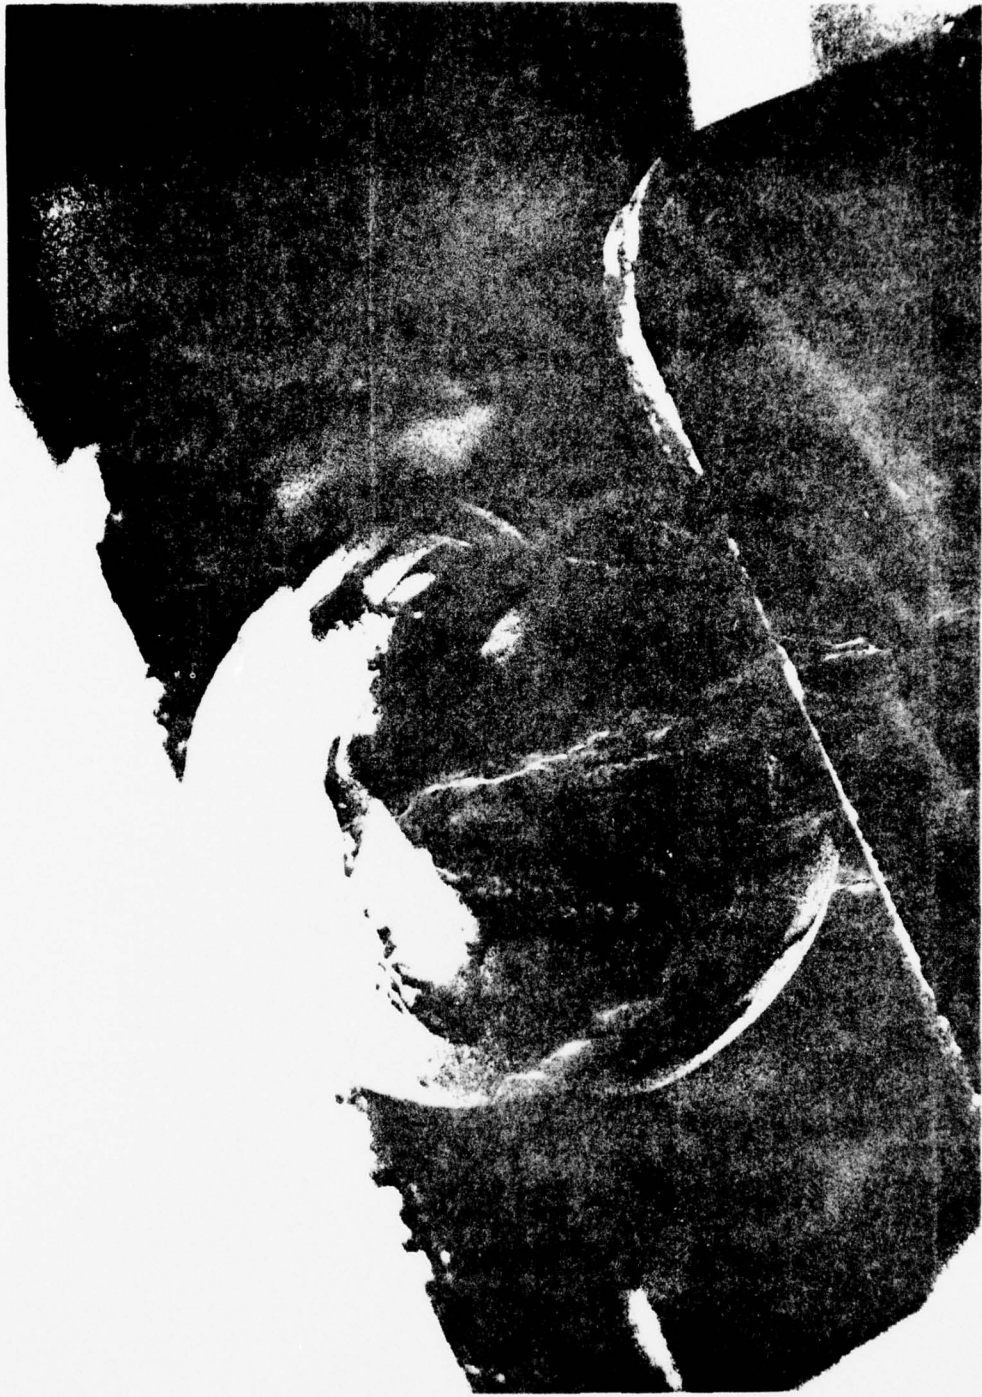
FIG. 38D

ABB-1101 - Output, Inner Bearing,
Corrosion on Ball.

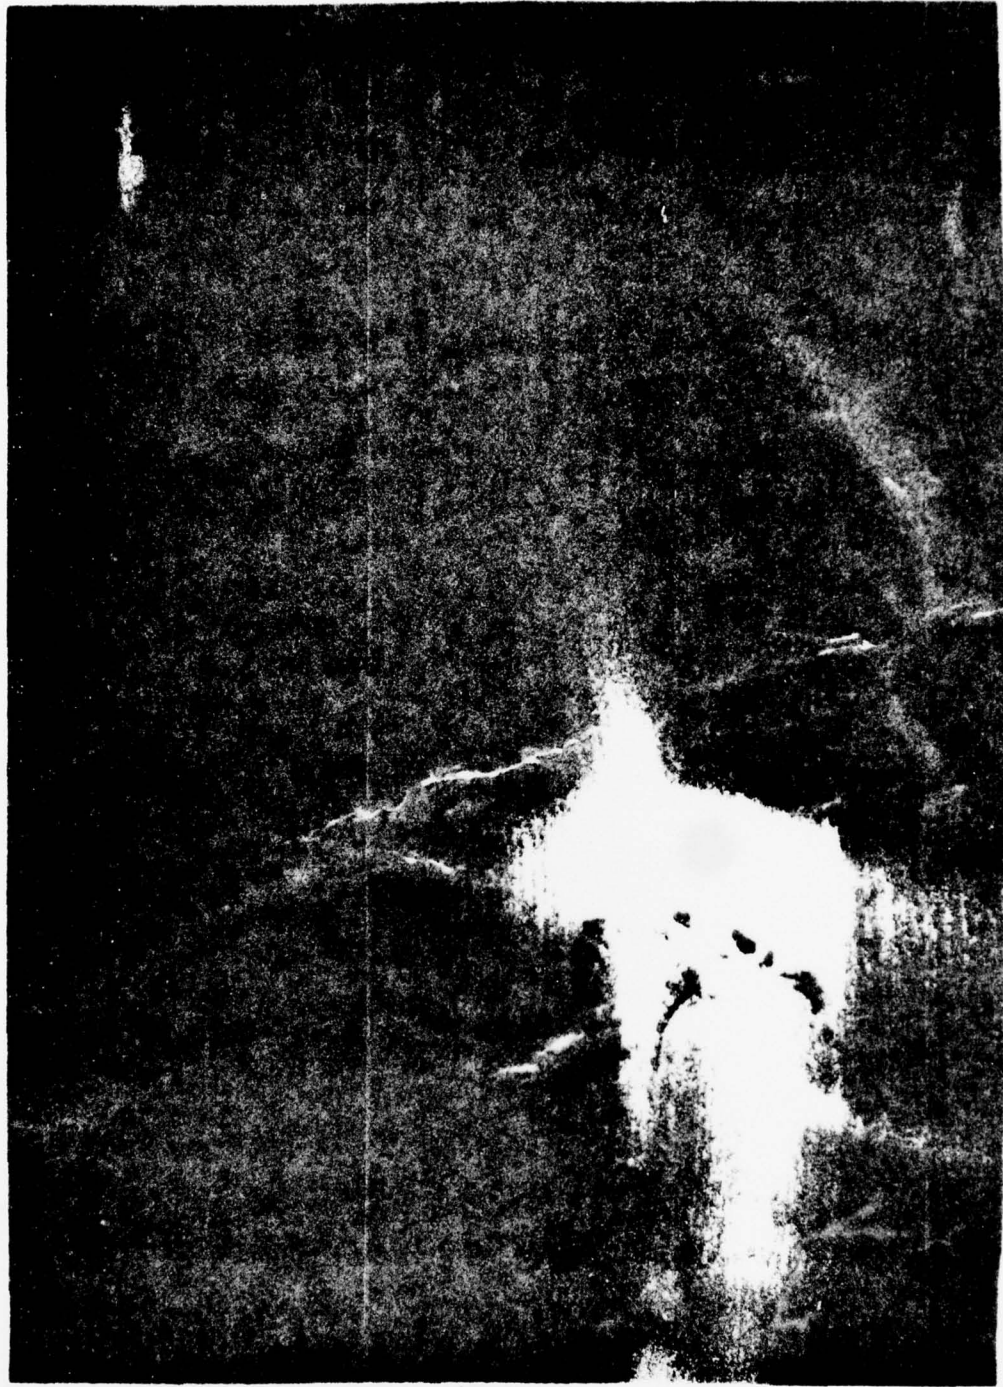
FIG. 38E

ABB-1101 - Output, Outer Bearing,
Corrosion and Pitting on Outer Race.

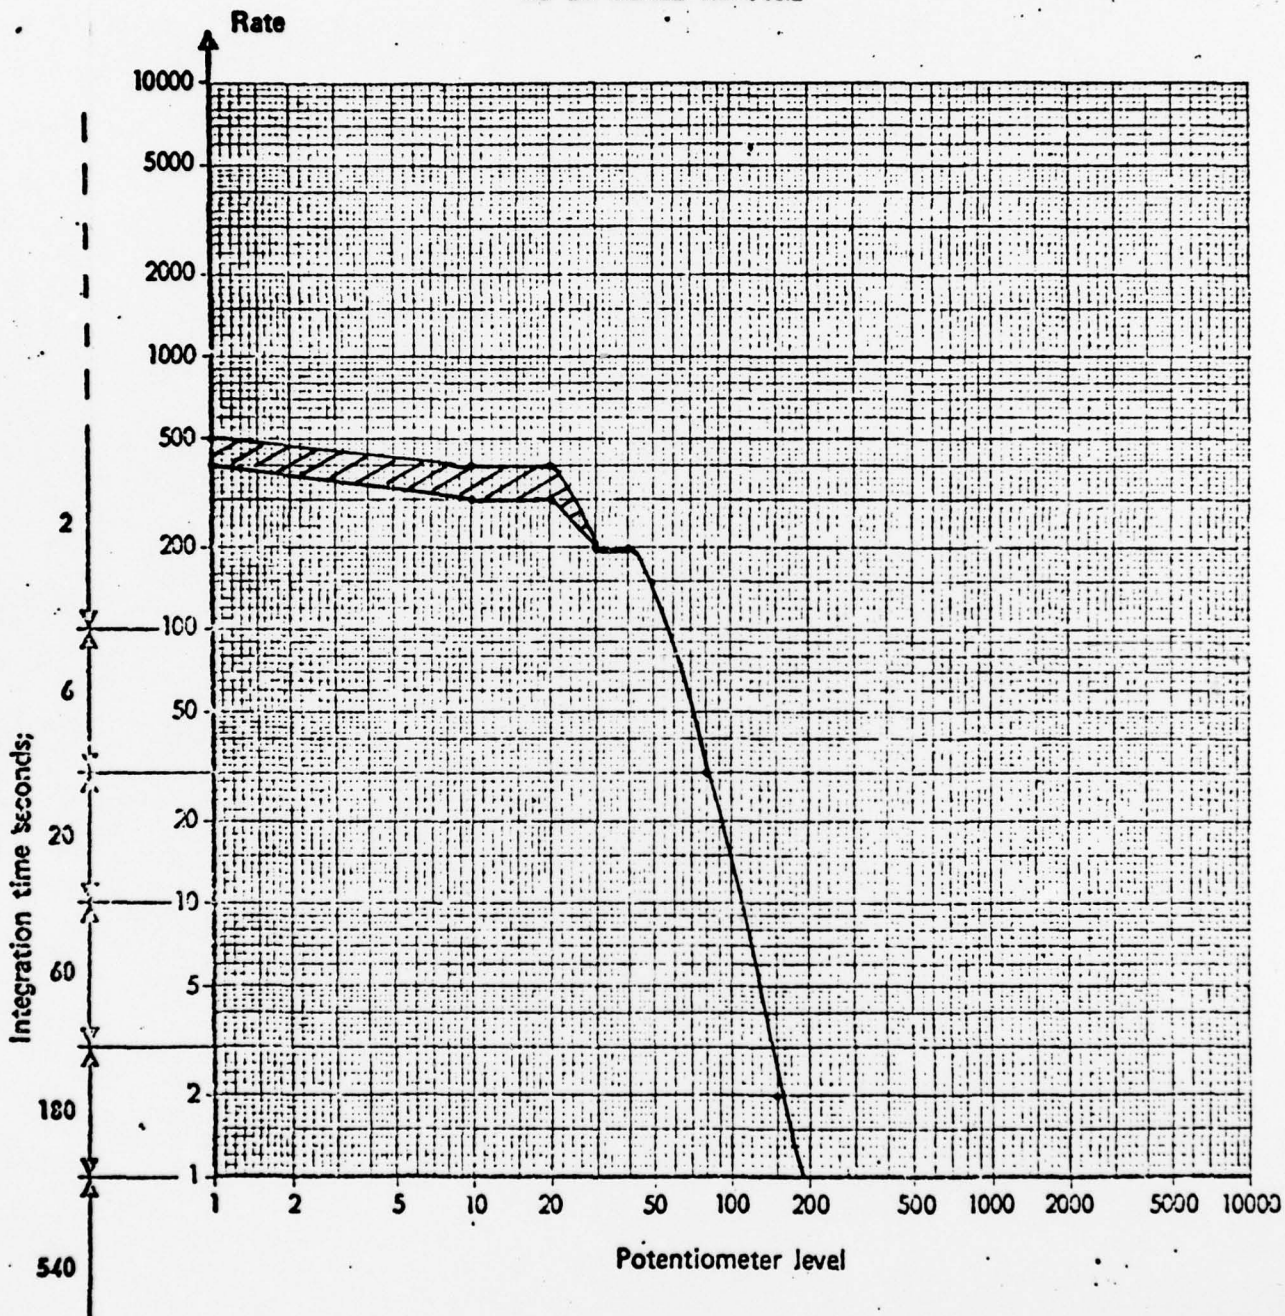
CURVE REPRESENTS THE OUTPUT DRIVE QUILL. GEARBOX REMOVED FOR TEARDOWN ANALYSIS.

The MEPA-10A shock profile of the output bearing of the quill assembly showed some irregularities in the curve shape. Needle swing again accounts for part of the manifested irregularities and the rate of 500 was considered high compared with normal. Teardown information showed that while some damage was evident, no severe damage existed.
