NEW JERSEY  
**BOONTON DAM**

**PARSIPPANY DIKE**

**PHASE I INSPECTION REPORT**

**NATIONAL DAM SAFETY PROGRAM**

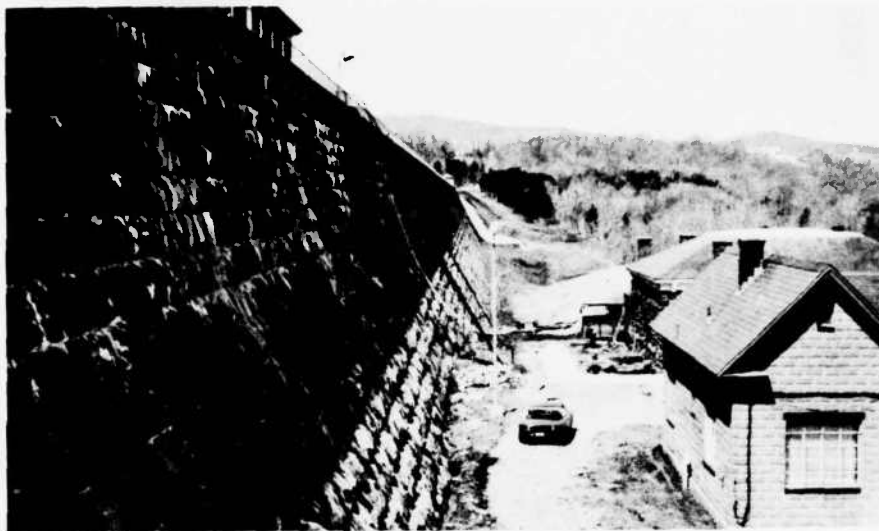
VIEW ALONG DOWNSTREAM FACE OF DAM

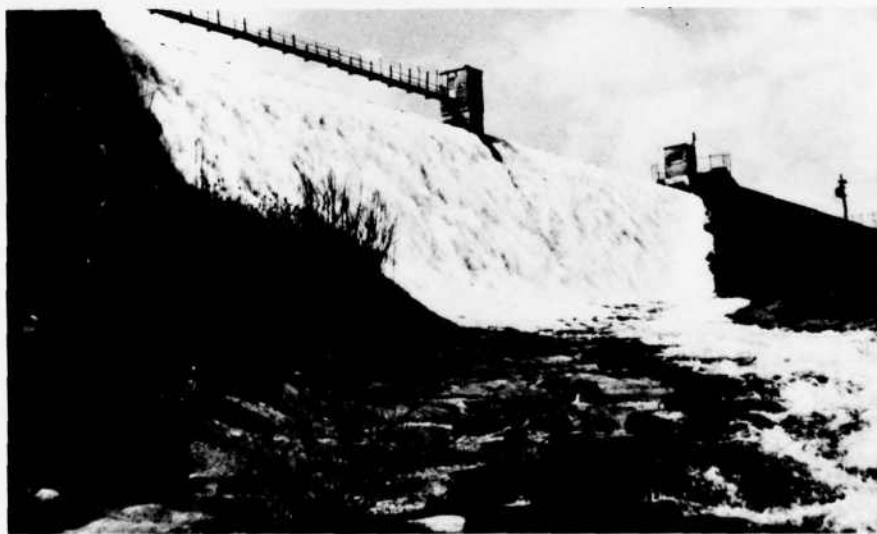
OVERFLOW SPILLWAY AND DOWNSTREAM CHANNEL

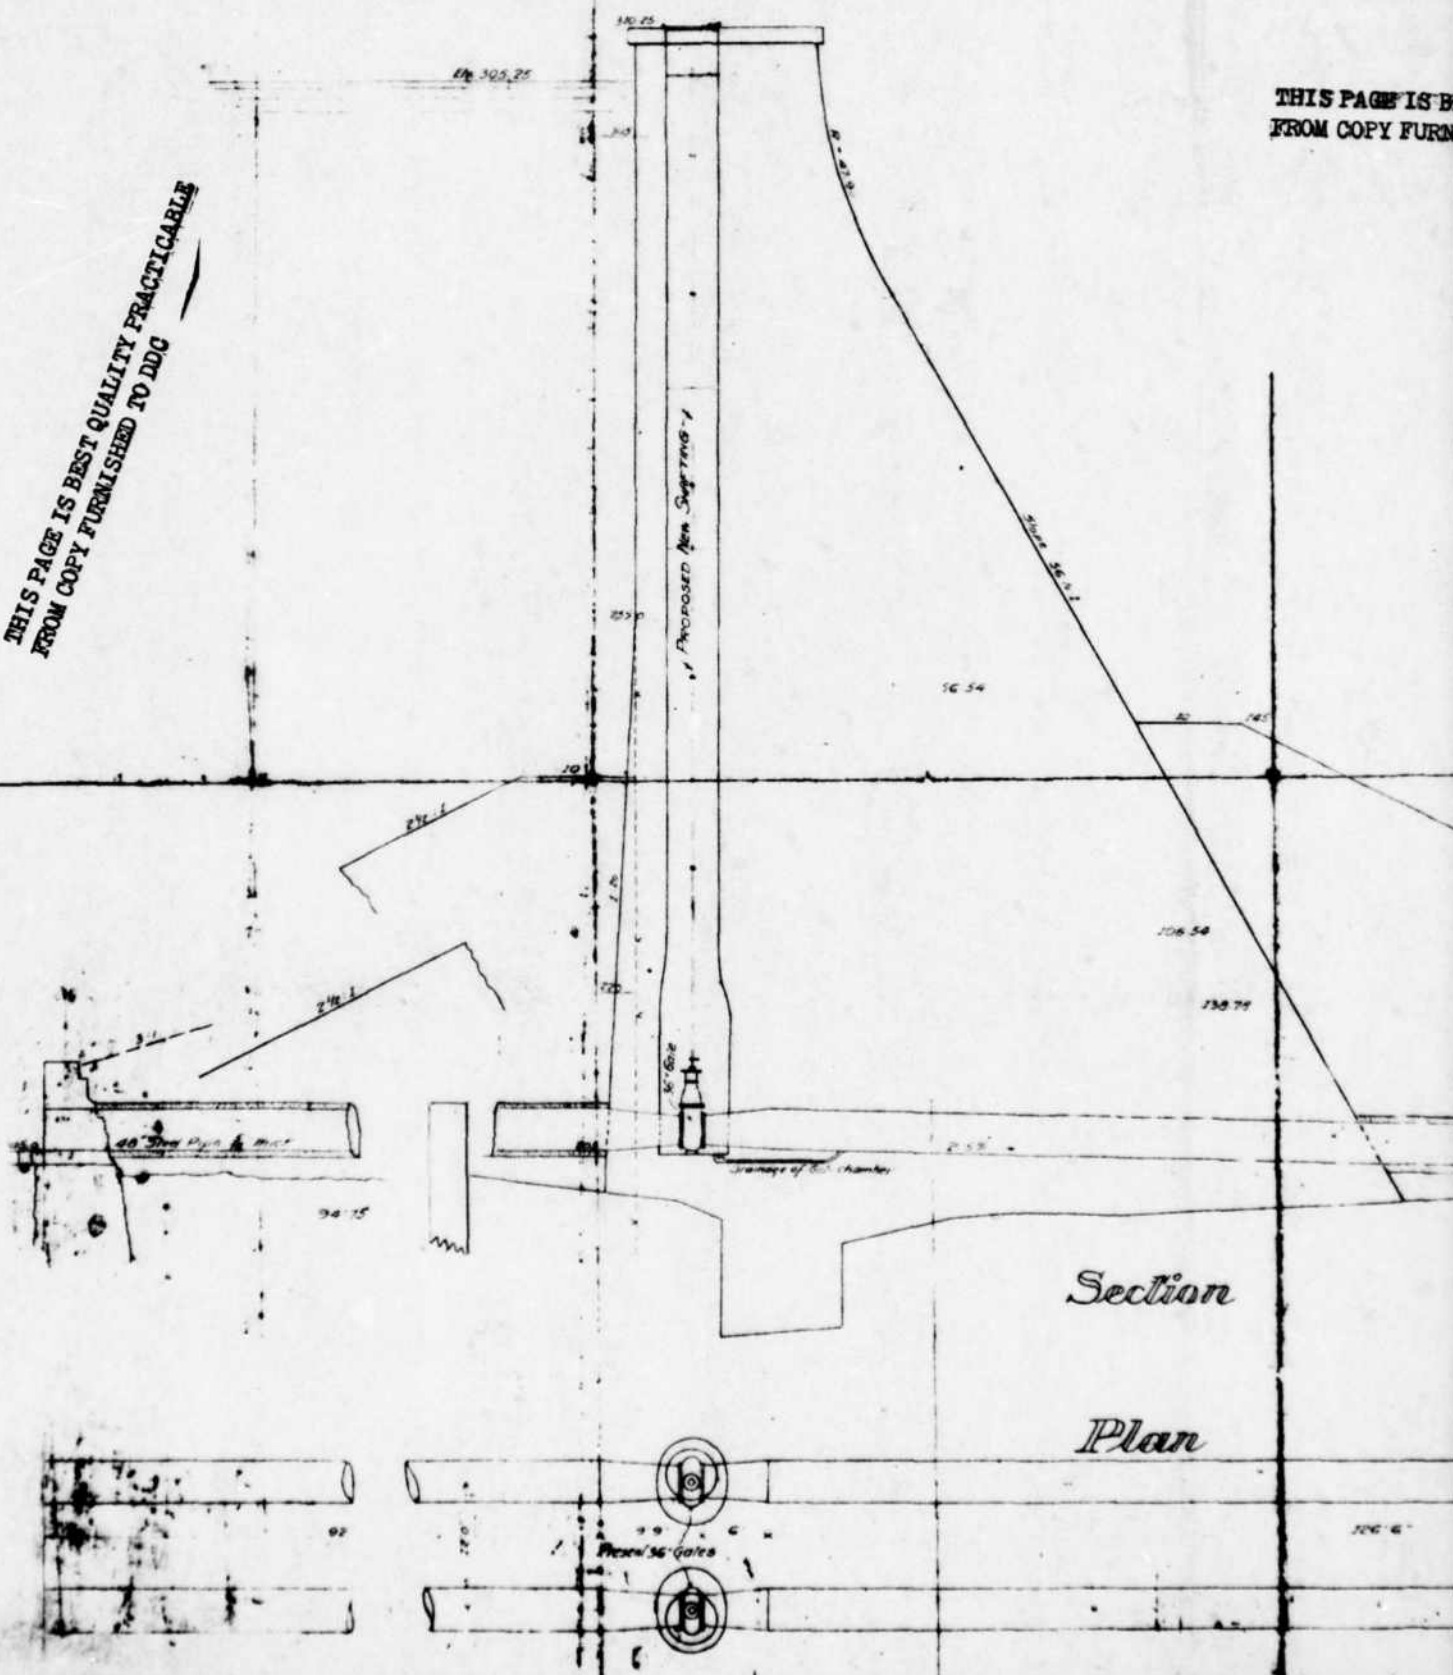
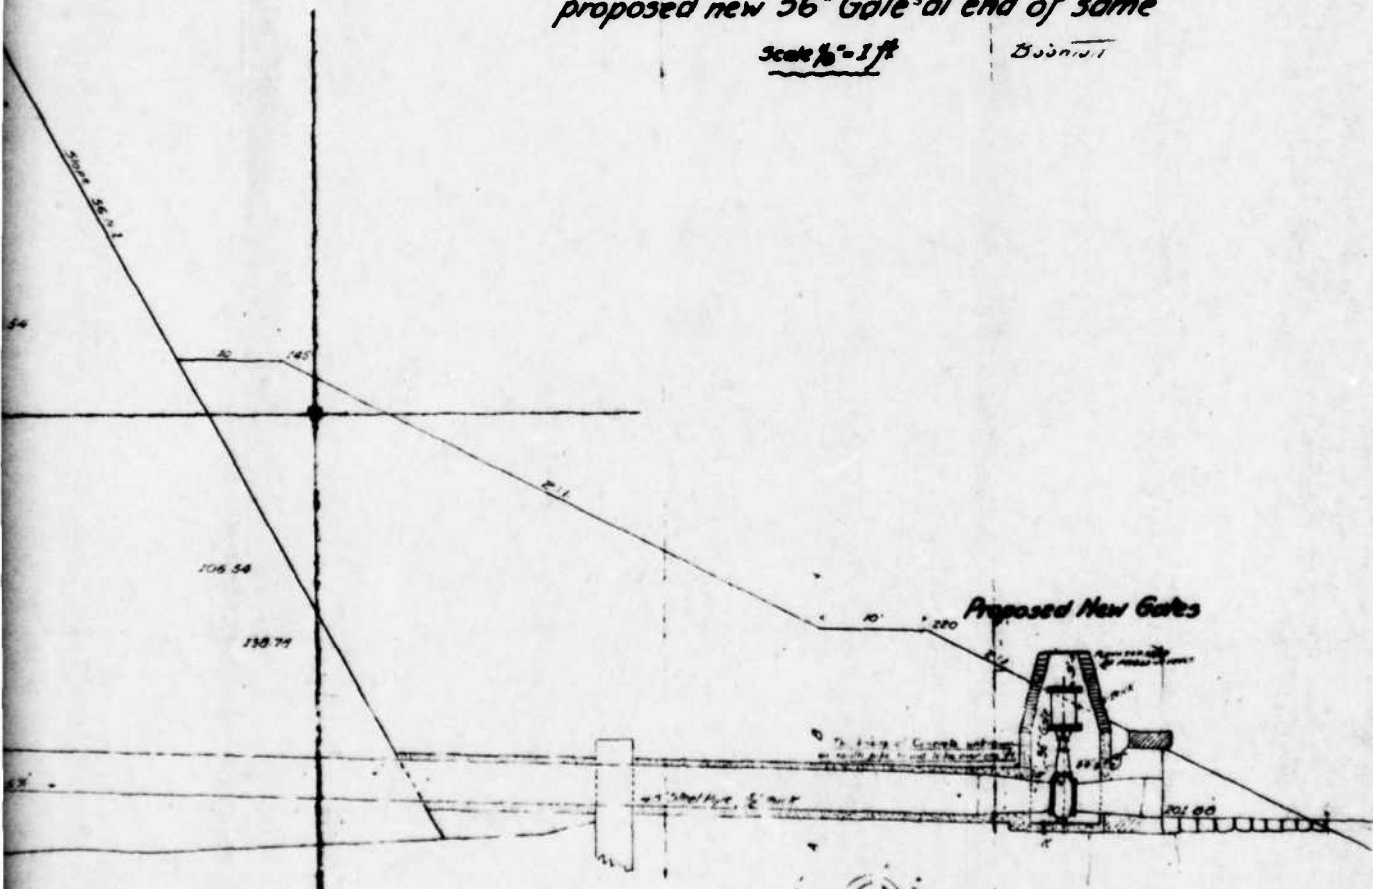
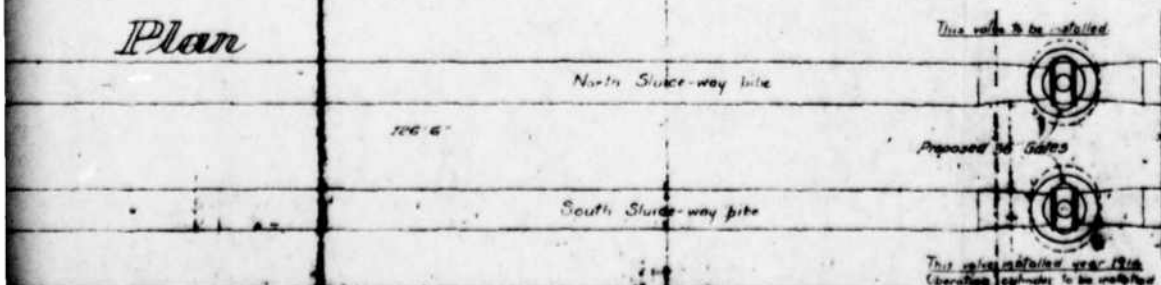
**FIGURE 5**

Water was observed discharging from a small pipe located in the bottom discharge structure. According to operating personnel, the discharge is from the valve chamber located within the dam (see Figure 5)

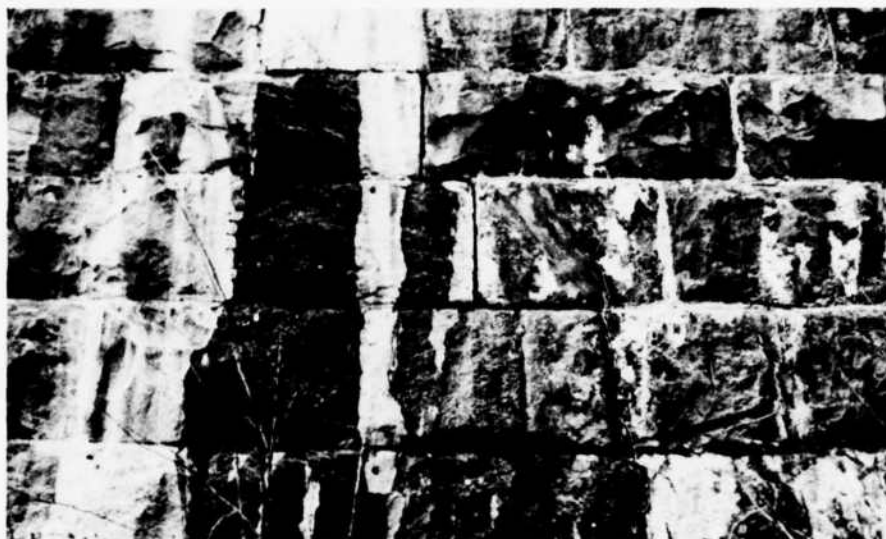
A crack in the jointing was located on the downstream face about 300 feet from the north embankment. Water is seeping from the crack at a rate to keep the stone moist.

CRACK AND SEEPAGE AT NORTH END OF DAM

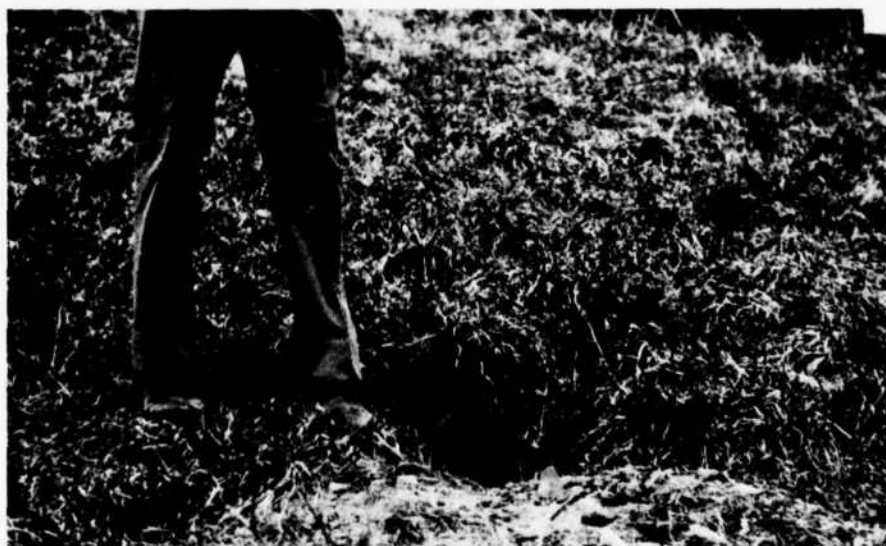
EMBANKMENT DAMAGE BY BURROWING RODENTS  
AT SOUTH END OF DAM

| VISUAL EXAMINATION OF | OBSERVATIONS | REMARKS OR RECOMMENDATIONS |
|---|---|---|
| SURFACE CRACKS | <p>None Noted</p> <p>Holes in the earth embankments caused by burrowing rodents were noted in several locations.</p> | <p>Operating personnel are aware of the problem and are actively engaged in eliminating the rodents.</p> |

5. Continue program to protect against damage due to burrowing rodents.

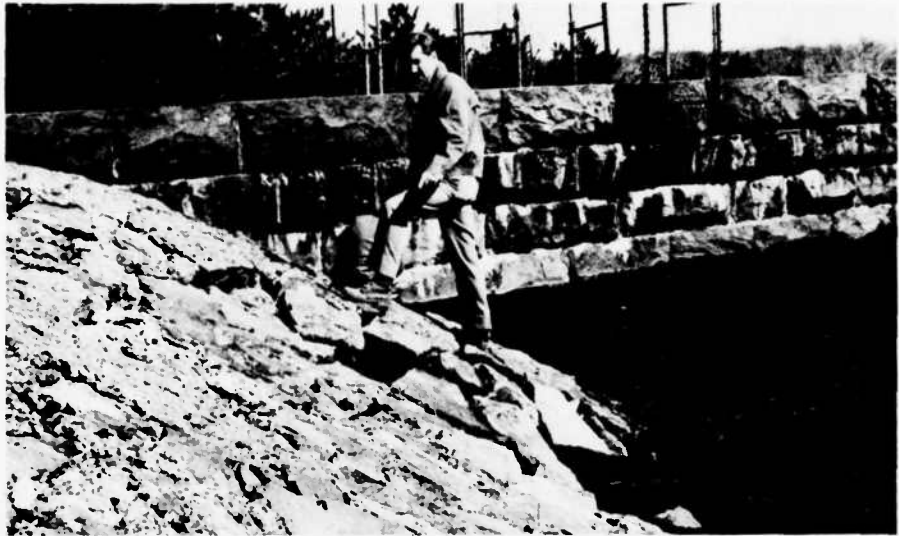
The upstream slope of the embankment is protected by a facing of grouted riprap. Failure of this facing was noted at a few areas along both embankments. A subsidence in the riprap facing, extending into the top of the embankments, is noticeable in both earth embankment extensions, approximately fifty feet from either end of the masonry dam (non-overflow section). In both cases, the subsidence is not appreciable.

DISLOCATION OF GROUTED RIP RAP SLOPE PROTECTION  
AT NORTH END OF DAM

3. Implement a maintenance program to repair all sections of the upstream facing of the earth embankment extensions and dike that have collapsed or show significant deterioration; or, in lieu of this, place riprap protection on the upstream face.

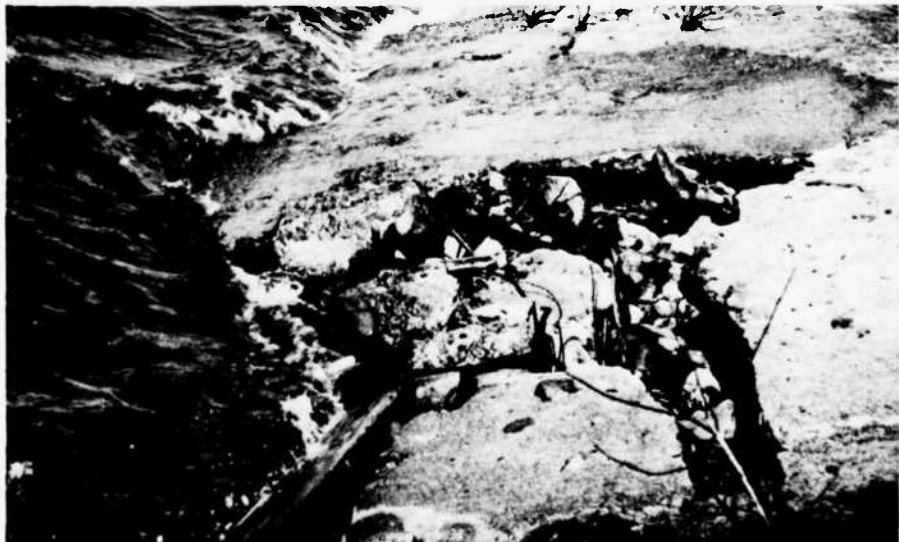
d. Parsippany Dike Parsippany Dike, an earthen structure approximately 3,200 feet long, is located at the southern end of the reservoir. The upstream slope is protected by riprap covered with a grout surface. Wave action has apparently eroded the fill just below the grouted surface material, and bridging of the grout surface is evident. This bridging has broken down in certain areas exposing the stone and random fill. A few small holes, probably caused by rodents, and two small tree stumps were also noted along the crest.

FAILURE OF SLOPE PROTECTION AT DIKE ALONG THE  
SOUTHERN END OF THE RESERVOIR
