DEGRADATION OF COATING ALLOYS  
IN SIMULATED MARINE ENVIRONMENTS

R.H. Barkalow and F.S. Pettit  
Pratt & Whitney Aircraft Division  
United Technologies Corporation  
400 Main Street  
East Hartford, Connecticut 06108

15 June 1978

Final Report: 1 March 1976 to 1 March 1978

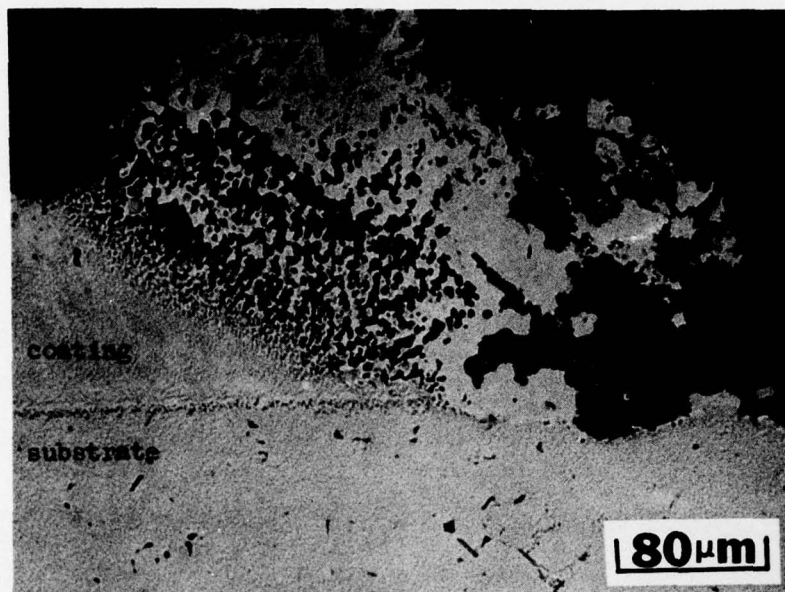
Figure 31a. Sidewise consumption of PWA 68 emanating from massive edge failure.

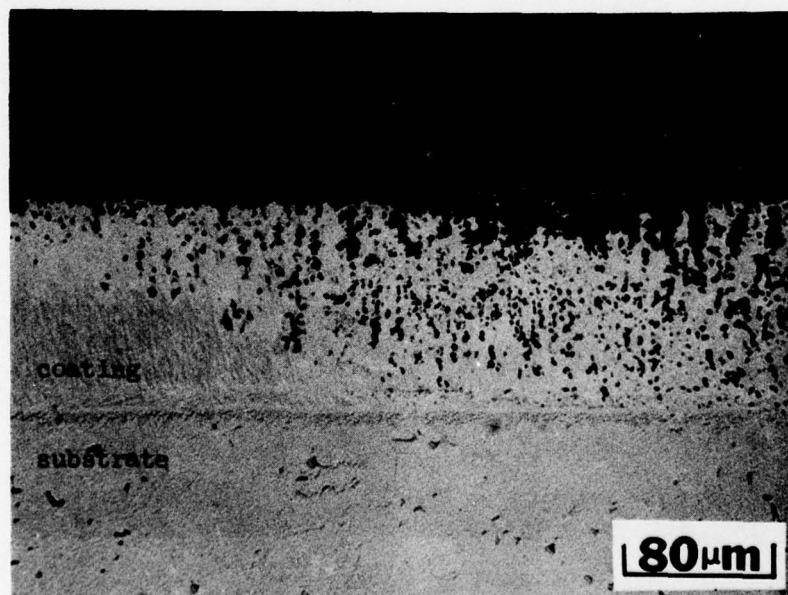
Figure 31b. Localized dealloying and internal oxidation of PWA 68, apparently the mechanism of coating penetration.

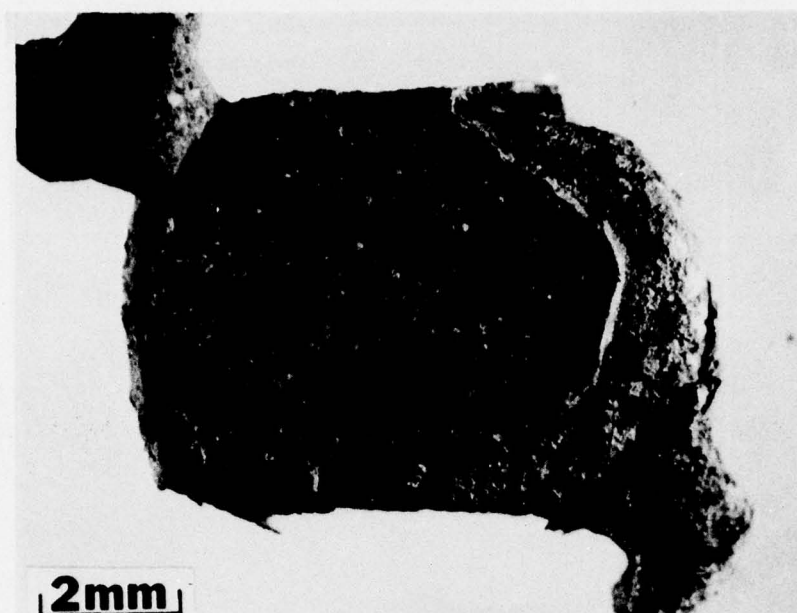
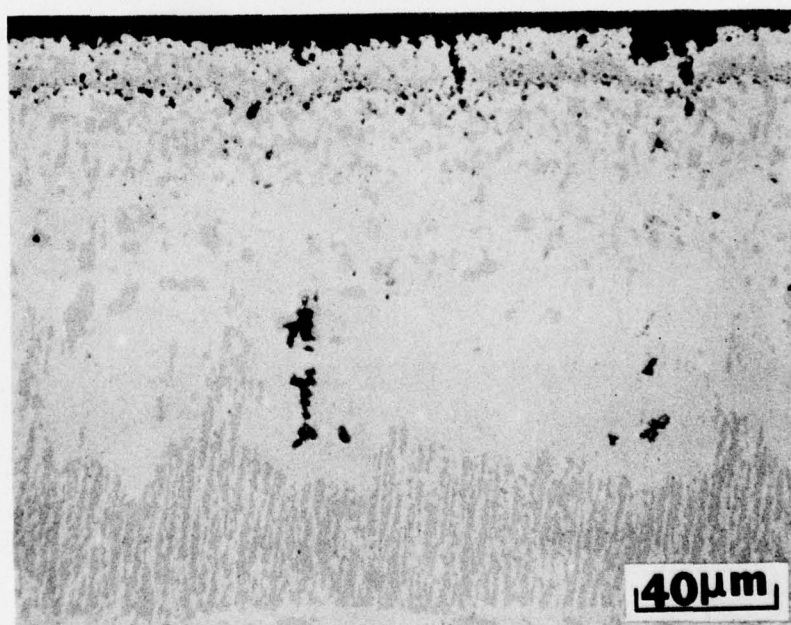
Figure 49. PWA 68 +  $\sim 12\mu\text{m}$  Pt overlayer; exposure time = 700 hours at  $899^\circ\text{C}$ . Thicker overlayer did not significantly improve performance (compare with Fig. 48).

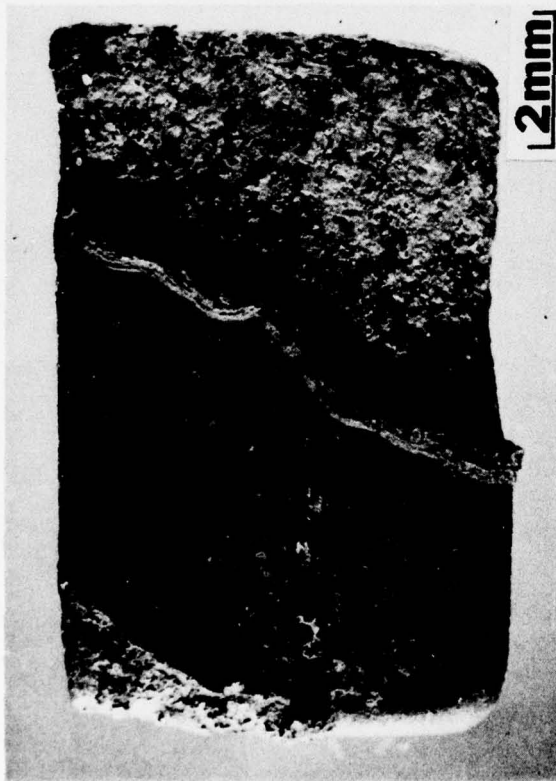
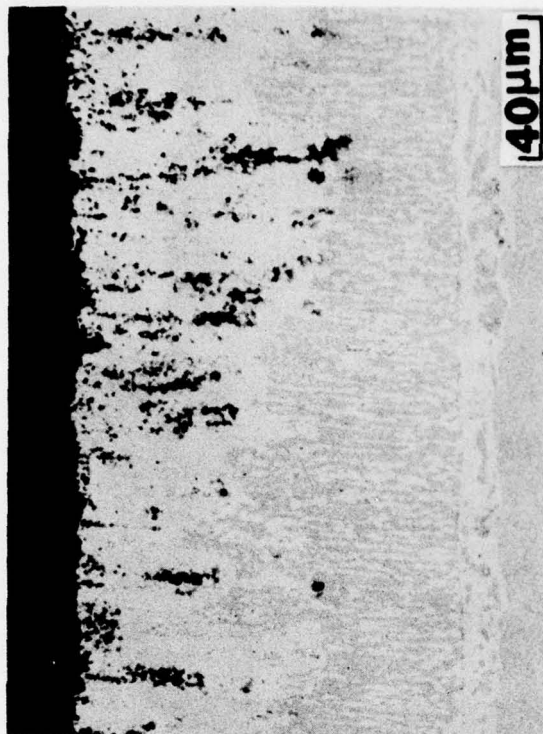
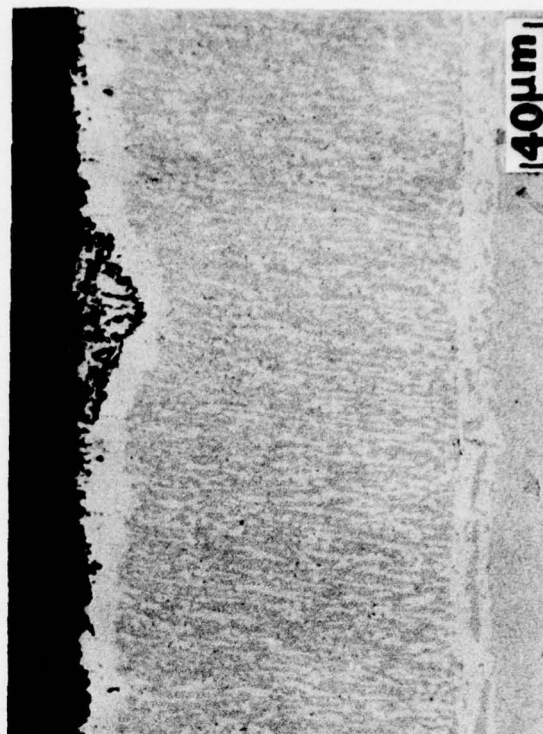
Figure 53. Surface condition and microstructural degradation of Ti-modified PWA 68 coating; exposure time = 520 hours in 899°C cyclic hot corrosion with  $\text{Na}_2\text{SO}_4$  - 50% NaCl.

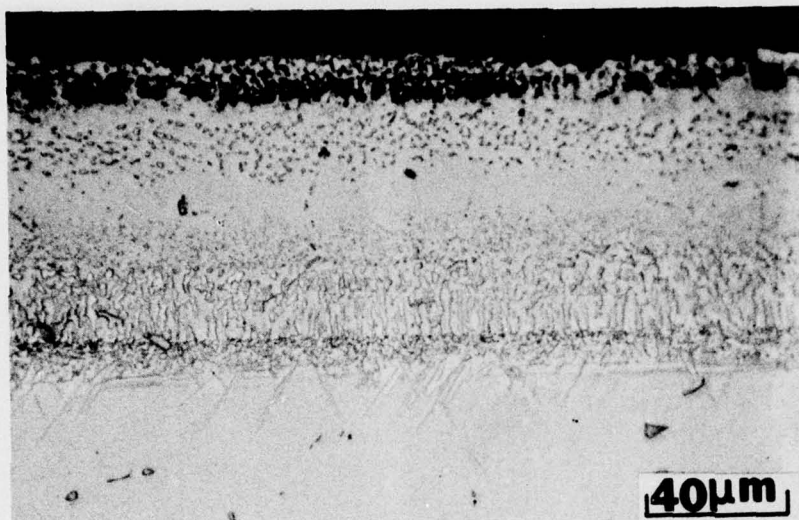
Figure 54. Microstructure of Ti-modified PWA 273 (6μm layer of sputtered titanium applied prior to aluminizing) after 1000 hours of cyclic hot corrosion testing at 899°C with  $\text{Na}_2\text{SO}_4$  - 50% NaCl

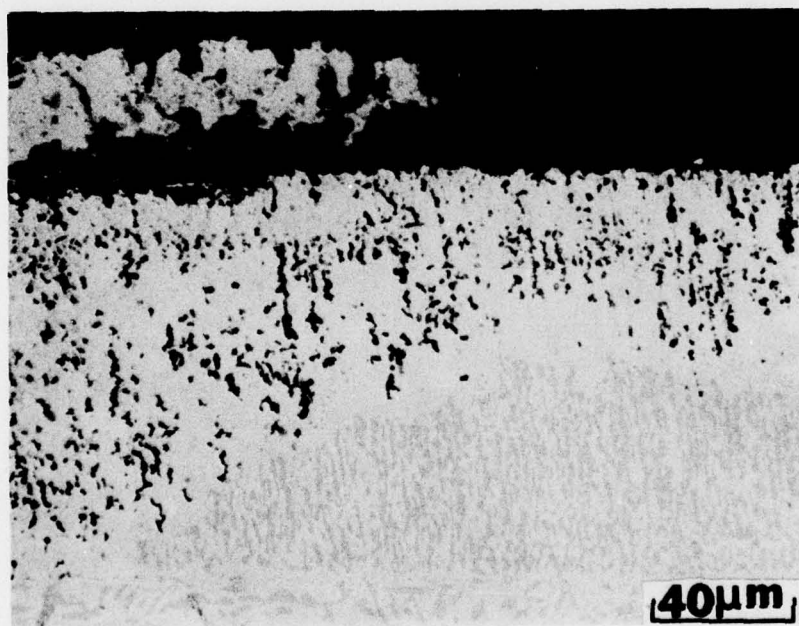
Figure 55. Oxidation of Ni overlayer and dealloying of PWA 68 after 80 hours exposure in 899°C cyclic hot corrosion test.

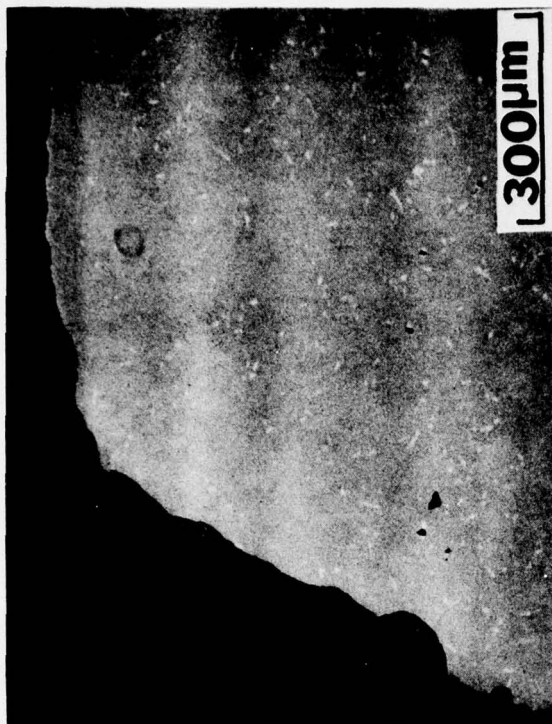
b. Failed edge
