MIDVALE DAM

**PHASE I INSPECTION REPORT
NATIONAL DAM SAFETY PROGRAM**

NJ 00205

JUNE 1978

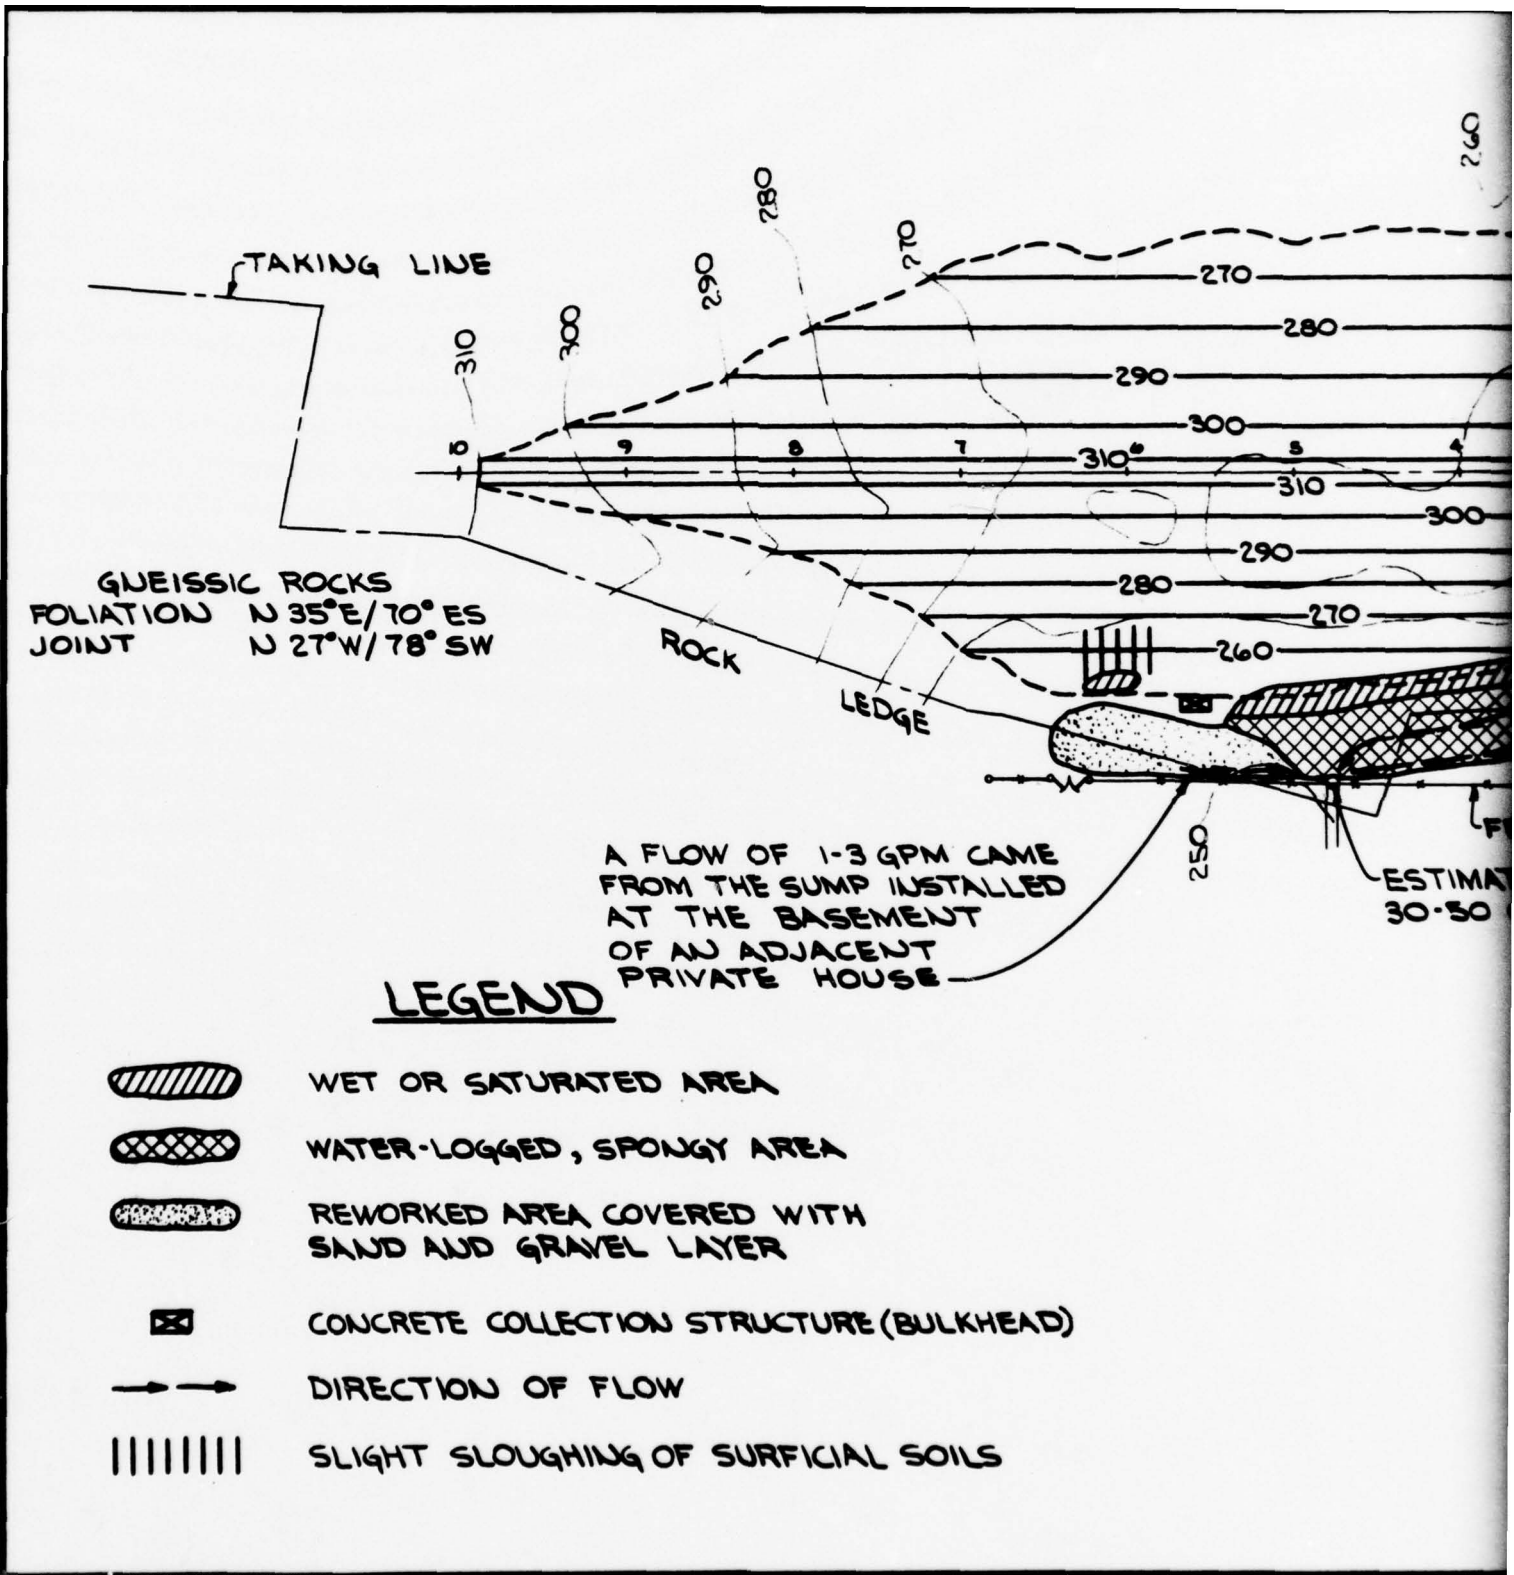
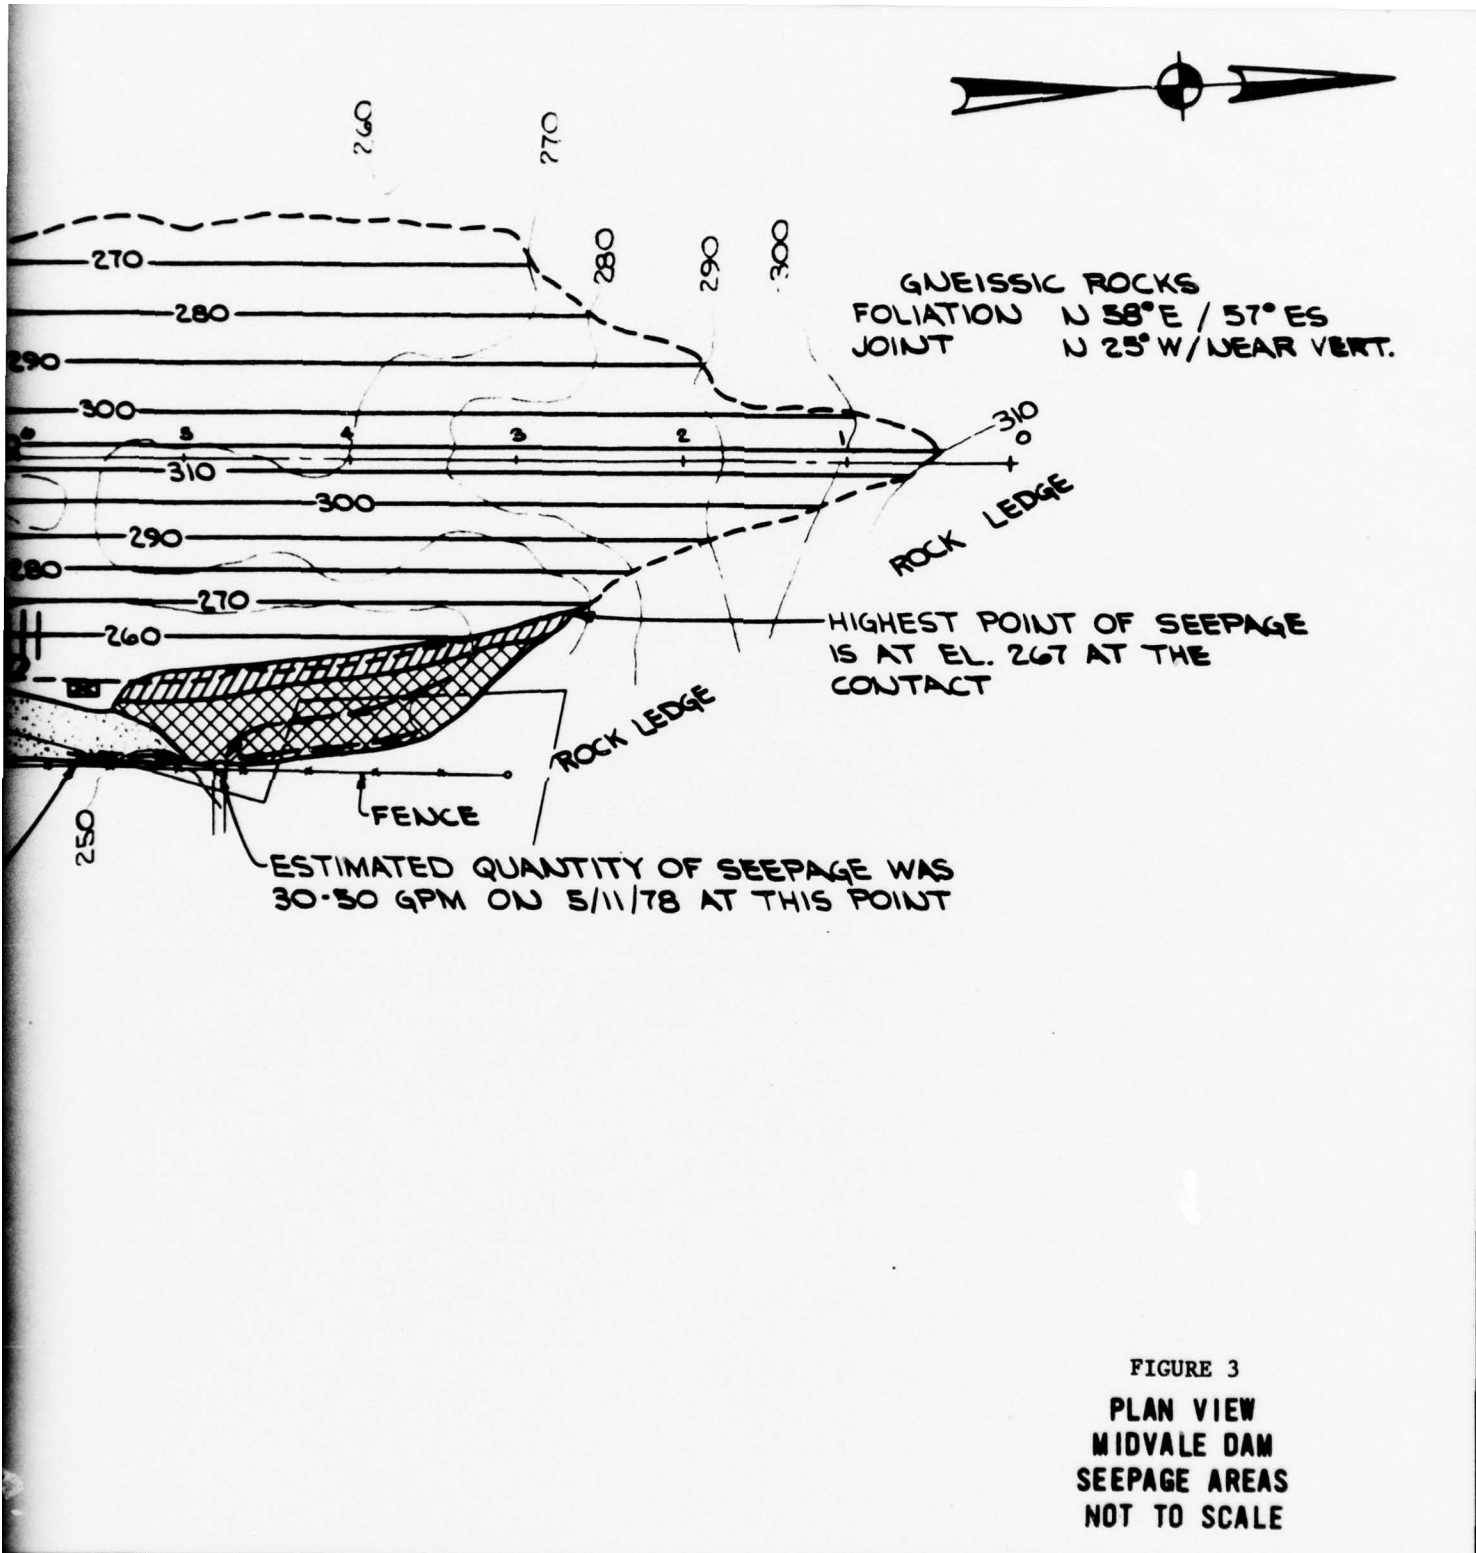
FIGURE 3
 PLAN VIEW
 MIDVALE DAM
 SEEPAGE AREAS
 NOT TO SCALE

6.1.1 Visual Observations: Seepage emanates from the toe and left abutment areas, as discussed in Section 3.1.2. The seepage apparently is not indicative of a present instability but must be assumed to pose a threat to the future integrity of the dam by possible piping and/or erosion. This threat must be assumed because adequate assessment cannot be made due to the lack of detailed information on the composition of the dam and flow characteristics through the dam and foundation.

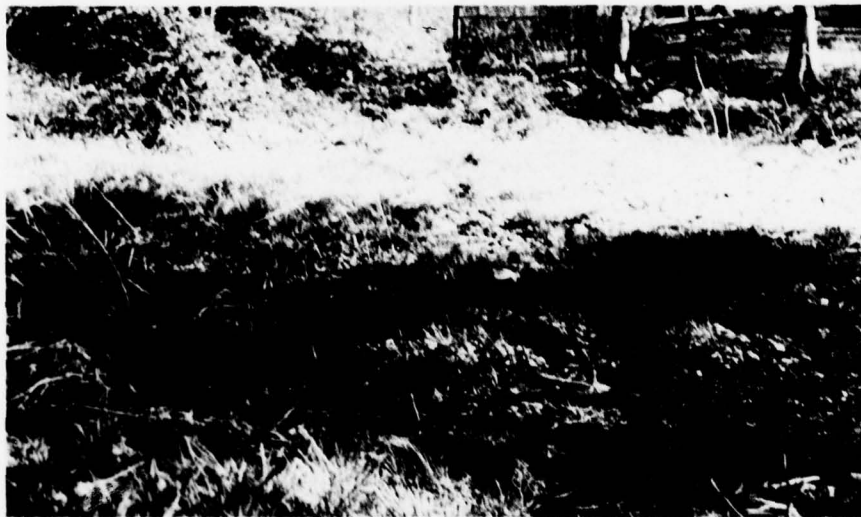
VIEW OF TOE AREA. NOTE WATER IN FOREGROUND

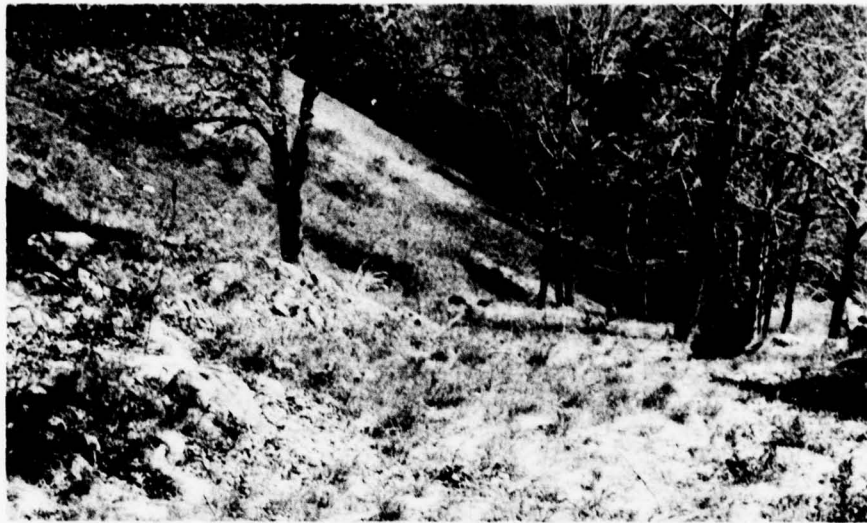
VIEW FROM UPPER RIGHT ABUTMENT
