PASSAIC RIVER BASIN

**GREEN SWAMP NO. I**

**PHASE I INSPECTION REPORT**  
**NATIONAL DAM SAFETY PROGRAM**

NJ 00209

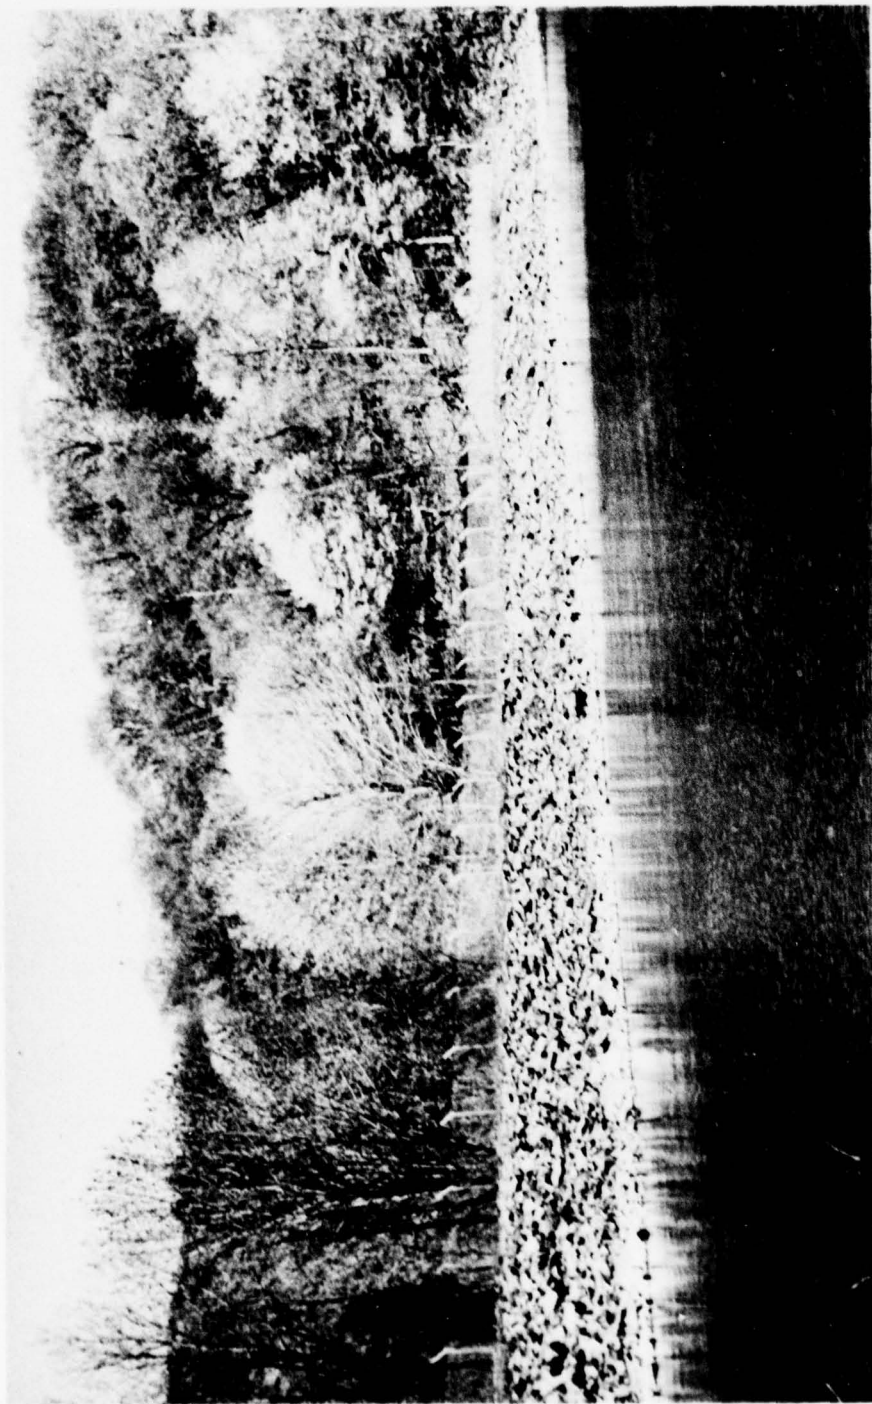
OVERVIEW - GREEN SWAMP NO. 1

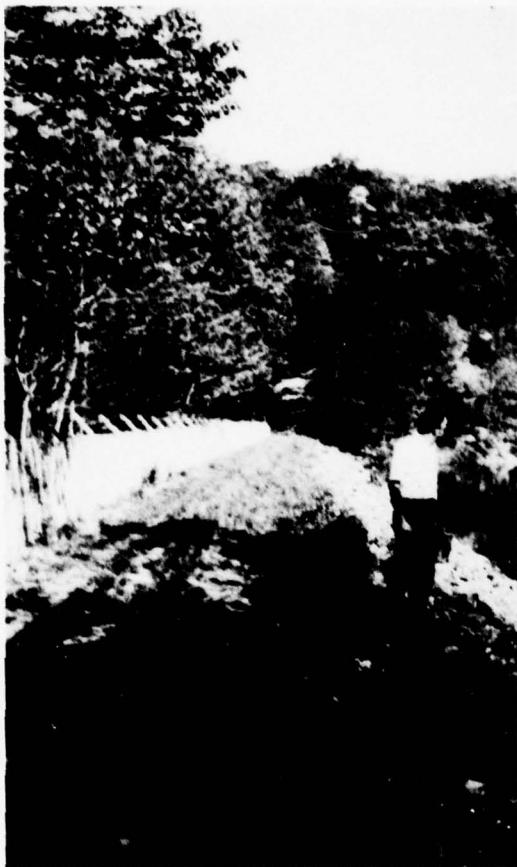
LOOKING WEST ALONG CREST

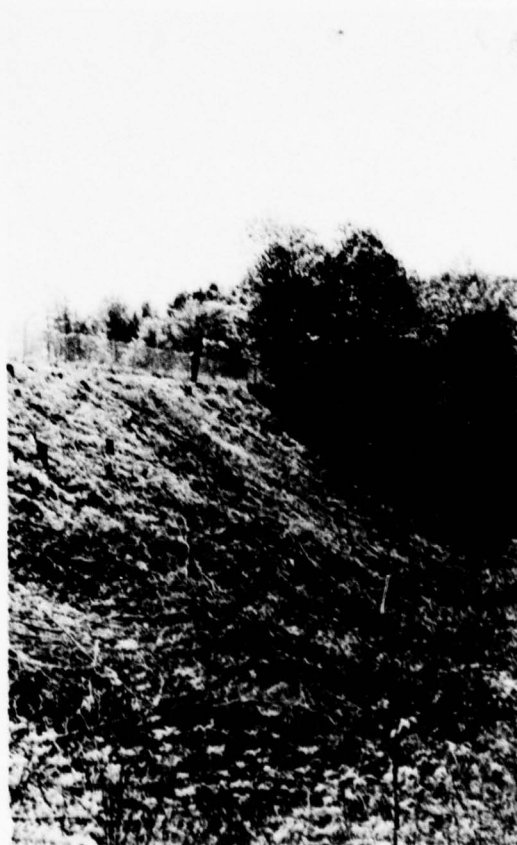
PARTIALLY CLEARED DOWNSTREAM  
SLOPE LOOKING TOWARDS LEFT ABUTMENT

7.2.2 Operational/Maintenance Procedures: Clearing and prevention of tree growth on the east side of the downstream embankment should be continued. The cleared embankment slope should be redressed and seeded with selected grass.
