PASSAIC RIVER BASIN

# WOLF DEN DAM

## PHASE I INSPECTION REPORT NATIONAL DAM SAFETY PROGRAM

JULY 1978

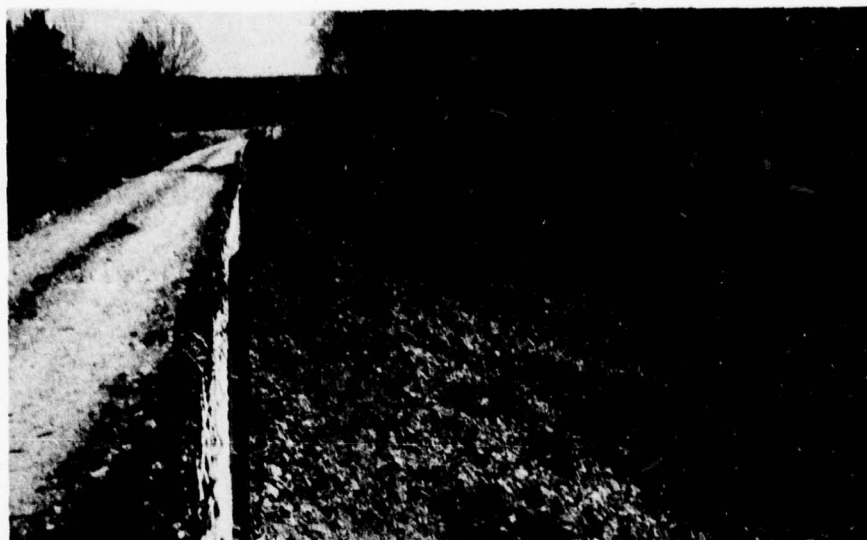
RECENTLY CLEARED SLOPE AREA

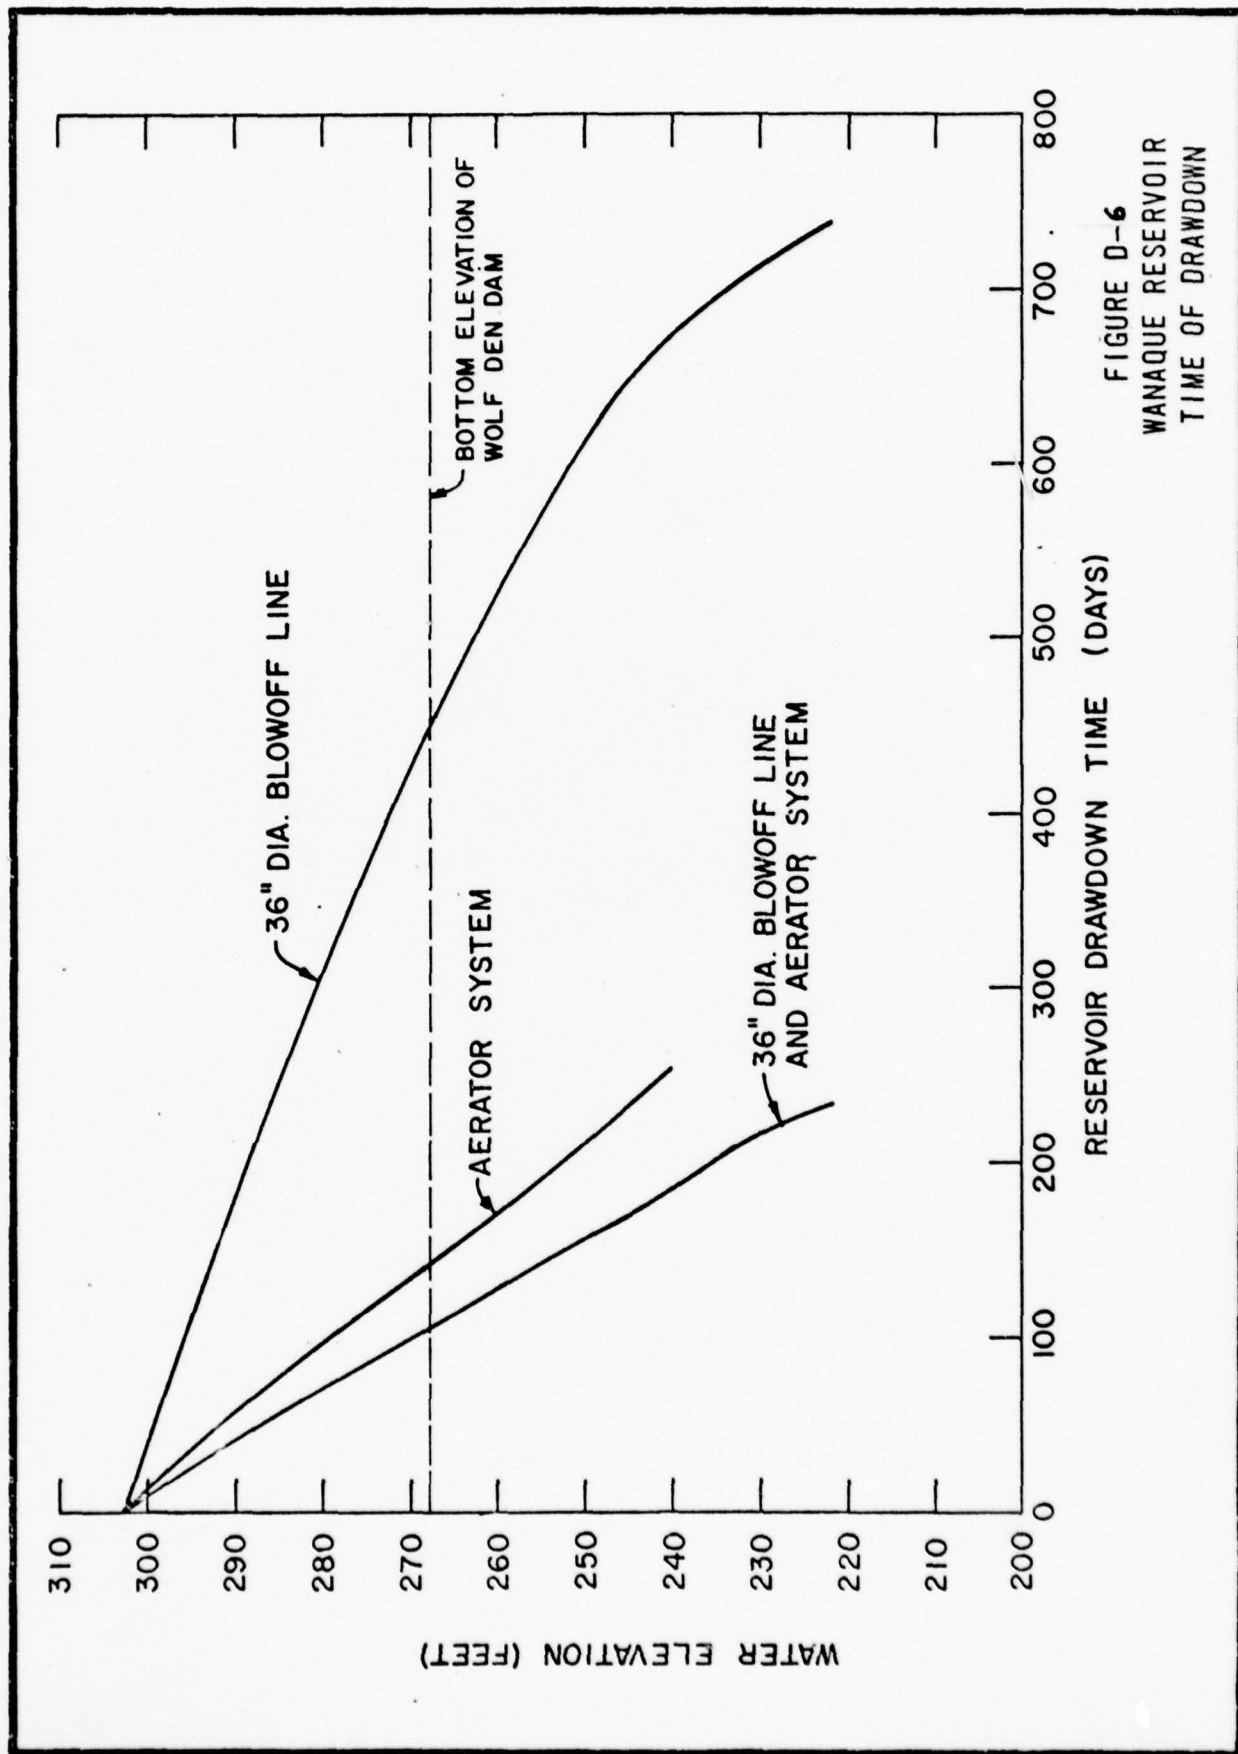
FIGURE D-6  
WANAQUE RESERVOIR  
TIME OF DRAWDOWN  
RESERVOIR DRAWDOWN TIME (DAYS)

7.1.1 Safety: No evidence was obtained to show that this dam in its present condition is structurally unsound. The inflow hydrograph for the probable maximum flood (PMF), as supplied by the Corps of Engineers, was routed through Wanaque Reservoir by means of the HEC-1 computer program. These results indicate that the dam will not be overtopped under PMF conditions. The time required to draw the reservoir down under emergency conditions is in excess of 108 days.

location and nature of the hazardous condition. Figure D-6 shows graphically the times required to lower the reservoir level with the existing facilities.
