# CRYSTAL LAKE DAM

PHASE I INSPECTION REPORT

NATIONAL DAM SAFETY PROGRAM

NJ 00217

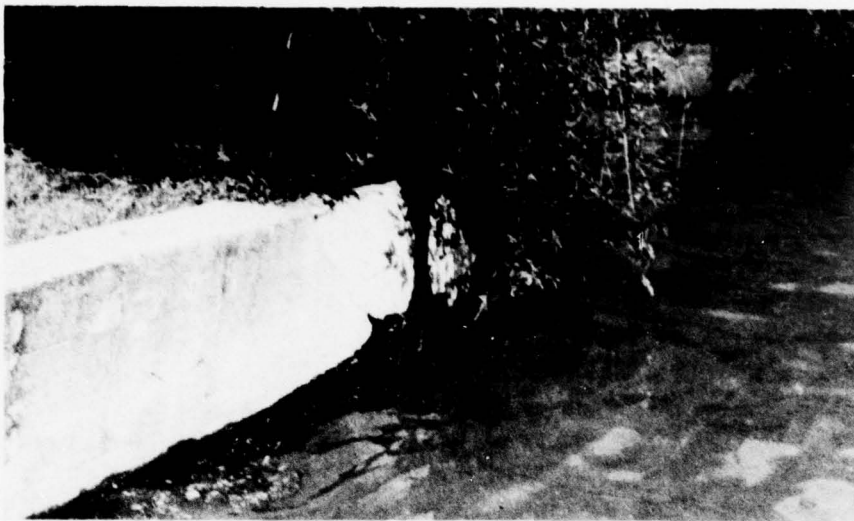
| VISUAL EXAMINATION OF | OBSERVATIONS | REMARKS OR RECOMMENDATIONS |
|---|---|---|
| STRUCTURAL CRACKING | <p>The left wing wall, at the intake side, has a 45° crack running from top of wall to top of 36-inch outlet pipe. The top of this concrete wall is badly deteriorated and the wall is tilted towards lake. The left wall has two vertical cracks, 3 feet apart, 12 feet from downstream edge of wall.</p> | |

UPSTREAM LEFT ABUTMENT  
HEAD WALL DAMAGE

(2) The cracked and tilted left hardwall at the 36-inch pipe drain should be repaired before its failure obstructs or damages the outlet gate.

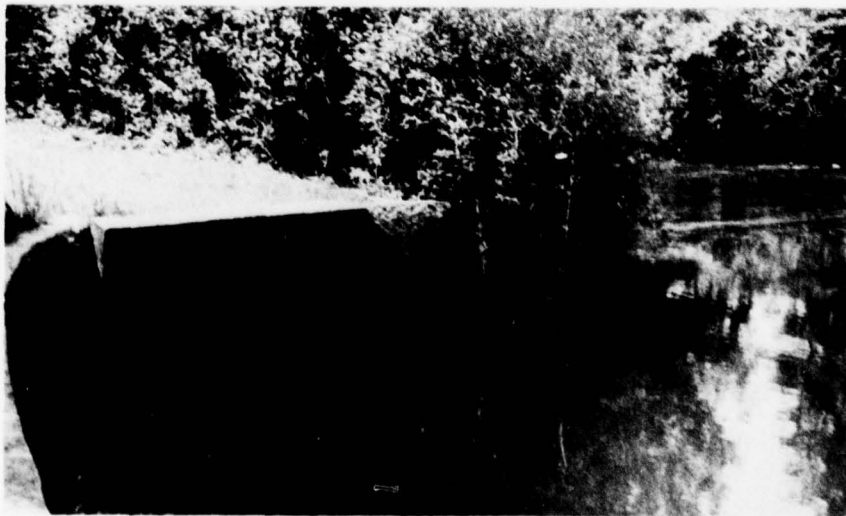
UPSTREAM LEFT ABUTMENT  
NOTICE TILTED HEAD WALL

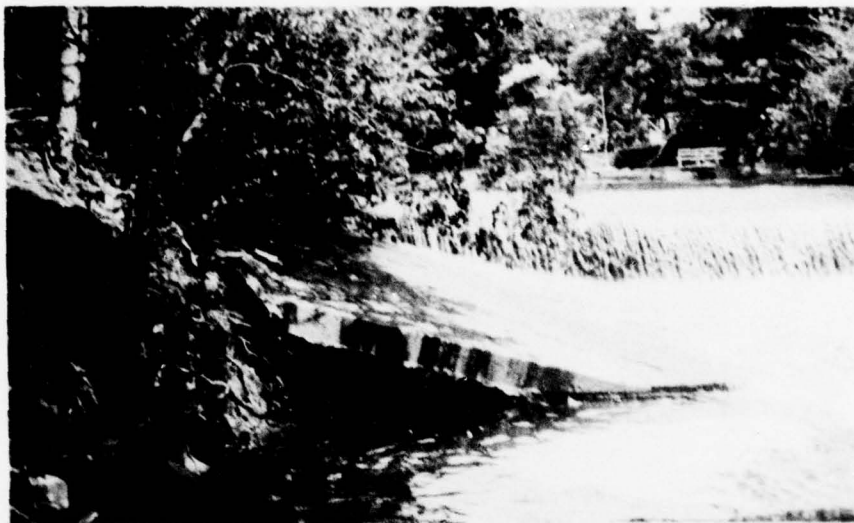
| VISUAL EXAMINATION OF | OBSERVATIONS | REMARKS AND RECOMMENDATIONS |
|---|---|---|
| FOUNDATION | A portion of spillway drop apron foundation was badly undermined. This caused a 2" gap to open up at the drop apron-spillway slab interface. No bedrock is exposed in the vicinity of the dam. Surficial material consists of sandy silt, silty sand with variable amounts of gravel as exposed along the river banks. | |

| VISUAL EXAMINATION OF | OBSERVATIONS | REMARKS OR RECOMMENDATIONS |
|---|---|---|
| CONSTRUCTION JOINTS | <p>At the right downstream corner of the wall and the slab a 4-inch gap was found. A 2-inch gap exists between the slab and downstream drop apron; a 4-inch void was found below the right downstream wall and slab.</p> | |

DOWNSTREAM DROP SPILLWAY APRON  
RIGHT ABUTMENT

(1) The extensive undermining of the right drop apron foundation should be corrected by suitable methods such as grouting.
