**CANOE BROOK RESERVOIR  
NO. 3 DAM**

**CANOE BROOK RESERVOIR  
NO. 3 DIKE**

**3 PHASE I INSPECTION REPORT  
NATIONAL DAM SAFETY PROGRAM.**

NJ 00527  
NJ 00550

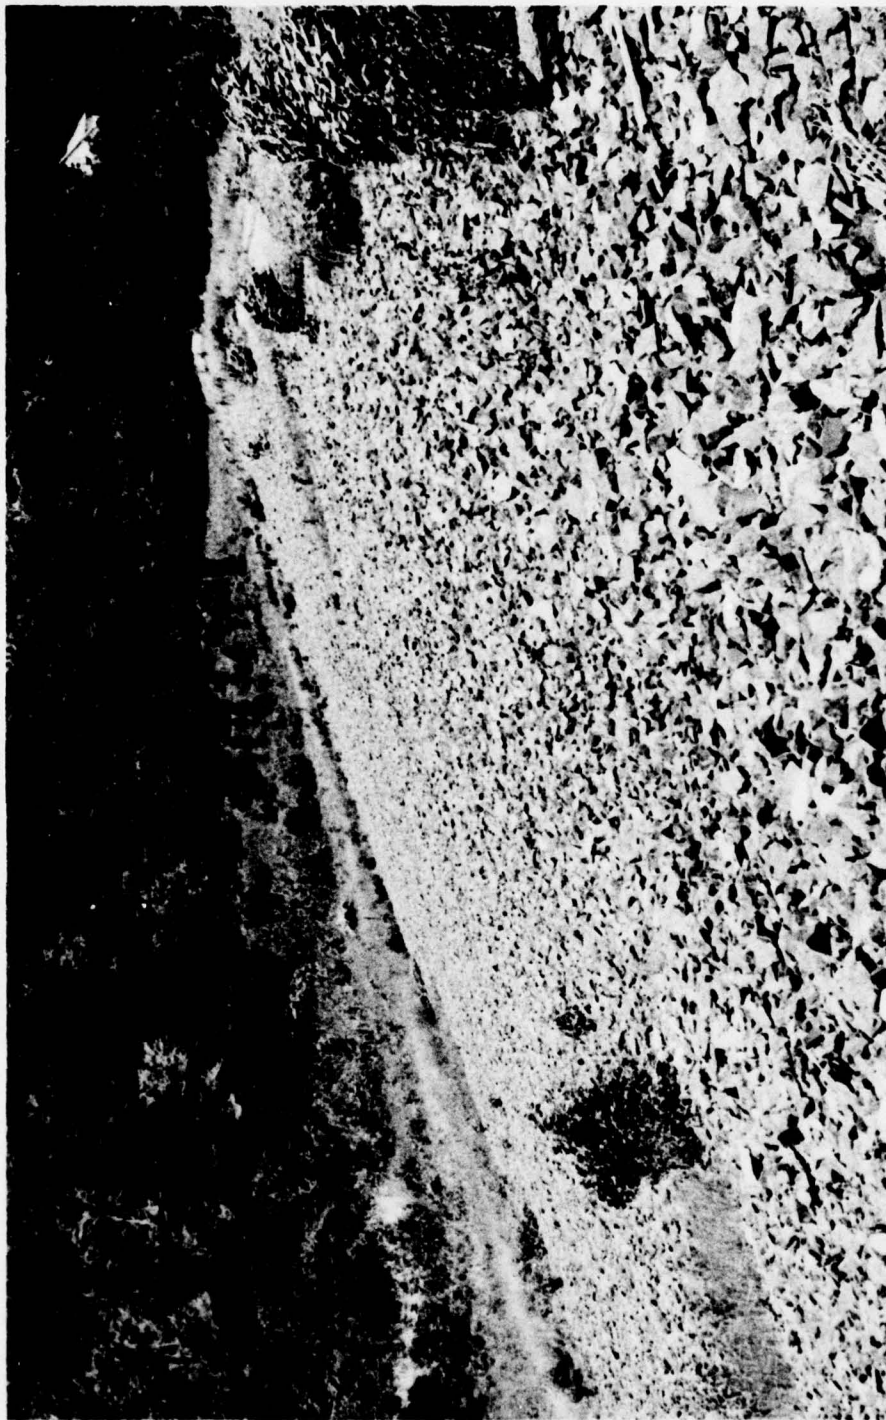
OVERALL VIEW OF DAM
