PASSAIC RIVER BASIN

# POINT VIEW DAM

PHASE I INSPECTION REPORT

NATIONAL DAM SAFETY PROGRAM

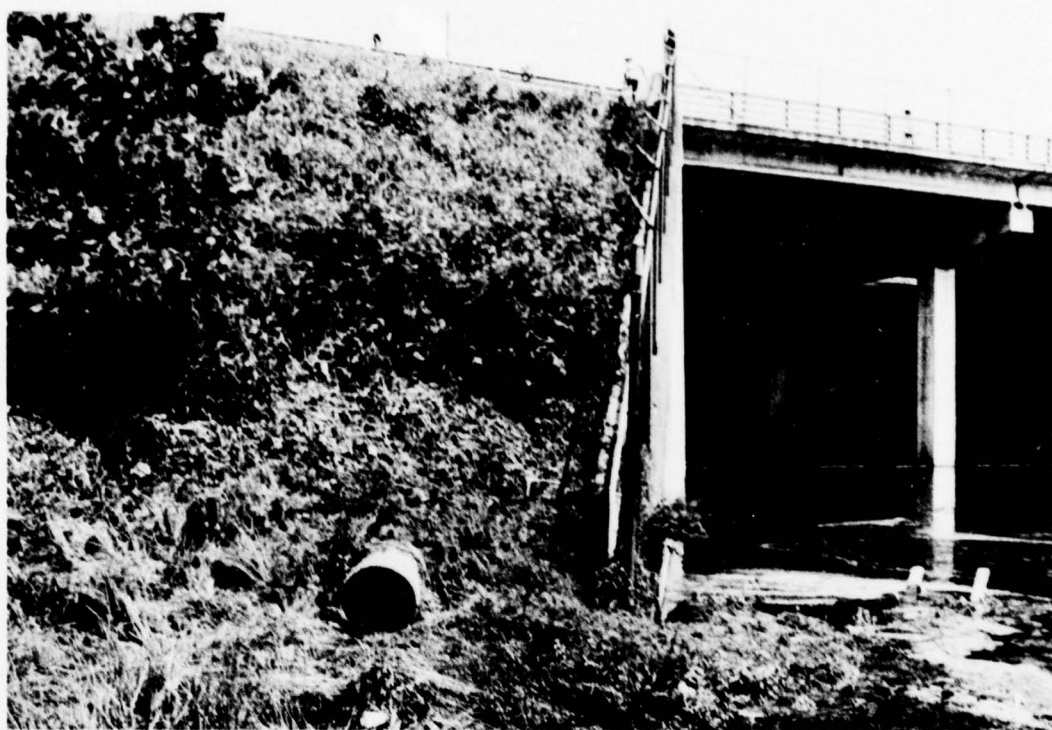
PHOTO 11

- b. Dam -
  - 1) Seepage and piping were observed at the downstream toe of the dam behind both spillway outlet wing walls on 9 June, as described in the supplement to the visual inspection check list in Appendix A. The seepage water was clear on 10 June, indicating that the piping had apparently stabilized. Seepage at the downstream toe of the dam probably indicates that the toe drain outlets, and perhaps also the toe drains themselves, are plugged.

- Photo 11 - View Upstream (East) at Right (North) Side Spillway Outlet Showing Wing Wall and Downstream Slope of Dam; 18 Inch Corrugated Metal Pipe in Left Center; Piping Hole (Close-up in Photo 12) Left of Wing Wall Three Feet Above Tailwater at Folded Rule - 9 June 1978
- Photo 12 - Close-up of Piping Hole Encountered in Test Pit at Toe of North Spillway Outlet Wing Wall (Photo 11) - 9 June 1978
- Photo 13 - View Downstream (West) Over East End of Lionshead Lake From Downstream Slope of Point View Dam, Left (South) of Spillway; Ditch Carrying Storm Water and Stream Flow From Left Abutment Area Enters Lake at Left Edge of Photo - 9 June 1978
- Photo 14 - View Downstream (Northwest) Over East End of Lionshead Lake From Southwest Bank - 9 June 1978

- 1) The Passaic Valley Water Commission should locate, excavate and clean as necessary the toe drain outlets at the ends of the two spillway outlet wing walls. In addition, the Commission should consider installation of additional toe drain outlets above tailwater level. It is expected that the consultant recommended in Item 2) below would provide guidance in this matter.

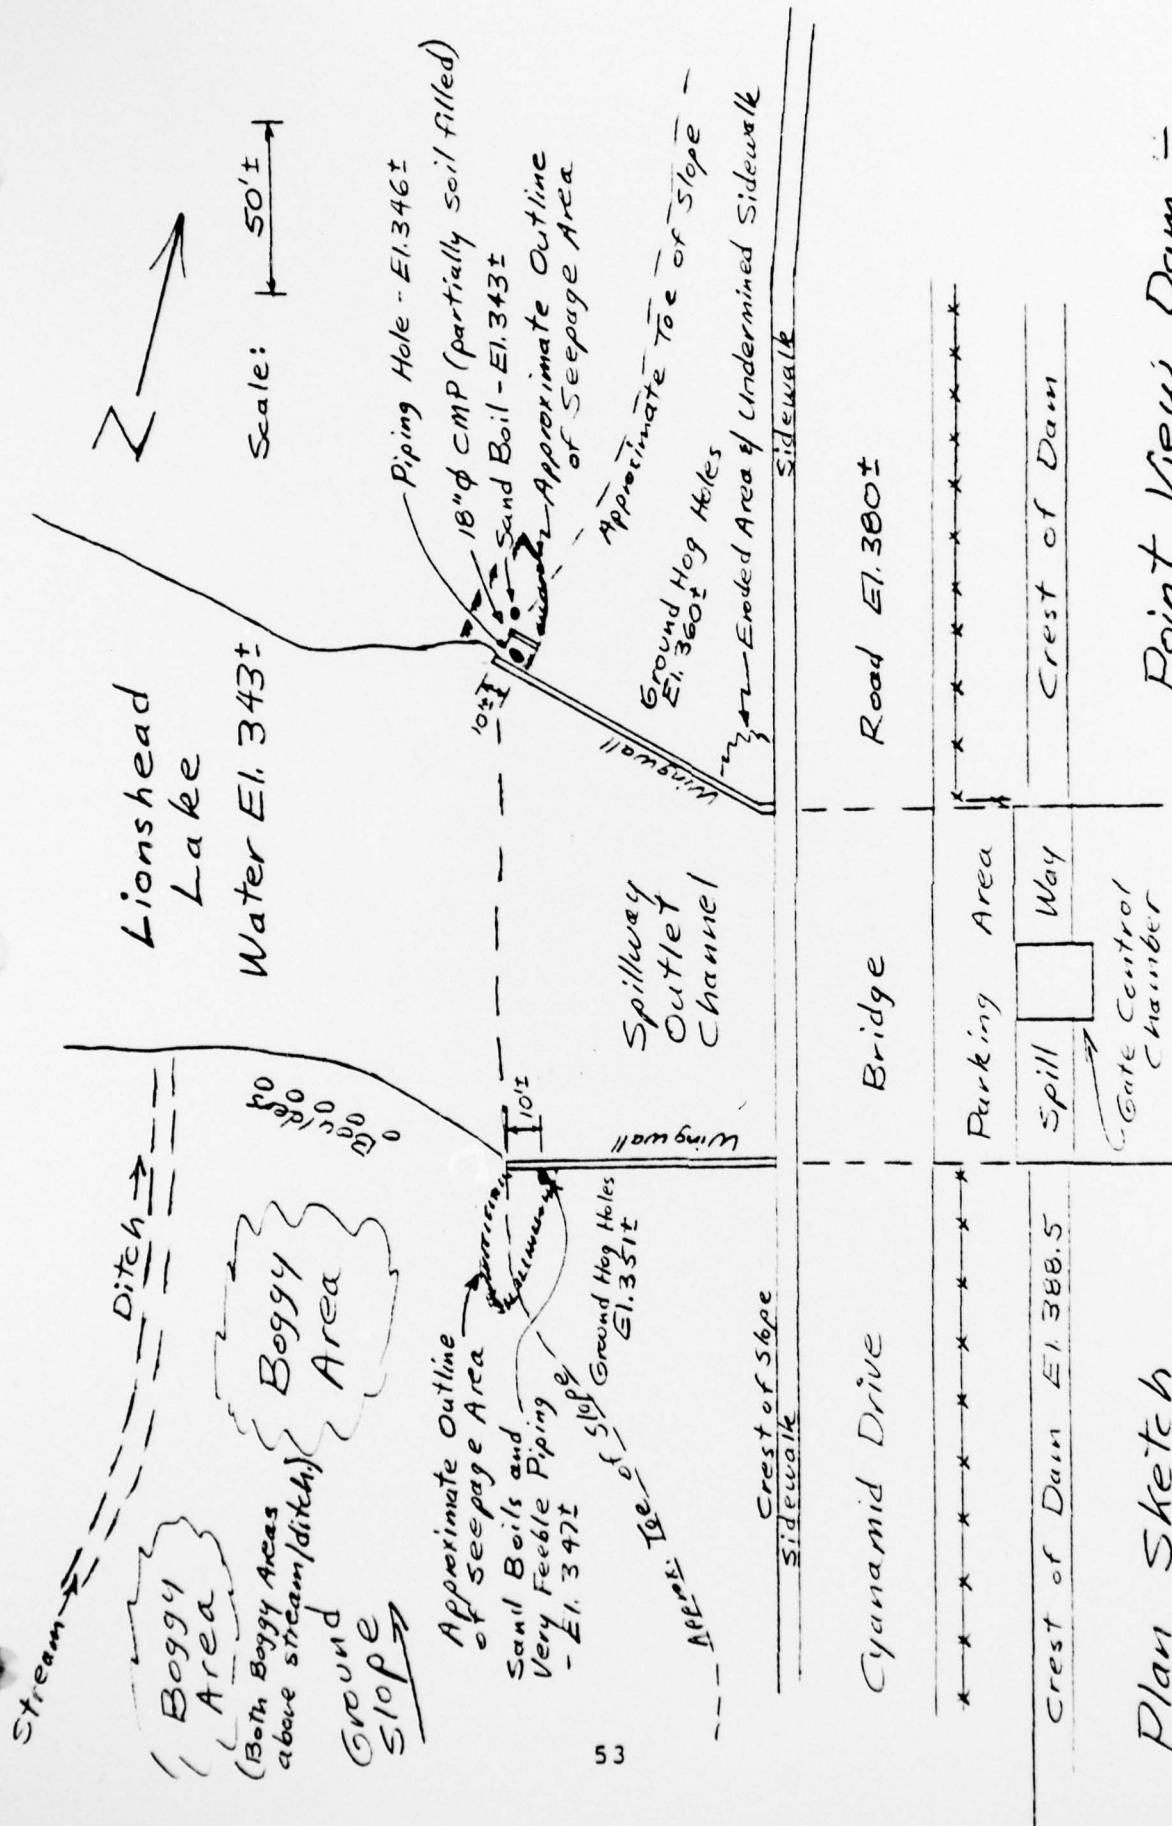
Point View Dam -  
Seepage & Piping Areas  
Observed 9 June 1978

During the Phase I field inspection of Point View Dam, Wayne Township, New Jersey, on 9 June 1978, seepage and piping were observed at the downstream toe of the dam behind both spillway outlet wingwalls, as shown on the attached plan sketch. It should be noted that outlets of the dam embankment toe drains and wingwall backfill drains could not be located in the field. These drain outlets are presumably below tailwater level at the ends of the two wingwalls. The seepage and piping situation, plus telephone discussions with the Philadelphia District, Corps of Engineers, on 9 June and a meeting at the dam site on 10 June with representatives of the Corps of Engineers, New Jersey Department of Environmental Protection, and Passaic Valley Water Commission (dam owner) are summarized in the following paragraphs.

On the afternoon of 9 June, a 1 in. diameter sand boil was observed at tailwater level (El. 343 $\pm$ ) approximately 13 ft. north of the west end of the right wingwall; see attached sketch. This boil in well graded sand had an estimated flow rate of 1 gpm and did not appear to have any piping or erosion of fine soil particles.

A seepage area similar to that behind the right wingwall was also observed behind the left wingwall at the junction of the downstream slope with the left abutment. In addition, two boggy areas were observed on the left abutment slope downstream from the dam. The seepage areas and two boggy areas are shown on the attached sketch. The upper portions of all three of these wet areas was about 4 ft above tailwater level. The appearance and vegetation of all three of these areas indicated that seepage had been occurring from them for considerable lengths of time in a relatively steady manner.

Due to time limitations, only one test pit was excavated in an area of concentrated seepage 10 ft east of and 2 ft behind the wingwall; see attached sketch. This test pit disclosed two sand boils, each about 1 in. in diameter, in well graded silty sand 4 ft above tailwater level. Total seepage flow was estimated to be about 7 or 8 gpm. The sand boils were observed for approximately one-half hour. On several occasions during this time interval, a few silt and fine sand particles were observed to wash from the sand boils in very feeble piping action. It was concluded that the well graded sand at this location was essentially self-healing with regard to piping.

It was concluded that the seepage behind the two wingwalls probably resulted primarily from plugging of the toe drain and wall drain outlets and perhaps plugging of the drains themselves. The situation was not considered to present an immediate safety hazard and no emergency actions were considered necessary. However, it was recognized by all present that

1. The Passaic Valley Water Commission should retain a consultant experienced in geotechnical aspects of earth dams to review the seepage situation and recommend appropriate additional investigations which might include:

- a. Reviewing background information on dam construction and drain installation
  - b. Excavation test pits in the downstream toe of the dam and behind the wingwalls to observe seepage conditions and fill materials.

- c. Drilling one or more borings in the downstream slope of the dam behind each wingwall to observe soil materials and water levels and to install open standpipe piezometers which could be monitored to clarify seepage conditions.
