CERL-TR-M-245

TECHNICAL REPORT M-245
June 1978
Foam Material Applications in Theater of Operations Construction

DAMAGED BUILDING REPAIR WITH POLYURETHANE FOAM

by
Alvin Smith

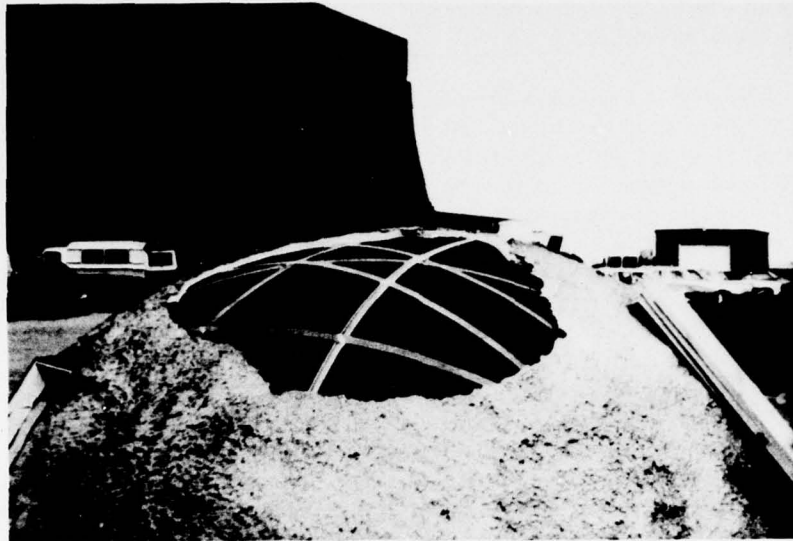
Figure 1. Hole in dome structure. Wood lath strips attached to give required shape.

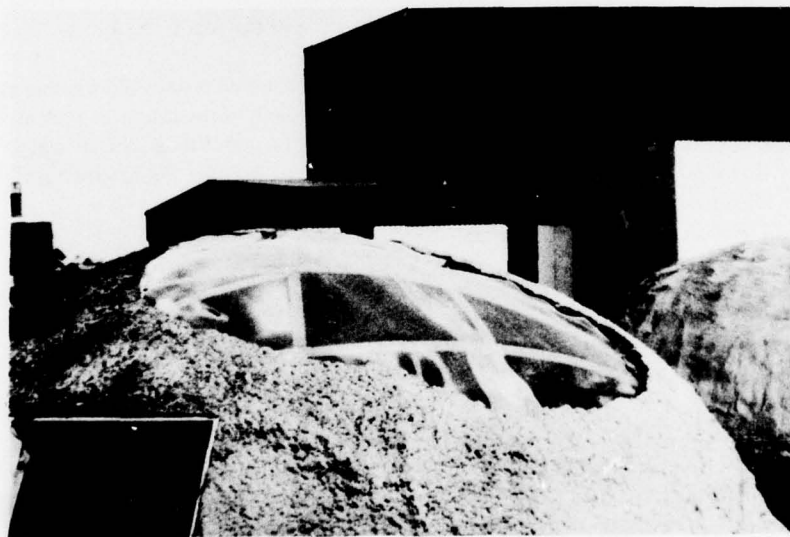
Figure 2. Aluminum screen wire in place.

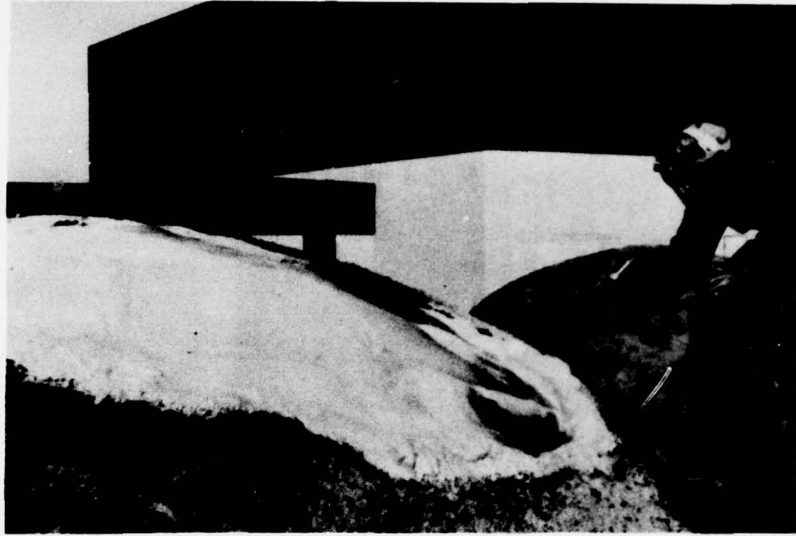
Figure 3. Foam spray application on screen wire to form patch.

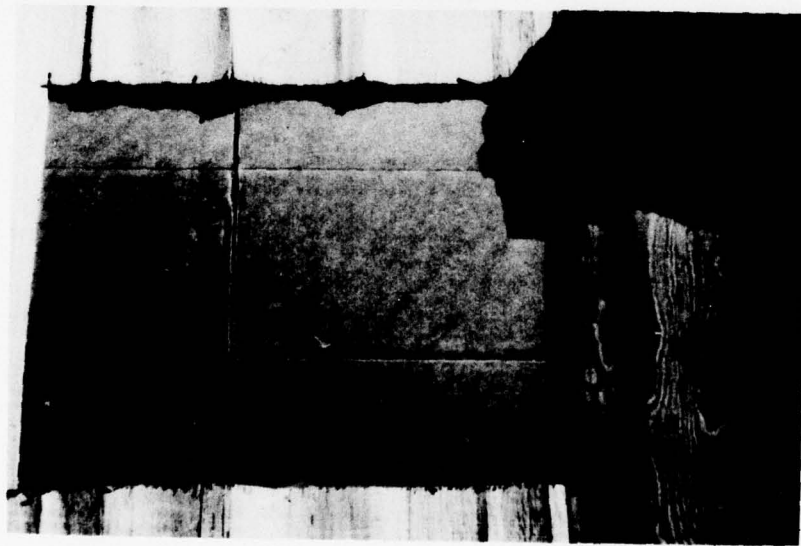
Figures 5 through 8 show holes prepared for repair using insect screen, corrugated paper box, plywood and burlap, respectively, as substrate. Figure 9 shows all four holes ready for repair work to begin.

Figure 6. Prepared hole with corrugated cardboard substrate.

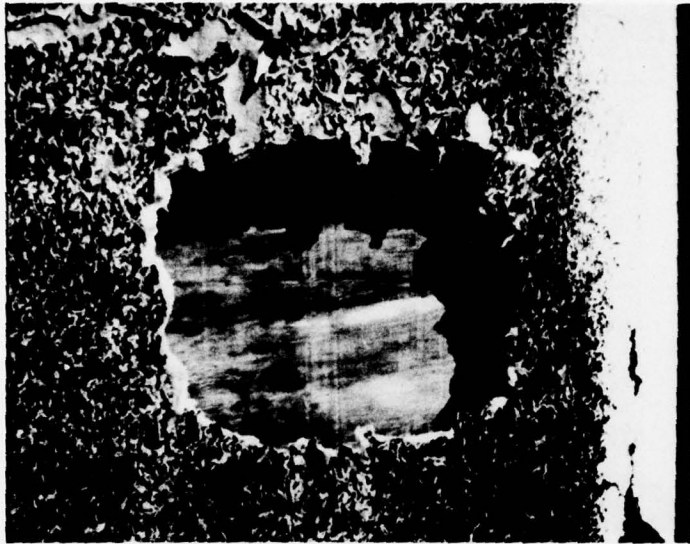
Figure 7. Prepared hole with plywood substrate.

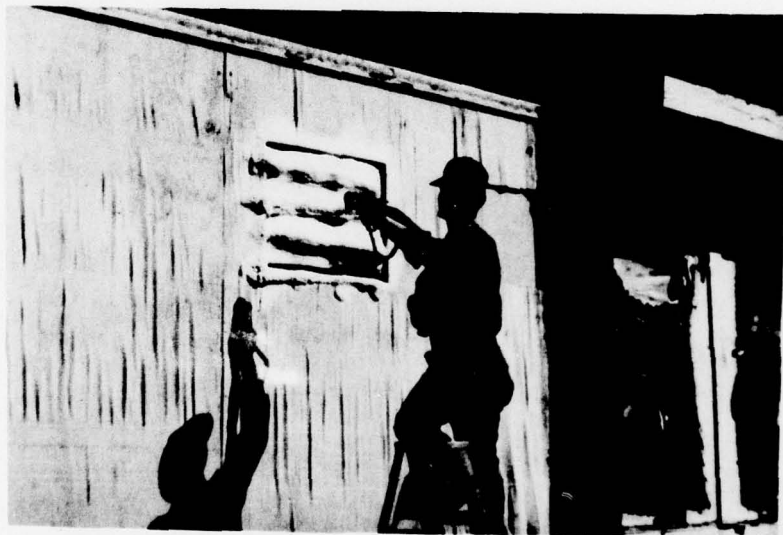
Figure 10. Spray foam being applied to insect screen substrate to make patch.

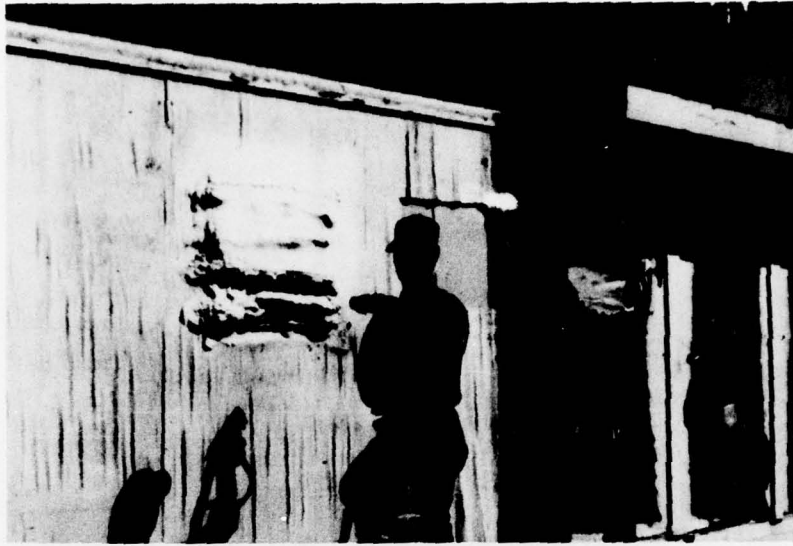
Figure 11. An excess of foam may be applied and trimmed off, if desired.

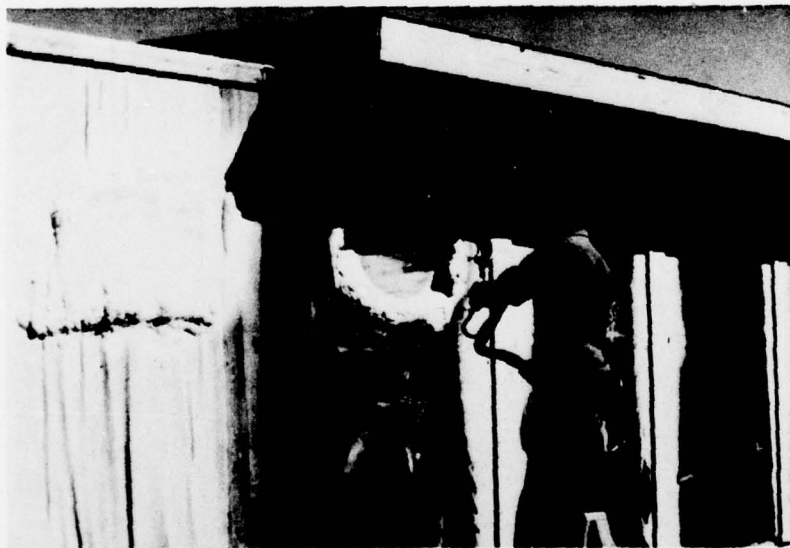
Figure 12. Application of foam to the edge of the hole first.

The best repair procedure is first to apply foam around the edges of the hole in order to provide a good seal to the existing wall (Figure 12). The remainder of the patch can then be filled in from the edges, as shown in Figure 13. Figure 14 shows completion of the foaming.

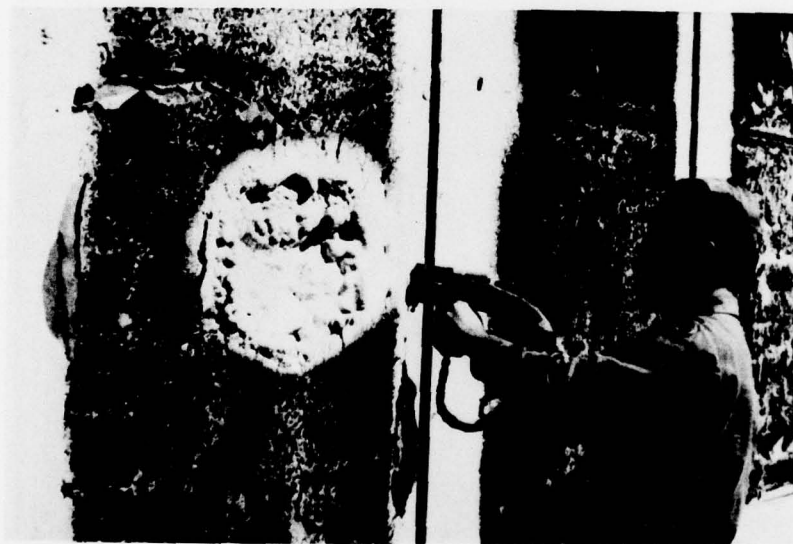
Figure 14. Completing the patch.

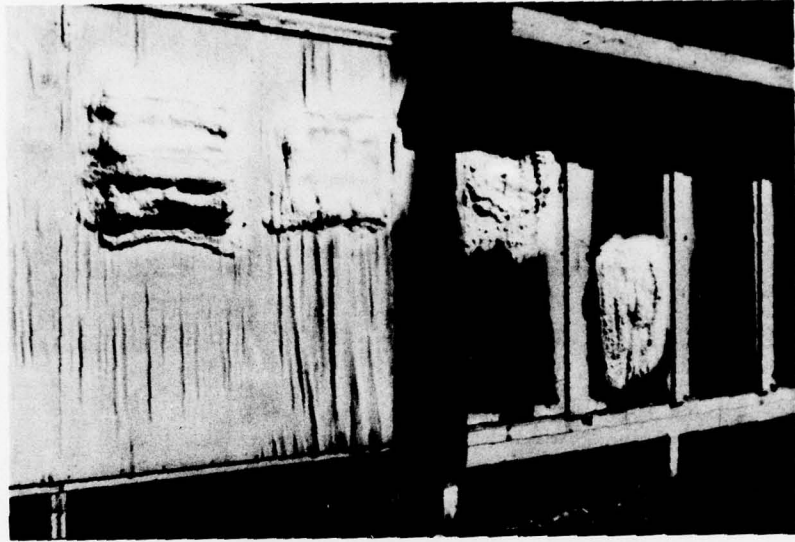
Figure 15. The four holes completely repaired.

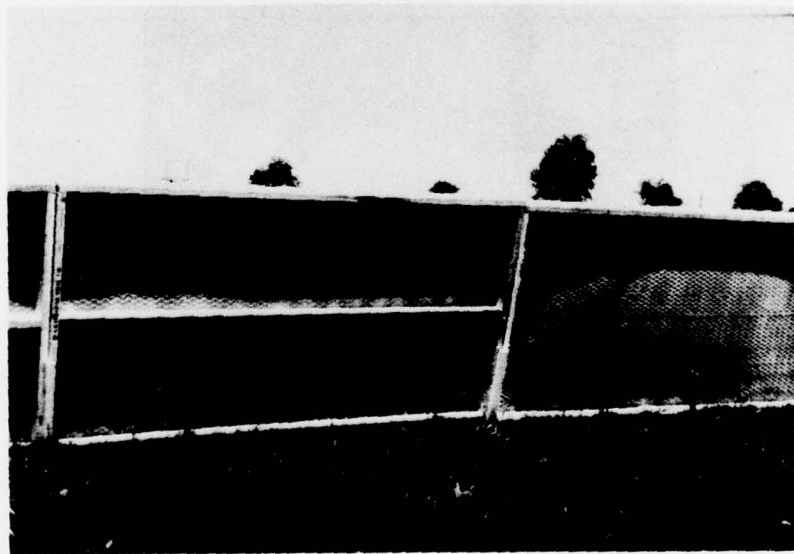
Figure 16. One large frame with an intermediate stud and one without.

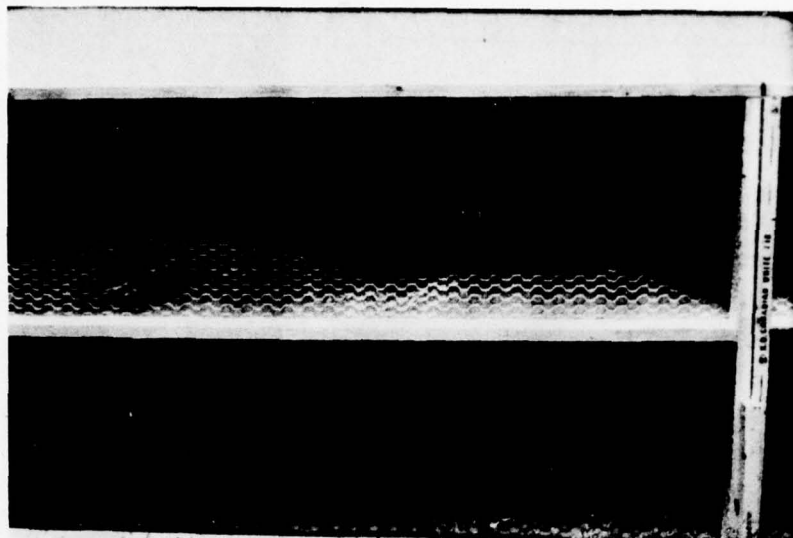
Figure 17. Rear view of large frame with intermediate stud, showing more detail of hexagonal netting substrate.

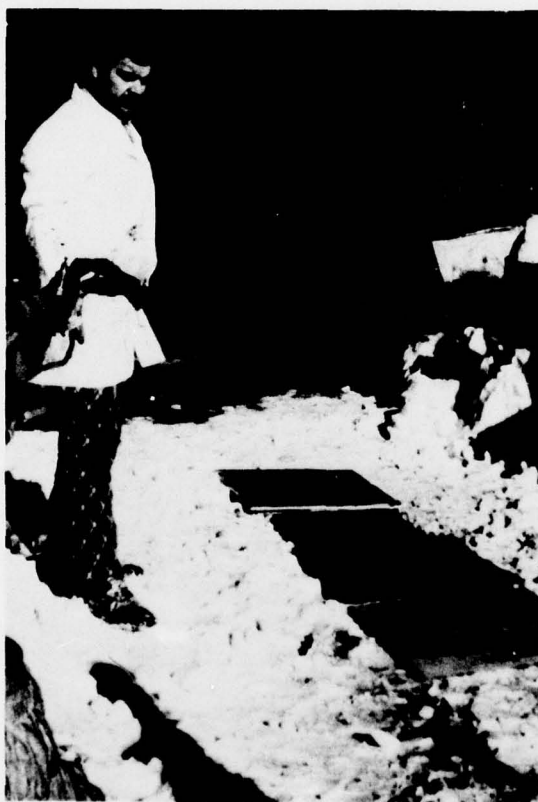
The four substrate materials (plywood, corrugated paper, aluminum sheet, and gypsum wall board) were left outside overnight at ambient temperature (-10°F [-23°C]) (Figure 18). As shown in Figure 19, foaming occurred more slowly on the materials that provide the greatest heat sink effect. However, after the initial delay, foaming occurs much as it does under more favorable conditions (Figure 20). There is a slight increase in the density of the foam and it takes about twice as long to react. Otherwise the foam is essentially normal. If foam build-up is too rapid, the foaming action tends to pull the unreacted surface layer away from the surface, resulting in poor bonding.

Figure 18. Four substrate materials (plywood, corrugated paper, aluminum sheet, and gypsum board, from front to rear) conditioned and ready for foam spray.
