ARMY ENGINEER DISTRICT PHILADELPHIA PA
NATIONAL DAM SAFETY PROGRAM. SILVER LAKE DAM. DE0031. DELAWARE --ETC(U)
JAN 78 F W VINCI

| REPORT DOCUMENTATION PAGE | | READ INSTRUCTIONS BEFORE COMPLETING FORM |
|--|--|---|
| 4. TITLE (and Subtitle) Phase I Inspection Report National Dam Safety Program Silver Lake Dam (DE0031) Kent County, Delaware | 5. TYPE OF REPORT & PERIOD COVERED FINAL report | |

PHASE ONE
NATIONAL DAM SAFETY PROGRAM
SILVER LAKE DAM
ST. JONES RIVER, DOVER, DELAWARE

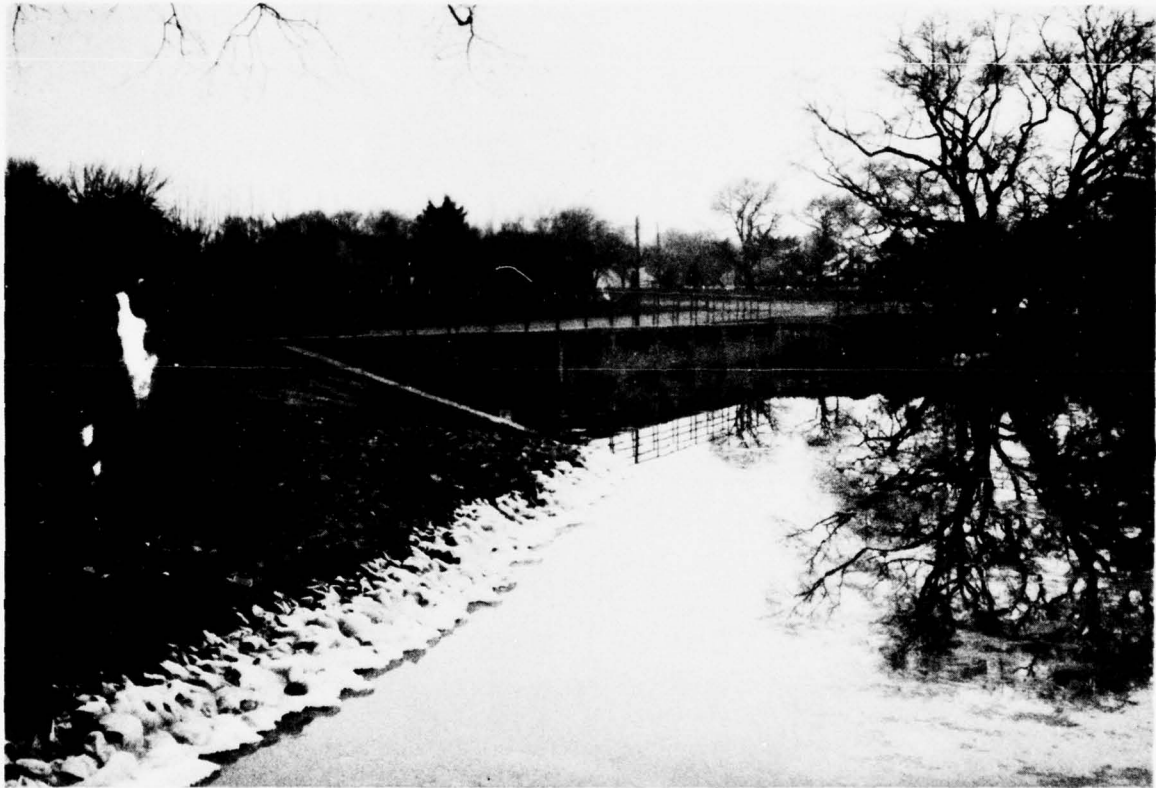
OVERVIEW PHOTO
SILVER LAKE DAM
VIEW LOOKING WEST
FROM
UPSTREAM OF LEFT ABUTMENT
TOWARD RIGHT ABUTMENT

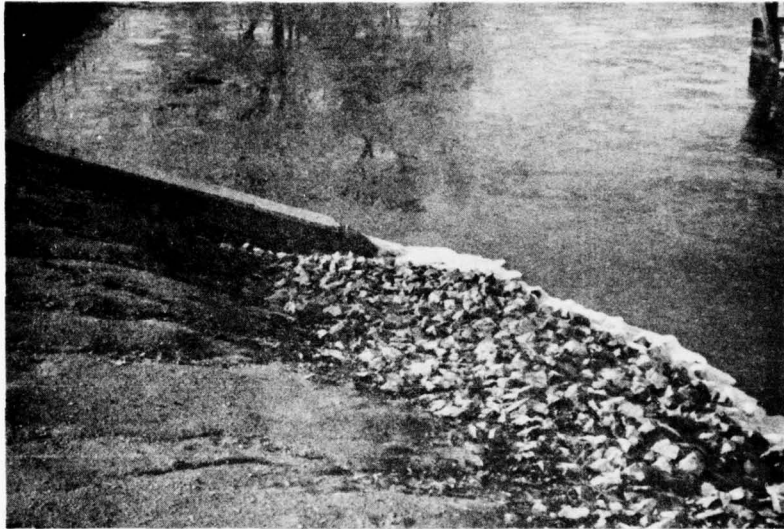
(3) Sloughing or erosion of embankment and abutment slopes: Sloughing was noted along the upstream embankment slope immediately left of the overflow structure. The sloughing appears to be the result of wave action; maintenance personnel attempted to alleviate the erosive action by placing 4-inch nominal ballast stone in the area. Stone appears unsatisfactory; see comment 6b (4) concerning the stone.

(2) Approach channel (concrete): The approach end of the left abutment overflow structure wall shows evidence of deteriorated concrete at the fluctuating freeze-thaw reservoir pool elevation. The right abutment wall approach end does not show this condition.

Deteriorated concrete at ice line--left abutment of overflow spillway structure

1. 13 Dec 77. Upstream embankment slope behind overflow structure left abutment wall. Note sloughing of embankment, 4" remedial stone, and deteriorating concrete at freeze-thaw line.

| VISUAL EXAMINATION OF | OBSERVATIONS | REMARKS OR RECOMMENDATIONS |
|--|--|---|
| RIPRAP FAILURES | Stone protection along left upstream slope appears inadequate to prevent wave erosion. | Recommend formal riprap protection at erosion location; minimum 12-inch thickness of well graded stone and 6-inch filter blanket. |

Deteriorated concrete at ice line should be repaired.

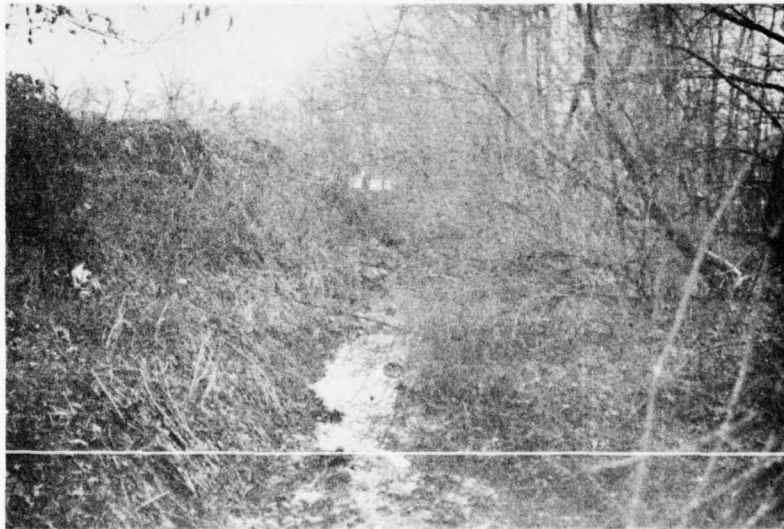
(7) Seepage: Seepage through the right embankment area was noted discharging into a storm water drainage swale approximately 400 feet downstream from the dam centerline. Invert elevation of the drainage swale is approximately 11 feet below normal pool elevation. No material transport was evident at the seepage locations and the seepage quantity does not appear of major significance although flow readings were not obtained or available.

| VISUAL EXAMINATION OF | OBSERVATIONS | REMARKS OR RECOMMENDATIONS |
|---|--|---|
| ANY NOTICEABLE SEEPAGE | Seepage noted along right section of embankment in drainage swale downstream of beach area. Seepage only noted entering from upstream bank facing reservoir; none on downstream bank. Seepage does not appear significant; no flow measurements available. | None. |

2. 13 Dec 77. Downstream right abutment drainage swale, looking southeast toward confluence with St. Jones River.

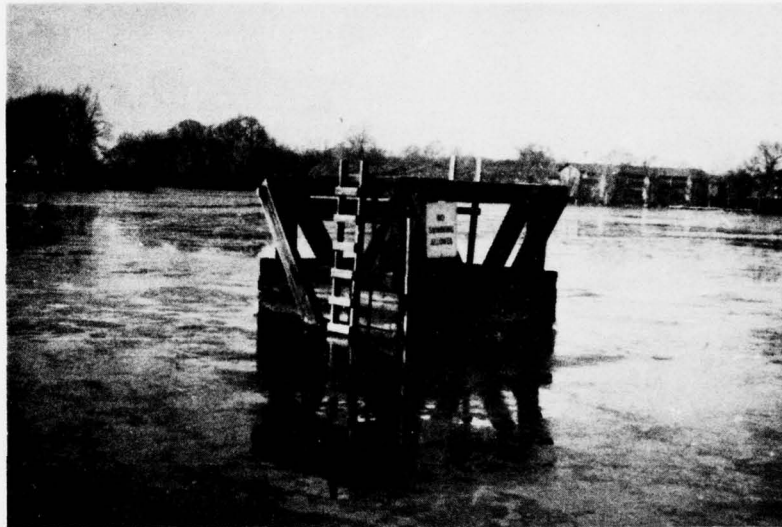
(8) Staff gage and recorder: A reservoir elevation staff gage exists on the drawdown intake structure, however, the gage appears deteriorated to the extent of replacement. No readings can be obtained from this gage. A U.S.G.S. water stage recorder is maintained on the St. Jones River approximately 1,950 feet downstream from the project site. Discharge records are available from 1958 to date; a period of approximately 20 years.

(1) Intake structure: Operating platform and sluice gate reported as operable; used on an annual basis to lower reservoir for beach cleaning and dock repairing. Owner representatives indicate diver is necessary to clean debris from sluice gate for complete closure, therefore, sluice gate was not operated; inclement weather (cold) precluded diving.

3. 13 Dec 77. View of sluice gate operating platform. Photo from left abutment area looking north toward upstream reservoir area.

(3) Install trashrack and replace staff gage at the intake structure.

Recommend intake be cleaned
and design formulated to prevent
debris from entering gate seat;
thereby, eliminating need for diver.

Recommend close inspection of
platform and sluice gate by owner
representatives during next
drawdown; diver can perform under-
water inspection

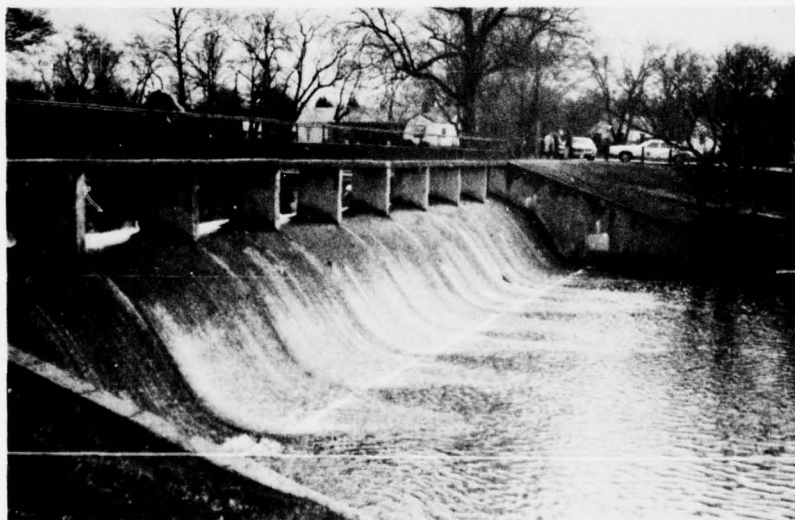
Numerous small popouts were noted in the downstream concrete ogee surface. The popouts, some of which appear to be tie rod patches, vary in size from 1/2-3 inches in diameter. The second monolith from east abutment contains two holes, approximately 1-1 1/2 feet horizontally, 2-3 inches wide, 10-12 feet from the west monolith edge and 3 feet above ogee bottom. The overall wier structure concrete appears to be in satisfactory condition. However, pool elevation precluded complete and thorough inspection of the upstream face.

4. 13 Dec 77. Overview of concrete gravity overflow structure, looking east from right abutment wall toward left abutment wall.

(1) Repair of concrete spalls and popouts in the overflow section of the spillway and at the upstream ends of the spillway abutment walls.

Recommend repair of concrete pop-out areas.

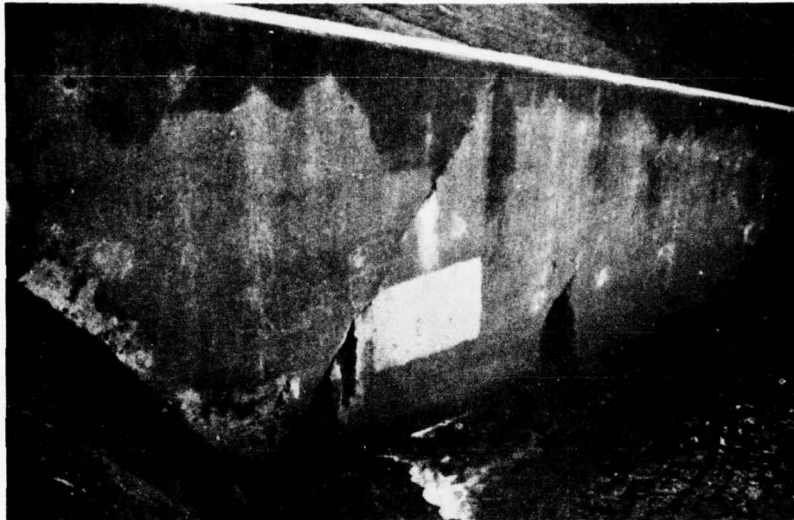
Both abutment walls have full length, top-to-bottom cracks downstream of the crest. Running water with efflorescence visible; cracks partially healing. No noticeable wall movement observed.

5. 13 Dec 77. Close view of overflow structure left abutment wall showing diagonal cracking with minor leakage, looking southeast from walkway.

Cracks do not appear to affect the structural stability of the walls, however, cracks should be monitored for deterioration and material piping.

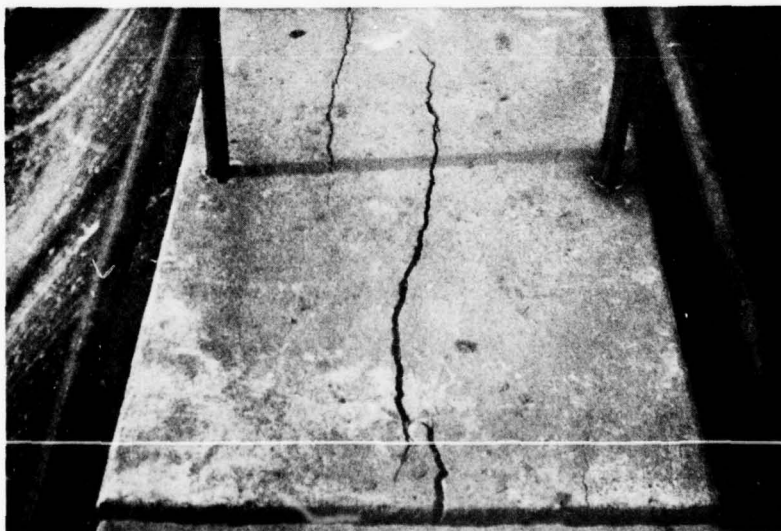
(4) Bridge and piers: A three-foot wide concrete walkway was constructed at top of dam elevation with support provided by vertical pedestals across the ogee weir crest. Several major longitudinal cracks were observed, 4 and 5 feet long, in the walkway above bay 5 (from left bank). Full length transverse cracks were observed at pedestal 6, and 10 feet left of pedestal 8. Generally, the underside of the walkway appeared badly spalled and deteriorated to the point of requiring replacement. The pedestals appeared cavitated at the spillway crest-pedestal flow line construction joint.

Fifth bay from left bank has large longitudinal cracks in center of walkway, 4 & 5 feet in length, open approximately $\frac{1}{2}$ -1 inch. Full length transverse crack at pier 6 and 10 feet left of pier 8.

6. 13 Dec 77. Longitudinal cracking of overflow structure walkway - fifth bay from left bank.

(2) Repair or replace deteriorated reinforced concrete foot bridge and piers.

As bridge walkway is badly deteriorated, it should be repaired or replaced.

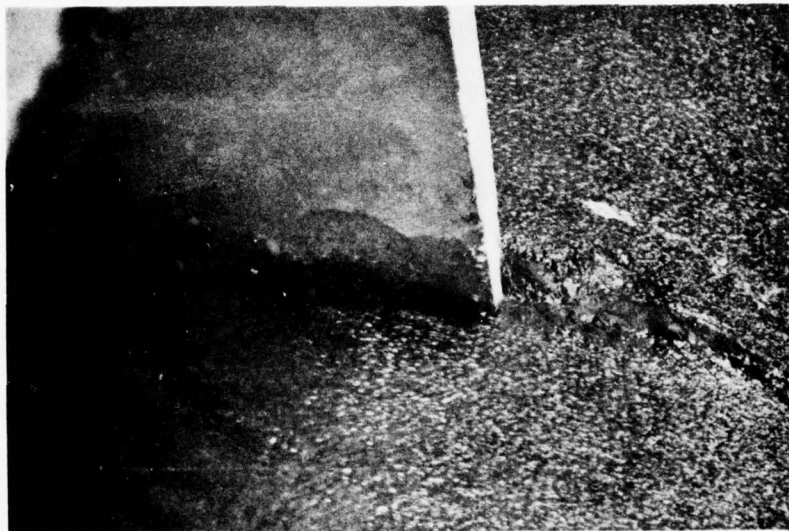
Some surface spalling on top walkway, between pier 11 and wall. Bars exposed (rusted) along west side of walkway--1 $\frac{1}{2}$ -inch diameter center steel exposed. South end of walkway between pier 2 and 3 badly cracked and spalled. Spalls average 2 per bay.

7. 13 Dec 77. Spalled concrete at pedestal/ogee crest construction joint.

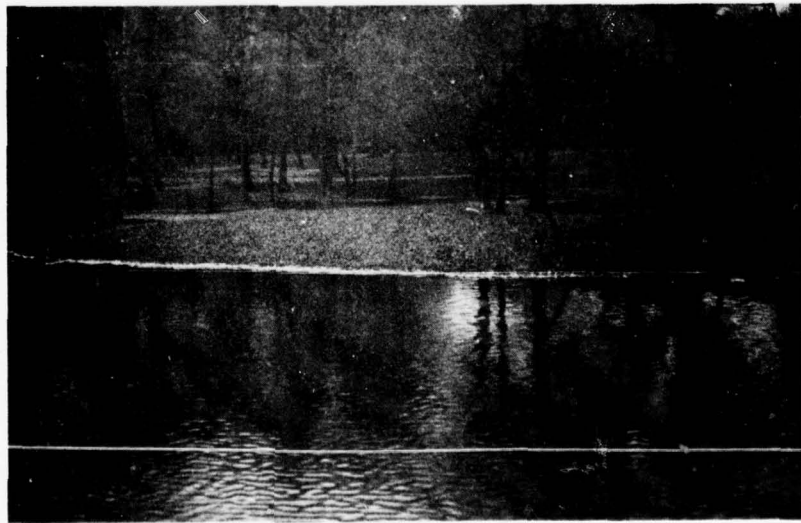
| VISUAL EXAMINATION OF | OBSERVATIONS | REMARKS OR RECOMMENDATIONS |
|---|--|---|
| CONDITION (OBSTRUCTIONS, DEBRIS, ETC.) | Downstream channel makes abrupt 45 degree bend immediately downstream of the ogee spillway. Bend will restrict flow during high discharges. Bridges at Division Street and Lockerman Street would constrict flow during flood releases. | Straightening of channel may be necessary if right bank cannot be stabilized. |

8. 13 Dec 77. Downstream right bank erosion area and 4" stone remedial measures.

Recommend larger riprap layer,
well-graded with filter blanket.
Recommend straightening of discharge
channel if erosion continues.
