C-130 WELDBONDED FUSELAGE PANEL FLIGHT EVALUATION PROGRAM.(U)

# C-130 WELDBONDED FUSELAGE PANEL FLIGHT EVALUATION PROGRAM

J. A. KIZER

FINAL REPORT OCTOBER 1974-DECEMBER 1977

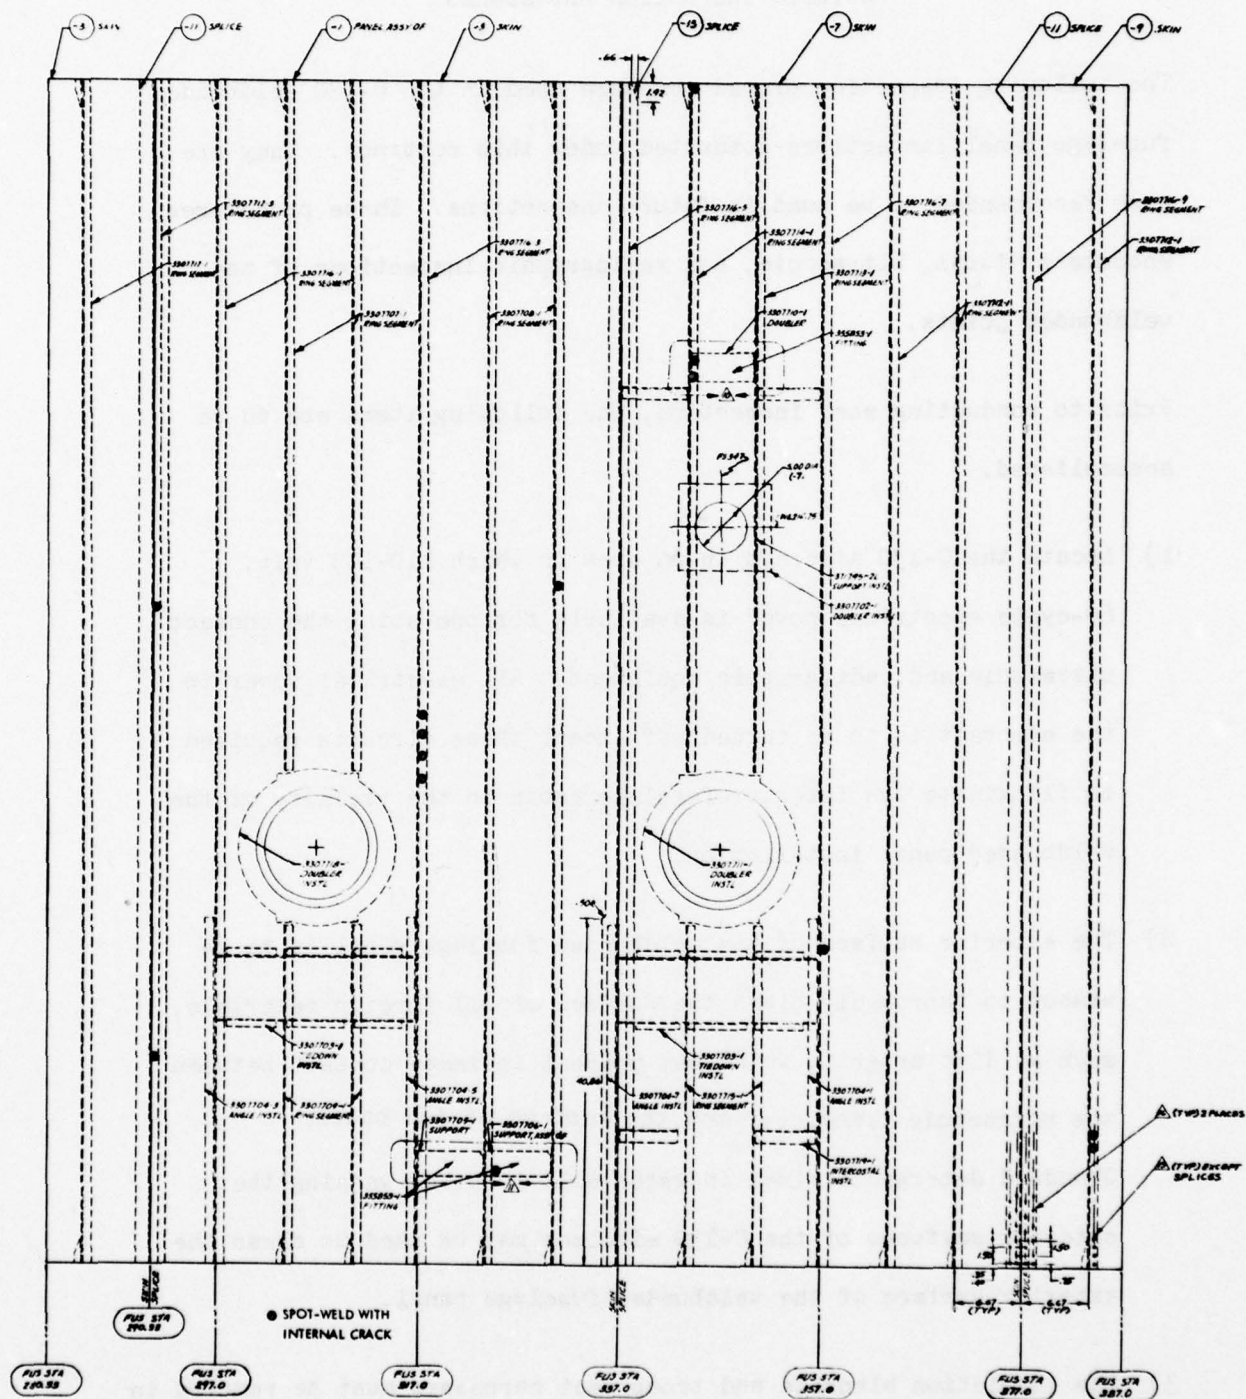
Figure 3 - C-130 Weldbonded Fuselage Panel Showing Spot-Weld Defects

The principal objective of this program was to evaluate the performance of the weldbonded joints in an operational environment. A total of seven inspections were planned to be conducted concurrently with aircraft isochronal inspections over the three-year period subsequent to the delivery of the aircraft. Visual, ultrasonic, and radiographic inspections were scheduled to be performed in which visual and ultrasonic inspections were to be conducted in all seven inspections, and radiographic inspections in three of the seven inspections. A baseline inspection including visual, ultrasonic, and radiographic inspections was conducted prior to delivery of the aircraft. During the baseline inspection, a total of fourteen (14) defects were detected during the radiographic inspection of the weldbonded joints upon completing fabrication of the fuselage panel, all of which were internal cracks in the spot-weld nuggets. None of the defects are in spot-welds that are adjacent to each other. No bondline defects were detected in the ultrasonic inspection that exceeded specification limits. The locations for the fourteen (14) defective spot-welds are shown on Figure 3.

\*No growth was detected in any of the fourteen (14) spot-weld defects detected in the baseline inspection which exceeded specification limits.

Radiographic inspections of the spot-welds in the aftermost region of the weldbonded fuselage panel were conducted during the third, fifth and seventh inspections. The spot-welds in the weldbonded splice at fuselage station 377.0 and the Z-section ring frame-to-skin joints at fuselage stations 357.0, 363.67, 370.33, and 383.67 were radiographically inspected during each of the three inspections. In addition, the fourteen (14) spot-welds detected during the baseline inspection that had internal cracks that exceeded specification limits were radiographically inspected during each of the three inspections for possible propagations. Radiographic inspection procedures and equipment used in conducting each of the three radiographic inspections were those described in Section II. During the three radiographic inspections, no additional spot-weld defects were detected and no propagations were revealed in any of the fourteen (14) spot-weld defects detected in the baseline inspection.

This recommendation is based on the satisfactory performance of the weldbonded fuselage panel since it entered operational service. Specifically, it is recommended that the spot-welds in the aftermost section of the weldbonded fuselage panel be radiographically inspected coincident with each aircraft depot maintenance (PDM) inspection. Furthermore, it is recommended that visual and ultrasonic inspections be conducted at every other aircraft isochronal inspection for the period between the first and second PDM. After the second PDM, visual and

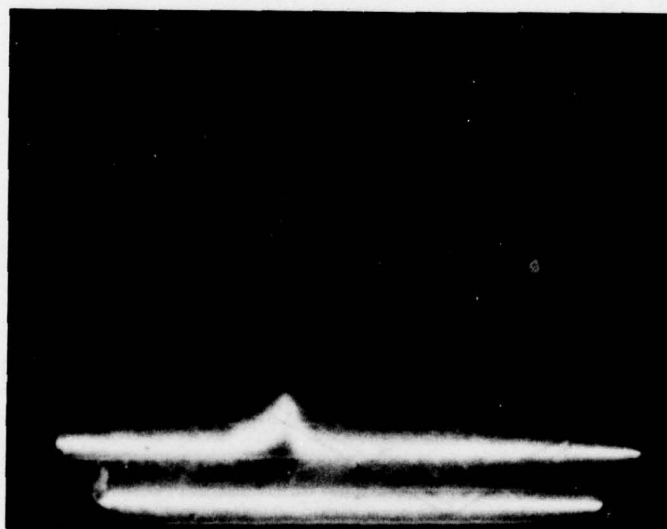
Figure 6 - CRT Signal of all Types of Disbonds in Bondline

- (1) Apply couplant on the designated Area 2 of the standard.
- (2) Place the transducer on a known good quality section of Area 2.
- (3) Adjust the Reflectoscope sweep to obtain a signal occupying approximately 50 percent of the cathode ray tube (CRT) screen. The signal of a quality bondline is as shown on Figure 5.
- (4) Place the transducer over known nearside and farside disbands in the appropriate zones of Area 2 of the standard.
- (5) Adjust the sweep delay/length controls of the Reflectoscope to move all signals off the CRT screen. A representative signal of both types of disbands is shown on Figure 6.
