USARTL-TR-78-13

REVIEW OF ENGINE/AIRFRAME/DRIVE TRAIN DYNAMIC  
INTERFACE DEVELOPMENT PROBLEMS

W. J. Twomey, E. H. Ham  
Sikorsky Aircraft  
Division of United Technologies Corporation  
Stratford, Conn. 06602

Final Report for Period August 1977 - March 1978

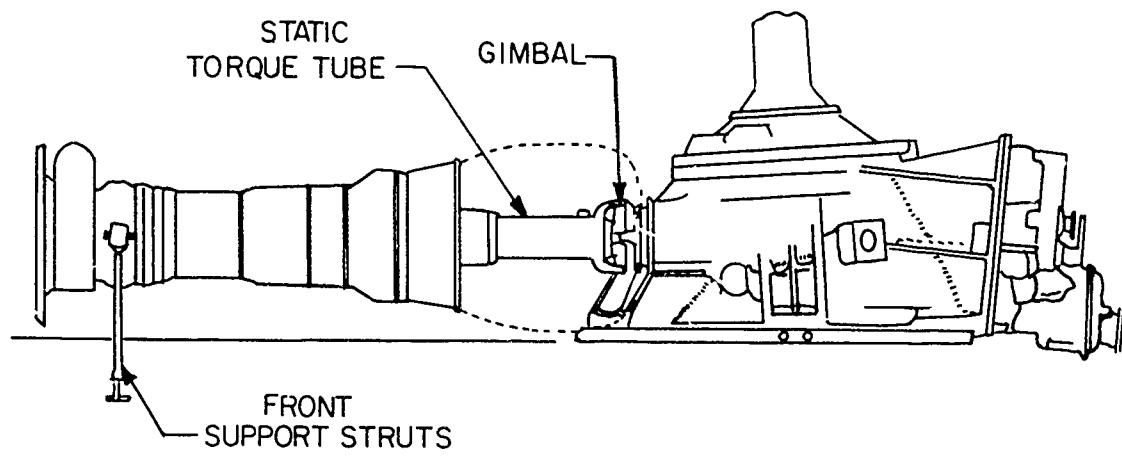
Figure 12. S-61 Engine Installation.

The first indication of this problem in the S-61L was the measurement of engine vibration levels which were above the maximum allowable, according to the engine environment specifications. The problem occurred in 1963 during developmental testing of the S-61L, which was a commercial derivative of the SH-3A. It was known from earlier studies of the SH-3A that these vibratory levels were high enough to cause a high stress problem in the power turbine bearing housing structure.

The solution was to increase the interface flexibility between the front frame of the engine and the airframe. Figure 12 shows the S-61L engine installation. The "hard" front engine support struts were switched to "soft" elastomeric isolation mounts. This lowered the resonant frequency of the critical first bending mode from 23 Hz to 10 Hz (Figure 13).

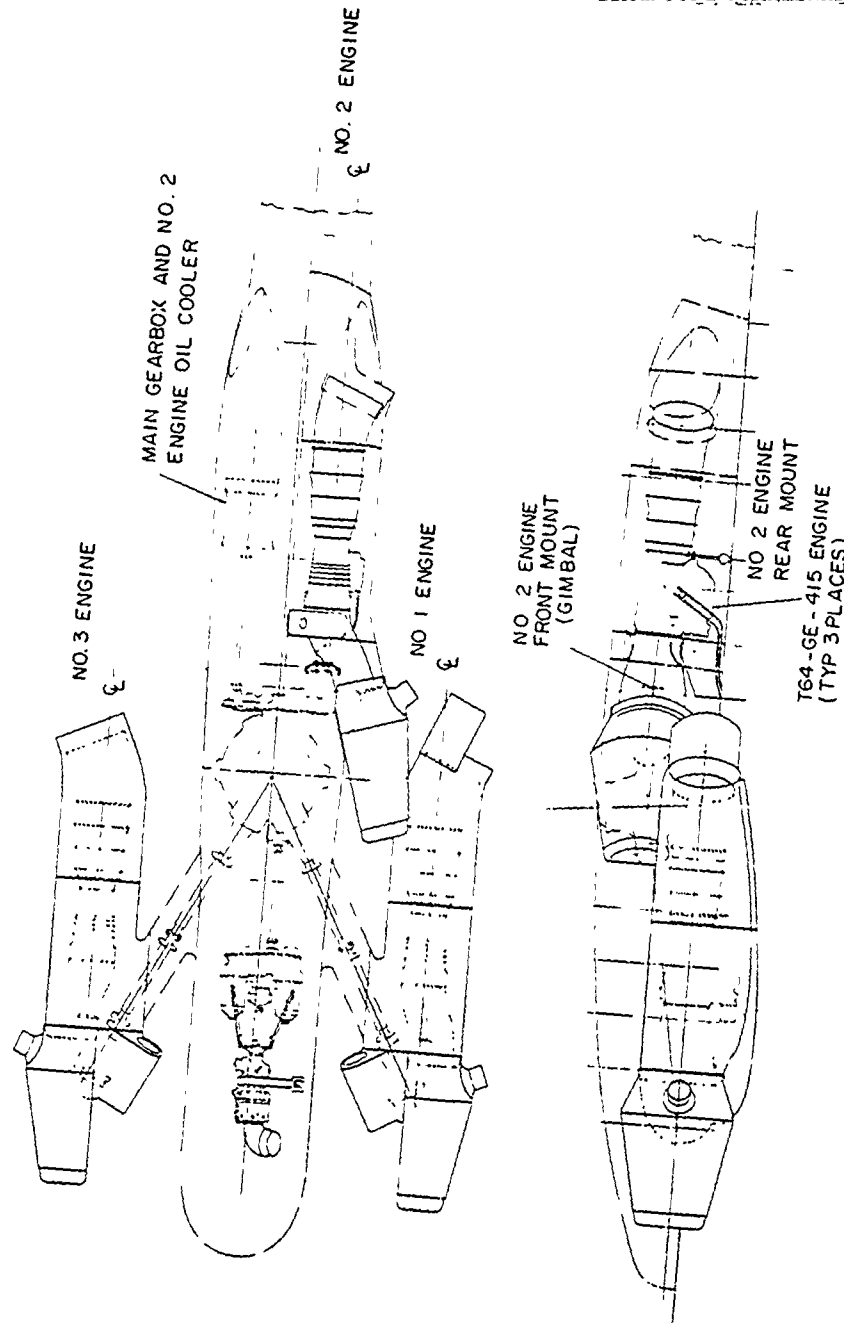
Figure 19. CH-53E Engine Arrangement.

During development testing of the CH-53E propulsion system on the PSTB (propulsion system test bed) the number 2 engine experienced a drive shaft disengagement from the gearbox that resulted in extensive damage to the engine and moderate secondary damage to the stand. This incident occurred in April 1971.

Investigation revealed that the engine was longitudinally responsive to the main rotor 7P excitation frequency of 20.6 Hz. It is believed that the relative longitudinal motions were the cause of breakage of the spline shaft retaining clip which allowed disengagement of the spline and subsequent overspeed of the engine. Vibration levels were not measured in the longitudinal direction because there had not been an allowable limit established for this direction.

The gimbal ring design was analyzed for feasible modifications for making a higher frequency installation. The concept of a lower frequency installation was discarded because it could cause additional wear on the spline due to larger relative motions between engine and gearbox. To expedite testing with a stiffer gimbal ring, a new one was manufactured of steel instead of aluminum as used in the original design. With this

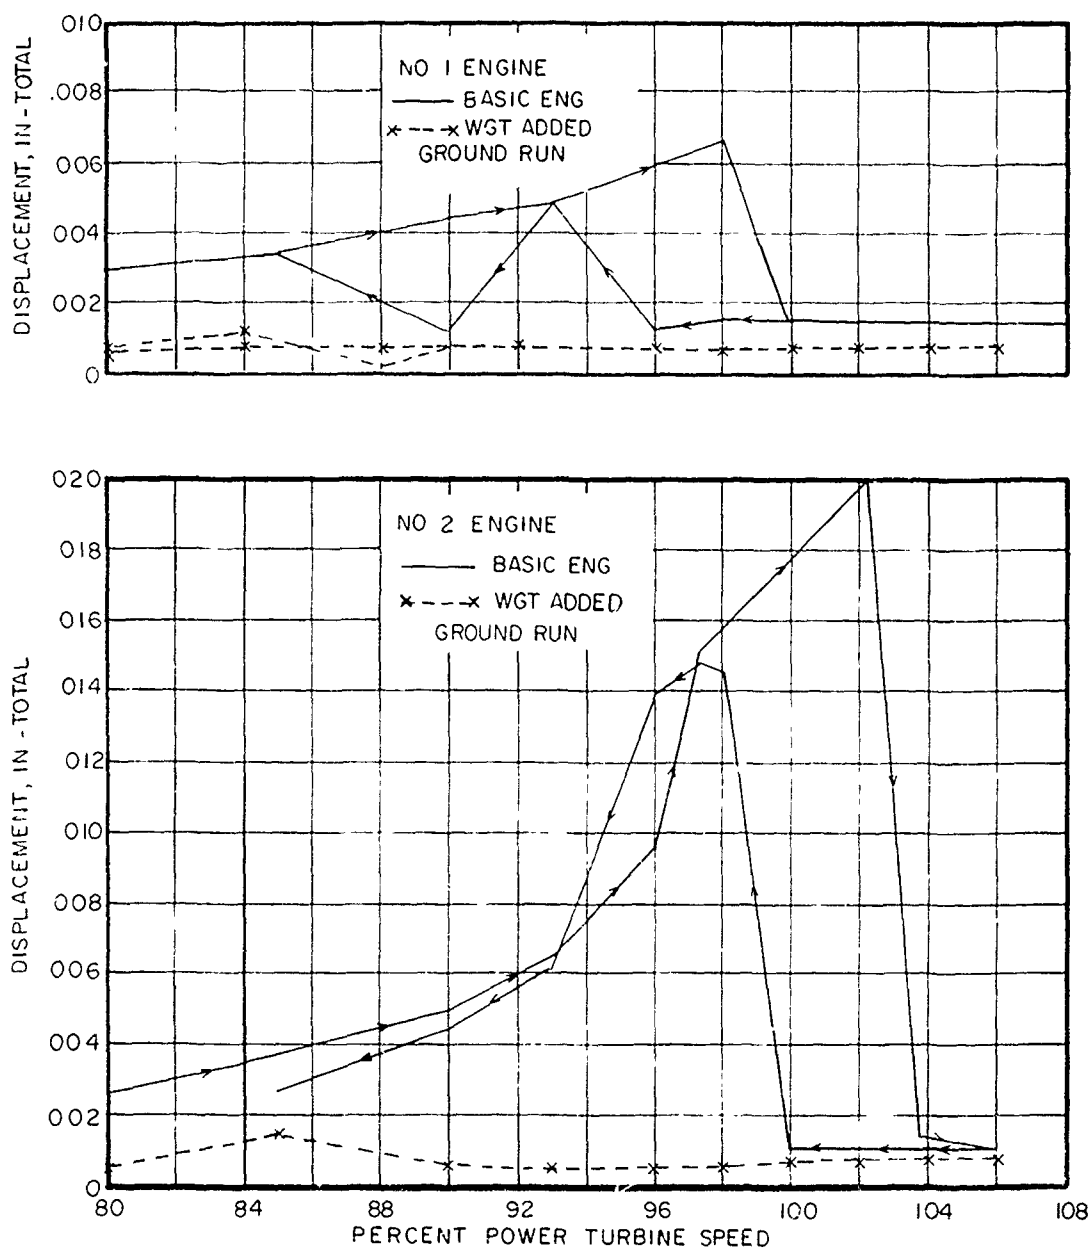
Figure 29. Engine Vibration - Effect of Adding 12½-Pound Weight to Torque Tube.

As shown in Figure 29, the weight lowered the resonance to 85%  $N_f$  which resulted in vibration levels within 3 mils at the bearing housing throughout the operating range.

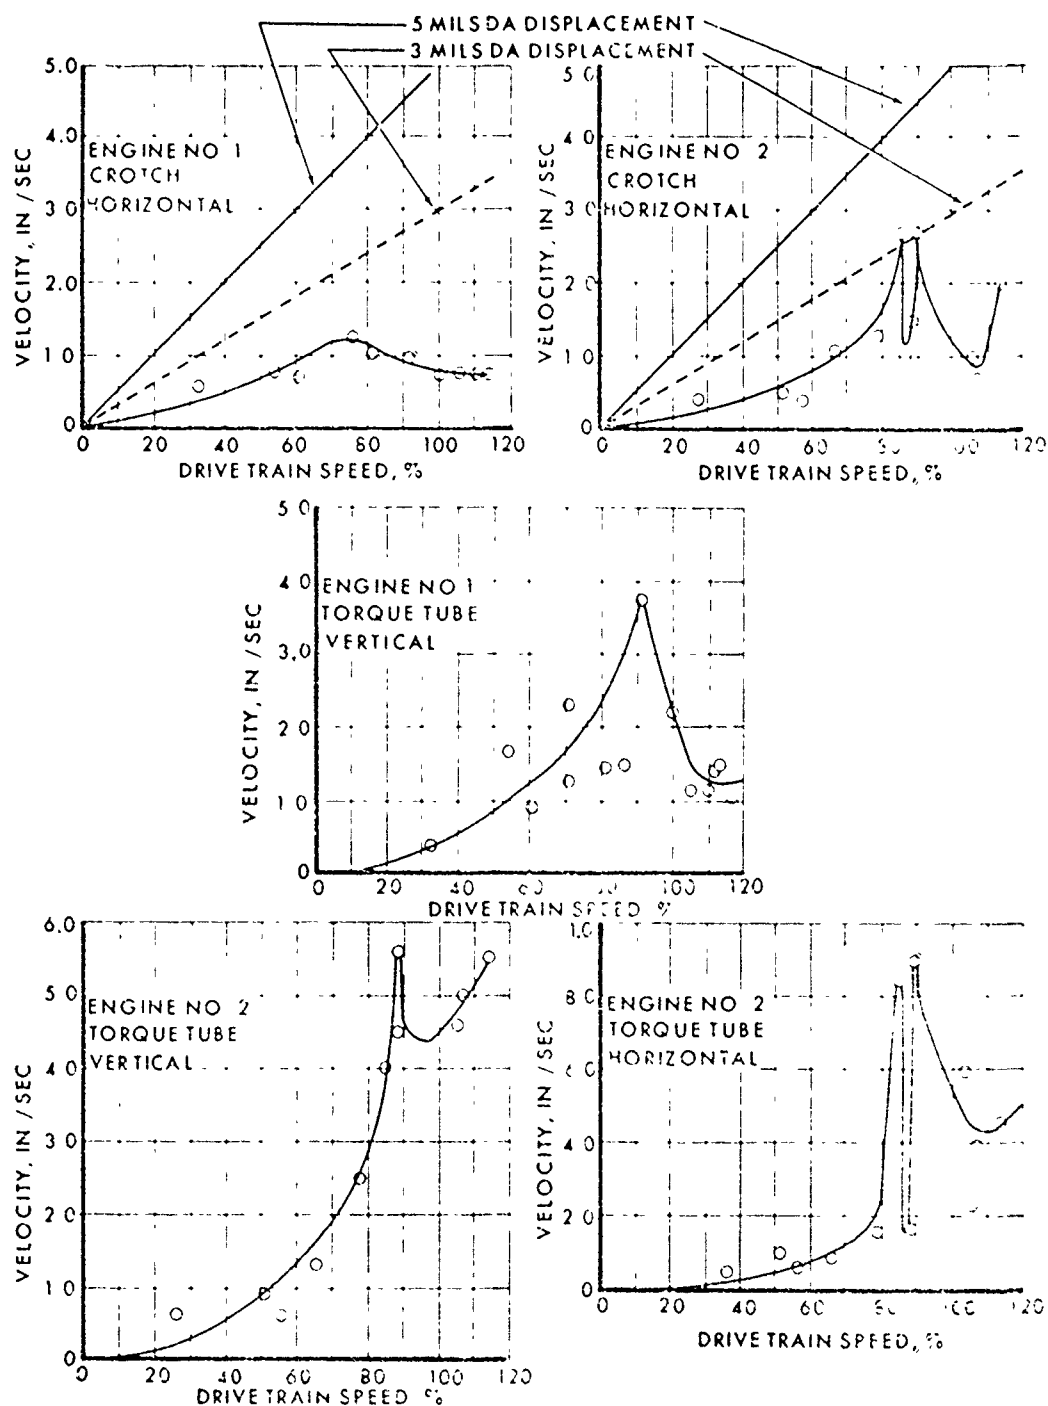
Figure 37. Engine Vibration Graphs.

The vibration pickups located on the engine torque tube are not engine pickups and are therefore not subject to the GE limits. Plots for these pickups are presented in Figure 37 where some evidence of a resonance is seen at 90-percent rotor speed. No limits have been determined for these locations; however, the vibration levels observed there are undoubtedly the major contribution to the gimbal mount deterioration.

The outer shafts with integral pole pieces were removed from the drive shaft, and roller gearbox development was continued. Further development work on the torque meter system was discontinued.
