STRATEGIC AIR COMMAND OFFUTT AFB NEBR AIRCRAFT ENGIN--ETC F/0 17/9  
GIANT IMAGE II RELIABILITY AND MAINTAINABILITY (B-52D). (U)

9 ENGINEERING REPORT, NO. P-313 ✓  
 6 GIANT IMAGE II RELIABILITY AND MAINTAINABILITY  
 (B-52D)  
 11 10 July 1978

ENGINEERING REPORT NO. P-286  
GIANT IMAGE RELIABILITY AND MAINTAINABILITY  
(B-52G/H)

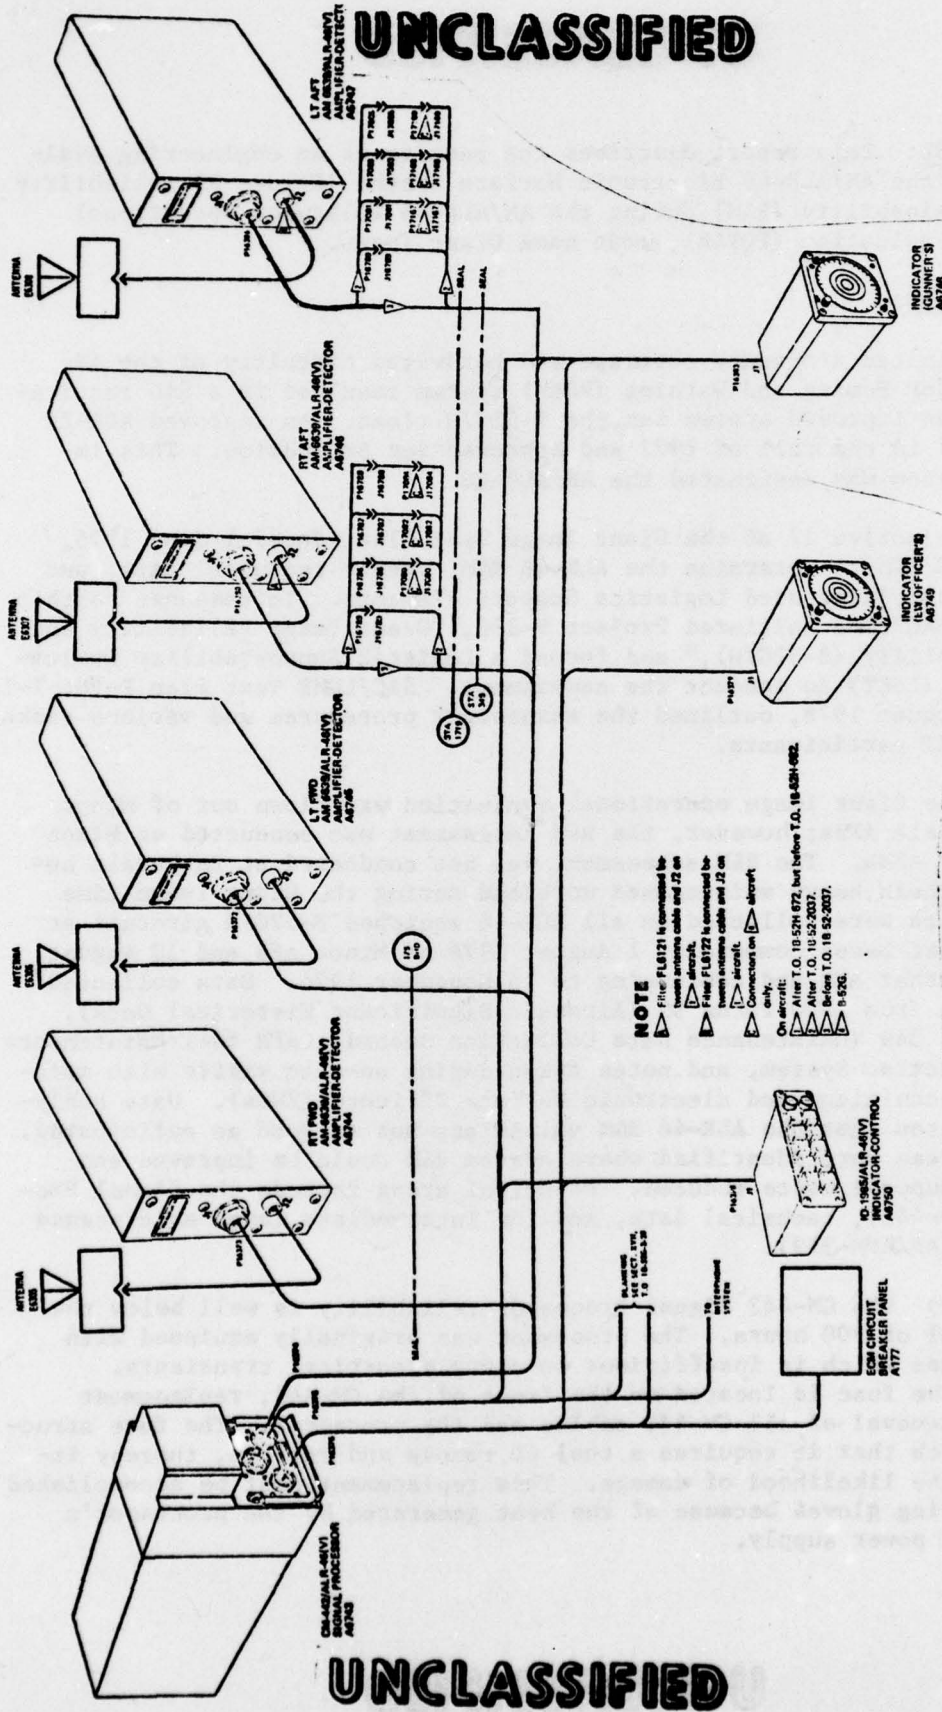
Figure 1 - AN/ALR-46 Electronic Warfare System

(1) The CM-442 Signal Processor reliability is well below the design goal of 300 hours. The processor was originally equipped with a 3-amp fuse which is insufficient to carry electrical transients. Although the fuse is located on the front of the CM-442, replacement requires removal of all CM-442 cables and the processor. The fuse structure is such that it requires a tool to remove and replace, thereby increasing the likelihood of damage. This replacement must be accomplished while wearing gloves because of the heat generated by the processor's integrated power supply.

(1) Take action to replace the present CM-442 fuse and fuse holder with the standard type fuse and fuse holder.

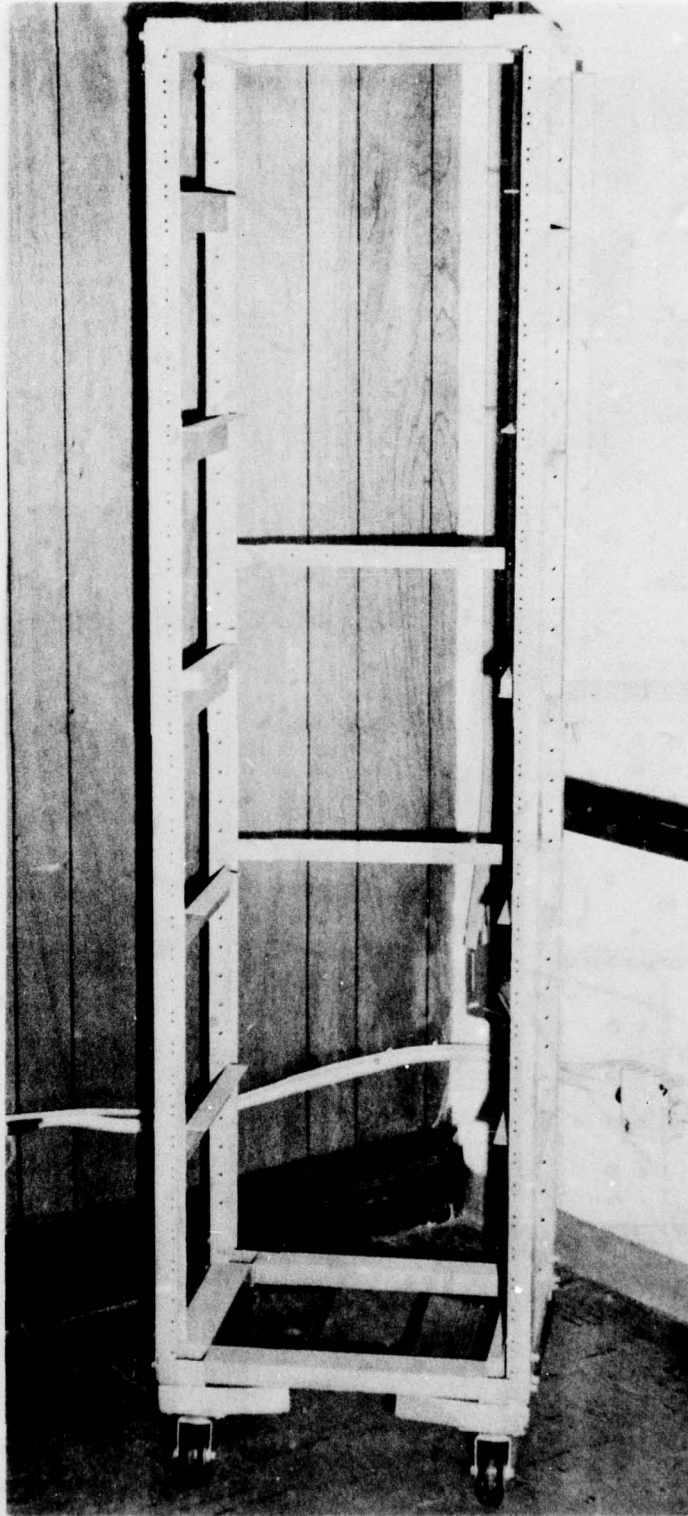
Figure 3 - Equipment Rack

(1) Fuse failures have been previously discussed and many of these problems have been resolved by increasing the fuse rating from 3-amps to 5-amps to handle electrical transients. However, the problem of removal and replacement of the fuse remains. The fuse and a spare are located on the lower front of the Signal Processor (Figure 5). The Signal Processor is mounted in an equipment rack on the floor to the left of the EWO as he is seated. Heat generated by the processor required a heat shield be added between the processor and the EWO. With the processor in its normal position, it is extremely difficult, if not impossible, to remove and replace the fuse. There is an equipment rack bulkhead approximately three inches (7.62 cm) to the front of the processor which obstructs access to the fuses. During the test flights several fuses failed and had to be replaced. The operator had to completely unstrap from his seat, disconnect the cables from the Signal Processor, remove it from the equipment rack, and then replace the fuse. The operator must wear gloves in handling the processor because of the heat generated by the integrated power supply. The fuse cap has a recessed slot requiring a tool (screwdriver or coin) to remove and replace. The cap material chips easily and with light force the slot edges become rounded. The cap must then be discarded. During this assessment, the Mather EWS shop had to drill out a fuse because an operator had stripped the slot edges and the shop was unable to remove the cap and fuse in any other manner. SrA Patricia Loegering, Mather AFB ALR-46 technician, investigated replacement of this fuse with the standard fuse and fuse holder, P/N FHN20G. The standard fuse holder does not require any tools for fuse replacement and will fit into the present fuse space. A Form 1000 has been submitted suggesting this change. This fuse and fuse holder would solve one operator problem but the signal processor location problem remains. Relocation of the signal processor is anticipated as part of the proposed AN/ALQ-155 Power Management System. If this system (ALQ-155) is not incorporated in the B-52G/H fleet, relocation of the Signal Processor should be considered.

c. Recommend Oklahoma City ALC relocate the CM-442 processor to improve accessibility to the fuse and eliminate the need to remove the processor from the equipment rack for fuse replacement.

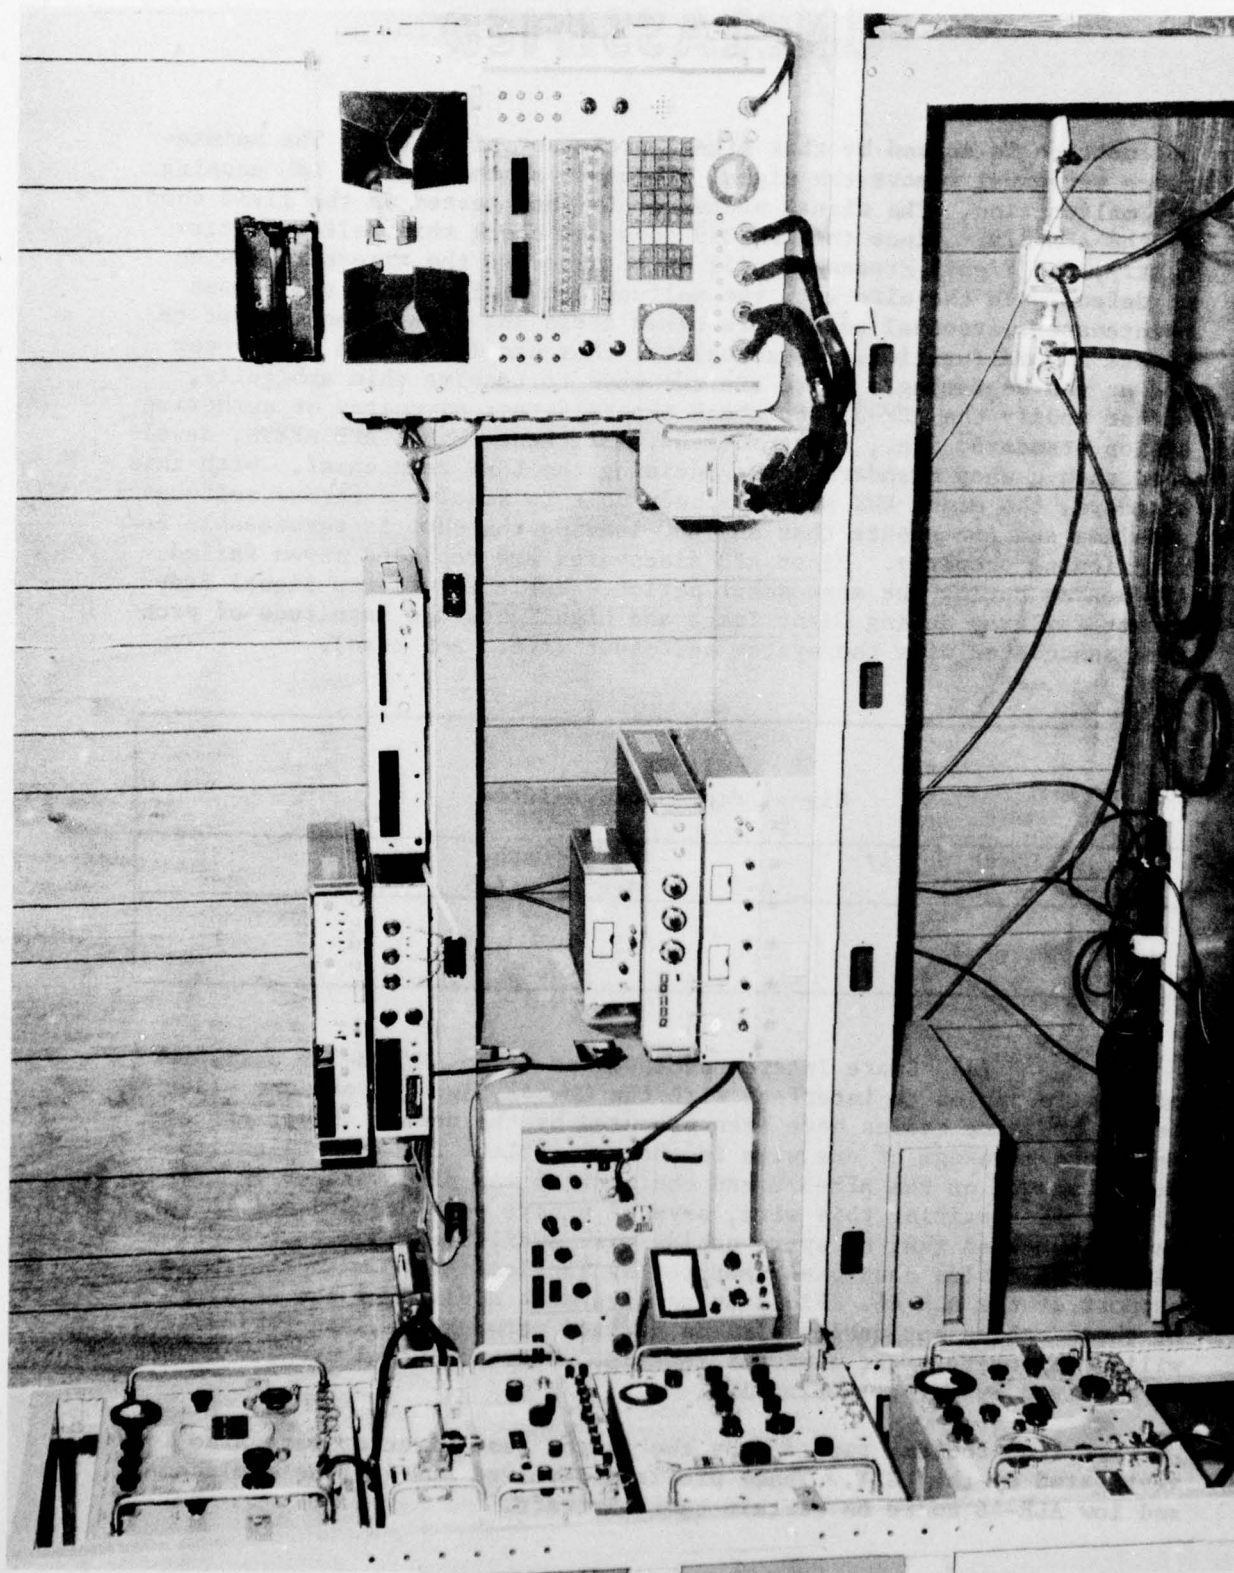
Figure 4 - Mather AFB AN/AIR-46 Work Area

j. The lack of a console or mounting racks for ALR-46 test equipment results in a potentially hazardous situation on the test bench. The scattered placement of equipment and connecting cables increases the possibility of the technician and equipment becoming entangled.

(a) Test Console - To properly connect the many needed items of test equipment, even where the equipment is logically mounted in a console, is difficult. To make these equipment inter-connections when the equipment is scattered throughout the work area, stacked one on top of the other, or even neatly arranged, is exceedingly difficult and subjects the equipment to damage from falling, incorrect electrical connections, or over-heating from poor air circulation. Figure 2 depicts a typical ALR-46 work bench, this one at Barksdale AFB. Mather AFB technicians have successfully resolved many problems by placing the RF signal generators in an equipment rack obtained from an old communications van (Figure 3). This rack can hold the five required RF signal generators (the fifth was out for calibration) in a safe secure manner, freeing the work bench for other required test equipment (Figure 4). A Form 1000 (No. MAT 051-77) has been submitted on this ALR-46 console set-up.

a. Recommend SAC/LGMA approve construction of an ALR-46 maintenance console.

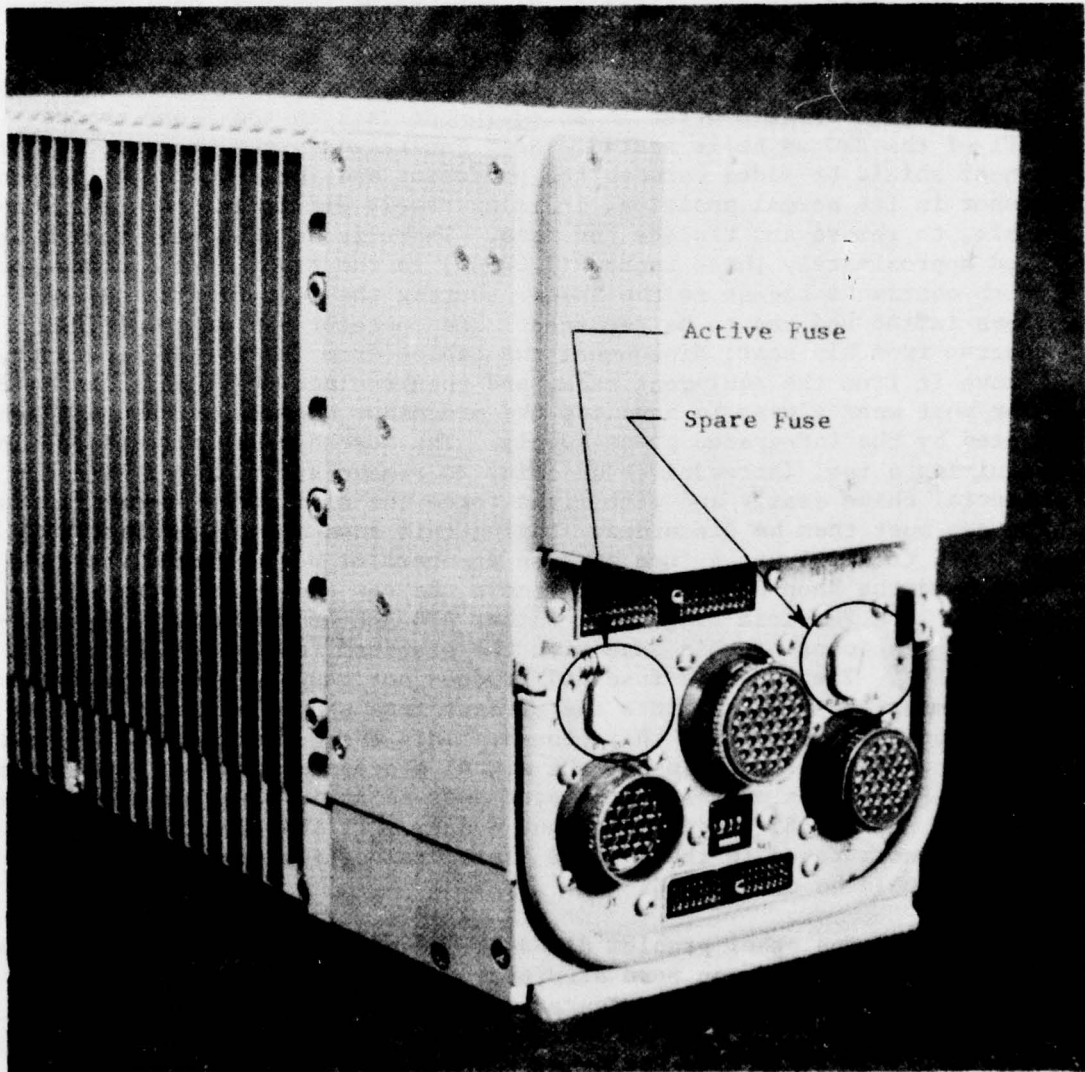
Figure 5 - AN/ALR-46 CM-442 Signal Processor

f. The processor fuse holder is extremely susceptible to damage during fuse removal and replacement.

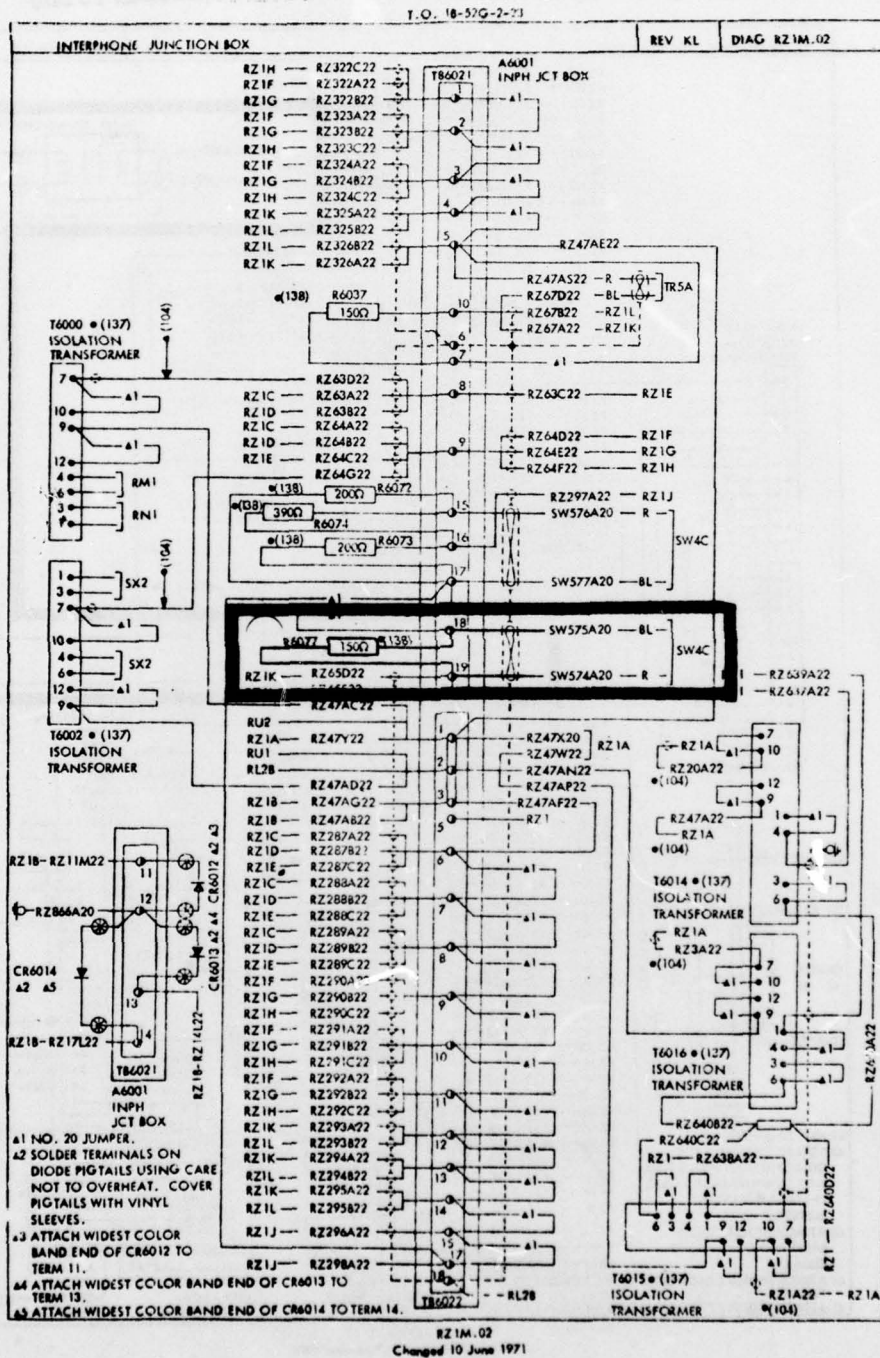
Figure 6 - B-52H Interphone Junction Box (Before TCTO 1B-52H-682)

g. Discrepancies in aircraft wiring contributed to poor ALR-46 audio performance.

terminals 18 and 19 (terminals 2 and 3 on TB6019 for B-52Gs) and resistor R6077 removed. Aircraft were found in three various configurations to include proper configuration with transformer installed and resistor removed, transformer installed and resistor not removed, and no transformer or resistor installed. These configurations were discovered at three bases after a telecon request for an inspection from the Giant Image LSET team chief. As a result, the SAC Deputy LGM requested all B-52G/H ALR-46 equipped units to conduct a one-time inspection to verify aircraft audio configurations and to bring them into compliance with applicable TCTOs. To date, six units have completed the inspection and have found seven aircraft improperly configured. The records of these seven aircraft reflected compliance with the applicable audio TCTOs. A significant improvement in ALR-46 audio was noted when the resistor R6077 was removed and the transformer installed.
