ENGINEERING REPORT LCR-E-1004

(E) **DUD INVESTIGATION OF  
M69 ELECTRIC DETONATOR**

(10) BY: JOSEPH O. JULIANO

US ARMY ARMAMENT RESEARCH AND DEVELOPMENT COMMAND

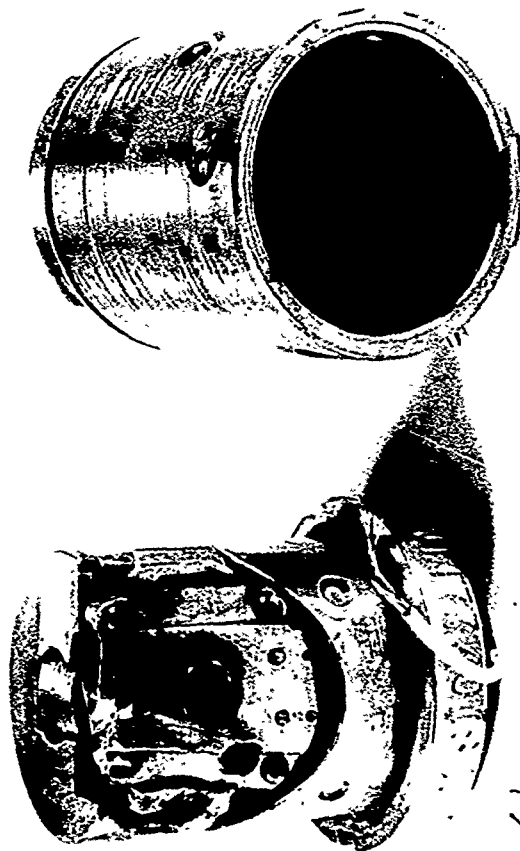
FIGURE 9

These tests were conducted, with the results as shown in Table II. Of the 10 units assembled for static detonator safety, three were unusable due to problems peculiar to the specially modified assembly necessary to initiate the detonator in the out-of-line position. The seven remaining units subjected to the out-of-line detonator safety tests showed successful resolution of the detonator safety problem. The units tested with M69 Detonators (Figure 9) show virtually no parts deformation as compared to those tested with the M48 Detonator (Figure 10) which were completely blown apart.

11509A/E1  
DETONATOR OUT OF  
LINE SAFETY TEST  
(AMBIENT)

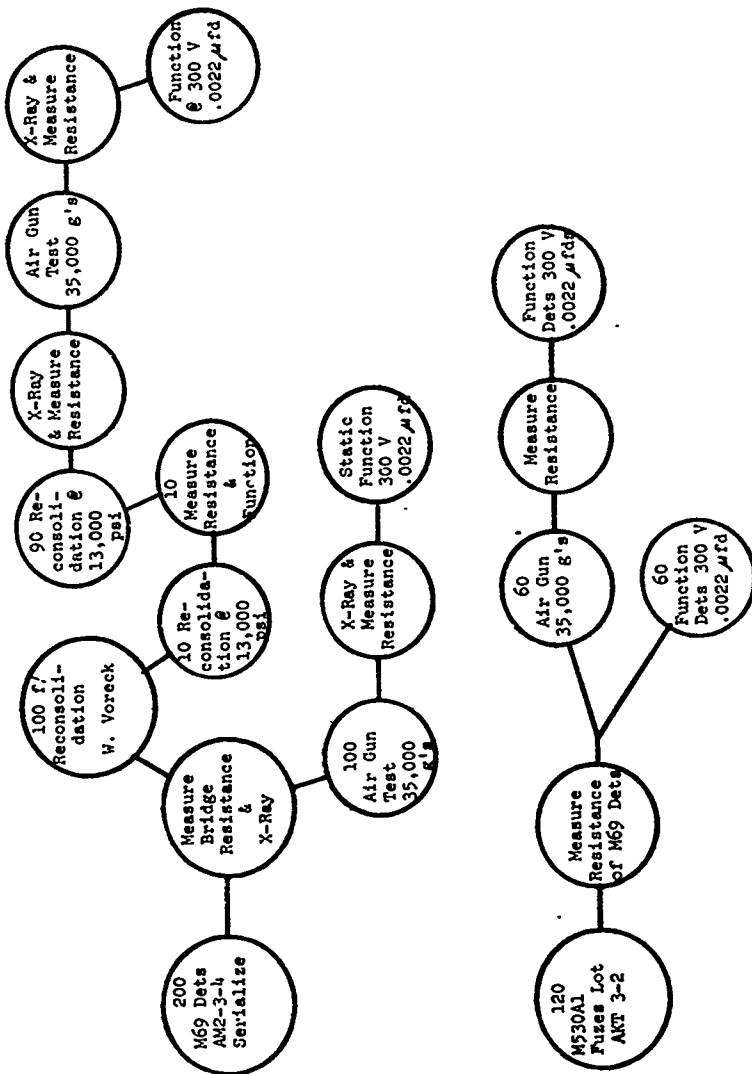
FIGURE 11

Consequently, it was decided that a test program should be outlined to investigate the cause of the duds and evaluate its resolution. Figure 11 represents the test plan implemented. The basic intent of this plan was to evaluate the present M69 Detonator Lot AM2-3-4 with which the problem occurred, an existing supposedly acceptable lot of M69 Detonators as loaded in M530A1 Fuzes and a quantity of Lot AM2-3-4 modified to correct the hypothesized problem.

# M69 DETONATOR INVESTIGATION PLAN
