HACKENSACK RIVER BASIN  
PASCACK BROOK, BERGEN COUNTY  
NEW JERSEY

# WOODCLIFF LAKE DAM

PHASE I INSPECTION REPORT  
NATIONAL DAM SAFETY PROGRAM

NJ00247

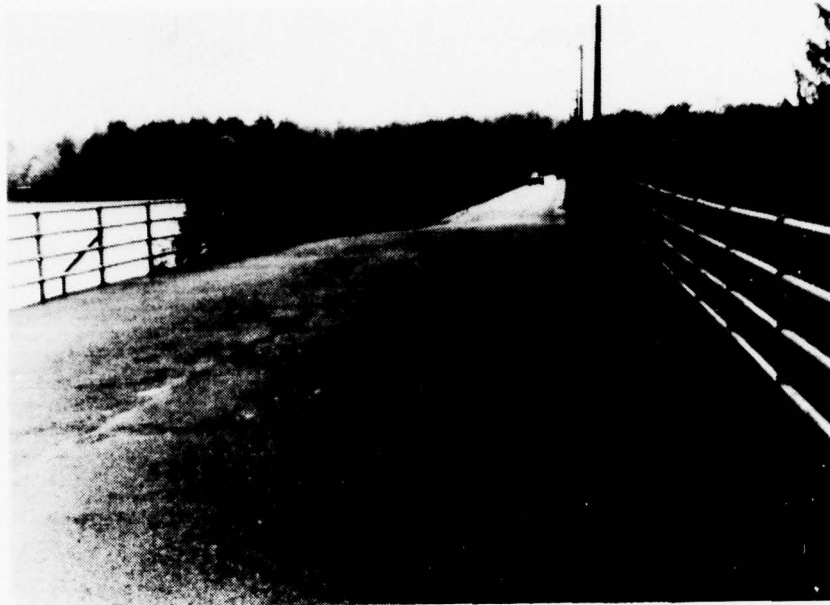
Photo 1 - Looking at dam crest along Church Road toward left abutment from spillway bridge on right abutment

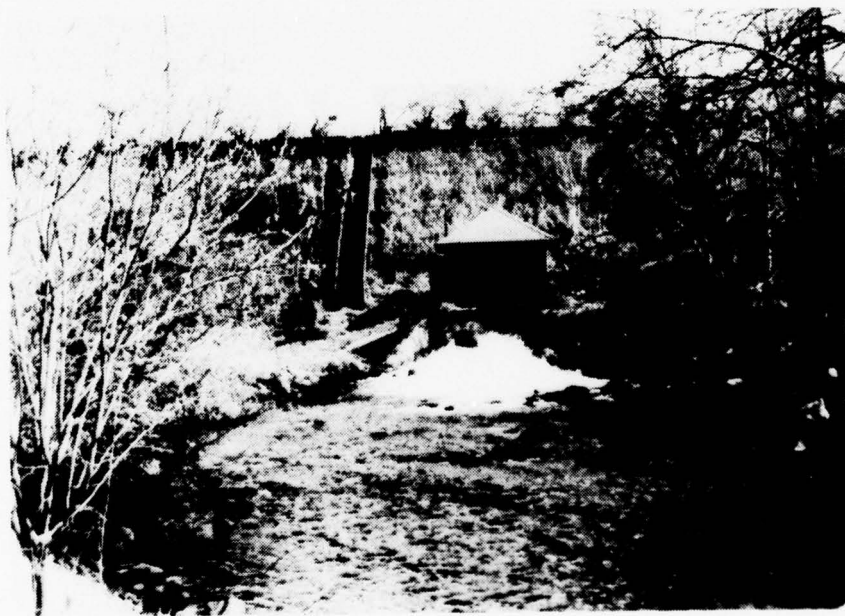
Photo 2 - Looking at dam embankment and low level outlet Gate House from downstream

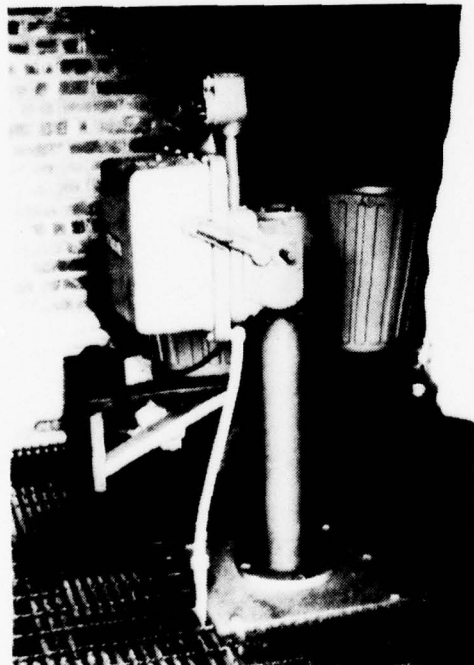
Both valves appeared to be in good condition. The packing glands were not leaking, and the 90 degree bevel gear reduction drives were well lubricated and appeared to be well maintained. The owner's representative stated that both valves are functional and are operated when necessary. At the time of the inspection, the motor operated valve had recently been opened to 25 percent (9 inches) opening, in order to provide downstream water for Pascack Brook, since the reservoir had fallen below the crest of the spillway. No records are available concerning the last complete inspection of the 48-inch line.

Photo 4 - Motor operated 36-inch service gate valve on 48-inch diameter low level line; hand operated 36-inch diameter emergency gate is upstream of service gate

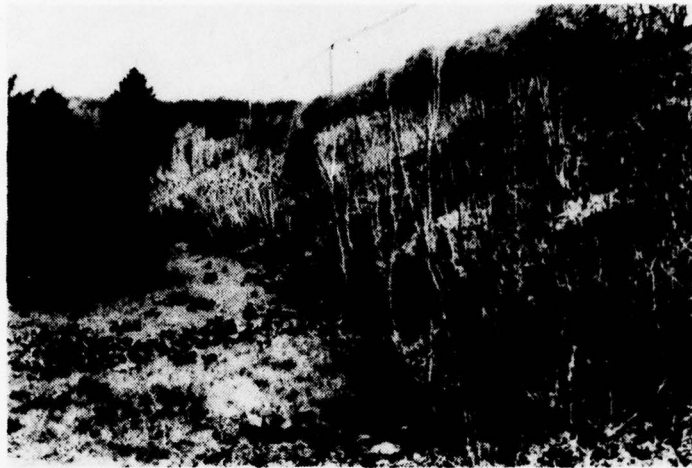
The embankment slopes are two on one and there are no signs of past or present downstream slope instability. Upstream slopes are protected by riprap and no problems were apparent above the water line. Downstream slopes were overgrown with brush and small trees. Several holes dug by burrowing animals were observed.

Photo 5 - View of downstream face of embankment standing in left abutment area looking toward right abutment

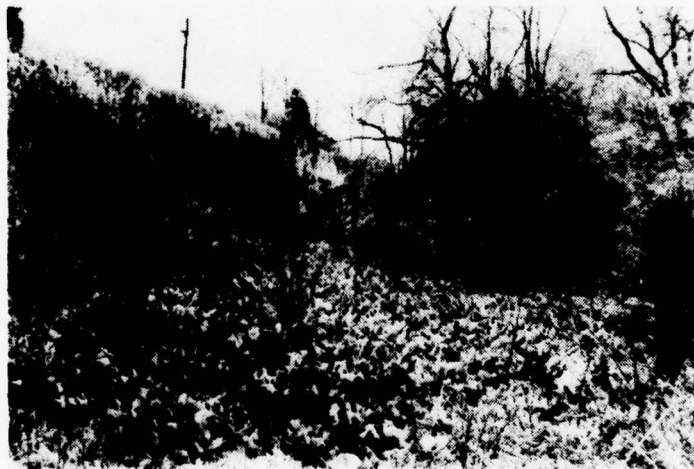
Seepage was observed in four locations just downstream of the embankment toe near the left abutment. The seepage combines to form a 2-foot wide rivulet carrying 5 to 10 gpm of clear water. At the time of the inspection, vegetation in the area left of the gate control house was indigenous to swampy areas. One observation well was located at the toe of the downstream embankment approximately 75 feet left of the gate control house. The level of water in the well was 1 ft. below ground surface.

Photo 6 - View of downstream face of embankment standing in left abutment area looking toward left abutment; note large areas of skunk cabbage growth at toe of embankment indicating high water table

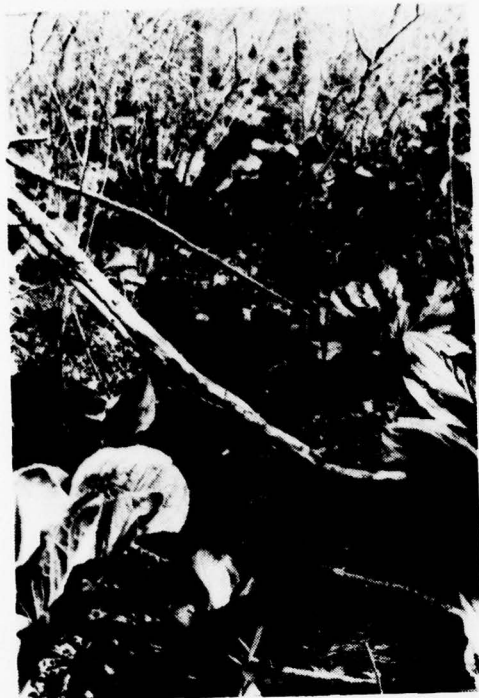
Seepage in this area is thought to be significant. Seepage may be occurring through cracks or joints in the corewall or through or under the sheet piling.

Photo 7 - Detail of seepage area  
on left abutment-rivulet  
downstream of embankment  
toe

3. Burrowing animals should be destroyed and their holes backfilled as best as possible, wherever they exist in the downstream embankment or at the area below the toe line.
4. Piezometers or observation wells should be installed in the embankment near the left abutment to determine the paths of the seepage observed. Seepage may be occurring through cracks or joints in the corewall or through or under the sheet piling. Once the location of the phreatic surface in the embankment is determined, then effective corrective measures can be considered and undertaken. Piezometers should also be installed in the vicinity of the gate house where there are no signs of leakage to provide a comparison with an apparently satisfactory section.

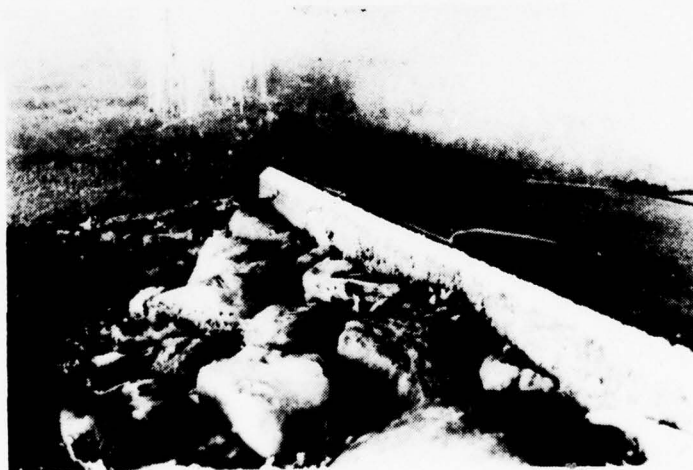
Photo 10 - Upstream face of spillway weir under spillway bridge showing approach stone protection, and abandoned and bent flashboard pins

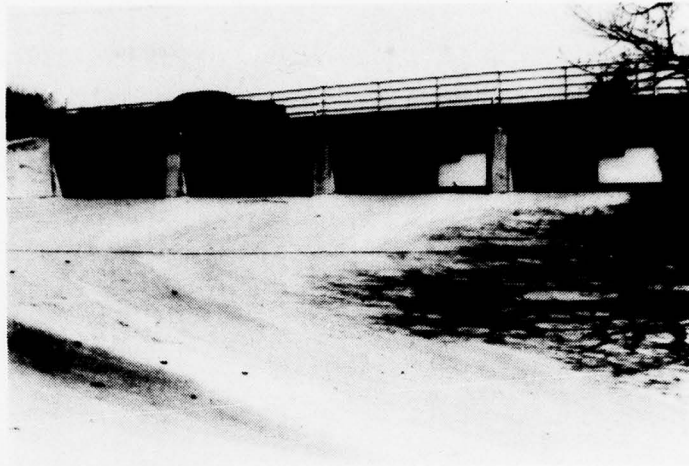
Photo 11 - View of spillway chute channel looking upstream at spillway bridge and Church Road; spillway chute turns through an angle of approximately 60 degrees at upper end

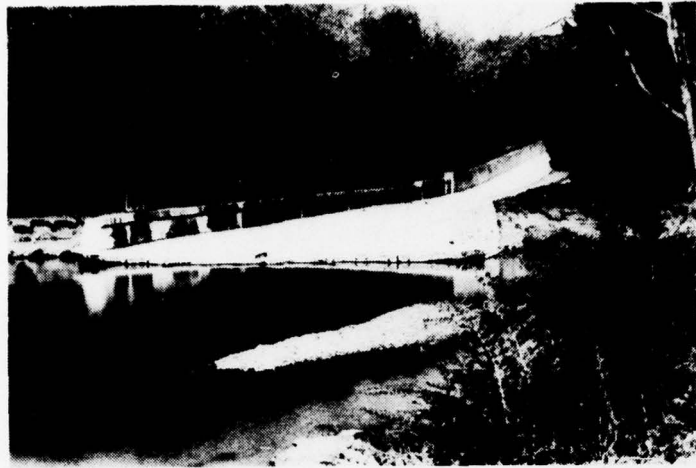
No seepage was visible in the area of the concrete spillway chute channel. Severe erosion, however, was observed at the end of the spillway chute channel which occurred as a result of the storm on November 8, 1977. According to the owner's engineering representative, repaving of the spillway chute slab in 1976 increased the discharge velocity. During the storm, the increased kinetic power of the discharging water, severely eroded the downstream channel banks for approximately 100 feet in length and 30 feet in width, cutting away the backfill behind the spillway chute wall for a distance of 15 feet upstream of the end of chute. The discharging water also tore away the steel sheet piling from the edge of the spillway chute concrete and displaced and bent it downstream. The spillway crest concrete and the spillway chute floor concrete is in acceptable to good condition. There is no cracking of the overlay concrete and all construction joints are in alignment. The chute walls are in acceptable condition, showing some minor surface deterioration. The jointing in walls is in good alignment.

Photo 13 - View of spillway chute channel from downstream; Channel area downstream of chute wall has been severely eroded by spillway discharges during storm of November 8, 1977

5. While the erosion at the end of the spillway chute does not pose an immediate threat to the stability of the dam at this time, due to its distance from the embankment, the situation should nevertheless be speedily corrected. The banks should be restored to their original contours and protected by stone. Studies should be made to determine the best way to dissipate the increased kinetic energy of the spillway chute water caused by lower friction losses on the repaved chute slab. The eroded materials should be removed from the stream channel and the channel regraded as required to produce a smooth water level surface during high stream stages.

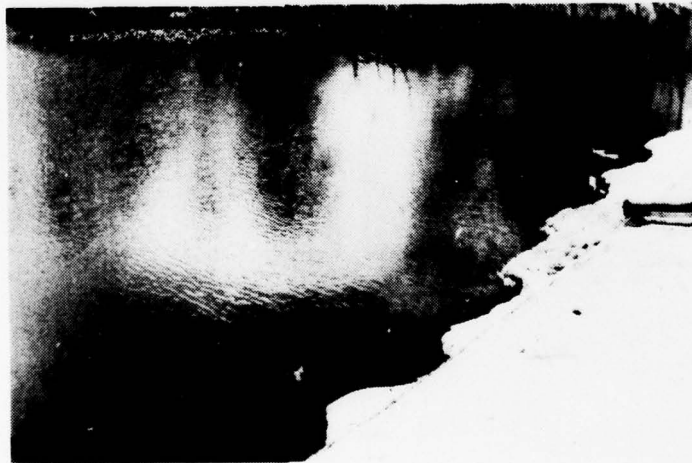
the right stilling basin wall was heightened by 2.5 feet in the area where the chute turns through an angle of approximately 60 degrees, to prevent overtopping caused by supercritical flow standing waves. On November 8, 1977, during a severe rainstorm, the increased water velocity attained in the spillway chute by the smoother repaving caused considerable local damage on both sides of the channel downstream of the chute walls removing bank areas approximately 30-ft. wide by 100-ft. long, and redeposited the coarser fractions 75 ft. to 100 ft. downstream in the channel. The increased velocity also tore away the top edge of the steel sheet piling from the end of the chute slab concrete and bent it downstream.

Photo 14 - Detail of damage to steel sheet pile cut-off installed at end of spillway chute channel caused during storm of November 8, 1977. Sheet piling has been torn away from end of chute slab and bent downstream

- (1) The erosion at the end of the spillway chute and in the downstream channel should be repaired and protected from future erosion. The downstream sheet pile cut-off should be repaired and an energy dissipation sill installed.
- (2) The downstream embankment should be cleared of trees and brush and a suitable vegetative cover established.
- (3) Burrowing animals should be destroyed and their holes backfilled.
- (4) The water level recorder in the gaging station should be repaired.
- (5) The owner should upgrade his Operation and Maintenance procedures by issuing an Operation and Maintenance Manual.

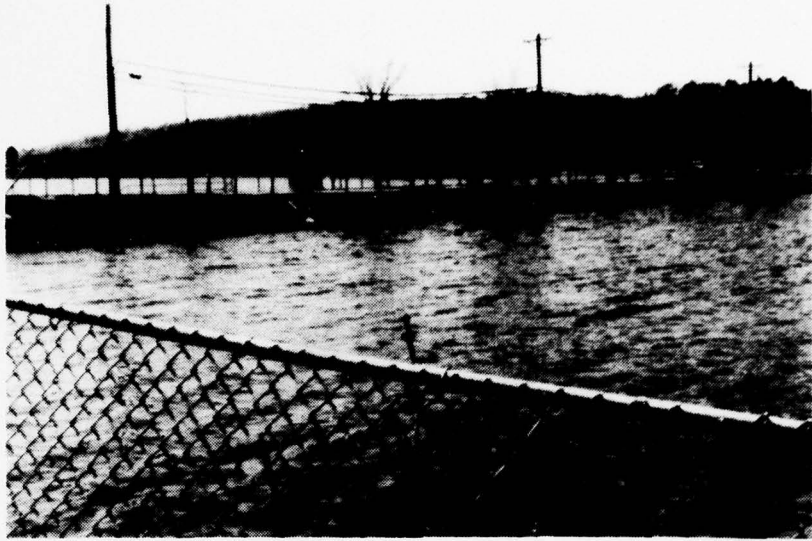
The reservoir at Woodcliff Lake Dam impounds 2,750 acre feet of water from a tributary area of 19.4 square miles. The reservoir is traversed by a causeway that cuts the reservoir in half. The two parts of the causeway are connected by an arched culvert 25-foot wide by 16.8-foot high.

Photo 15 - View of upstream face of causeway dividing Woodcliff Lake into two parts; connected by a single barrel culvert 25-foot wide by 18'-9" high
