# MILL DAM

PHASE I INSPECTION REPORT

NATIONAL DAM SAFETY PROGRAM

NJ 00060

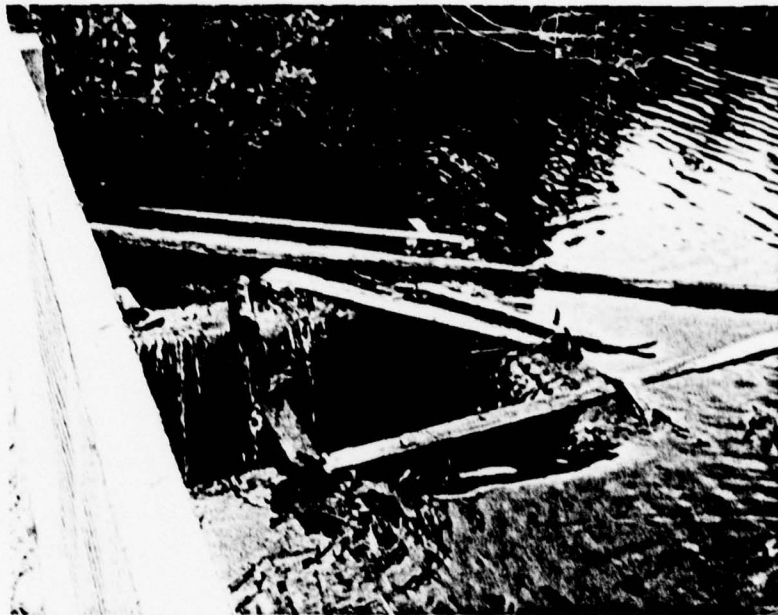
Spillway  
June 1978

The wood box drop inlet and exposed portions of the timber sheeting appear to be in good to excellent condition. There is some splitting of the timber members but no serious structural deterioration was noted although some repairs and modifications have been made to the inlet structure when it was compared to the original engineering drawings. The timber sheeting alignment appears true and no evidence was noted of tieback failure.
