PASSAIC RIVER BASIN

# HALEDON RESERVOIR

## PHASE I INSPECTION REPORT NATIONAL DAM SAFETY PROGRAM

NJ 00021

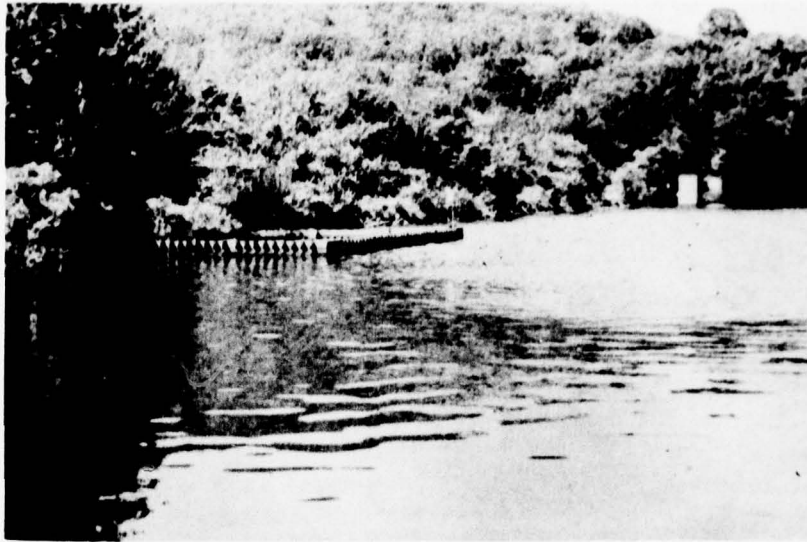
Photo 1 - View of dam from upstream left shoreline.

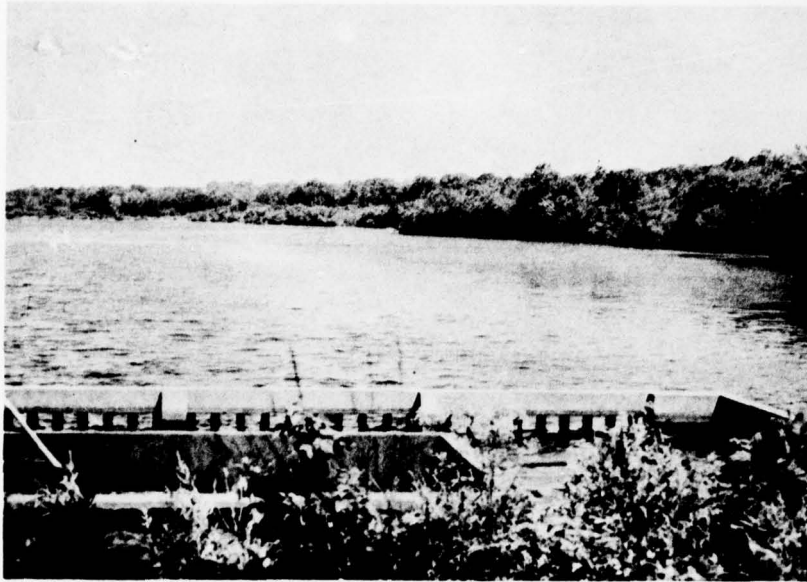
Photo 11 - Haledon Reservoir and left shoreline.

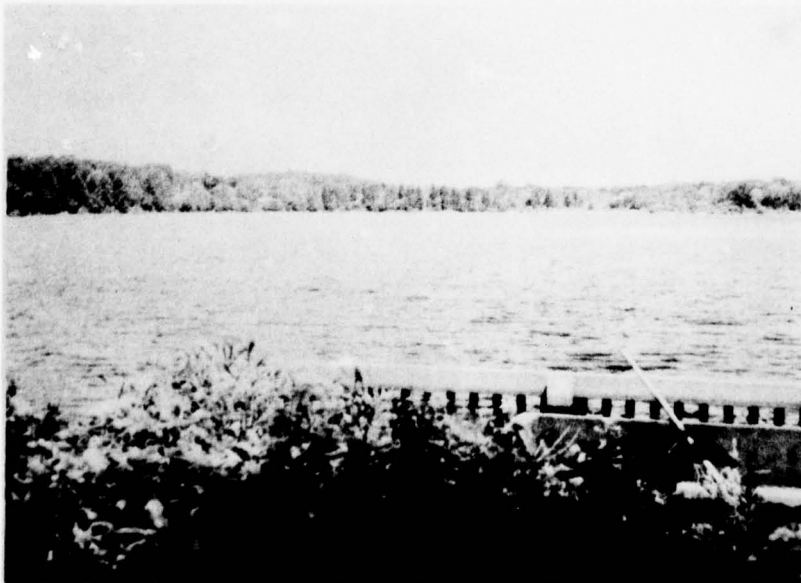
Photo 12 - Haledon Reservoir and right shoreline.
