IRISH BROOK DAM

PHASE I INSPECTION REPORT

NATIONAL DAM SAFETY PROGRAM

NJ 00204

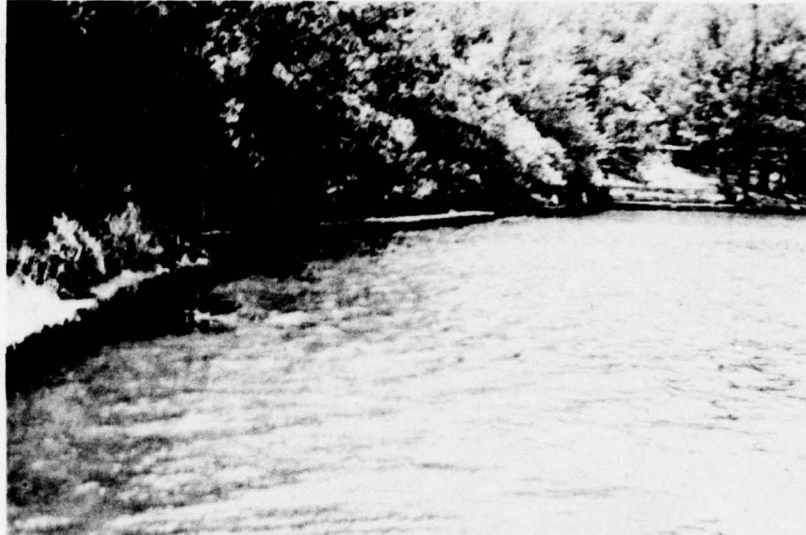
Photo 1 - View of dam, spillway and both abutments from left shoreline.

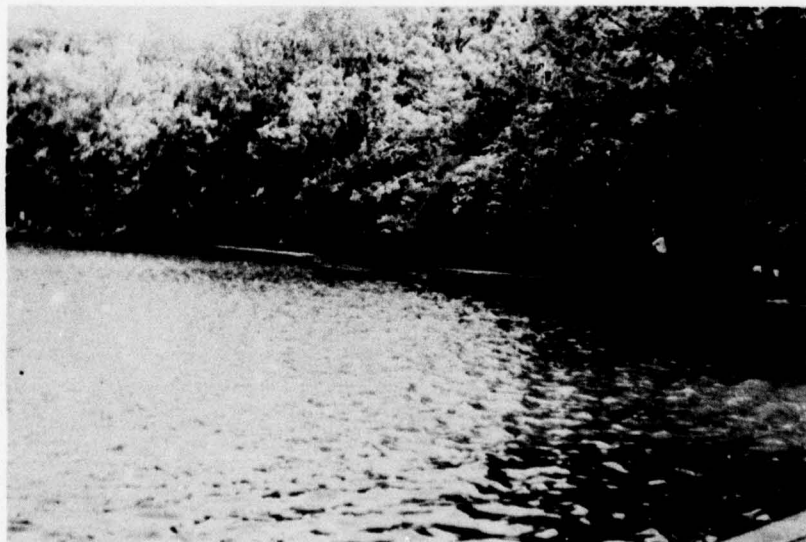
Photo 2 - View of dam and notch spillway from right shoreline.

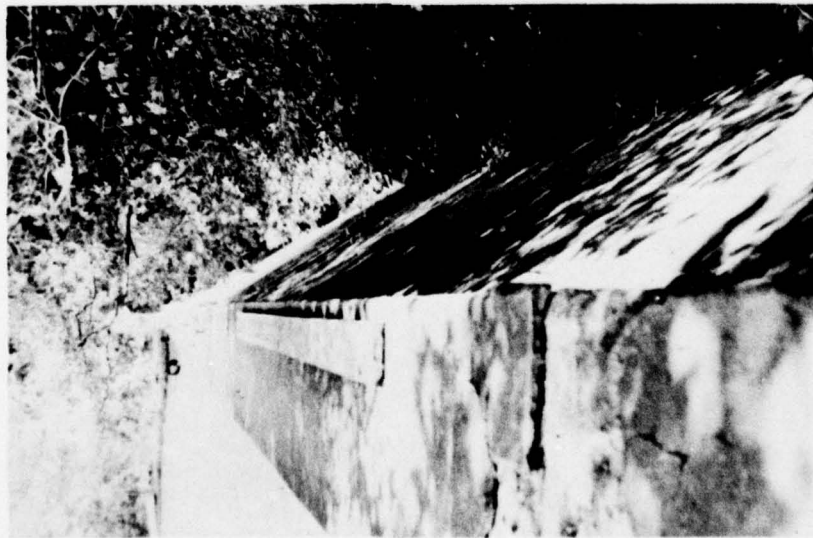
Vines were observed growing up the face of the dam, rooted in cracks.

Photo 3 - Crest and downstream face of dam.

Brush and vines growing on the downstream face, and decayed vegetation at the toe should be removed and kept clean.

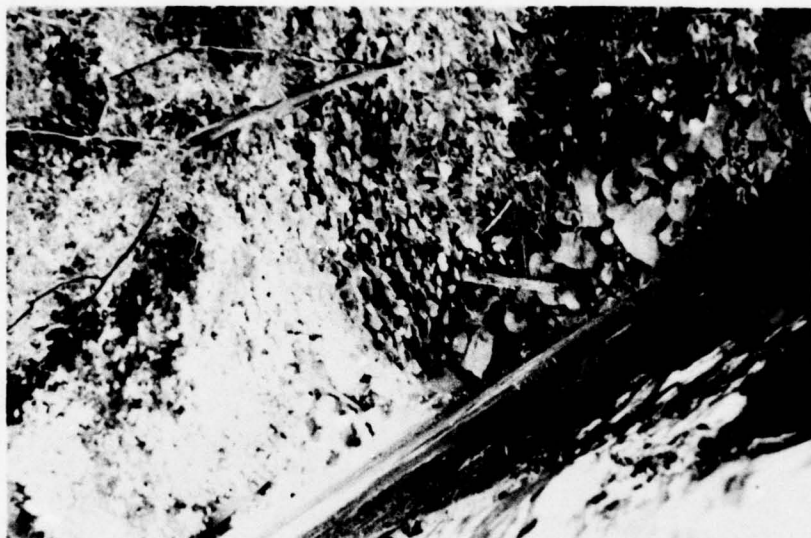
Photo 6 - Looking at downstream toe and area from right side of spillway.

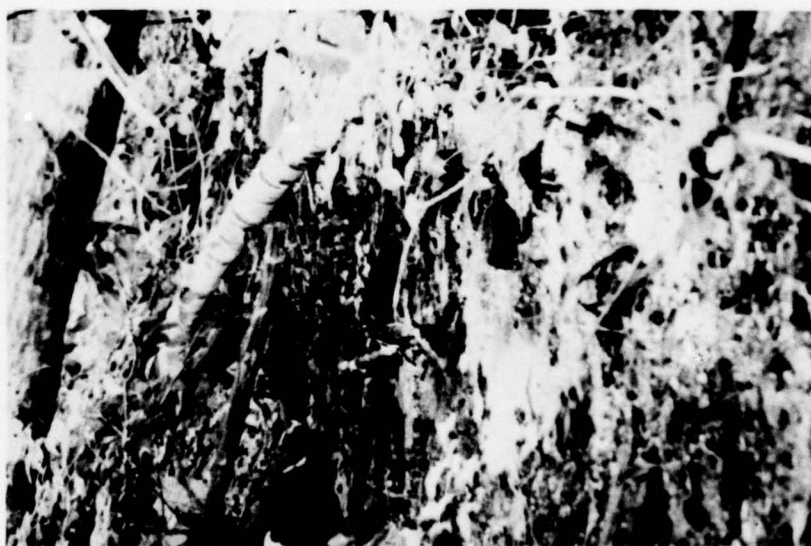
Some horizontal construction joints show evidence of past leakage with the presence of leaching deposits, however, virtually all joints were dry at the time of the inspection. A seep was observed approximately 20 feet downstream of the dam near the right abutment. Estimated seepage was about 2 g.p.m. and appeared to be free of fine soil grains.

Photo 5 - View of seepage right side of dam.

b. A program for regularly observing seepage should be implemented within six months from the date of approval of this report.

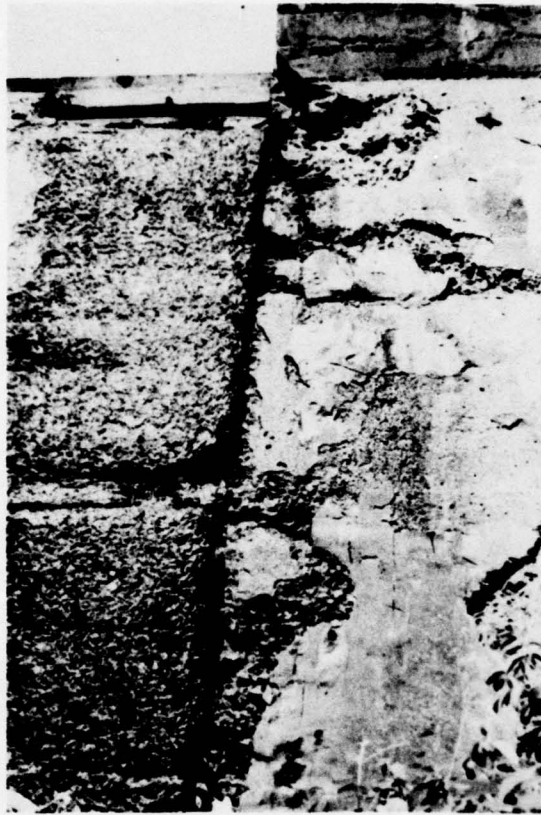
The downstream surface is moderately spalled. The surface has been patched numerous times to keep it in good condition. A vertical construction joint was observed on the right side of the spillway. While the joint had been patched with mortar, it continues to seep and a build-up of leaching deposits was observed.

Photo 7 - Construction joint and spalling left side of notch spillway.

Areas of deteriorated, spalled or seriously cracked concrete should be repaired annually to prevent progressive damage.

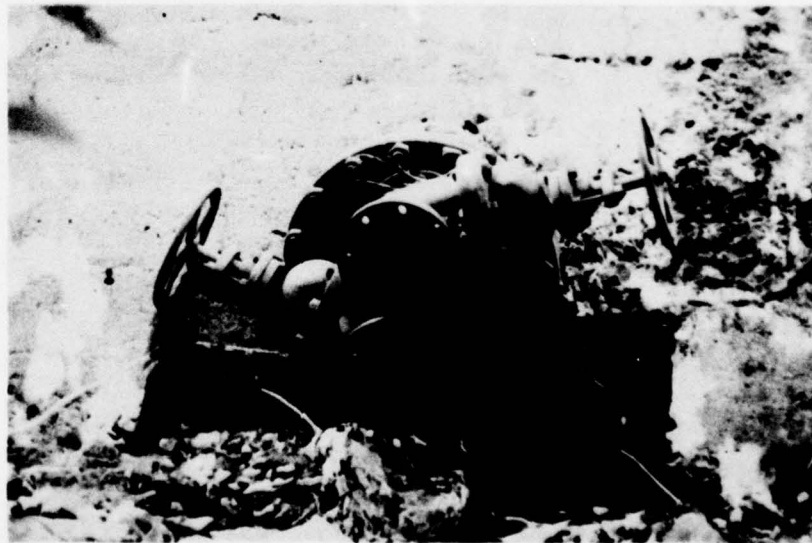
An 18-inch diameter cast iron pipe, fitted with a flange plate and two 6-inch gate valves, is located 22.5 feet left of the spillway, 15 feet below the crest. The pipe and valves have been plugged and are no longer operable. The sluice gate located in Post Brook Dam is the only facility for draining the lake. Operation is every 5 to 7 years as previously noted and maintenance is as needed.

Photo 8 - View of two 6-inch valves installed on flange plate on plugged 18-inch cast iron pipe.

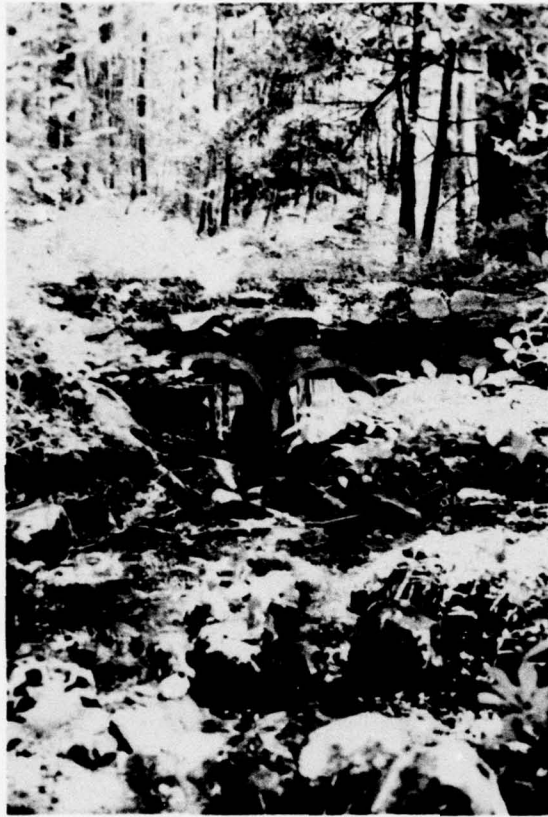
Photo 9 - Two culverts under private road downstream of dam.

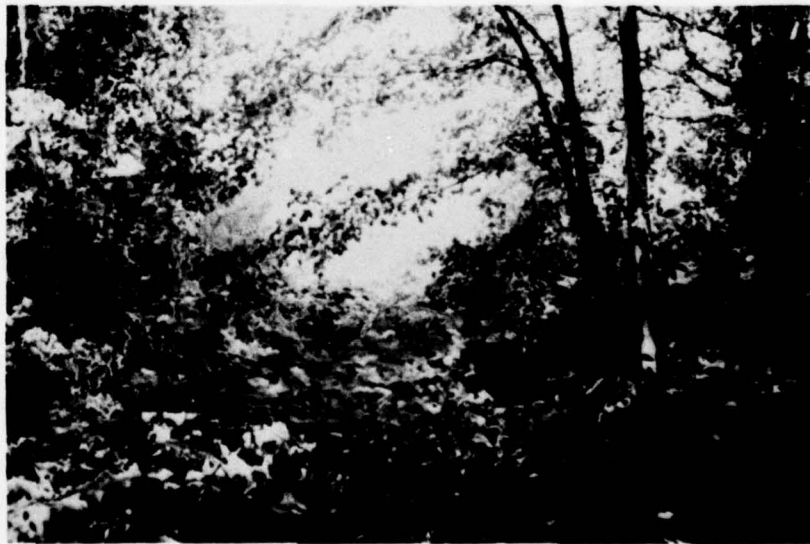
Photo 10 - Discharge channel looking upstream from culverts.

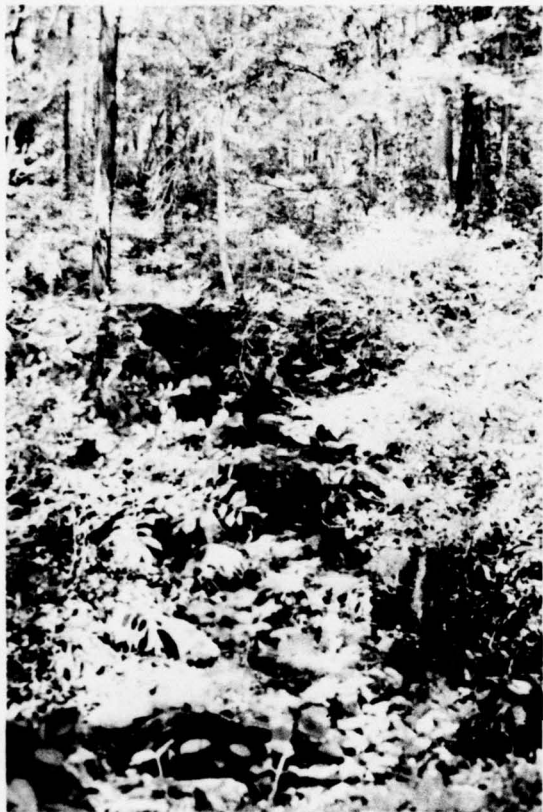
Photo 11 - View of discharge channel looking toward the dam.

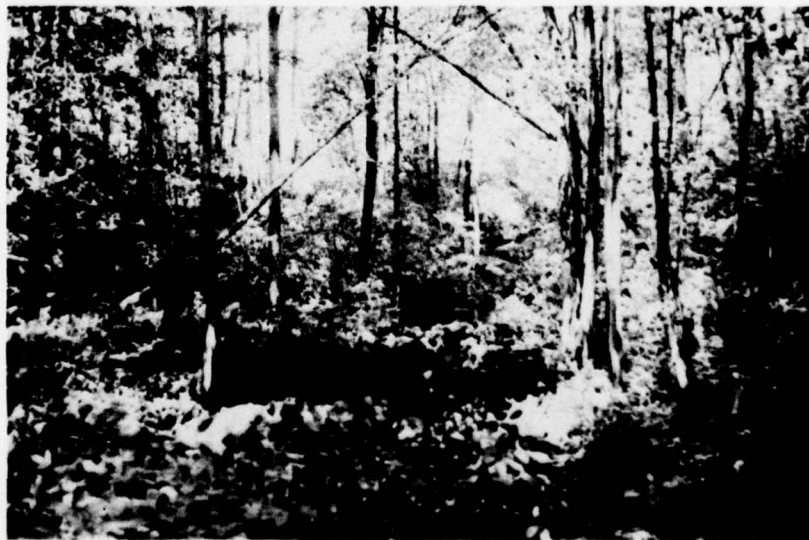
Photo 12 - Discharge channel looking toward dam.

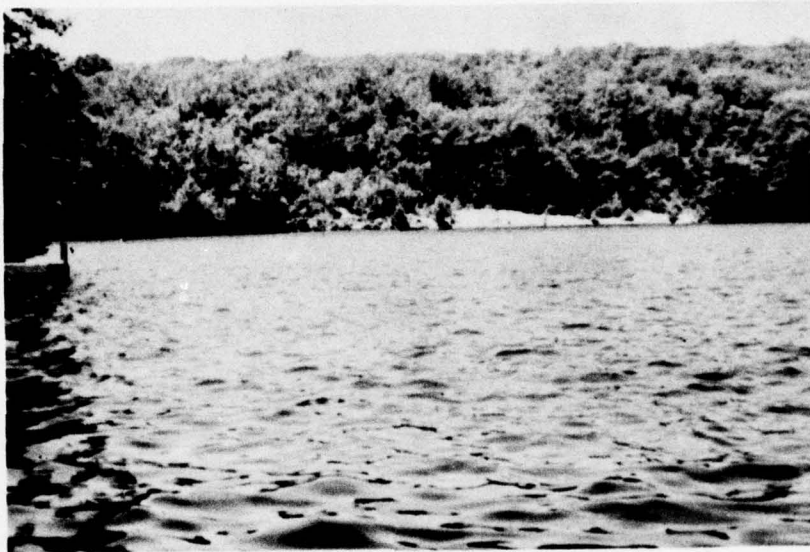
Photo 13 - Lake Iosco and right shoreline showing rock outcrop.
