PASSAIC RIVER BASIN

POST BROOK DAM

PHASE I INSPECTION REPORT

NATIONAL DAM SAFETY PROGRAM

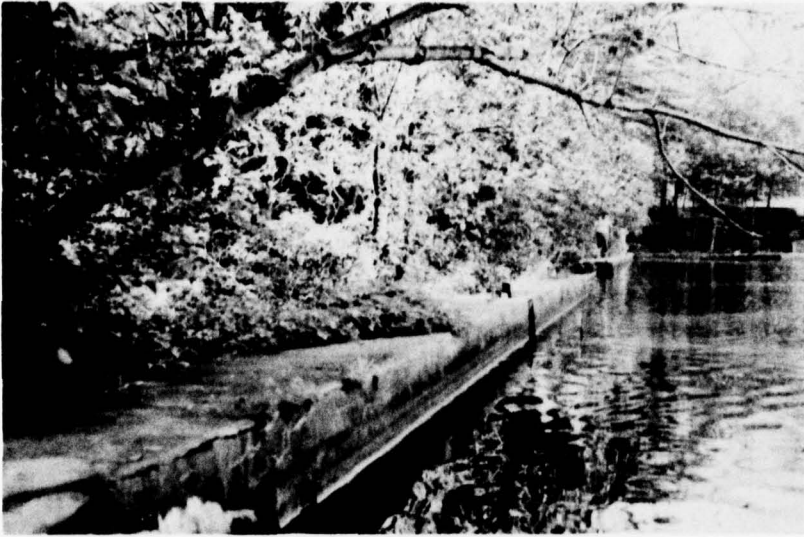
Photo 1 - View of dam, outlet notch and spillway from left abutment.

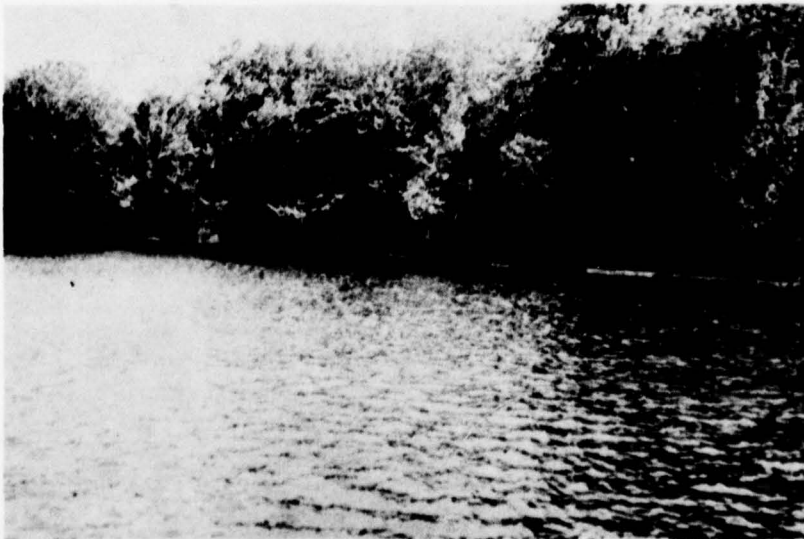
Photo 2 - View of dam from upstream right shoreline.

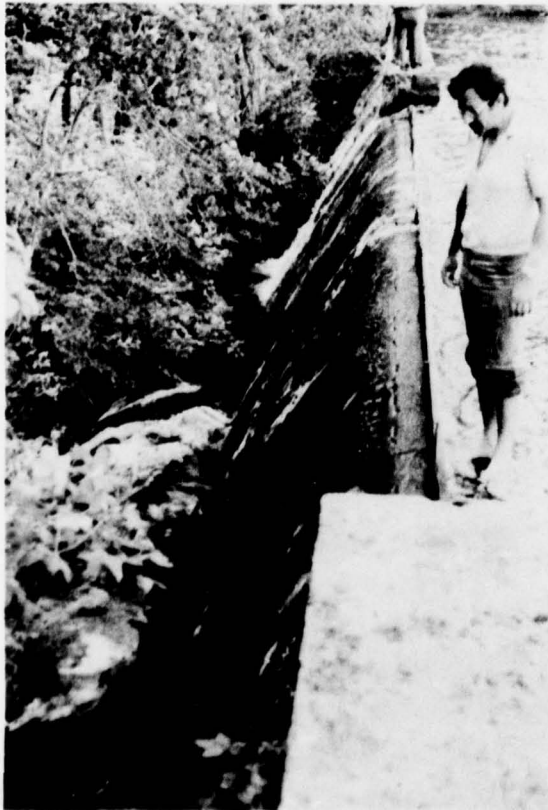
Photo 4 - Spillway crest.

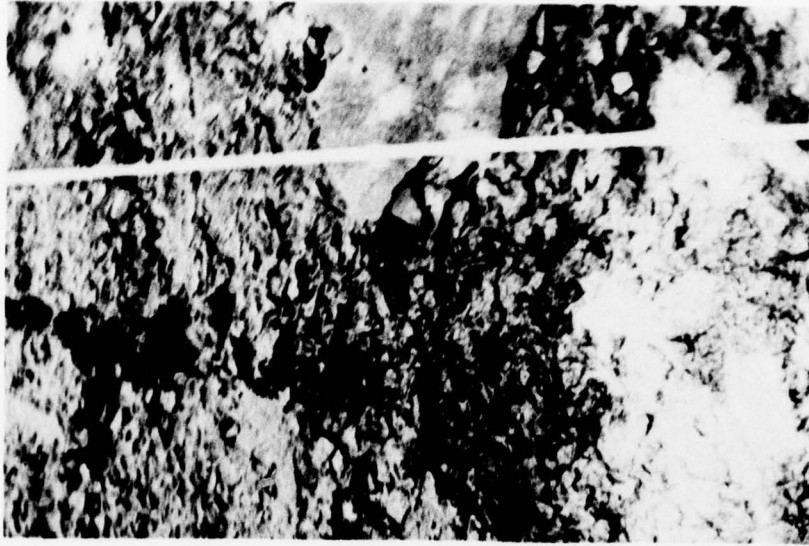
Moderate concrete spalling has occurred on the downstream face of the dam. Considerable spalling has occurred in the mortar cap placed on the crest. Severe spalling has occurred just above a rock contact at the left end of the dam on the downstream side. Several cracks were observed at through joints, however, the concrete appeared to be strong and sound.

Photo 6 - Concrete deterioration and spalling in downstream face of spillway at joint.

Areas of deteriorated, spalled or seriously cracked concrete should be repaired annually to prevent progressive damage.

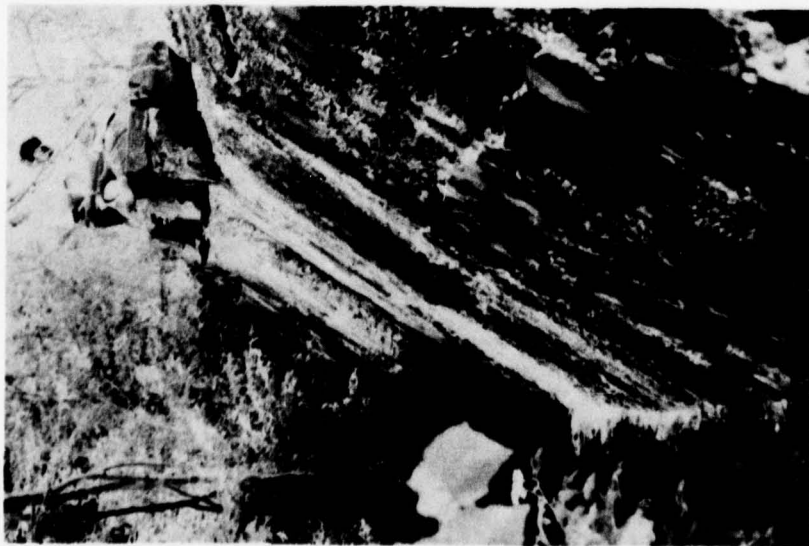
The downstream surface is moderately spalled. Light spalling could be seen on visible portions of the upstream surface. A vertical construction joint, or possible through crack, was observed, however, it was not leaking at the time of inspection.

Photo 5 - Downstream face of spillway.

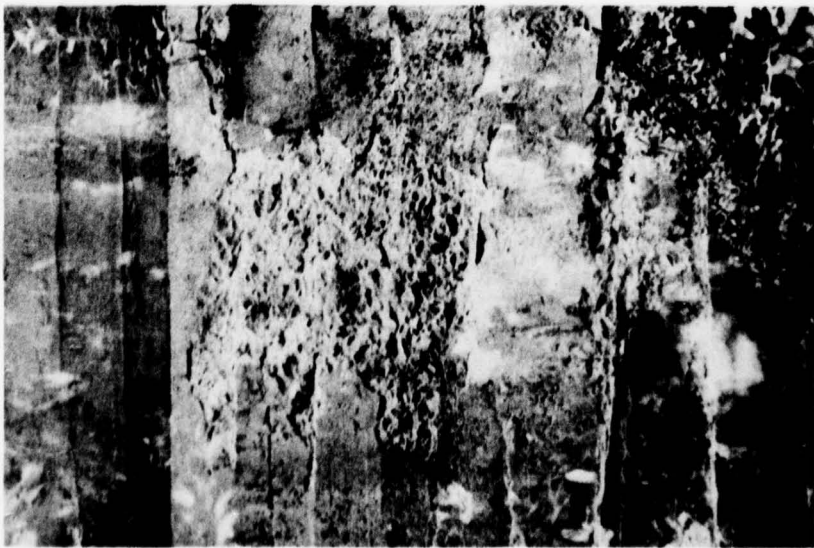
Photo 7 - Typical spalling on downstream face of dam.

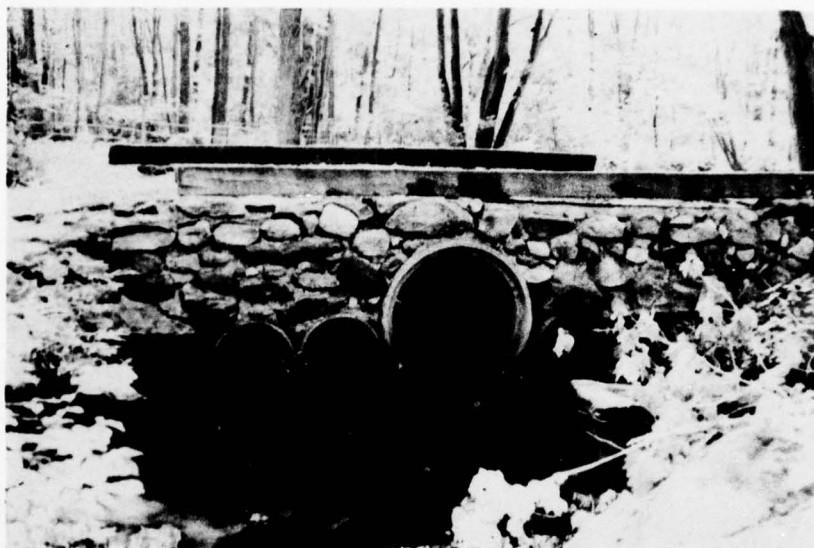
Photo 11 - Multiple culverts under private road downstream of dam.

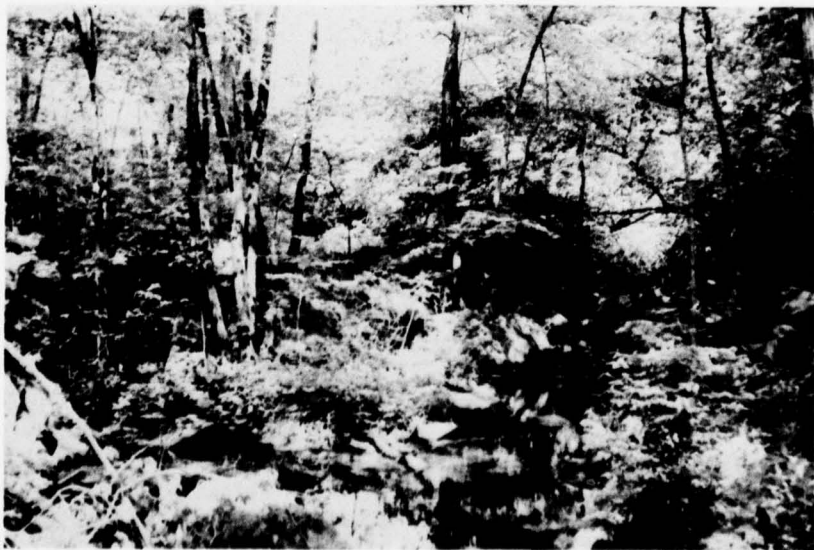
Photo 12 - View looking upstream at dam from culverts.

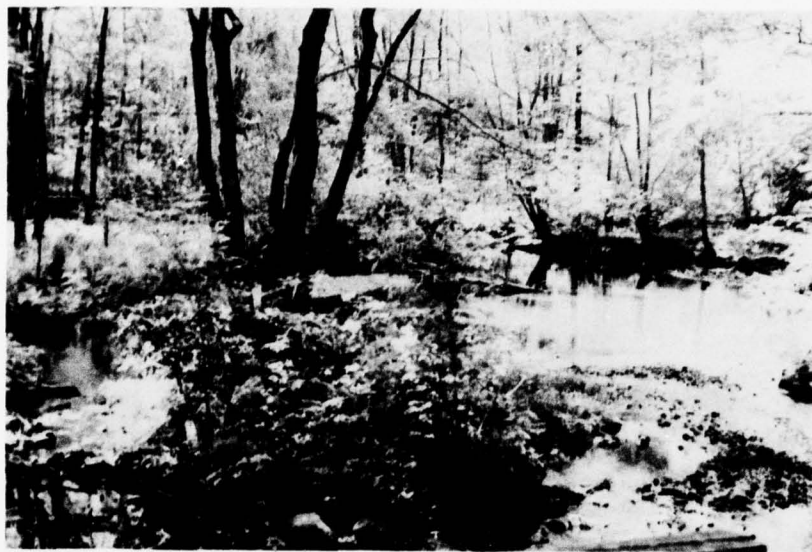
Photo 13 - View looking downstream from culverts.

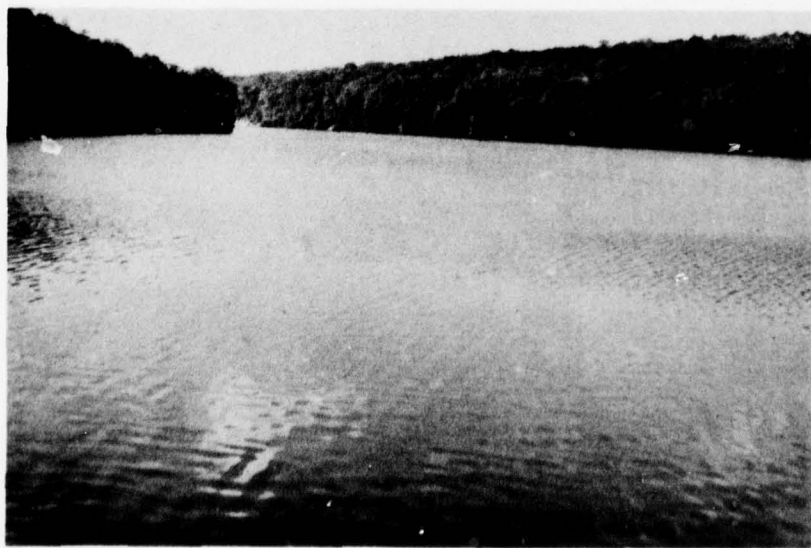
Photo 14 - View of Lake Iosco and shorelines.
