PASSAIC RIVER BASIN

# HIGHLAND LAKE DAM

PHASE I INSPECTION REPORT

NATIONAL DAM SAFETY PROGRAM

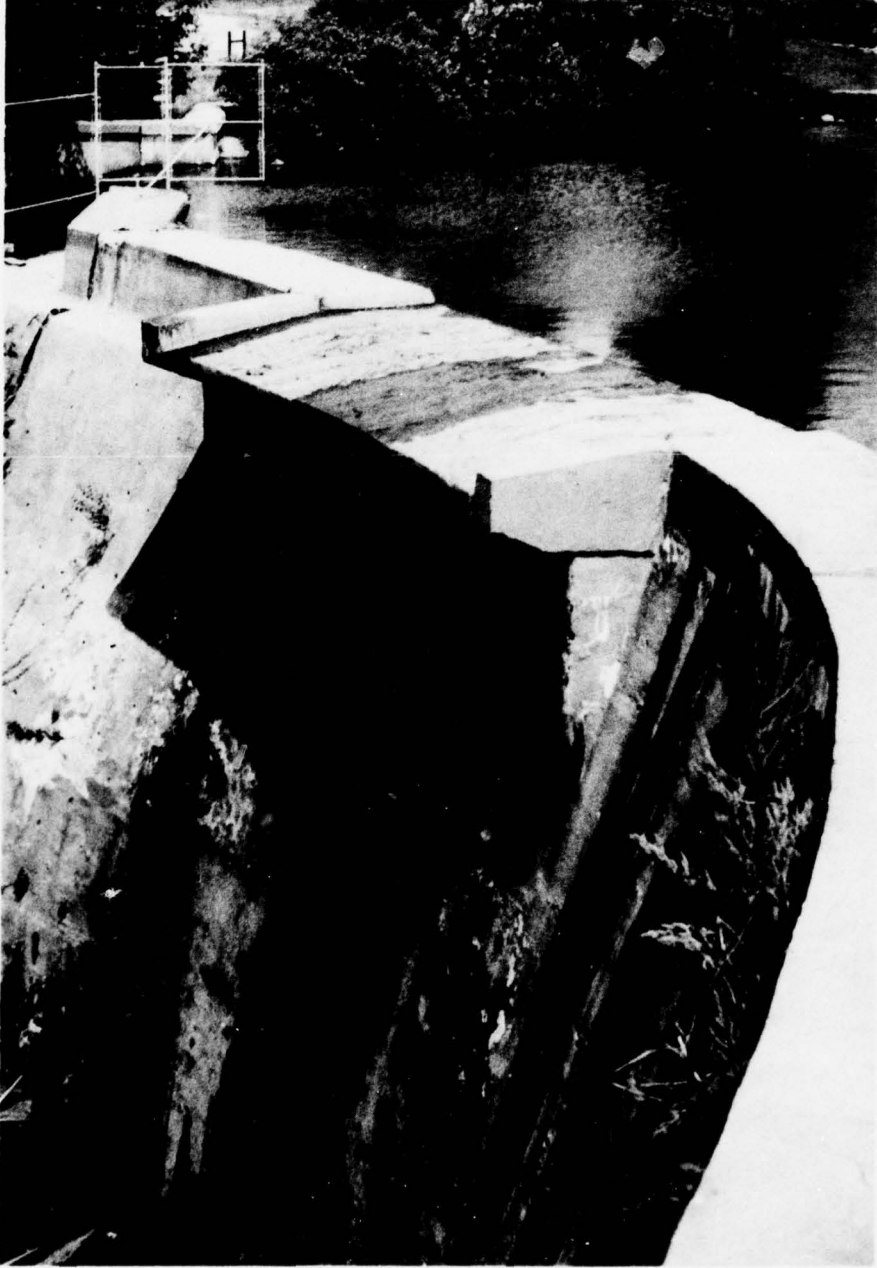
HIGHLAND LAKE

Dam and main spillway; service spillway is on right abutment at far shoreline.

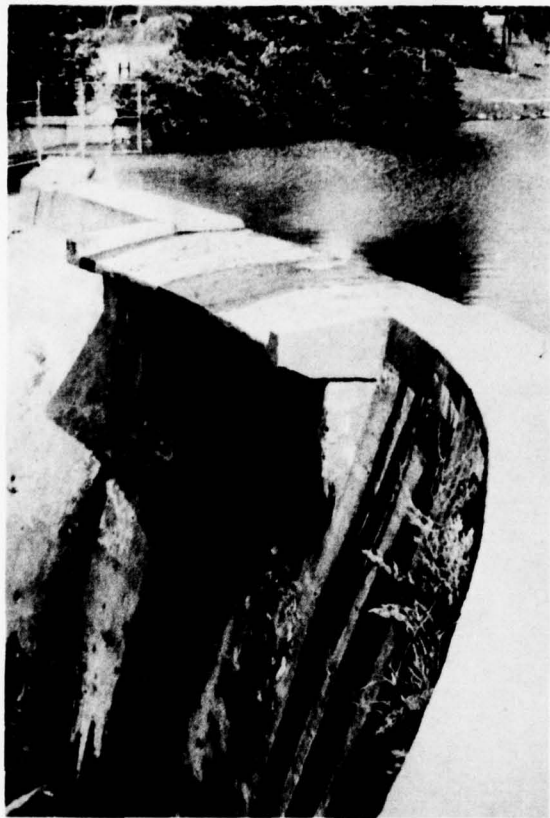
Photo 1 - View along crest of dam from left abutment showing main spillway and service spillway on right abutment.

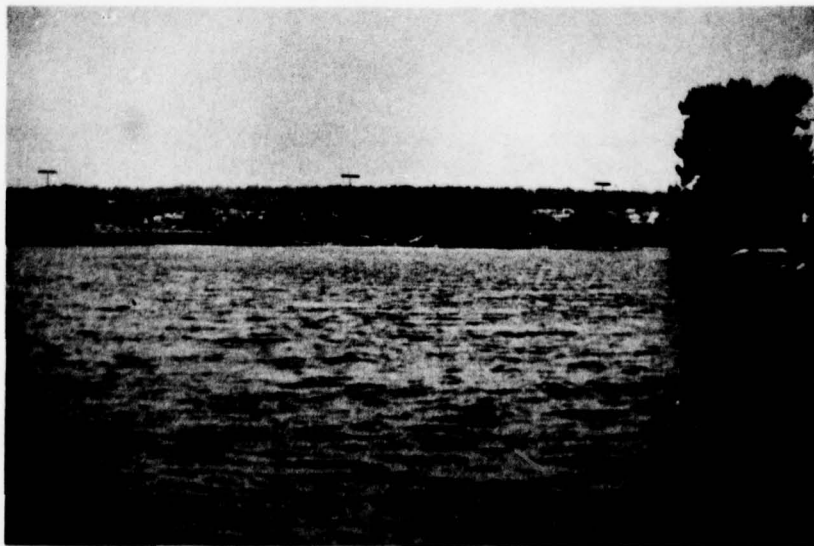
Photo 2 - View of dam and left abutment from upstream right shoreline.

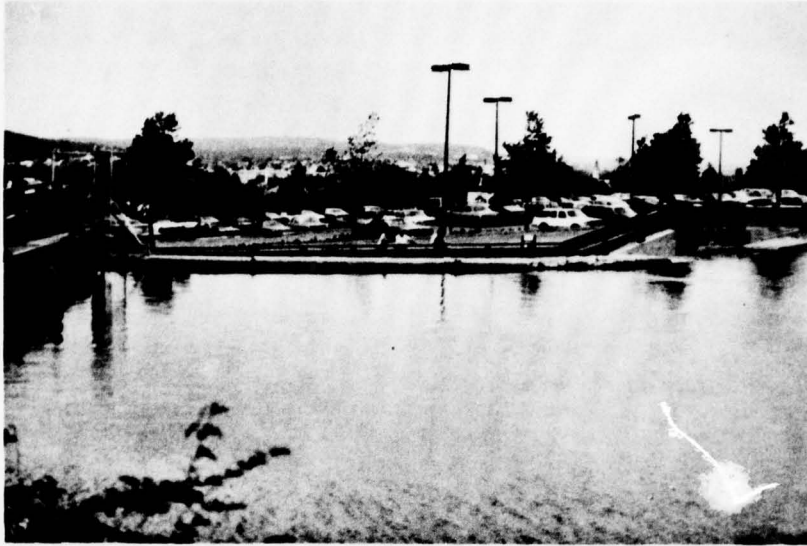
Photo 3 - View of dam and bank parking lot below dam.

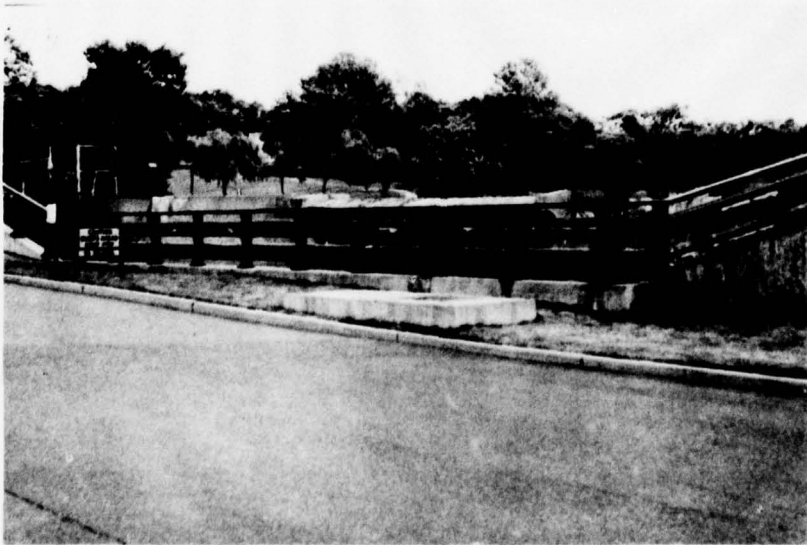
Photo 4 - View of dam from bank parking lot. Dam is partially hidden by guard railing on parking lot retaining wall.

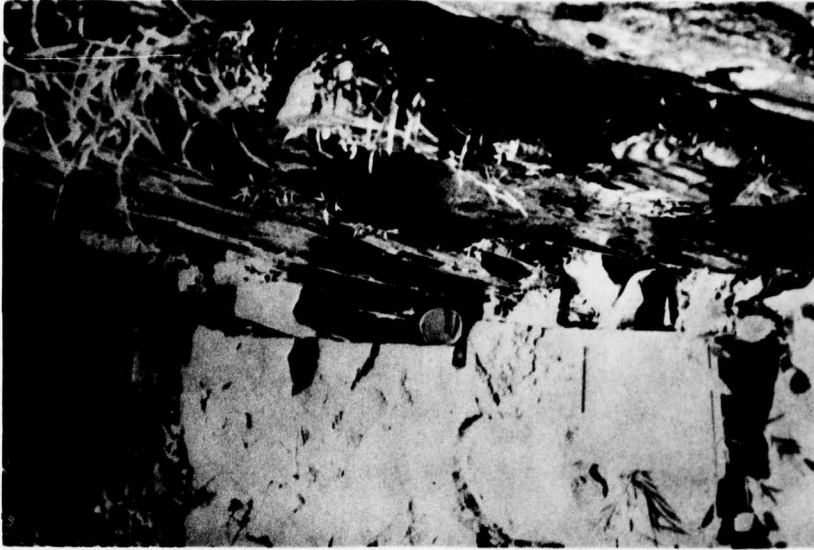
A prominent joint set exposed in the left abutment area strikes  $N5^{\circ}E$ , and dips  $80^{\circ}SE$  and has a joint spacing of 1 to 3 feet. This joint set parallels a fault, mapped by others, about one-half mile east of the dam. Near the base of the dam, downstream of the left abutment, this prominent joint set is opened a maximum of 4 inches and average about 1-1/2 inches along a joint trace of 25 feet. (This feature is believed to be due to stress relief.) The rock in this area is broken by two additional joint sets mutually perpendicular, irregularly spaced (average-3 feet) and having variable trace lengths (average-less than 1 foot).

Photo 6 - View of joint in rock located in left abutment of dam.

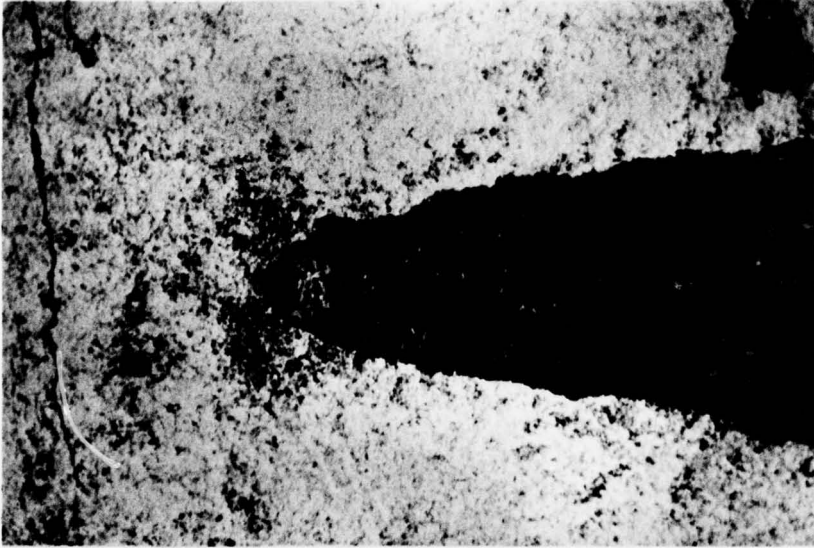
The face of the dam consisted of 2 to 6 inches of gunite with a grid of 1 inch diameter weep holes, many of which were discharging small quantities of clean water. It was determined, from an area where the gunite had broken away, that the original face of the dam was brick. The brick in this location, about four tenths of the height of the dam from the base at the right abutment, had become very loose at its contact with the abutment. A void, about 10 inches deep, has developed behind the gunite in this area. Considerable spalling of the gunite has occurred, particularly near the right abutment.

Photo 8 - Drain hole in gunitite facing on downstream face of dam.

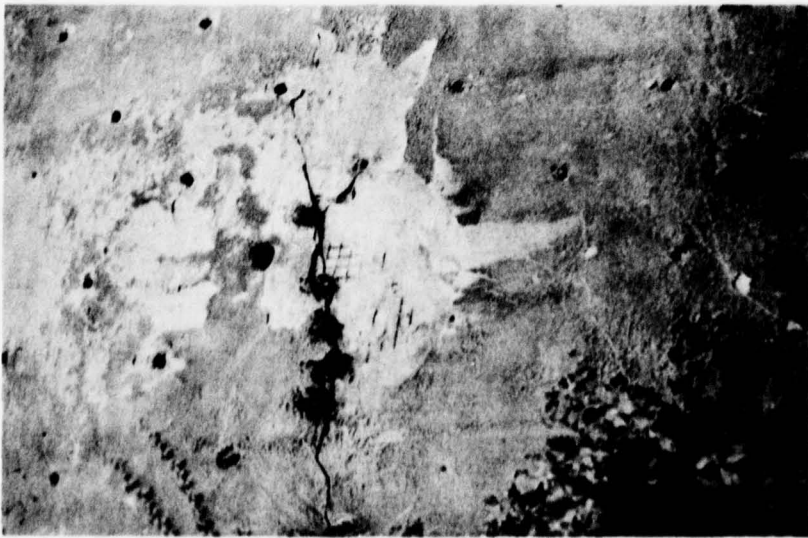
Photo 9 - Drain holes and exposed wire mesh under spalled gunite.

The deteriorated facing of the dam should be repaired.

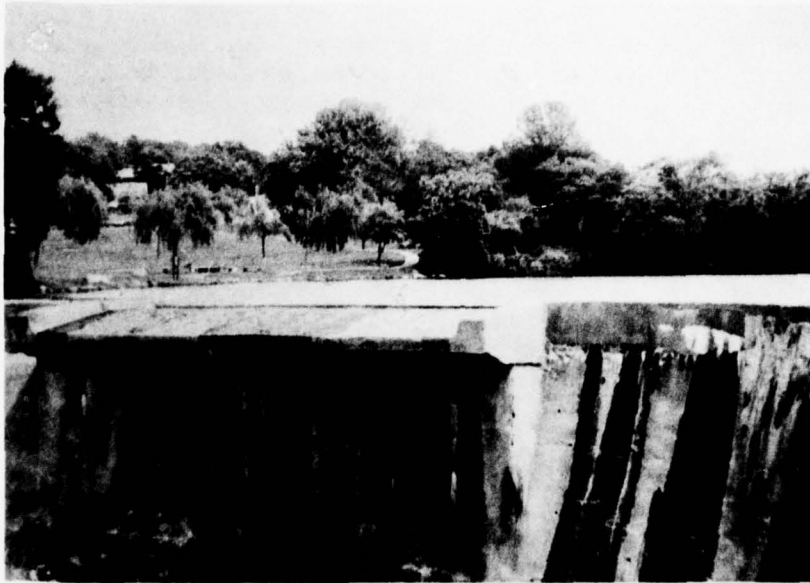
Photo 11 - Main spillway and right shoreline.

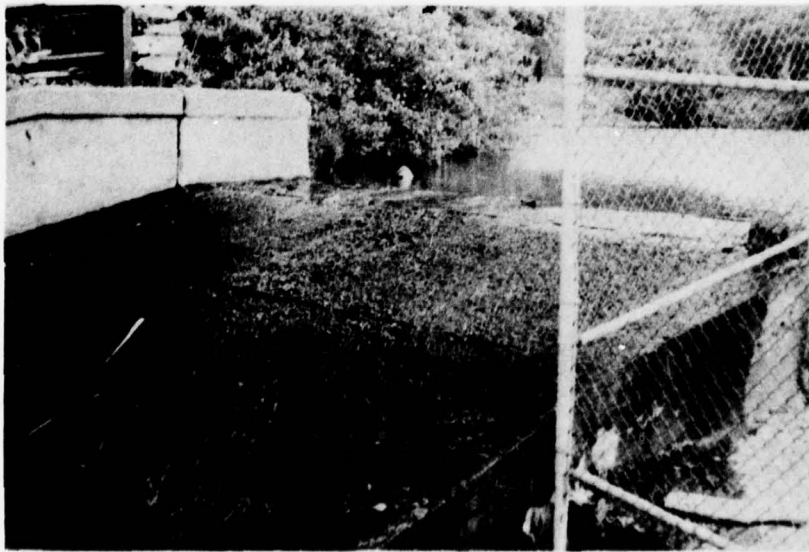
Photo 12 - Service spillway from downstream.

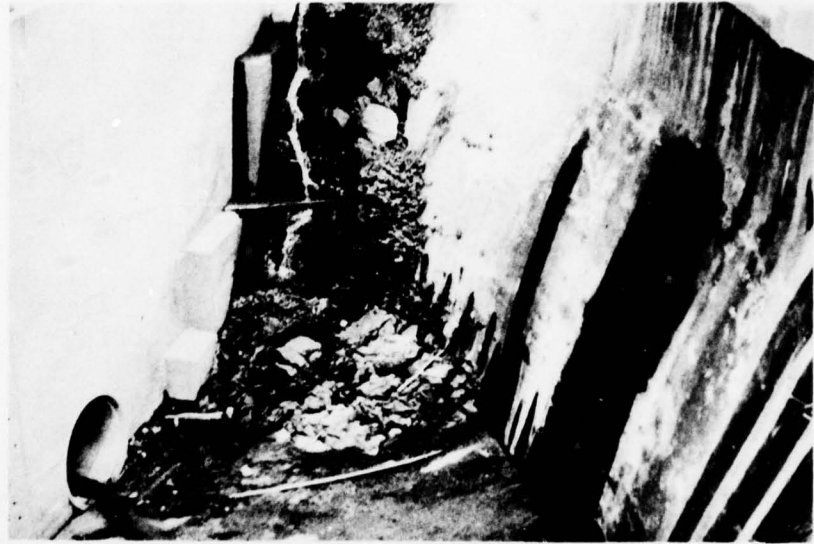
Photo 13 - View of dam, bottom slab under main spillway, retaining wall and discharge culvert under parking lot.

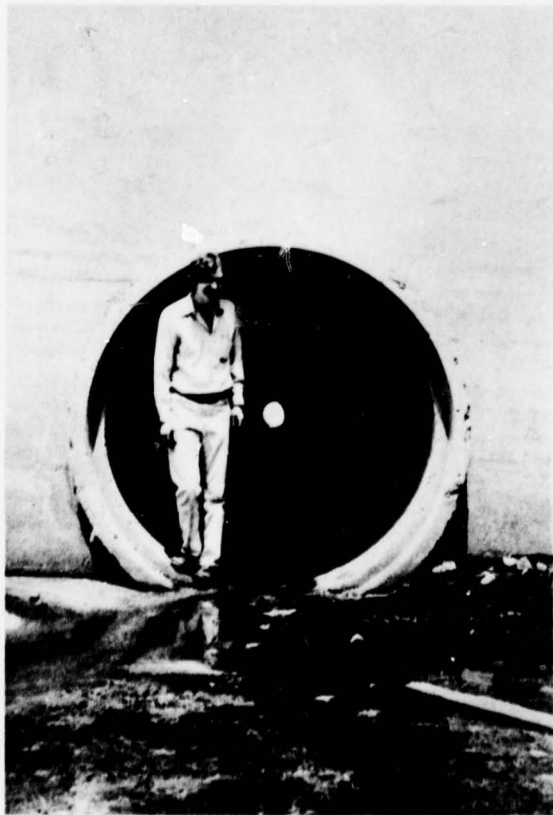
Photo 14 - Inlet and 6 ft. diameter concrete pipe discharge culvert.

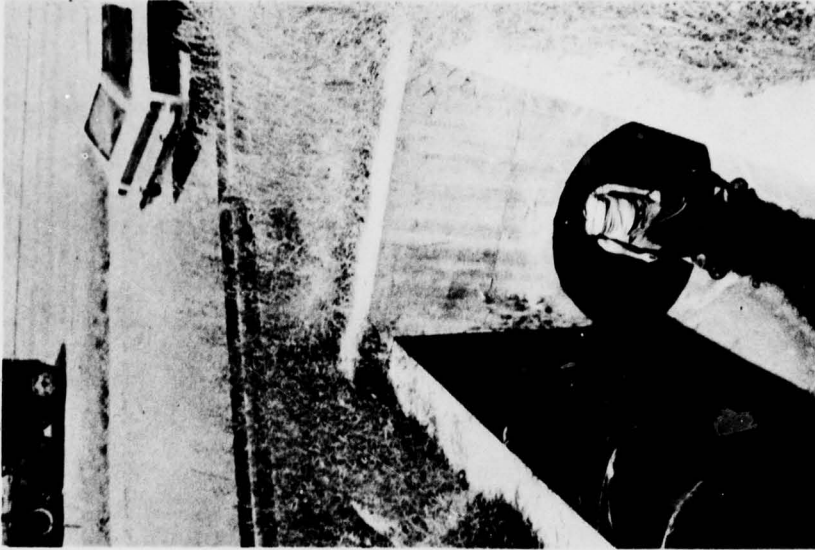
Photo 16 - Inlet to 6 ft. diameter culvert  
under Highway 80.

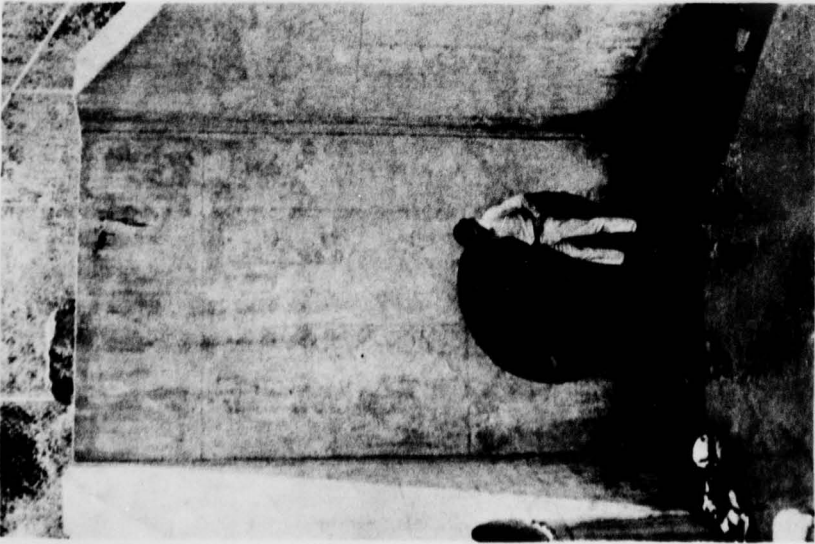
Photo 15 - Outlet structure for parking lot  
culvert.

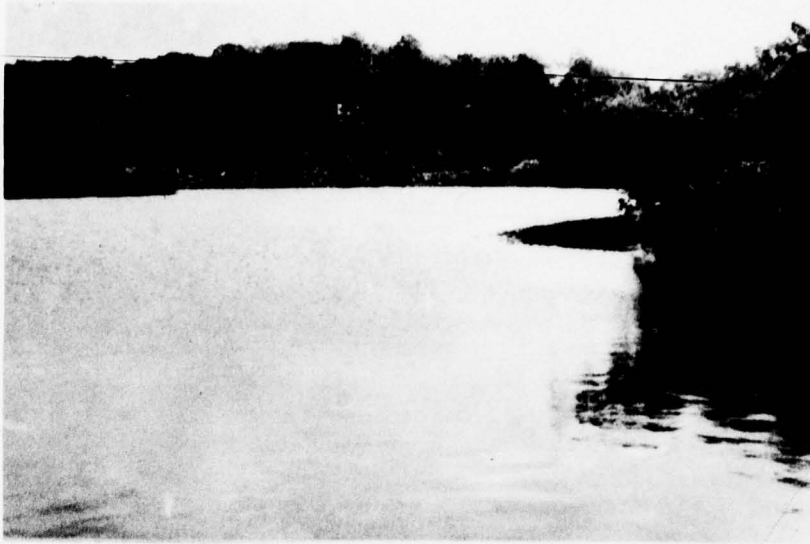
Photo 17 - View of Highland Lake from right abutment showing barrage built from bank excavation and forming small upper impoundment.
