PASSAIC RIVER BASIN

NEW STREET RESERVOIR DAM

PHASE I INSPECTION REPORT
NATIONAL DAM SAFETY PROGRAM

Name of Dam: New Street Reservoir Dam, I.D. NJ00242
State Located: New Jersey
County Located: Passaic
Stream: Slippery Rock Brook
Date of Inspection: June 30, and July 7, 1978

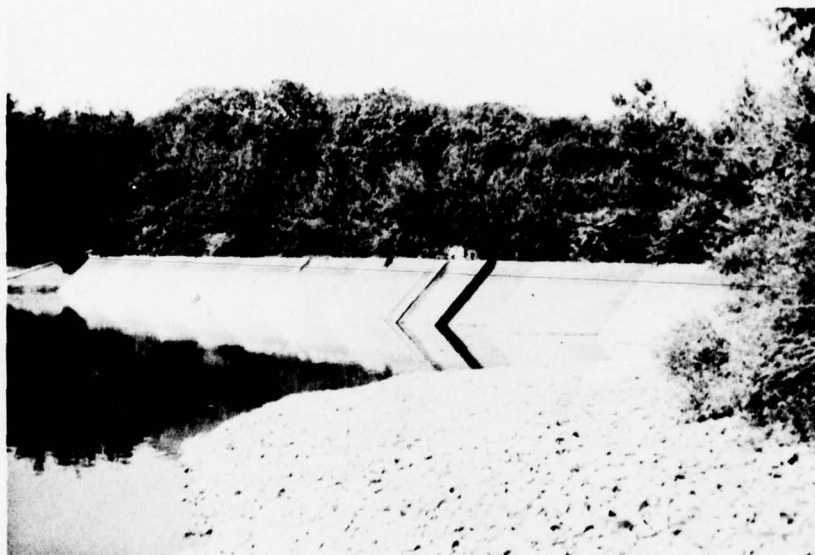
Photo 1 - Upstream view of dam from right shoreline.

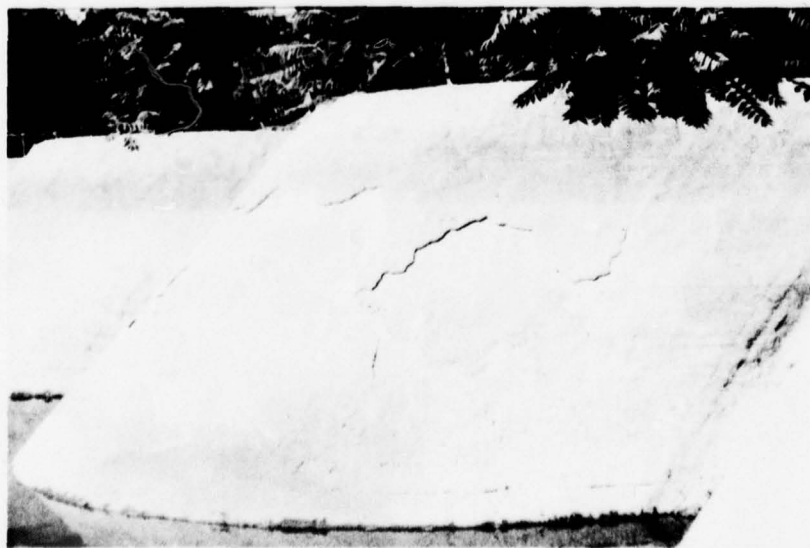
VISUAL EXAMINATION OF	OBSERVATIONS	REMARKS OR RECOMMENDATIONS
SURFACE CRACKS CONCRETE SURFACES	Guniting coating in good condition on upstream facing. Some minor spalling on arches near right abutment.	Spalled guniting should be repaired. See notes under leakage.
STRUCTURAL CRACKING	See notes on attached sheet.	
VERTICAL AND HORIZONTAL ALIGNMENT	No evidence of movement of the structure could be found.	
MONOLITH JOINTS	The joints between arches not visible for inspection but guniting facing does not indicate movement or separation.	
CONSTRUCTION JOINTS	Construction joints between buttress cap beams and shells are all tight and show no evidence of movement or distress. No evidence of rust stains can be found on the concrete surfaces except beneath the ships ladder and metal platform.

Photo 2 - View of spalled gunite on upstream surface of dam.

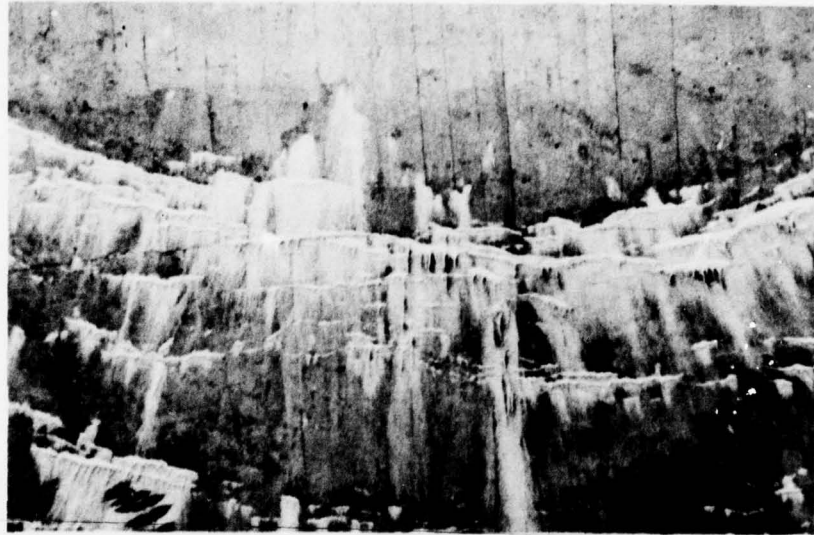
VISUAL EXAMINATION OF	OBSERVATIONS	REMARKS OR RECOMMENDATIONS
SEEPAGE OR LEAKAGE	No seepage can be found downstream of dam. Numerous seepages through concrete in arches are evident. Much deposit has built-up in some arches. (See attached sheet.) Deposits appear to be dry but cannot tell how old deposits are.	Inspect all arches annually to detect wet or growing deposit. Gunite or water-proof upstream face of arches showing seepage or growing deposits. Make photo survey for future comparison.
STRUCTURE TO ABUTMENT/EMBANKMENT JUNCTIONS	Abutments appear excellent. No evidence of abutment erosion could be found. Very minor erosion is evident behind first three buttresses on left abutment resulting from recent overtopping of dam due to pumping plant operator error.	See Reservoir Operation.
DRAINS	None.	
WATER PASSAGES	None.	
FOUNDATION	Dam appears to be found on rock. No evidence of wet areas or seepage can be found.	Brush and small trees should be cleared out between buttresses and under arches.

Photo 7 - Leach deposits near top of arch slab.

2. The upstream face of the dam should be waterproofed by application of gunnite, chemicals, or membrane coatings to prevent leakage and possible further leaching of concrete in arch shells. Chemical analysis of the leach deposits should be made to determine if they are formed from concrete leaching or dissolved chemicals in the water.

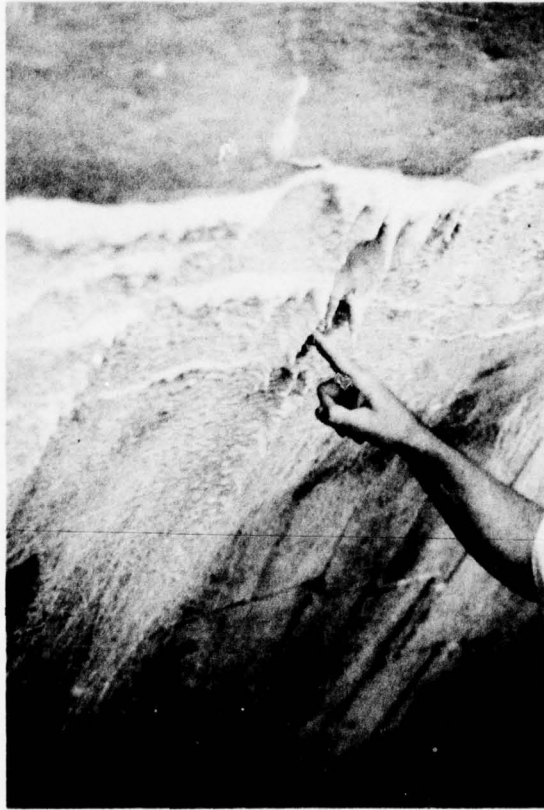
Photo 9 - Close-up view of leach deposits.

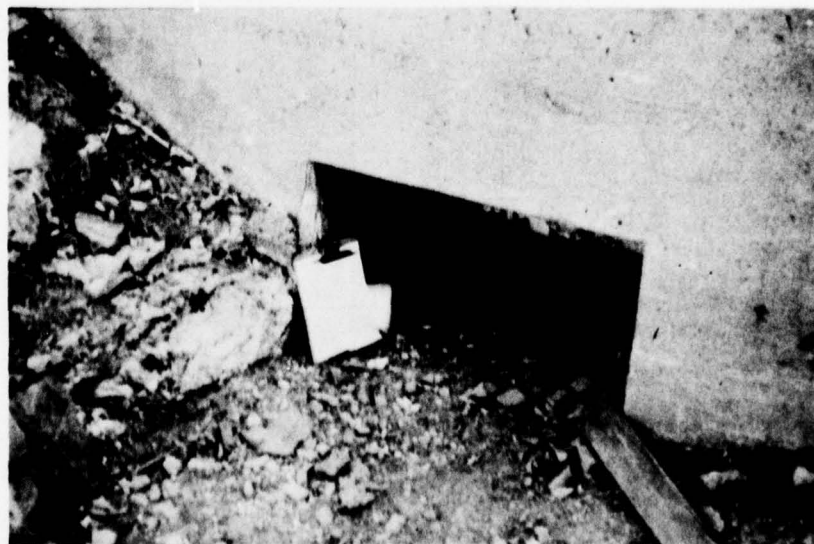
Photo 10 - View of spillway outlet opening.

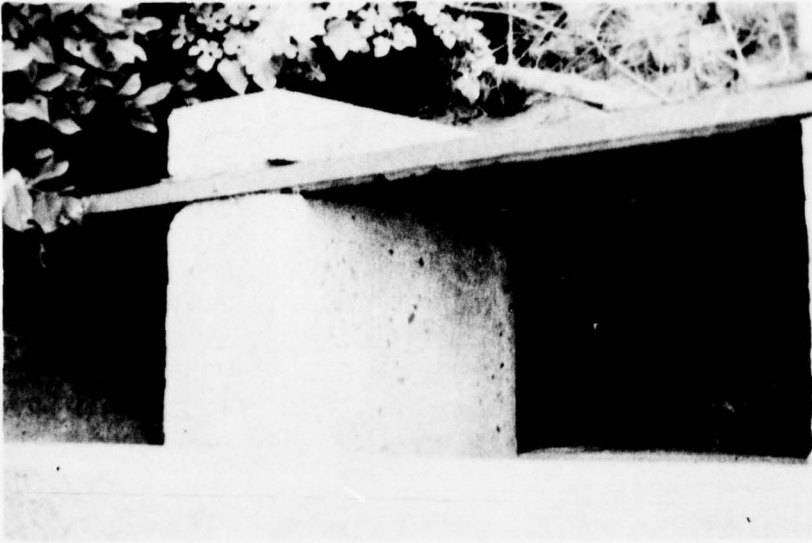
Photo 12 - View of stop boards in spillway box.

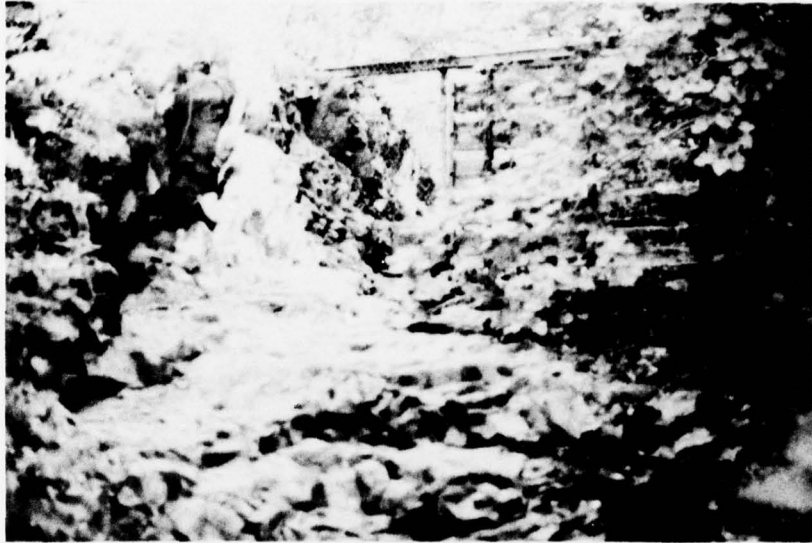
Photo 13 - View in perimeter interceptor and by-pass channel to Barbour Pond showing vertical swing fence gate in channel.

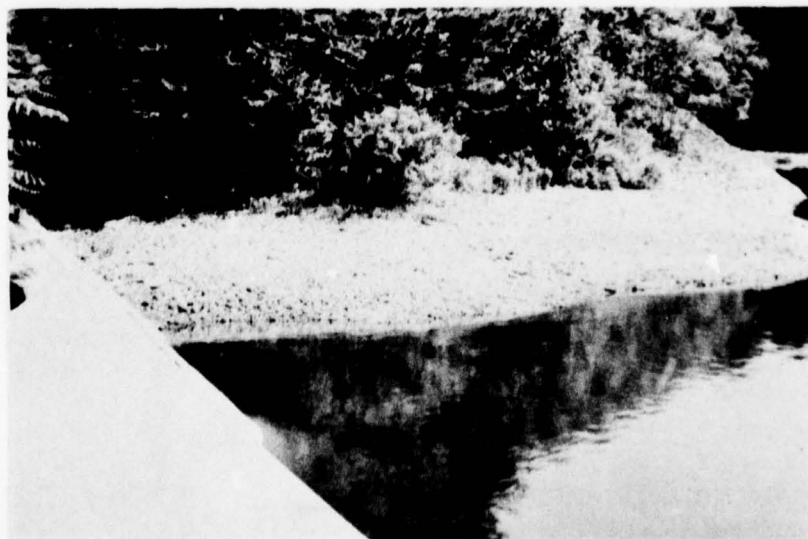
Photo 16 - Right abutment slope showing riprap protection.
