# JERSEY CITY RESERVOIR NO.2 DAM

PHASE I INSPECTION REPORT

NATIONAL DAM SAFETY PROGRAM

Name of Dam Jersey City Reservoir No. 2 NJ 00523

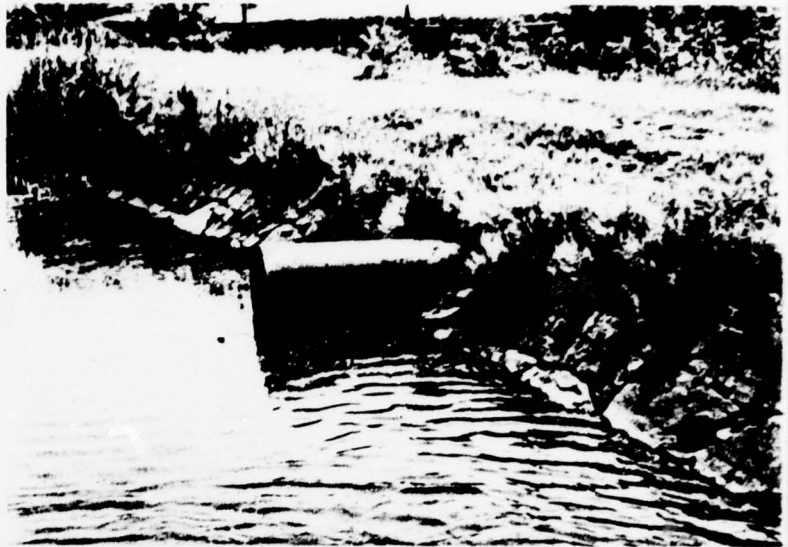
36" Ø OVERFLOW  
AT SE CORNER

It is recommended that the existing overflow pipe be tested and utilized in the future to assist in controlling water elevations.

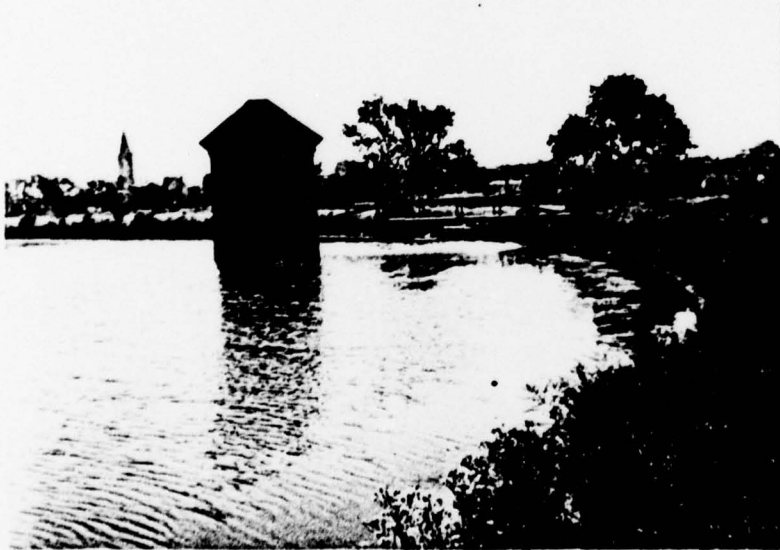
SCREEN HOUSE - SE

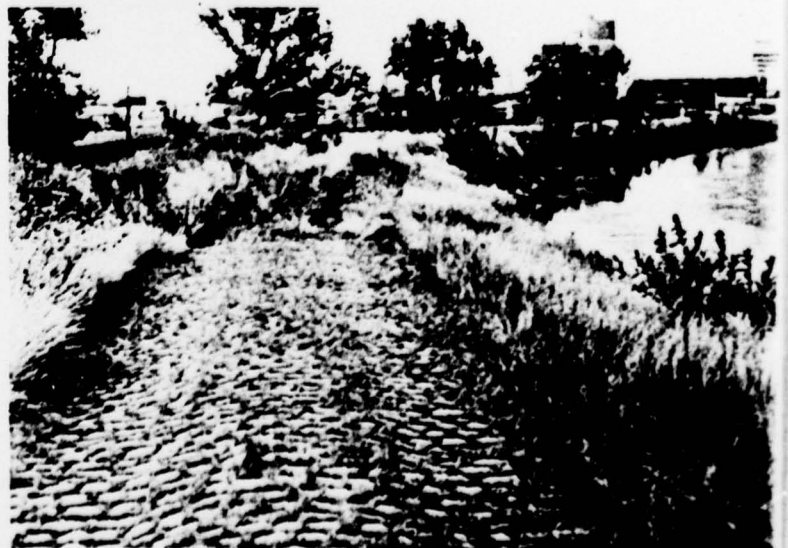
TOP OF EMBANKMENT  
(INDICATING COBBLESTONE  
PAVING AT STORAGE SHED  
& GATE HOUSE)
