ATLANTIC COAST BASIN

UNION LAKE DAM

PHASE I INSPECTION REPORT

NATIONAL DAM SAFETY PROGRAM

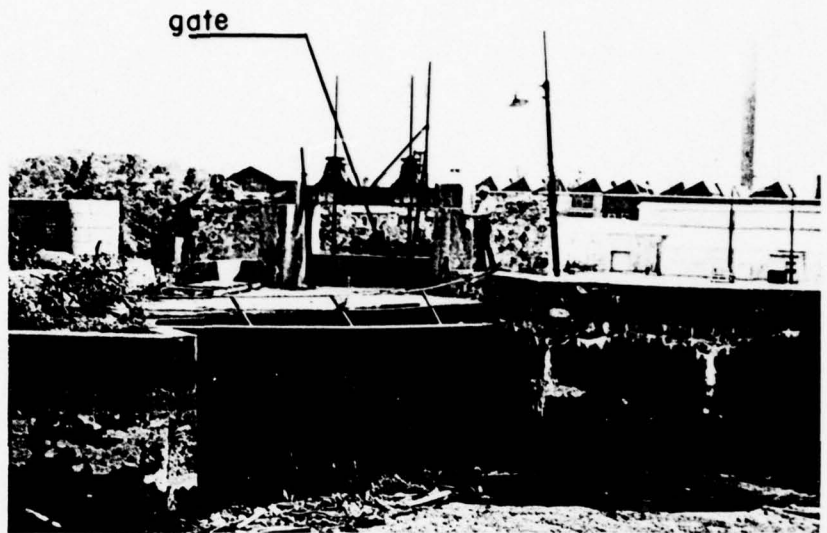
A fire in April 1977 destroyed the generator building and the penstock control gate and the regulating controls were damaged. The gate is now inoperative and remains about half open and is plugged with debris. At the present, the entire facility appears to be abandoned.

As previously mentioned in Section 1.2.g., the canal intake structure (3-5.7'x7.0' head gates) at the east abutment is operational but the channel is blocked downstream at the penstock (which is open about half way but clogged with debris). The capacity of these outlet sluices is limited as the penstock control gate capacity, if repaired, is limited by the power plant turbine (about 300 cfs). Representatives of the owners informed the inspection team that the penstock gate and electrical lifting devices were scheduled for repair in late summer.

Inoperative gate to 9' Powerhouse penstock
July 1978

(3) Clean and repair the penstock gate downstream at the burned-out power house, or, alternatively, construct a raceway around this gate to increase the capacity of powerhouse canal.

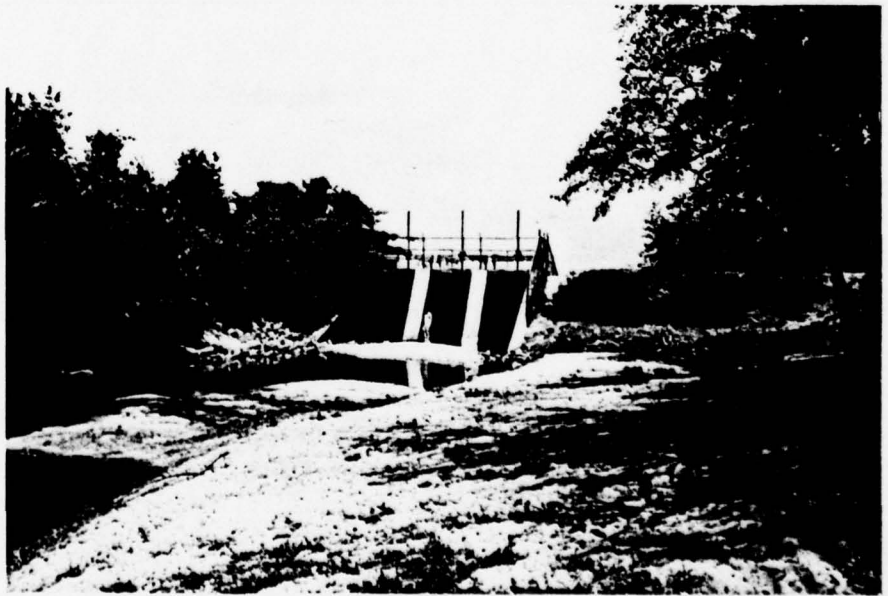
On inspection, the spillway appeared to be in adequate condition, with the inflatable Fabridam functioning well. However, there are several deficiencies, the more noticeable being the inadequacy of the sluice gates to draw-down the reservoir in the event of a weakness developing in the embankment, and the perched downstream spillway apron which would subject the channel to sweepout for releases in excess of about 600 cfs. Further, the capacity of the spillway, as presently constructed is deficient for handling floods of more than those of moderate frequency.

Sluiceways as viewed from Raceway
June 1978

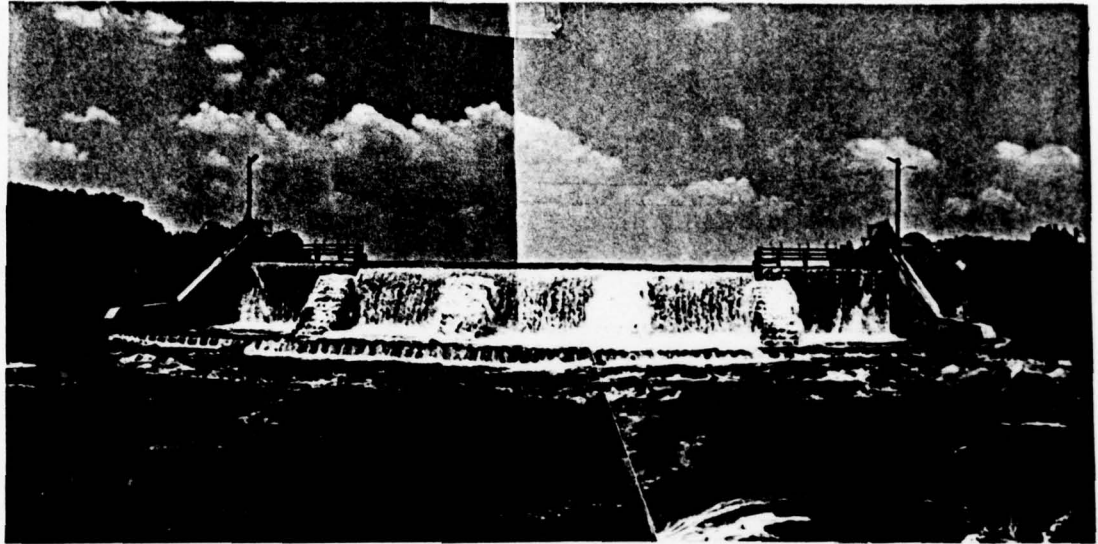
Spillway
June 1978

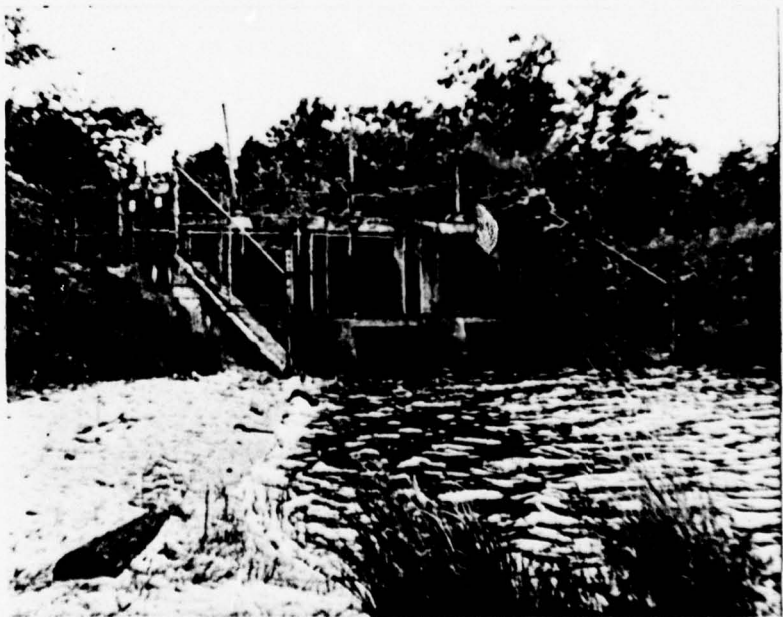
Lakeside view of Sluiceways
June 1978

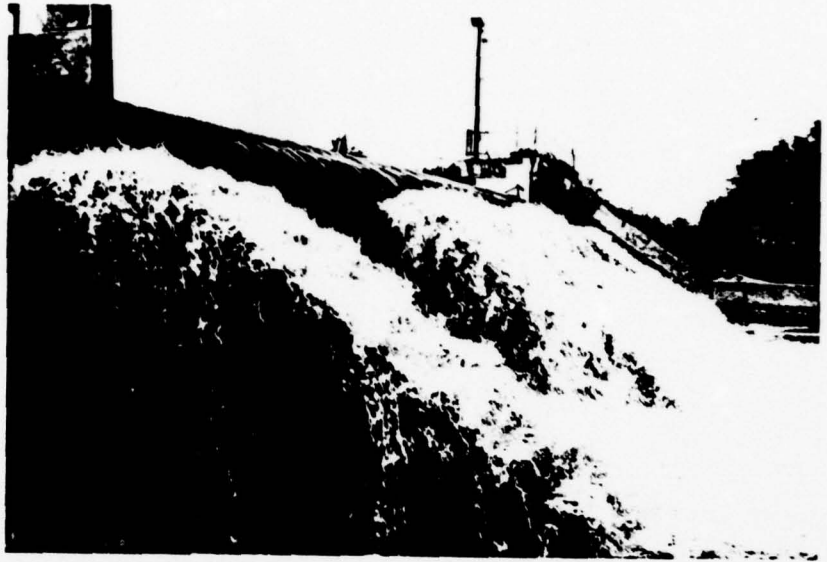
Drawdown of lake*
July 1978

**FABRICAM DEFLATED FOR INSPECTION TEAM, 19 JULY 1978*

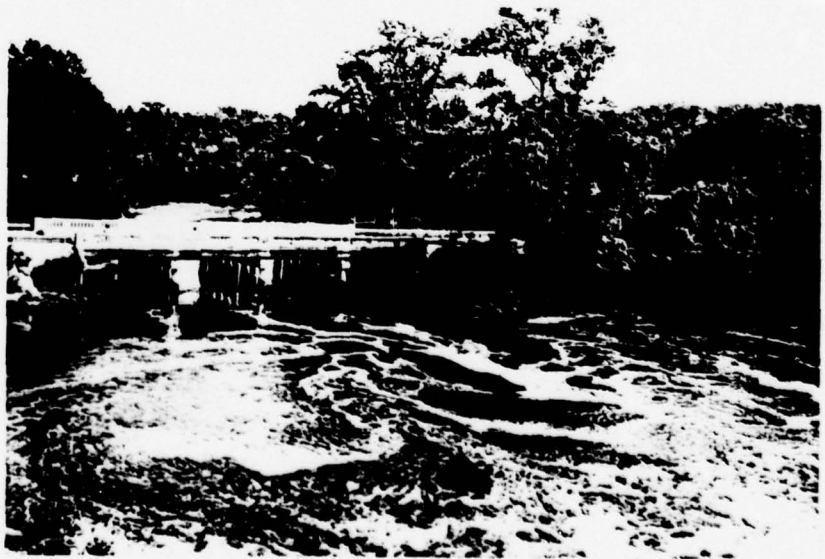
Further investigations should be undertaken in the near future as a collapse of this dam could conceivably wash out the hydraulically substandard (in relation to the SDF) Sharp Street bridge immediately downstream and would significantly increase the hazard to loss of life and damage to property.

County Bridge downstream of Spillway
July 1978

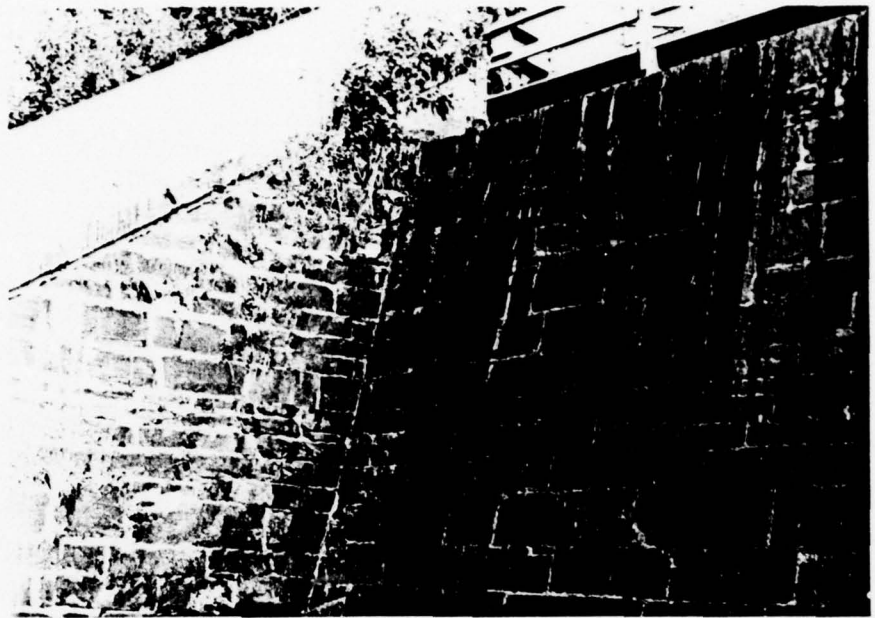
Spillway and Abutment faces
July 1978

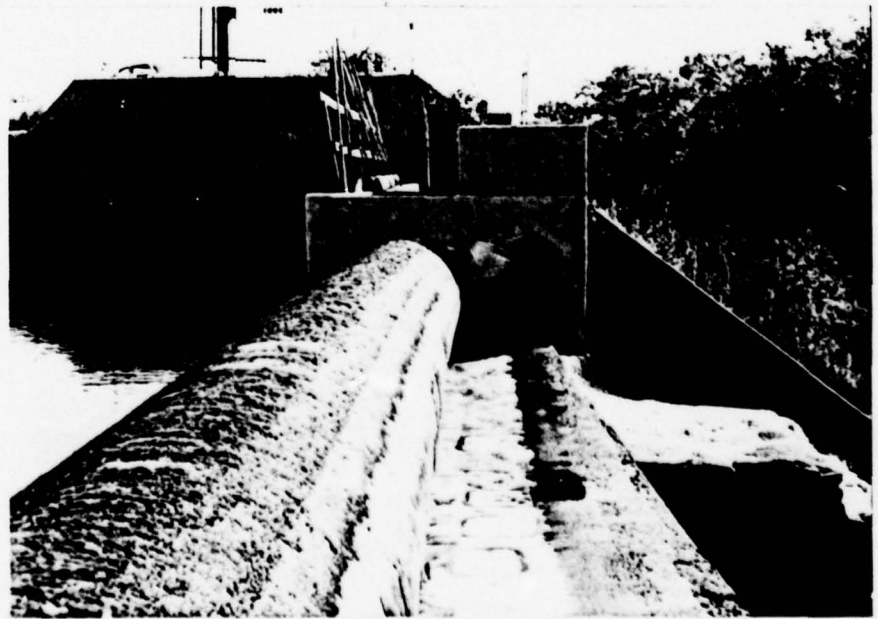
Inflated Fabridam
July 1978

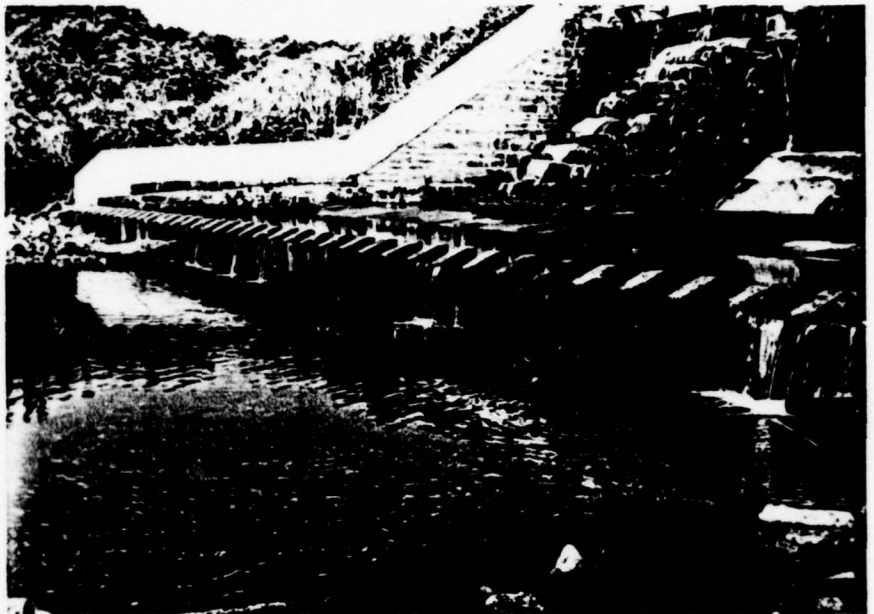
VISUAL EXAMINATION OF	OBSERVATIONS	REMARKS OR RECOMMENDATIONS
SURFACE CRACKS	No major cracks observed.	
UNUSUAL MOVEMENT OR CRACKING AT OR BEYOND THE TOE	No unusual movement or slides observed.	
SLOUGHING OR EROSION OF EMBANKMENT AND ABUTMENT SLOPES	Some erosion at downstream slopes.	Slopes very irregular. " cleared of major growth.
VERTICAL AND HORIZONTAL ALIGNMENT OF THE CREST	Satisfactory. Width varies (20' Avg).	
RIPRAP FAILURES	Riprap on upstream face appears to have no bedding layer.	Riprap in downstream stilling basin scattered about at edges. Steel sheeting undercut at south edge of apron.

Sheet Piling at front edge of slab
July 1978
