PARKS COLL OF SAINT LOUIS UNIV CAHOKIA ILL  
SHOCK PULSE METER ANALYSIS.(U)

## SHOCK PULSE METER ANALYSIS

15 OCTOBER 1974

FINAL REPORT

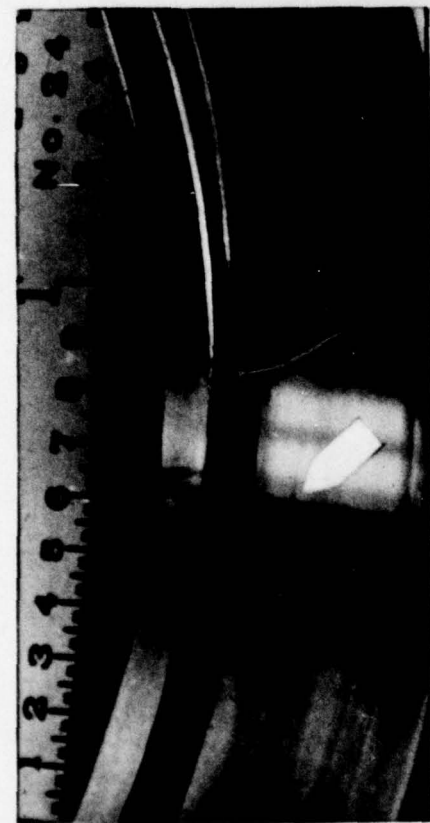
Roller Bearing  
S/N 21020  
Outer Race

The output drive quill roller bearing showed one scratch about 1/8" long in the outer race. All other damage was due to minor corrosion and pitting. The Duplex Bearing Set showed damage to the cages of both bearings due to inner race contact, some small scratches and minor corrosion.

Outer Race: Light Pitting and Corrosion  
1 scratch

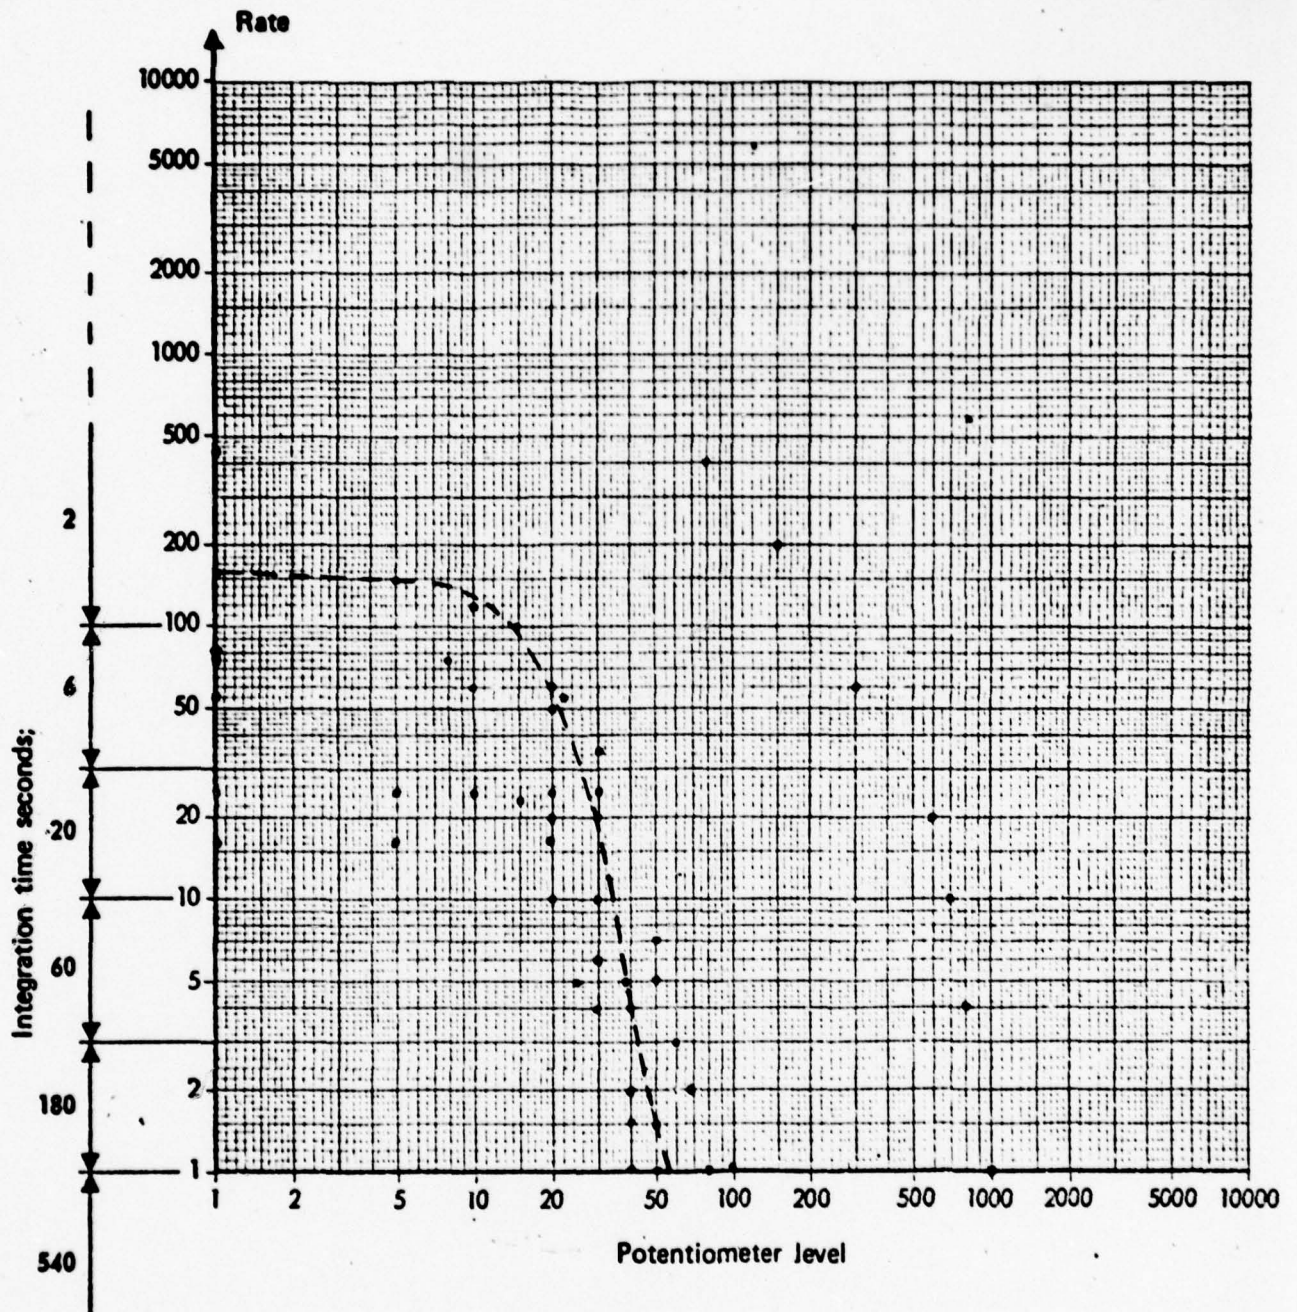
Scatter Diagram  
Transmission Mast Bearing Assembly

Shock pulse data was collected from two locations on the transmission. Figures 14 and 15 show the attachment point for the transmission input drive quill and for the mast bearing assembly. Figure 16 is a scatter diagram of nine different transmissions with the accelerometer attached to the input drive quill. The dotted line is that recorded from Bearcat 13 at Fort Rucker, Alabama. This is the only transmission of known good condition, having been inspected prior to its use in the AIDAPS program. One of the transmissions installed on UH-1C 66-15071 indicates a much higher rate and level than the others.

It was beyond the scope of work to remove and disassemble a transmission. However, past history has shown that exceptionally high readings above the norm generally indicate degraded components. There is no way to determine the level of degradation nor to isolate it within the transmission.

- 3) Undertake an engineering effort aimed at the refinement of accelerometer attachment with emphasis toward flight worthy installations.
- 4) The mast bearing and input drive quill of aircraft 66-15071 a UH-1C helicopter belonging to the 281st Aviation Company at Bi-State Airport showed shock emissions profiles which necessitate collateral teardown information. Since both components were parts of the transmission assembly of the helicopter, there is a likelihood that a defect may be present in the assembly, teardown information would be needed to confirm this supposition.
