| REPORT DOCUMENTATION PAGE | | READ INSTRUCTIONS<br>BEFORE COMPLETING FORM |
|---|---|---|
| 4. TITLE (and Subtitle)<br>Phase I Inspection Report<br>National Dam Safety Program<br>Hanover Lake Dam<br>Burlington County, N.J. | 5. TYPE OF REPORT & PERIOD COVERED<br>⑨ FINAL / Rpt. | 6. PERFORMING ORG. REPORT NUMBER |

HANOVER LAKE DAM (NJ00459)

PHASE I REPORT  
NATIONAL DAM SAFETY PROGRAM

HANOVER LAKE DAM    FED I.D.No. NJ00459

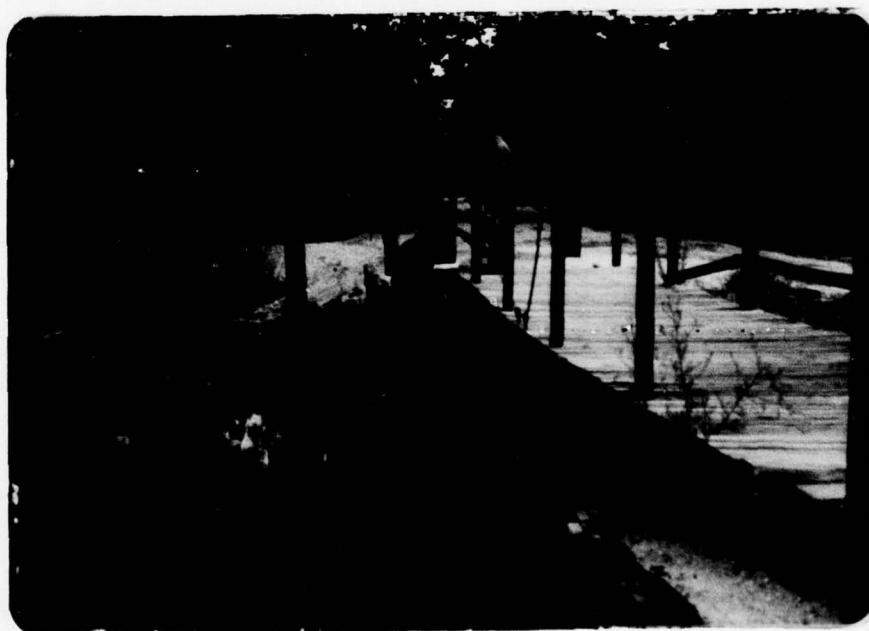
Upstream view of wooden bridge  
pier abutments. 6 July 1978

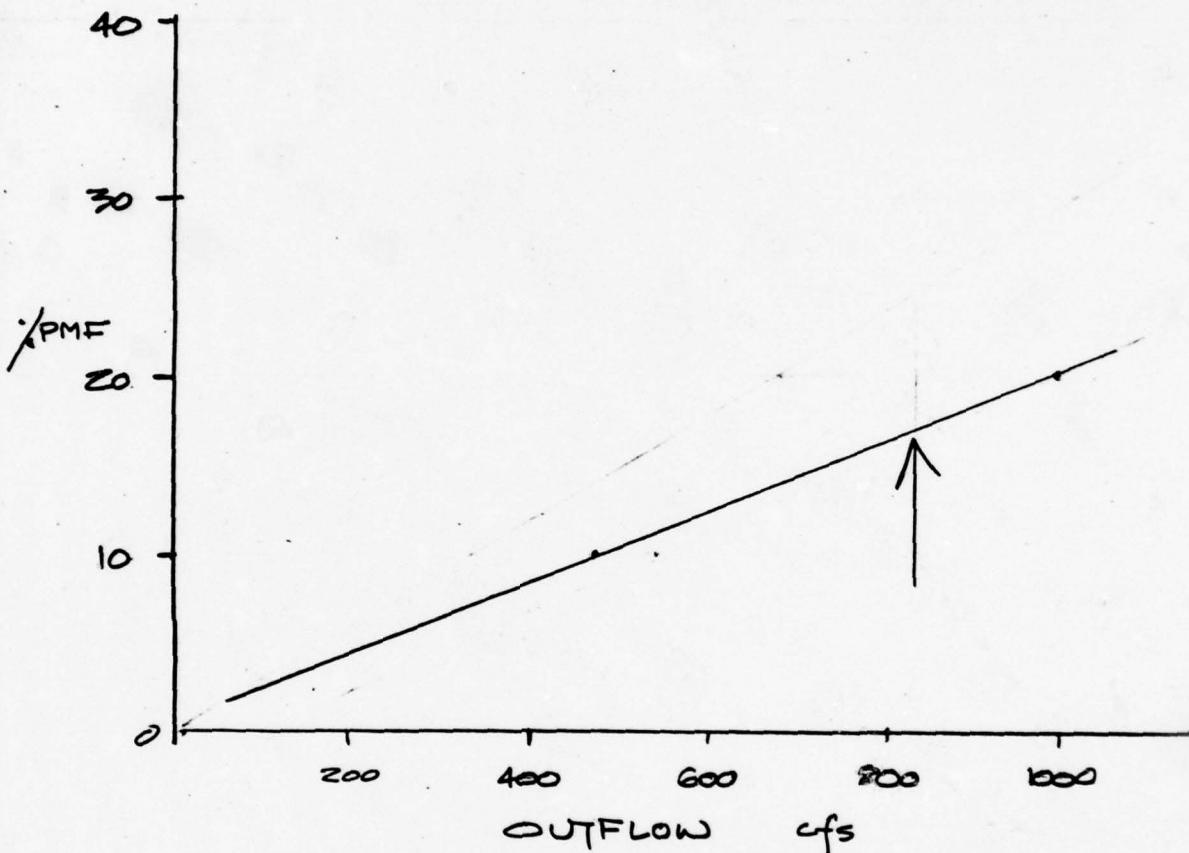
OVERTOPPING POTENTIAL

3. Overtopping occurs at a 69.6 ft  $\pm$   $Q \approx 830$  cfs  
 $\therefore$  dam can pass approximately 17% of PMF
