BEAR SWAMP LAKE

DAM NO. 2

PHASE I INSPECTION REPORT

NATIONAL DAM SAFETY PROGRAM

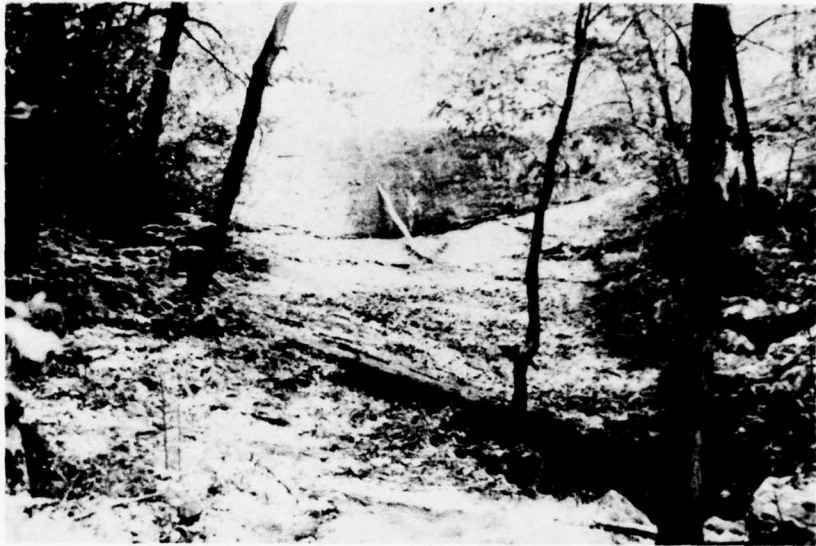
Photo 3 - View of dam and spillway from downstream showing concrete apron and plunge pool below spillway.

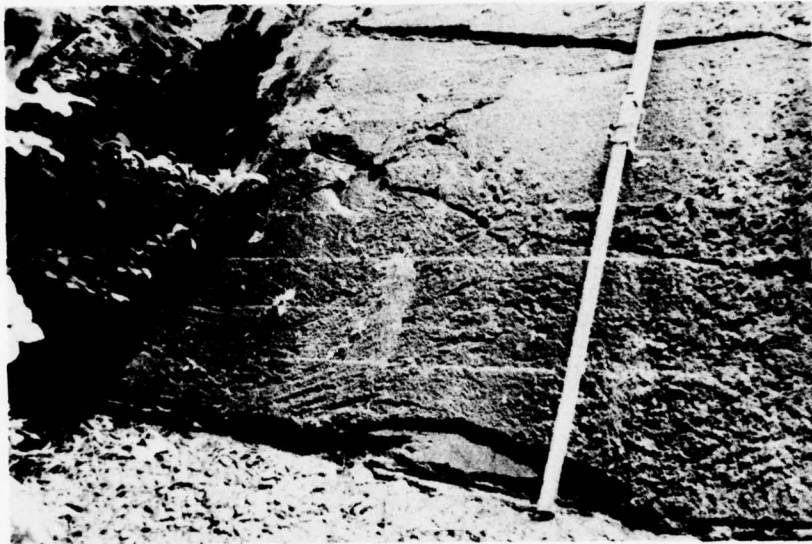
A structural crack has occurred through the spillway about 10 feet from the right side. Leakage in the order of 0.5 g.p.m. was observed in this area. Some minor leakage was also observed from two horizontal construction joints in the spillway. No serious cracking was observed in the spillway apron.

Photo 5 - Leakage and spalled surface on spillway right side.

Areas of deteriorated, spalled or seriously cracked concrete should be cleaned and patched annually to prevent progressive damage.

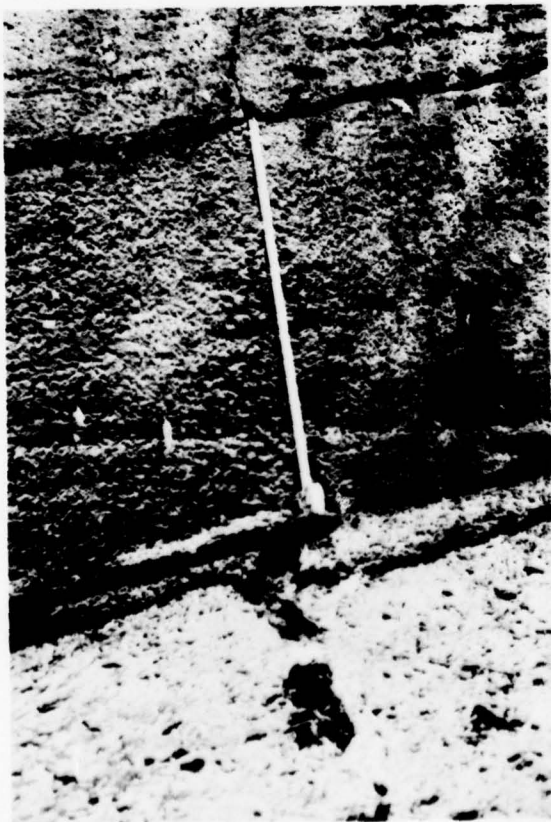
Photo 6 - Leakage through crack in spillway left side.

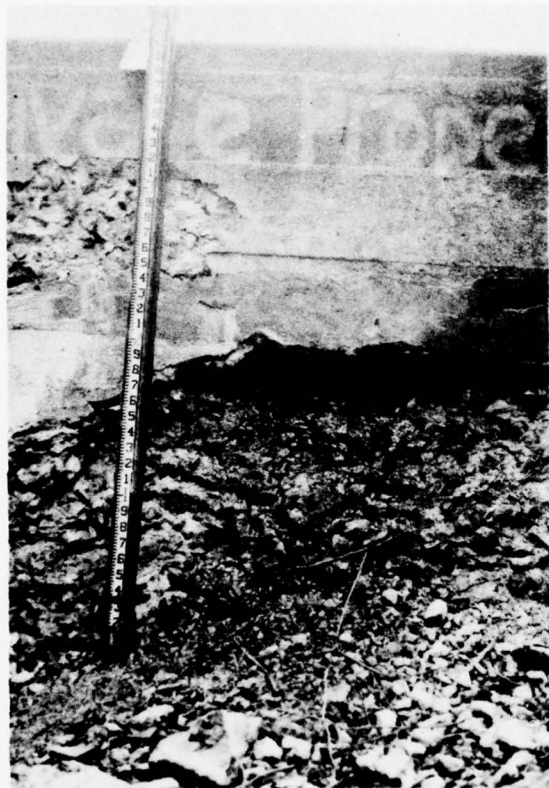
Some deep spalling has occurred at the toe of the section to the left of the spillway. Some leakage was visible in this area. A large horizontal crack has occurred in the section to the right of the spillway. No leakage was apparent in this location. Minor frost spalling has occurred on the upstream face. Construction joints appeared to be tight. There were no indications of either horizontal or vertical movement of the structure.

Photo 7 - Spalling and leakage
near left abutment.

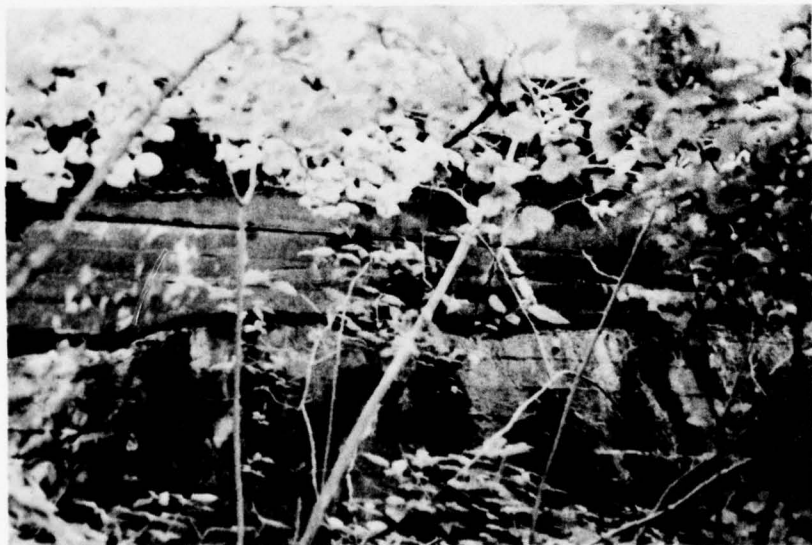
Photo 8 - Horizontal crack right side near abutment.

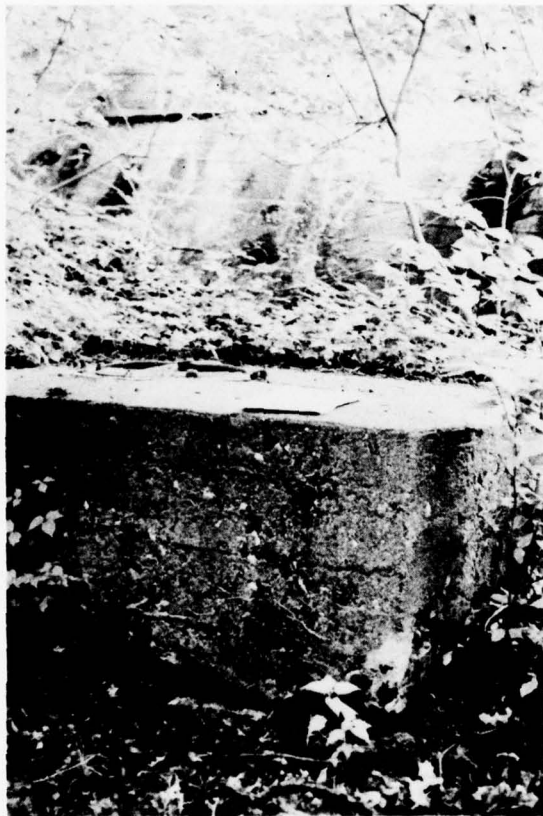
Photo 9 - Concrete valve vault
for low level outlet
pipe.
