**title:** ANACAPA ISLAND SPLIT PIPE INSPECTION OF  
JUNE 1977 AND APRIL 1978

**author:** W. R. Tausig and R. L. Brackett

**date:** September 1978

## CIVIL ENGINEERING LABORATORY

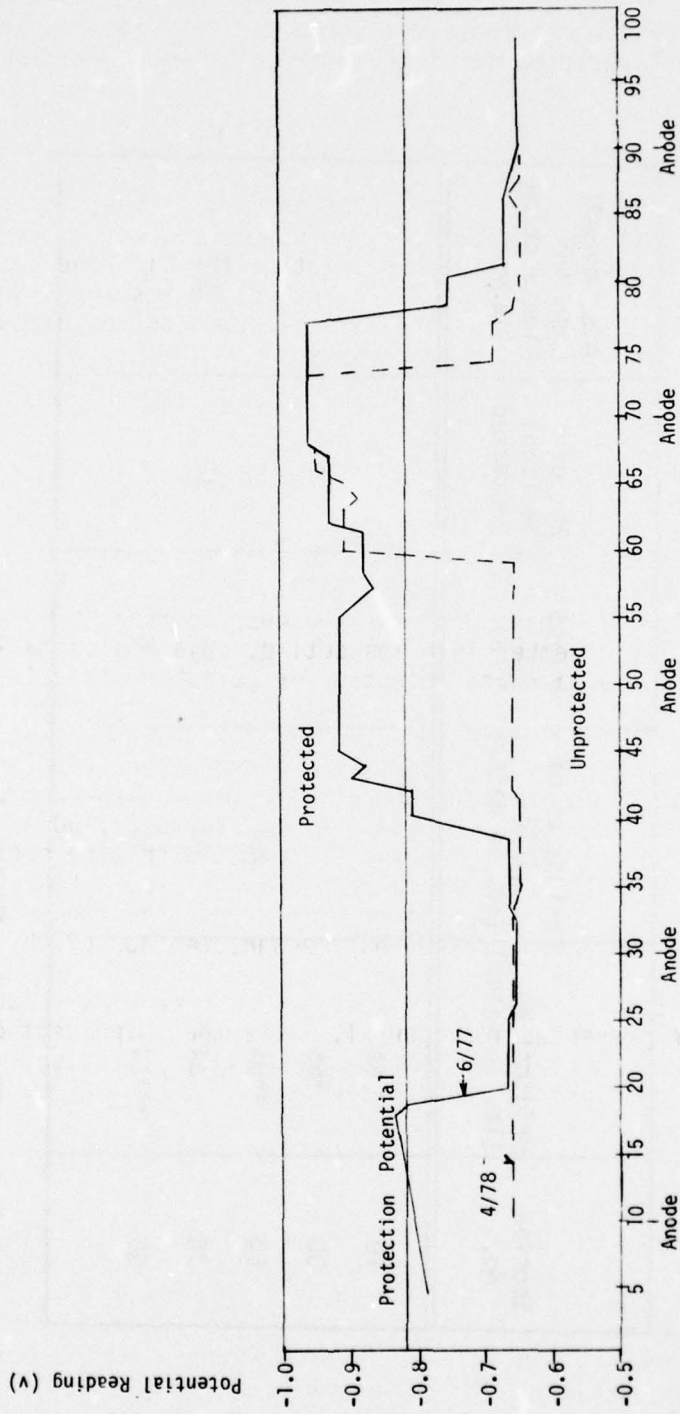
Figure 1. Cathodic Protection Potential

Galvanic potential readings were taken with an underwater voltmeter. The results are presented in Figure 1. Note that pipe sections 43 through 77 are the only sections cathodically protected. The remaining pipe sections are unprotected due to the numerous broken jumper and anode cables.

Galvanic potential readings were again obtained over the entire pipe installation. Results of these data are included in Figure 1. Note that due to further jumper cable and anode failures, only pipe sections 60 through 73 are cathodically protected.

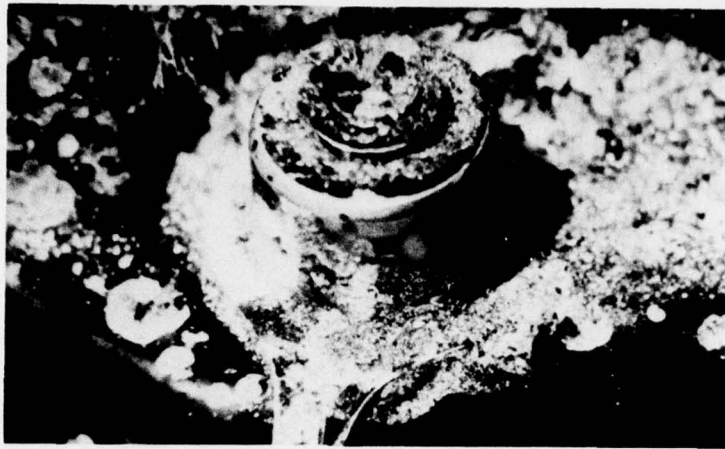
Figure 2a shows an example of a cathodically protected, BOM fastener from the June 1977 inspection. Figure 2b shows an example of a cathodically protected BOM fastener from the April 1978 inspection, after 25 months of submersion. Note in comparing these figures that there is little or no sign of corrosion on the fasteners.

Figure 2a. Cathodically protected fastener from pipe section 57, June 1977.

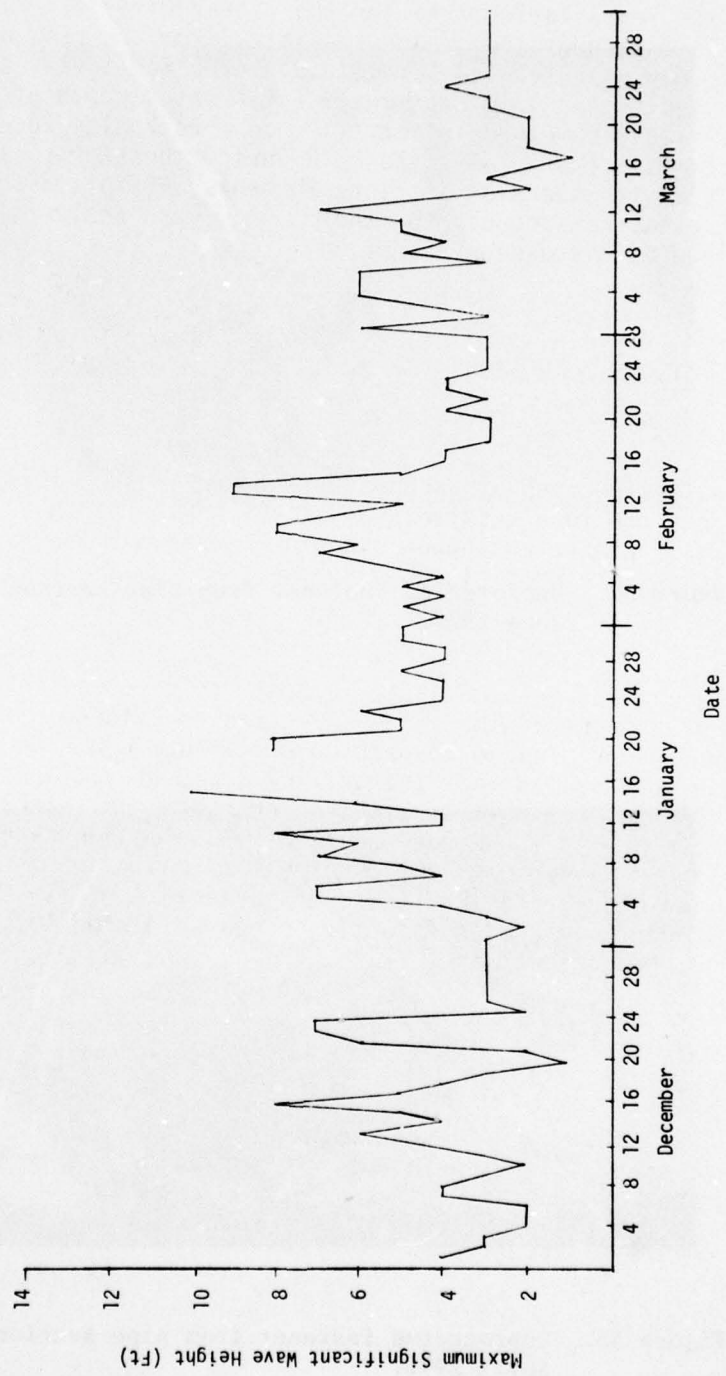
Figure 4. Significant Wave Heights

wave forces. Figure 4 shows the maximum significant wave heights in the pipe installation area for the winter of 1978. Pipe sections 2 through 10 were dislodged and separated from the rest of the installation. Only pipe section 1 remained rockbolted to the shore. All pipe sections beyond section 10 (at a water depth of 10 feet out to 42 feet) remained intact. The four rockbolts located on pipe sections 2 and 3 failed to hold during the storm. In addition, the Hi-Shear fasteners on sections 2 through 10 failed to hold these pipe halves securely together. A failure analysis of the pipe damage is discussed in section 7.

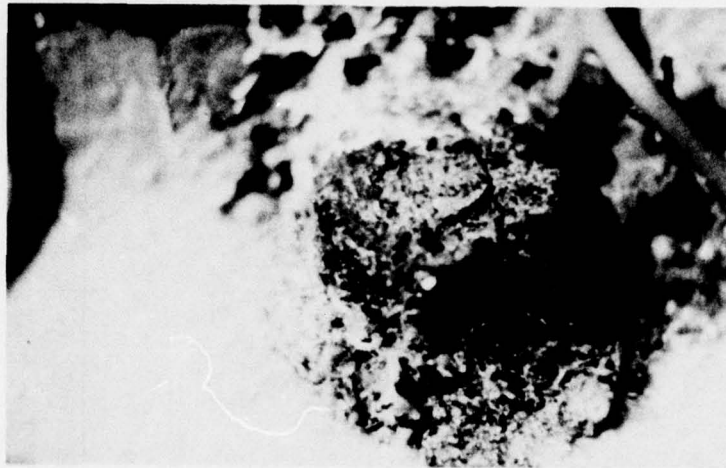
Visual inspection of each pipe fastener in June 1977 revealed no failures due to excessive corrosion. Fasteners that were not cathodically protected showed signs of corrosion. However, there were no signs of loose pipe halves due to corrosive failures.

Figure 5a. Unprotected fastener from pipe section 87,  
June 1977.

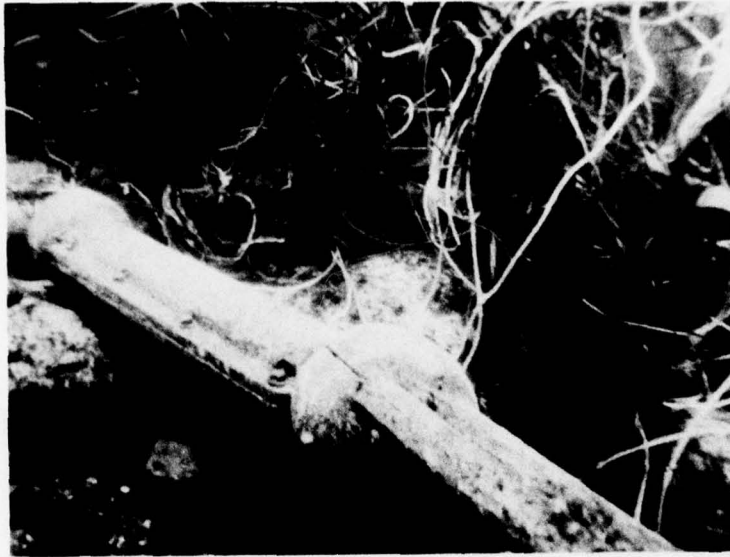
In May 1978, seven of the damaged pipe sections 2 through 10 were recovered for closer inspection and failure analysis. Figure 6 shows four views of the damaged installation and broken pipe. Note the large amount of tangled wire and armor from the exposed multi-conductor cable. Pipe sections 2 through 5 were found intact but severed completely from the rest of the installation. These sections were installed with stainless steel Hi-Shear fasteners. Close examination of these fasteners revealed that the pipe flange holes had enlarged around the fastener due to the galvanic interaction between the cast iron pipe and stainless steel fastener. Although none of the stainless fasteners were missing, the pipe halves were loose enough to allow the bell end of section 2 to open and slip off pipe section 1. Figure 7 shows the gap created between pipe

Figure 6a. Damaged pipe showing tangled multiconductive cable.

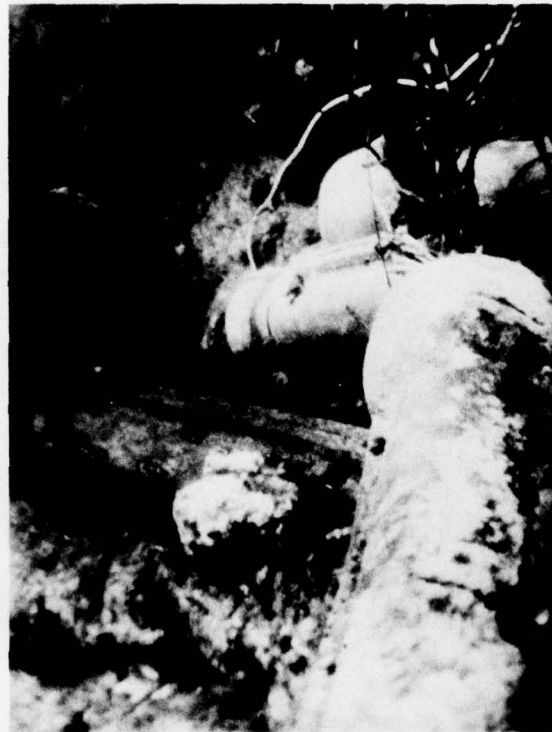
Figure 6b. Damaged pipe separated from installation.

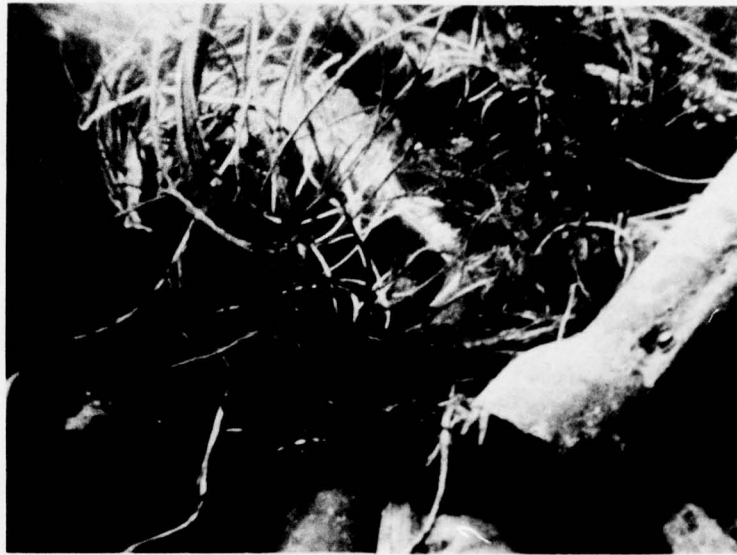
Figure 6c. Cable end extending from pipe section 11.

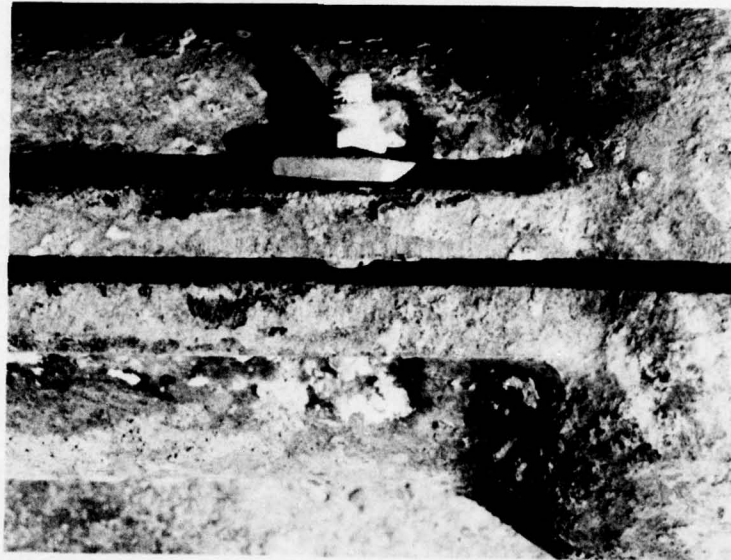
halves due to the fasteners slipping through the enlarged flange halves. The combination of corrosion and high winter wave loads was enough to cause the rockbolts to fail on pipe sections 2 and 3. Figure 8 shows the remains of two recovered rockbolts in which one had severed and one had pulled out.

Figure 7. Gap in pipe halves due to slippage of Hi-Shear stainless steel fasteners.

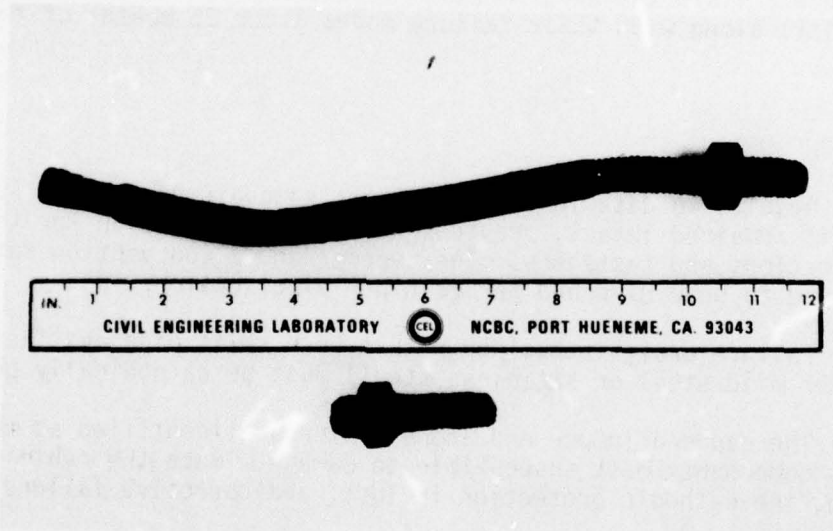
Figure 8. Recovered rockbolts.

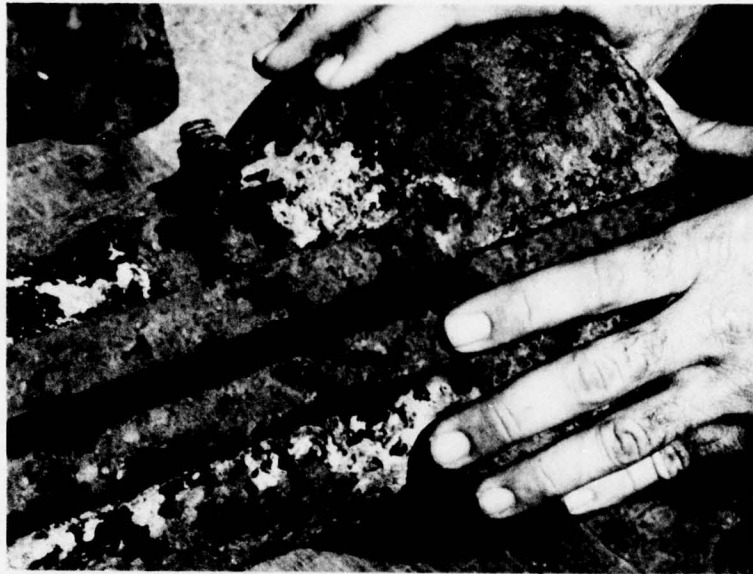
Pipe sections 6 through 10, which were installed with mild steel Hi-Shear fasteners, were found to be completely disassembled (refer to Figure 6d). The majority of these fasteners were missing from the pipe halves. Close examination of the recovered fasteners revealed that corrosion between the steel pipe and steel fastener decreased the diameter of the flared end of the fastener by about 0.1 inches. Failure occurred when these fasteners corroded enough to slip through the pipe flange holes. Figure 9 shows the mode of failure for the mild steel Hi-Shear fasteners.

Figure 9. Corroded Hi-Shear steel fasteners slipping through the pipe flange.

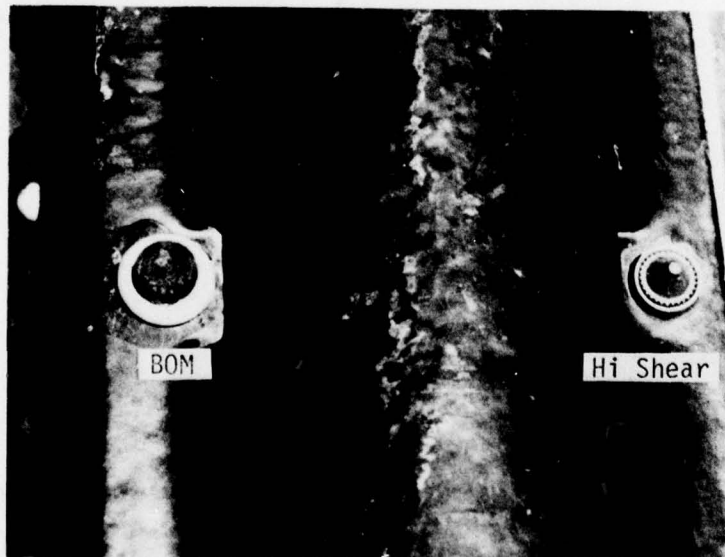
The only fasteners that remained intact were the BOM fasteners which were installed beginning with Section 11. These fasteners have enlarged swaged ends, which resist slippage due to corrosion. Figure 10 shows a comparison of the enlarged swaged end of a BOM fastener with the swaged end of a Hi-Shear fastener.

Figure 10. Comparison of the swaged end of a BOM and Hi-Shear fastener.

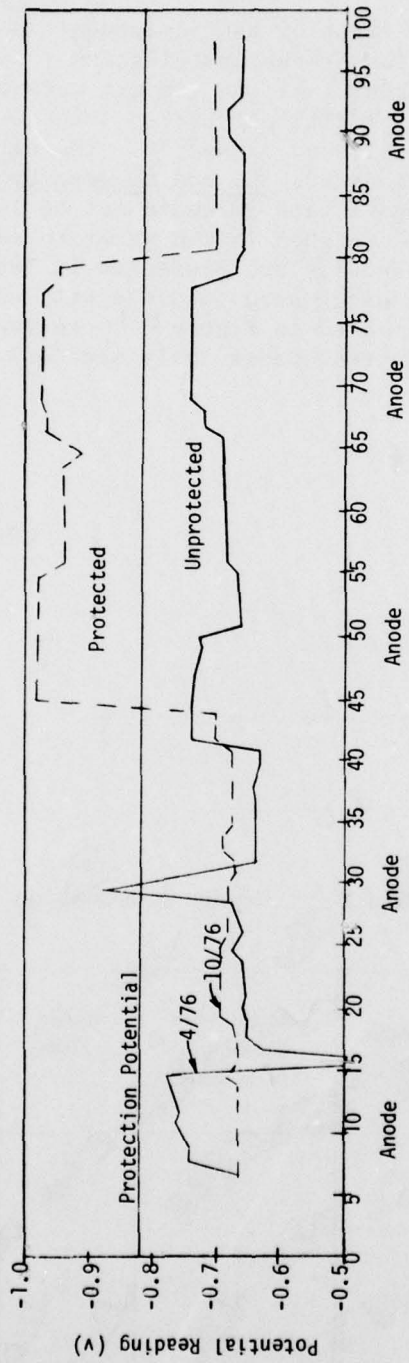
Figure B-1. Cathodic Protection Potential  
Split Pipe Section No.

Galvanic potential readings were obtained with an underwater voltmeter; the results are presented in Figure B-1. Because of the numerous broken jumpers and disconnected anodes, only sections 45 through 78 are being protected.
