Report No. CG-D-61-78

COLLISION ACCIDENT  
INVESTIGATIONS FOR 1977  
SEASON

FINAL REPORT

APRIL 1978

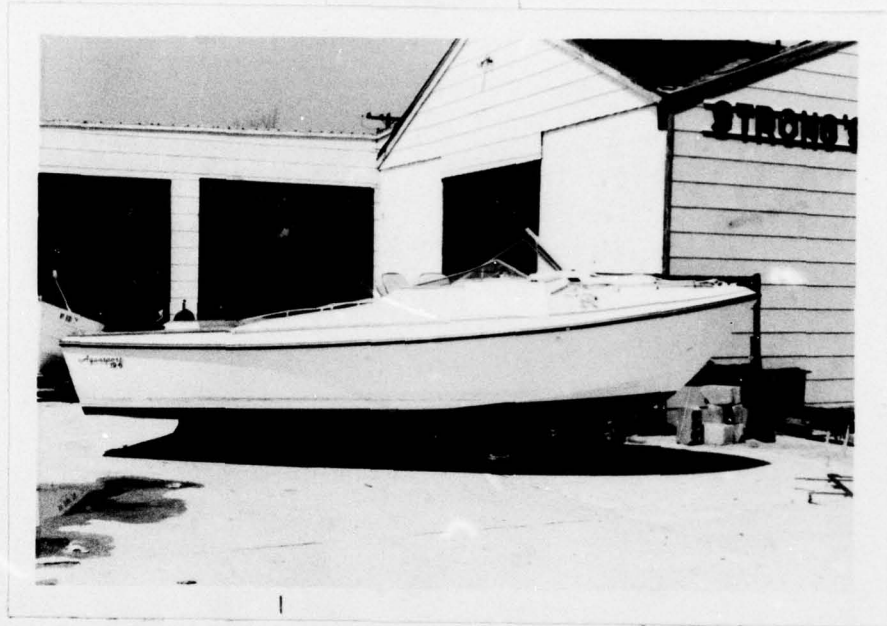
FIGURE 7

AQUA SPORT INVOLVED IN COLLISION

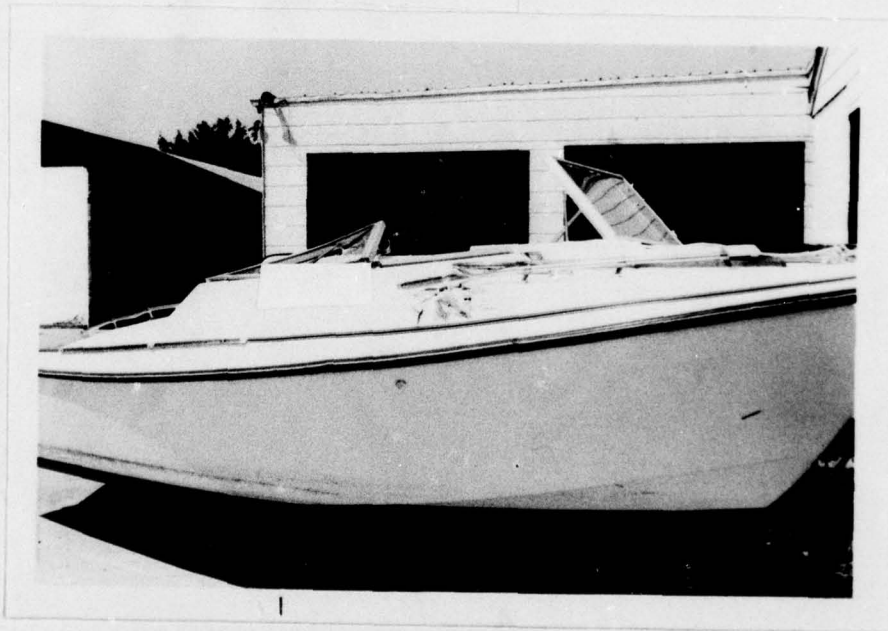
FIGURE 8

Damage to Boat #1 indicated a bow high position of Boat #2 at impact. This would indicate that Boat #2 was traveling at least 10-15 mph (24 kph) at impact.

DAMAGE TO DECK, NOTE ANGLE OF IMPACT

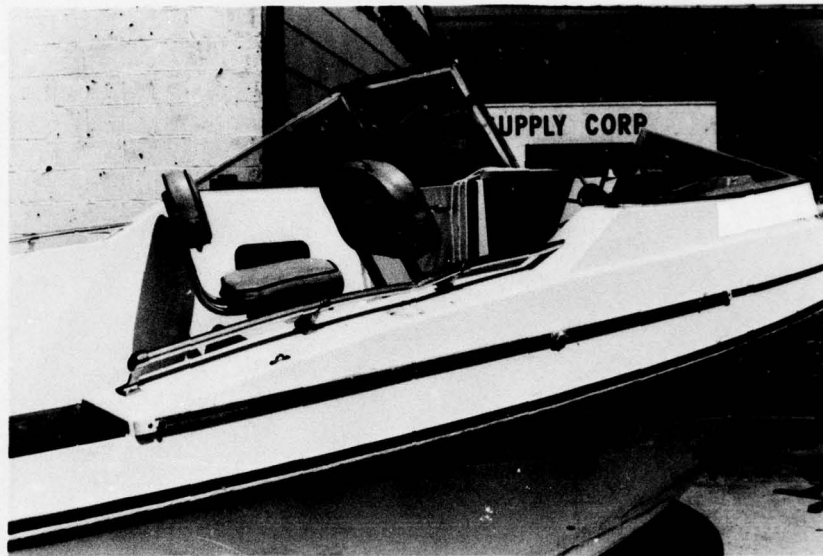
FIGURE 9

DAMAGE TO SIDE RAIL CAUSED BY THE KEEL OF THE SEA RAY, A CITIZEN'S BAND RADIO ANTENNA HAD BEEN MOUNTED ADJACENT TO THE CREASE IN THE SIDE RAIL. INJURED 5 YR. OLD CHILD WAS SITTING JUST AFT OF THE HELMSMAN'S SEAT AND NEAR AREA OF THE DAMAGED RAIL.

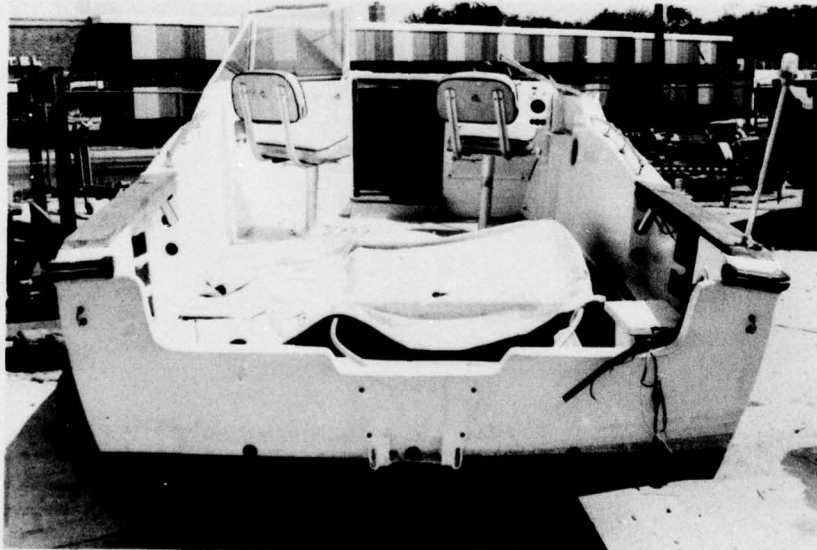
FIGURE 10

INTERIOR OF THE 19' 6" AQUA SPORT, (ENGINE HAD BEEN INSTALLED ON ANOTHER HULL FOR DELIVERY TO CUSTOMER.)

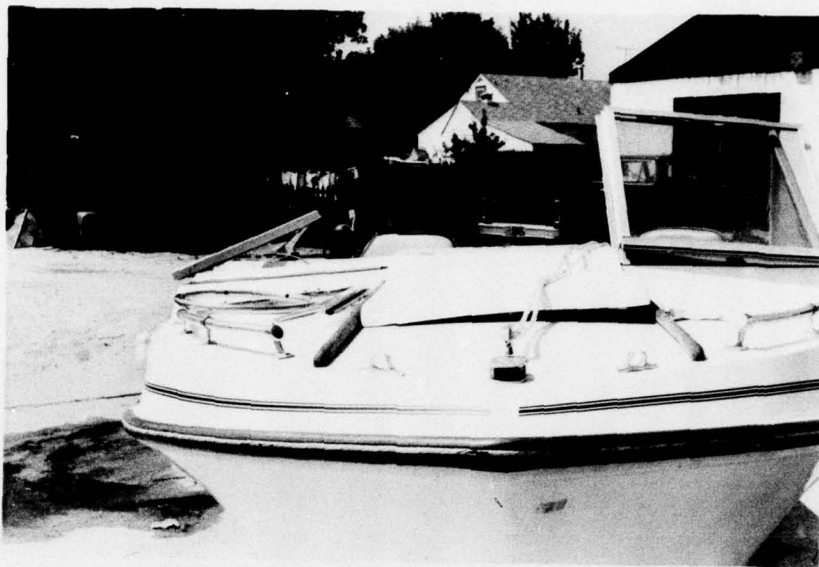
FIGURE 11

HATCH WHERE PASSENGER WAS STANDING

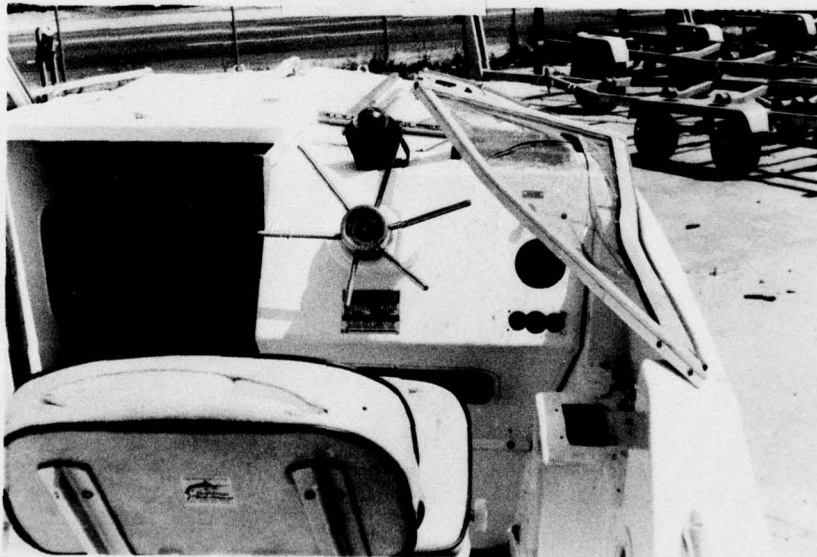
FIGURE 12

DAMAGE TO HELM AND VIEW OF AREA BELOW DECK.  
NOTE DAMAGE TO COMPASS WHERE KEEL PASSED  
OVER THE DECK, AND DAMAGE TO HELMSMANS  
SEAT CAUSED BY THE SEA RAY KEEL AS IT  
SLID AFT.

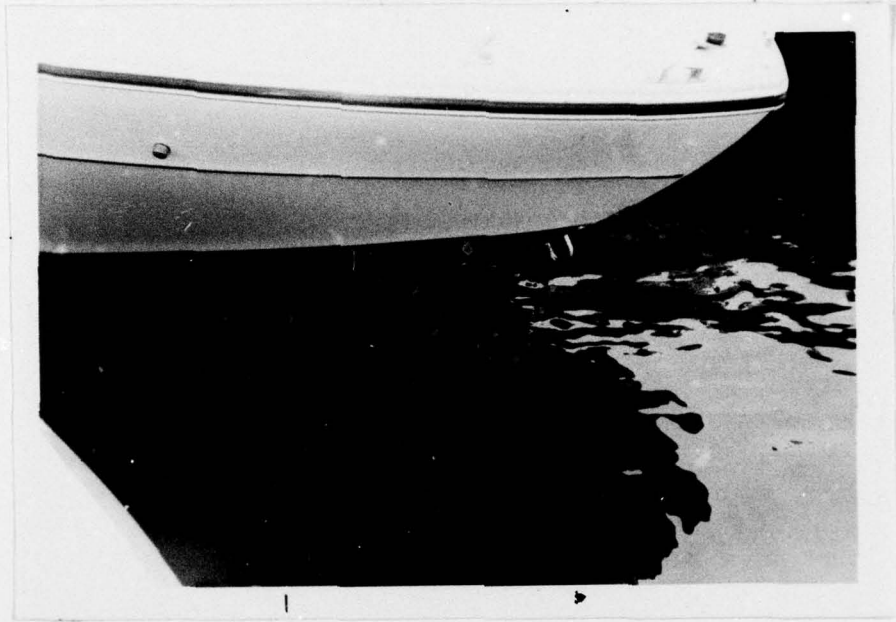
FIGURE 15

19' SEA RAY -- NOTICE SCRATCHES ON KEEL
