9438 HIGH LEVEL TRAVELING WAVE TUBE AMPLIFIER ANOMALY. VOLUME I--ETC(U)

FINAL REPORT
9438 HIGH LEVEL TRAVELING
WAVE TUBE AMPLIFIER ANOMALY

VOLUME I

Prepared by
J. A. Durschinger
TRW, Inc.
TRW Defense and Space Systems Group
One Space Park
Redondo Beach, CA 90278

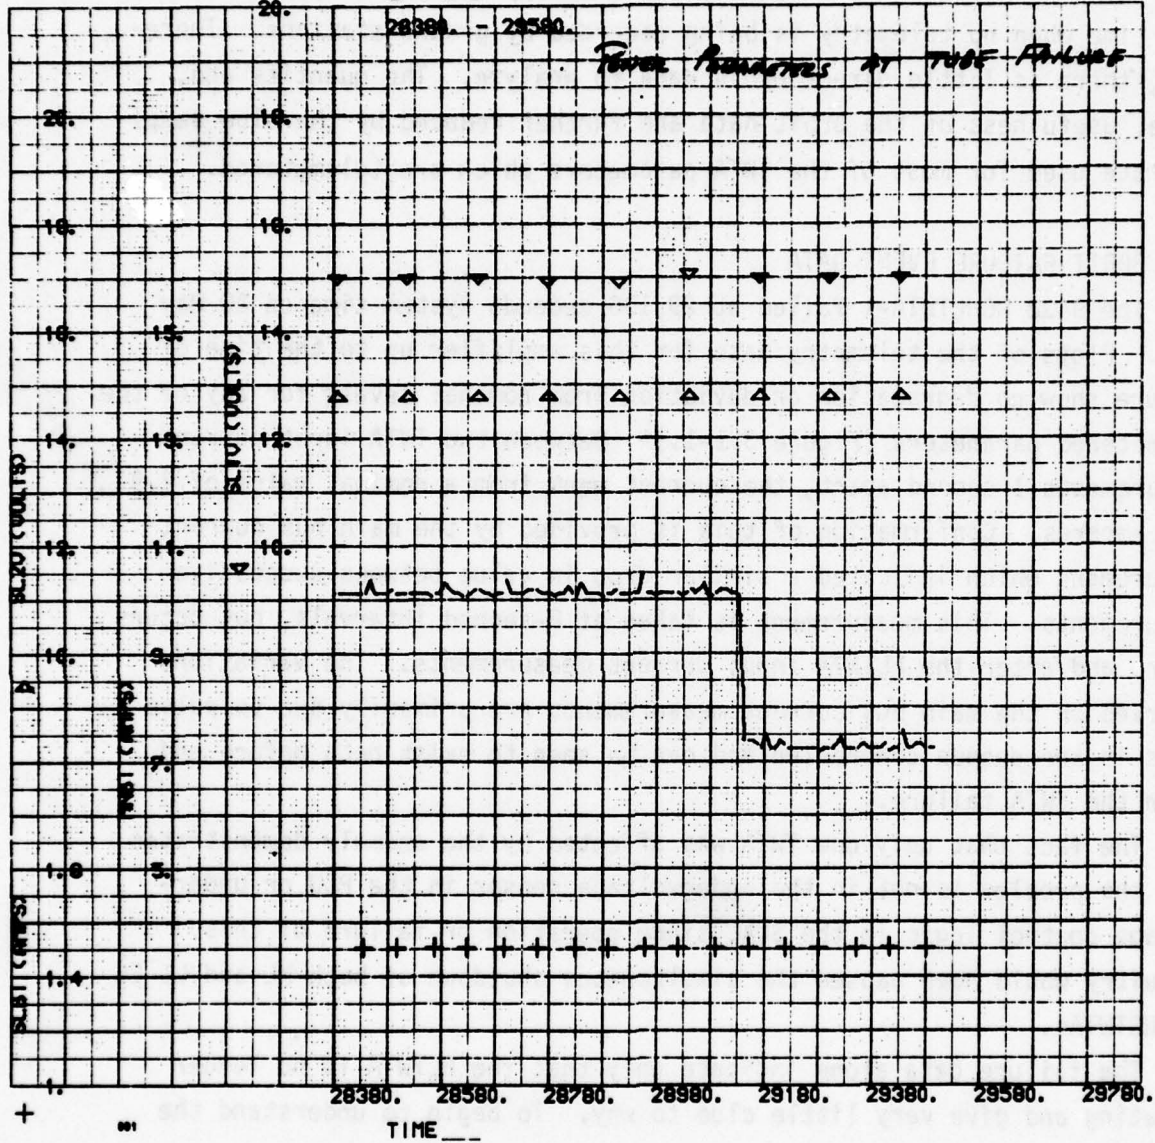
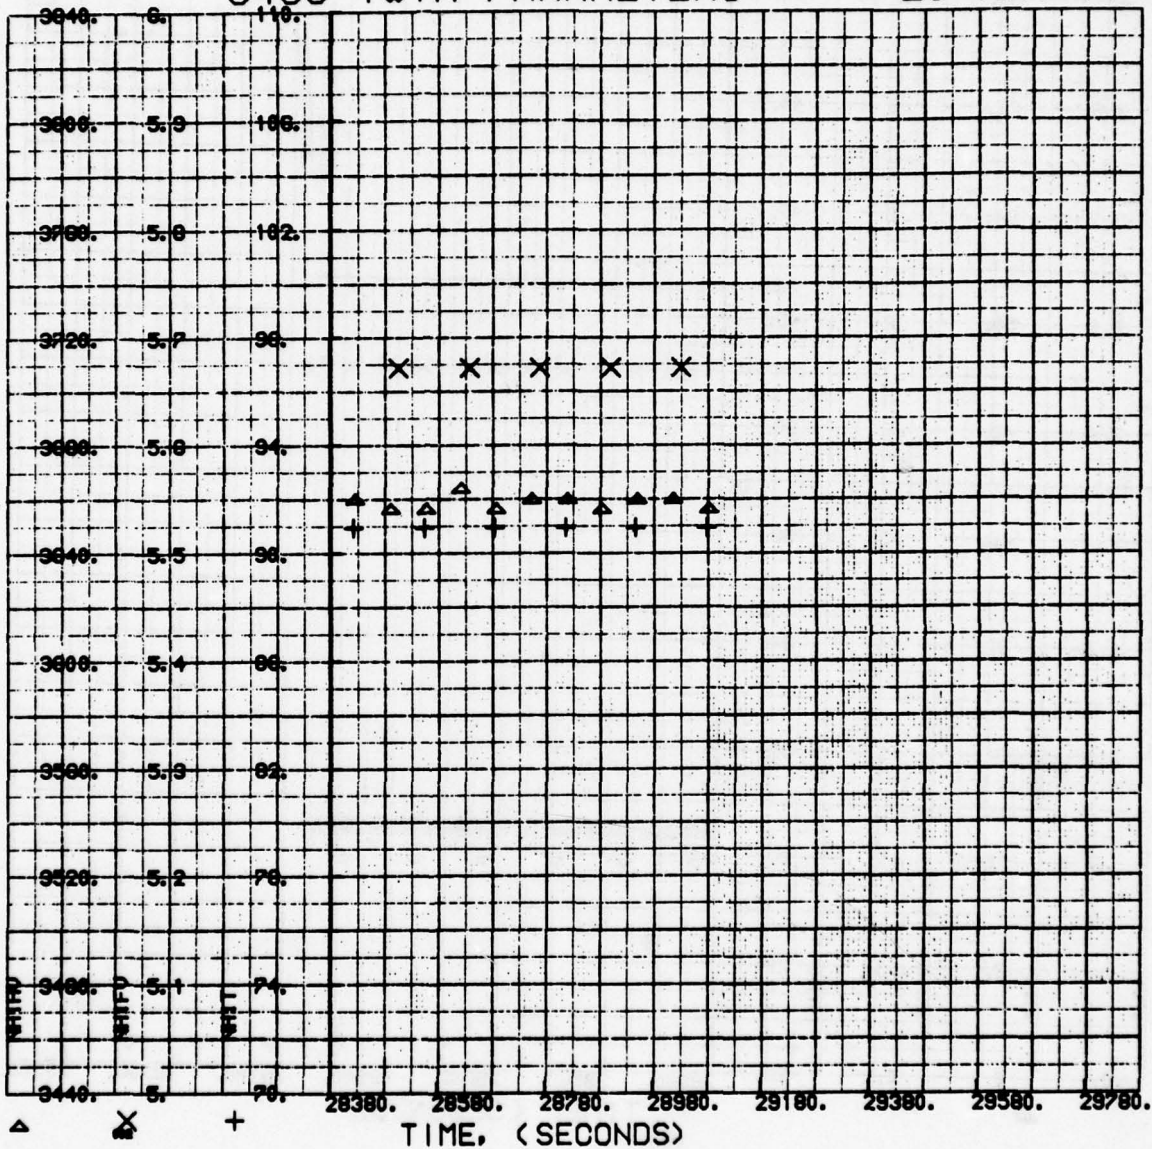
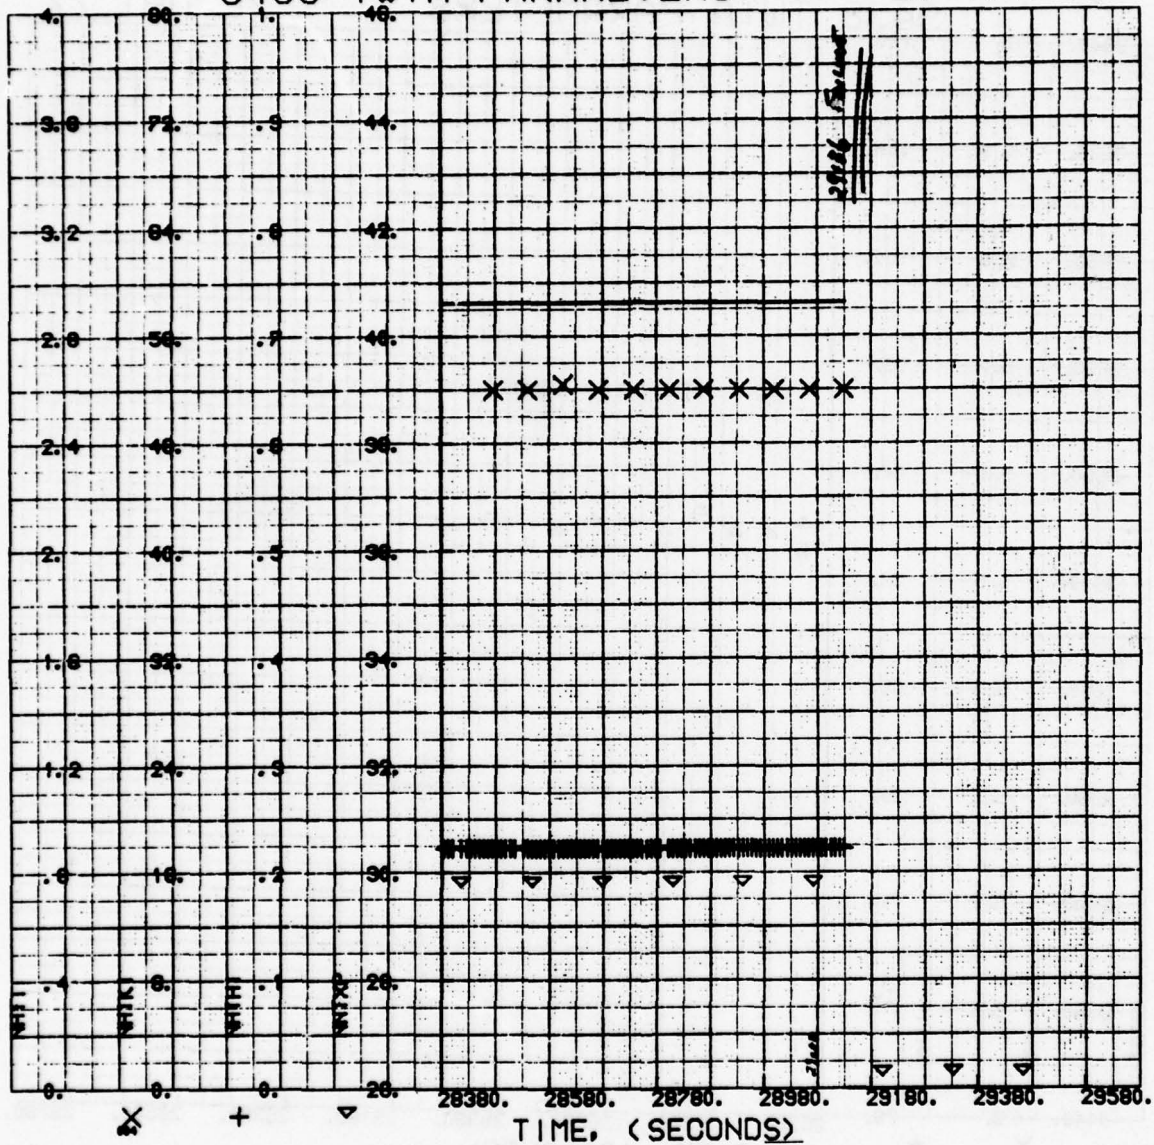
Figure 3.1-1. F8 HLTWA-1 Parameters at Time of Orbit Failure (20 May 1977)
 Show Sudden Turn Off Without Warning

anomaly, it was necessary to attempt to turn the TWT on. This was first done approximately 25,000 seconds after the failure. At this turn-on attempt (Figure 3.1-2) and for all others attempted later (Appendix A-1), the HLTWTA response was similar: The power supply turned on and provided filament voltage to the TWT. After approximately 90 seconds, when the internal high voltage delay timer timed out, the amplifier immediately shut down. The high-voltage delay timer is designed for a nominal time delay between initial turn-on and application of high voltages to the TWT of 90 seconds. A review of the initial turn-on of this TWT in orbit showed this time delay had not changed from previous operation (Figure 3.1-3). A total of 11 turn-on attempts were made on 20 and 21 May 1977, all with the same result.

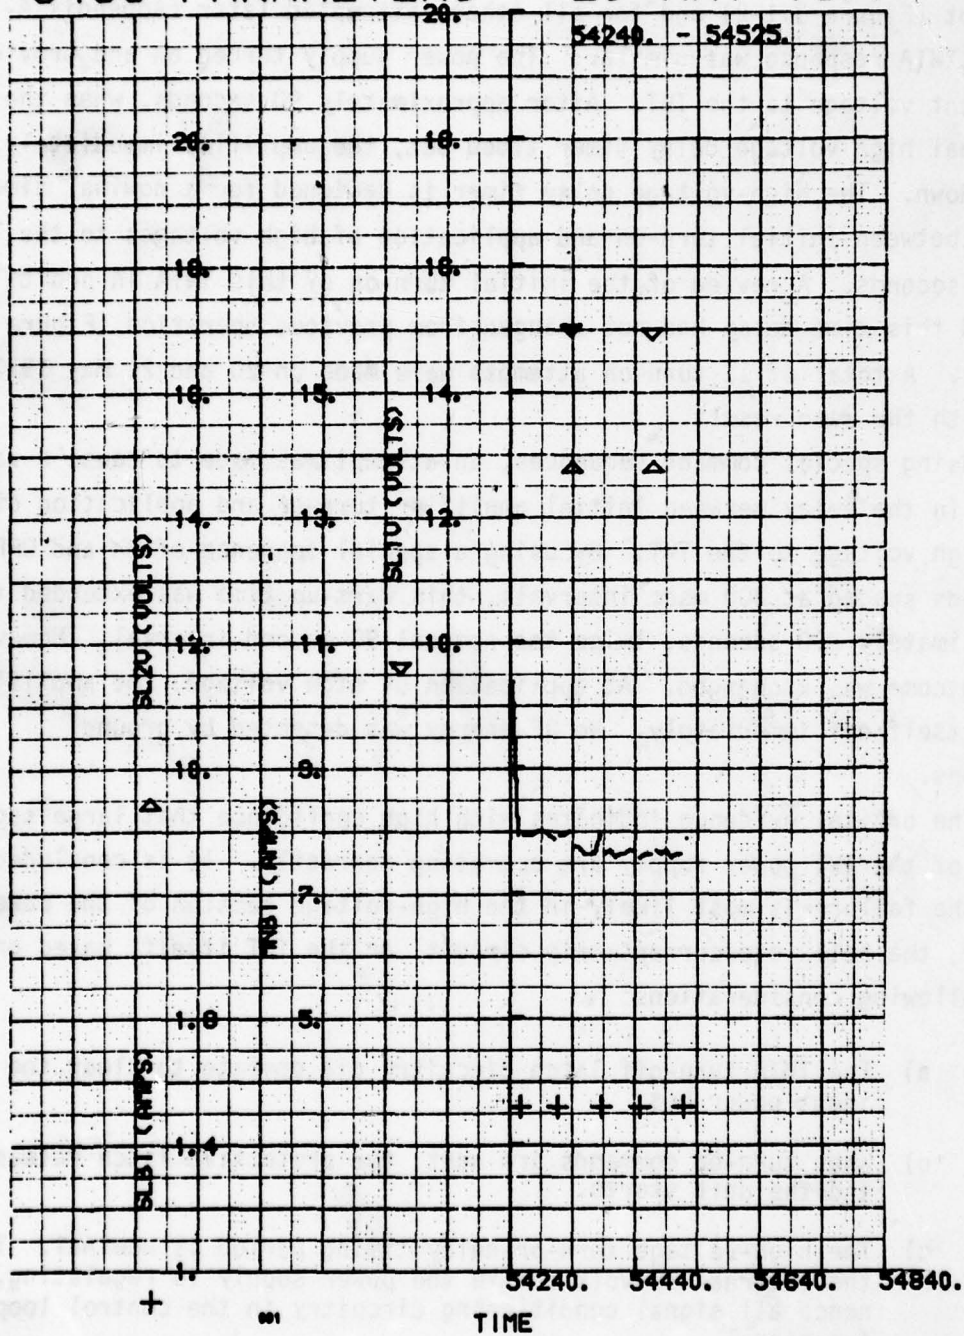
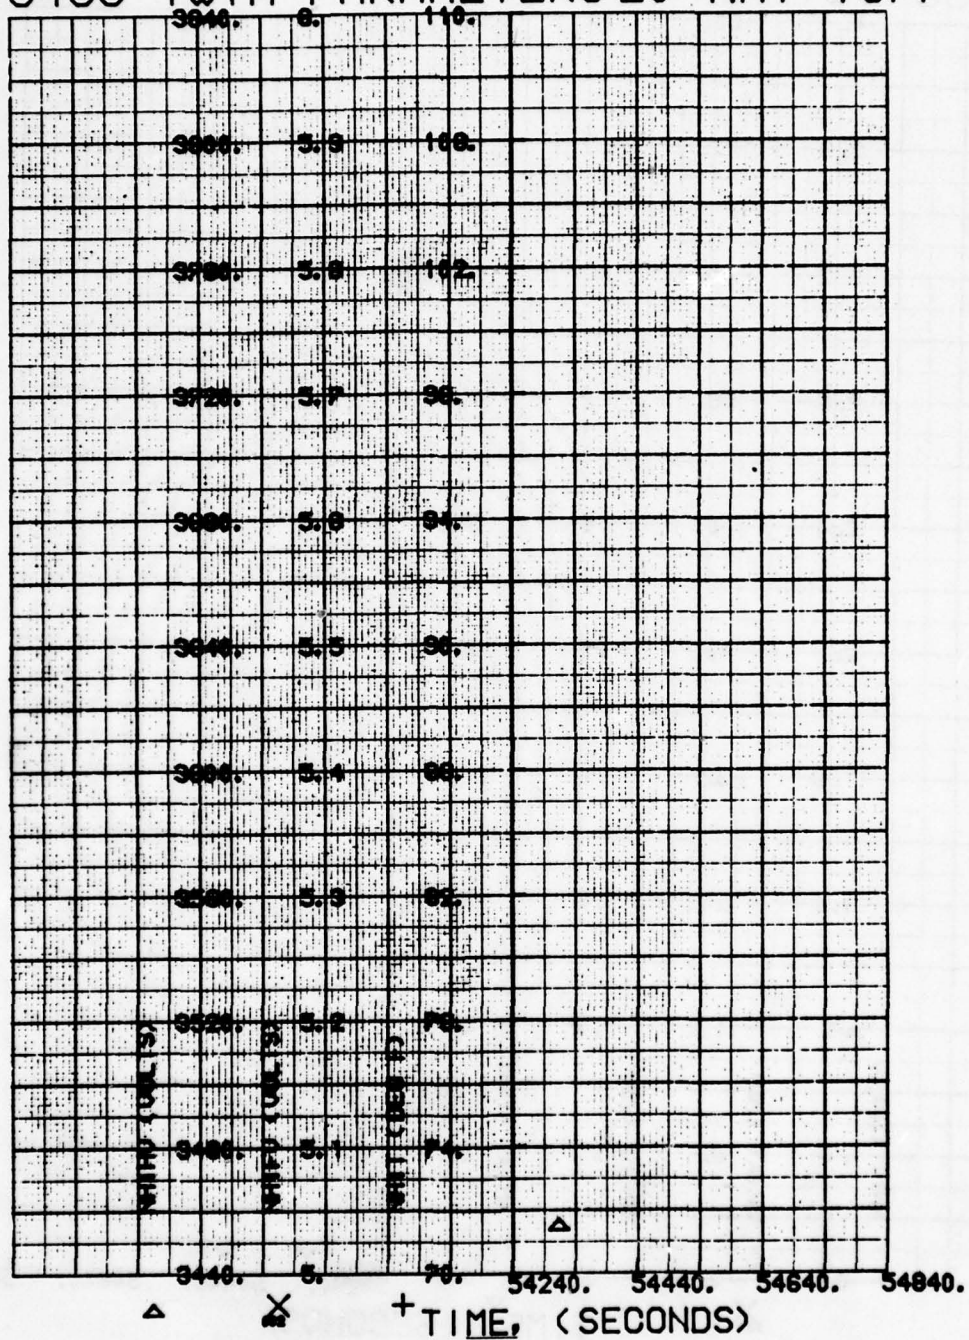
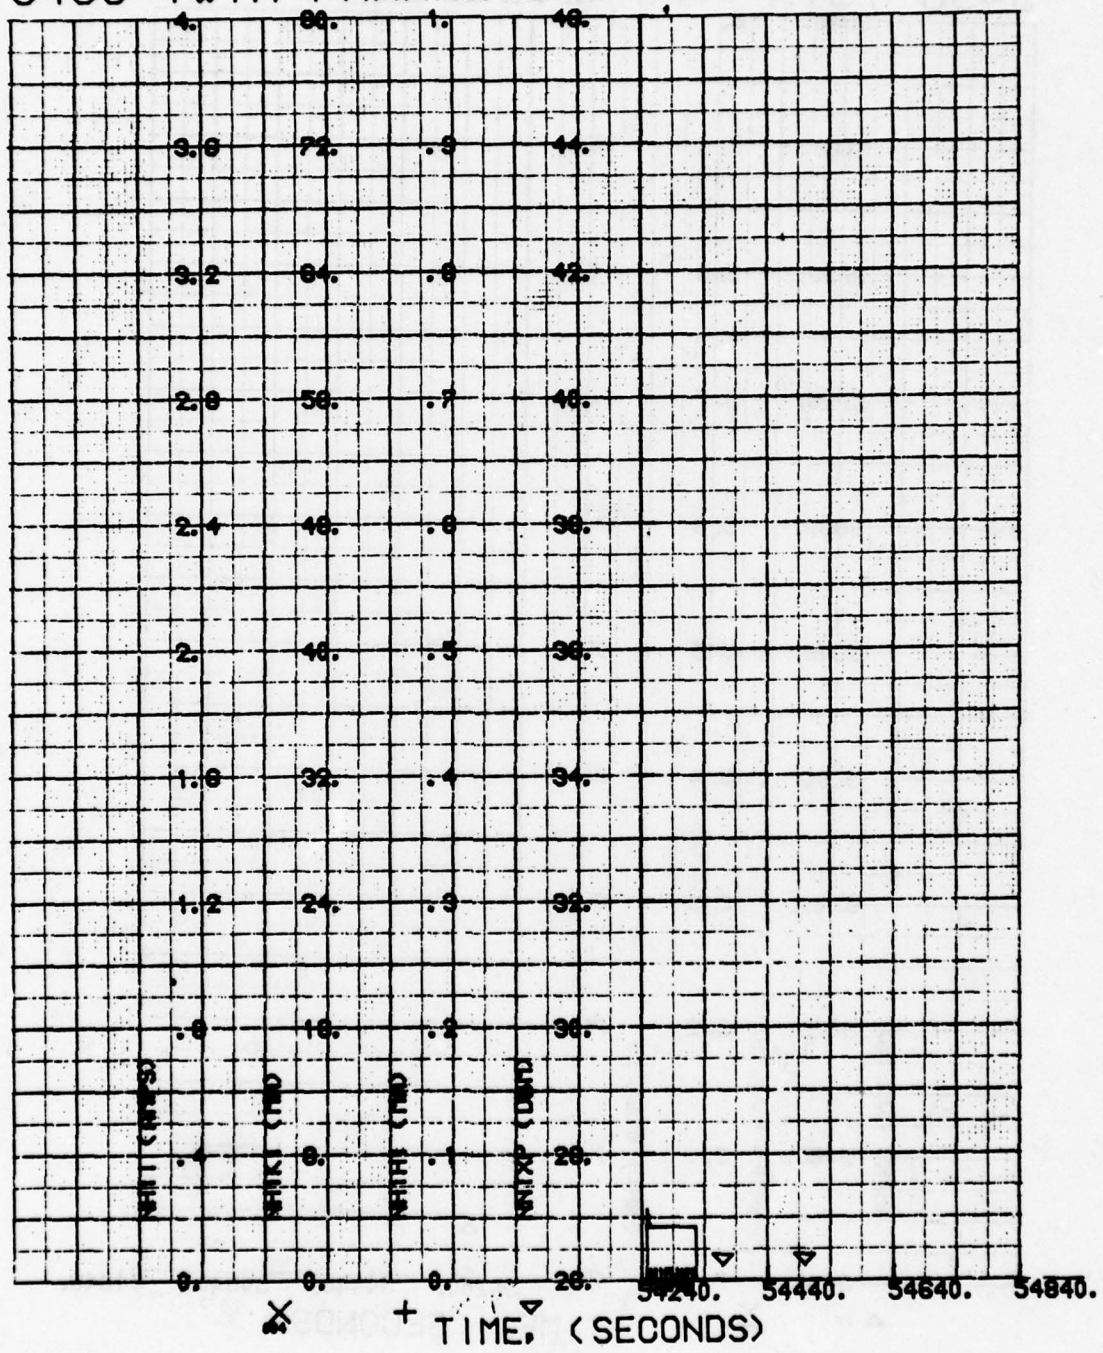
Figure 3.1-2. F8 HLTWA-1 Parameters at First Turn On Attempt Show Nominal Operation Until the Instant of Application of High Voltage (The Amplifier Shutdown Immediately Thereafter)

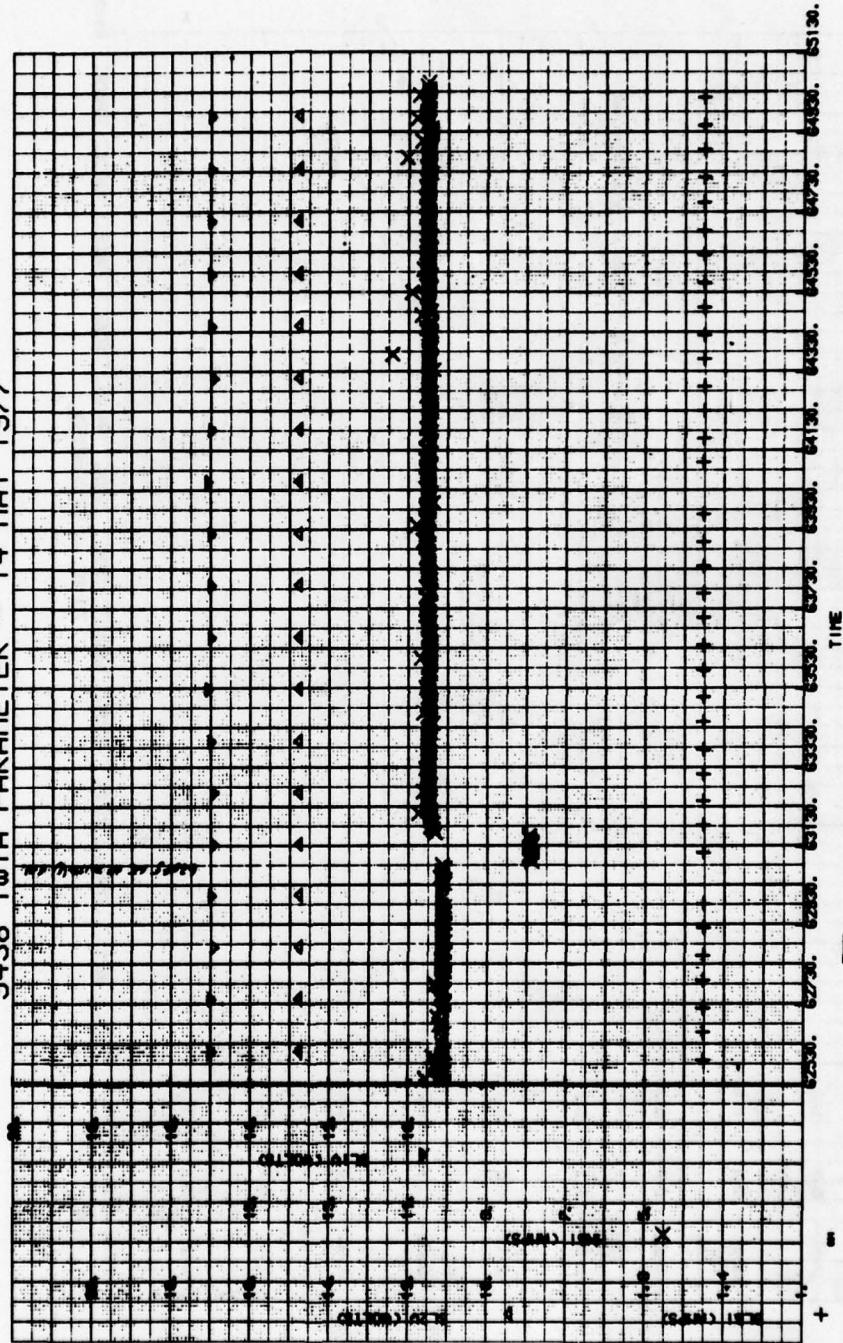
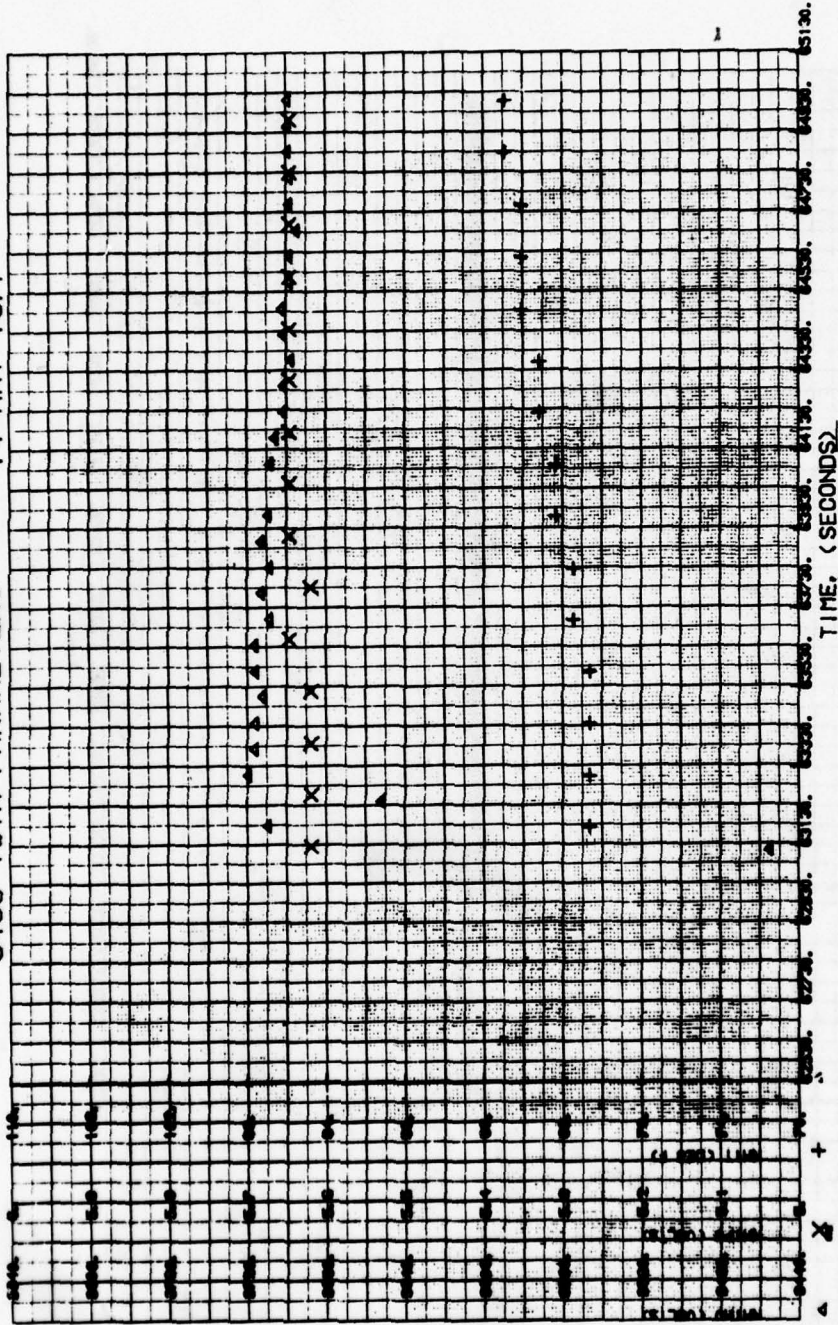
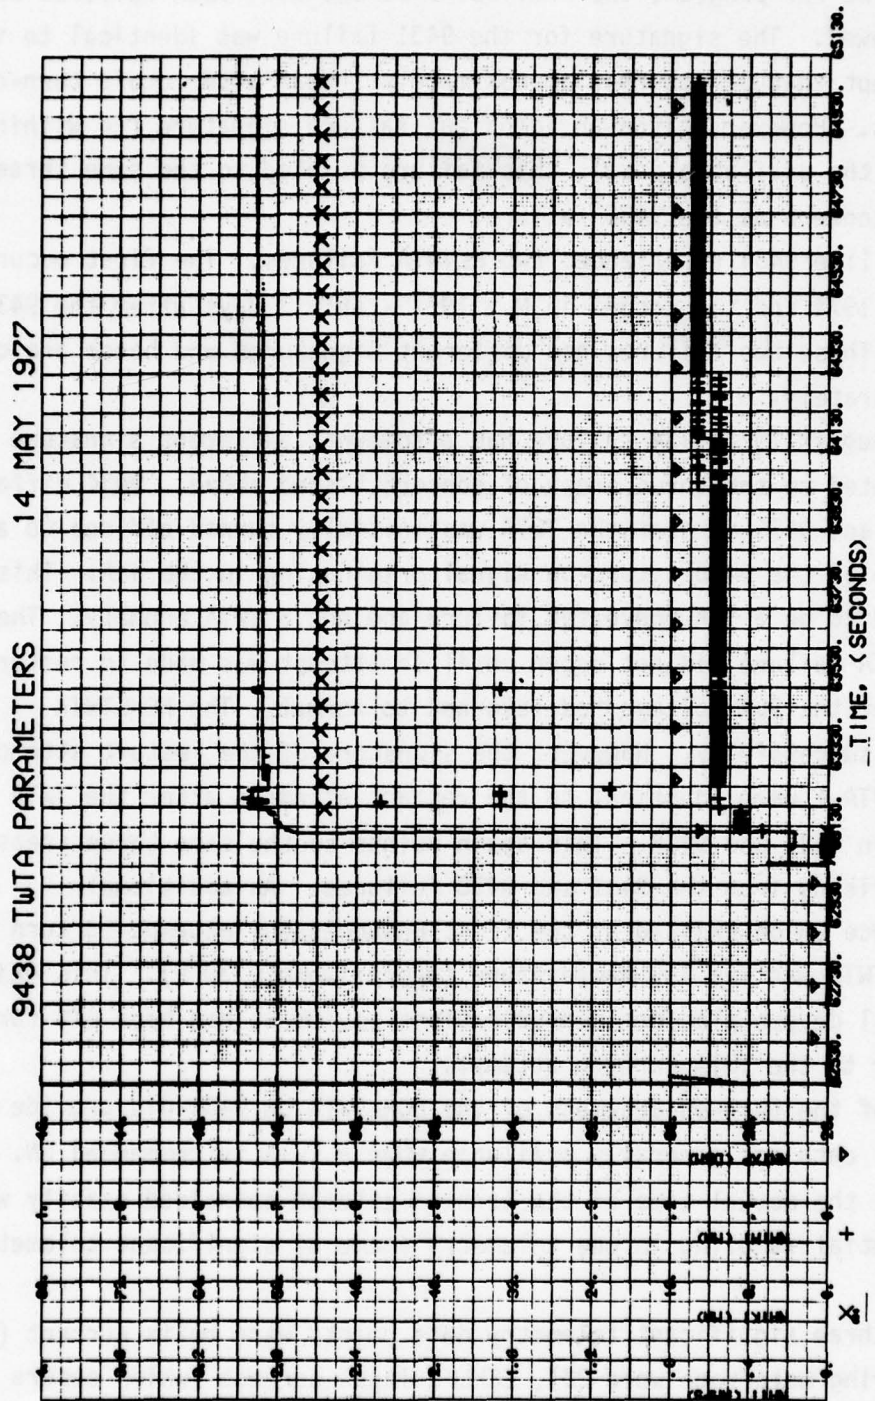
Figure 3.1-3. F8 HL TWTA-1 Initial Orbit Turn On Data Shows Nominal Operation of High Voltage Timer Followed by Successful Application of High Voltages to TWT

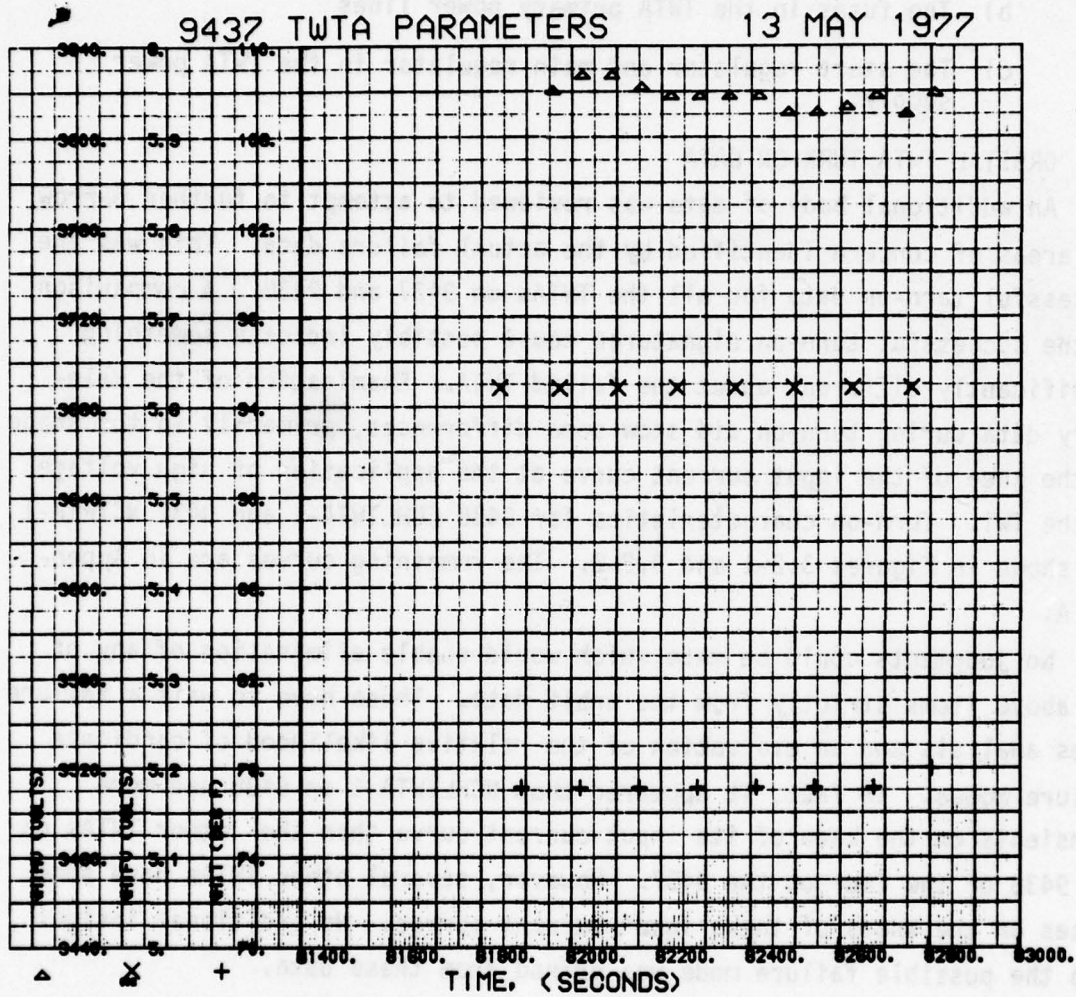
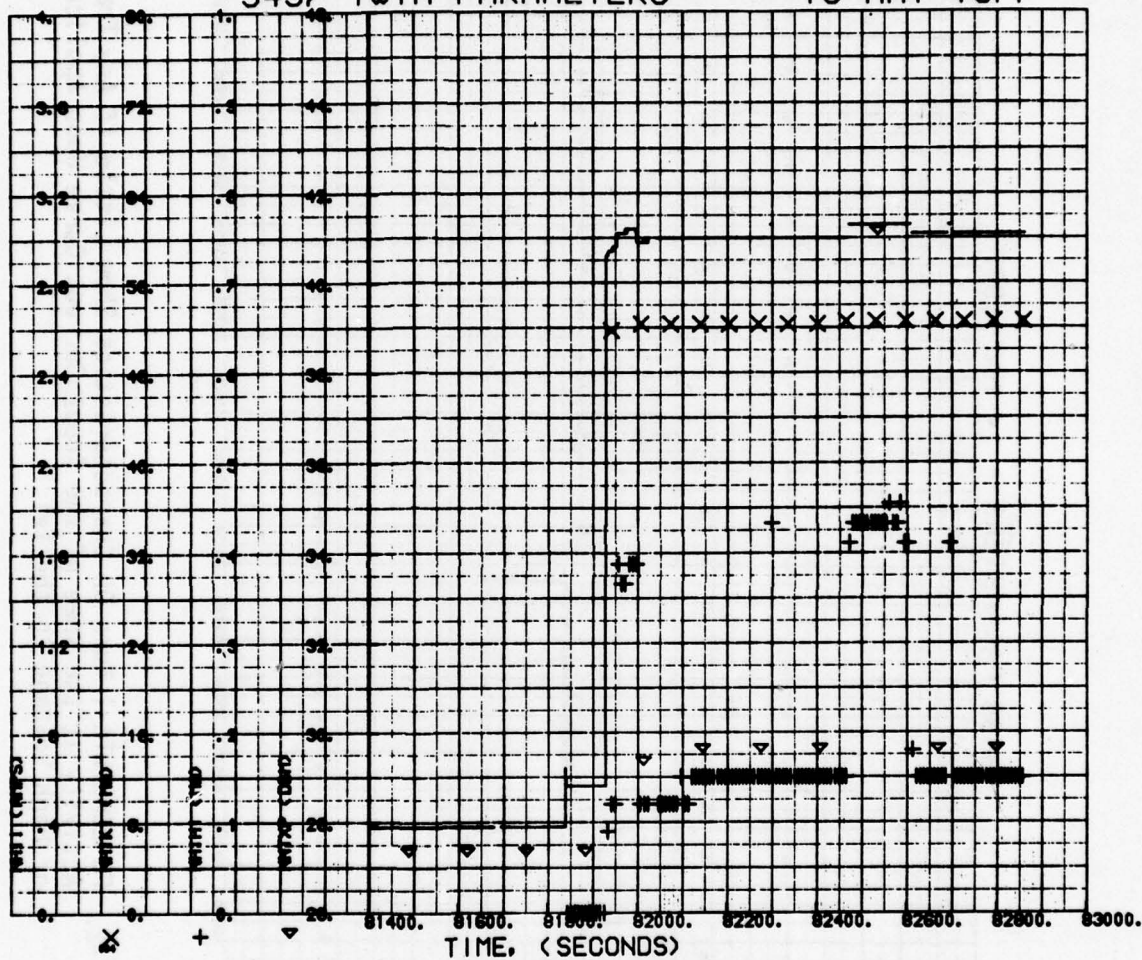
Although the 9438 TWTAs failure appeared to occur without warning, there were transients on the input current at application of high voltage in orbit, which was not what would be normally expected. Therefore, a study was performed of the ground test data for all eight HLTWTAs in payload 4 (9437 and 9438 satellites) to see if there was an historical difference in this characteristic for the failed TWTAs. This study included review of all steady-state operating data as well as ground test turn-on data.

Figure 3.2-1. F7 NCHLTWTA-1 Turn On Characteristics Show Some Input Current Transients Upon Application of High Voltage

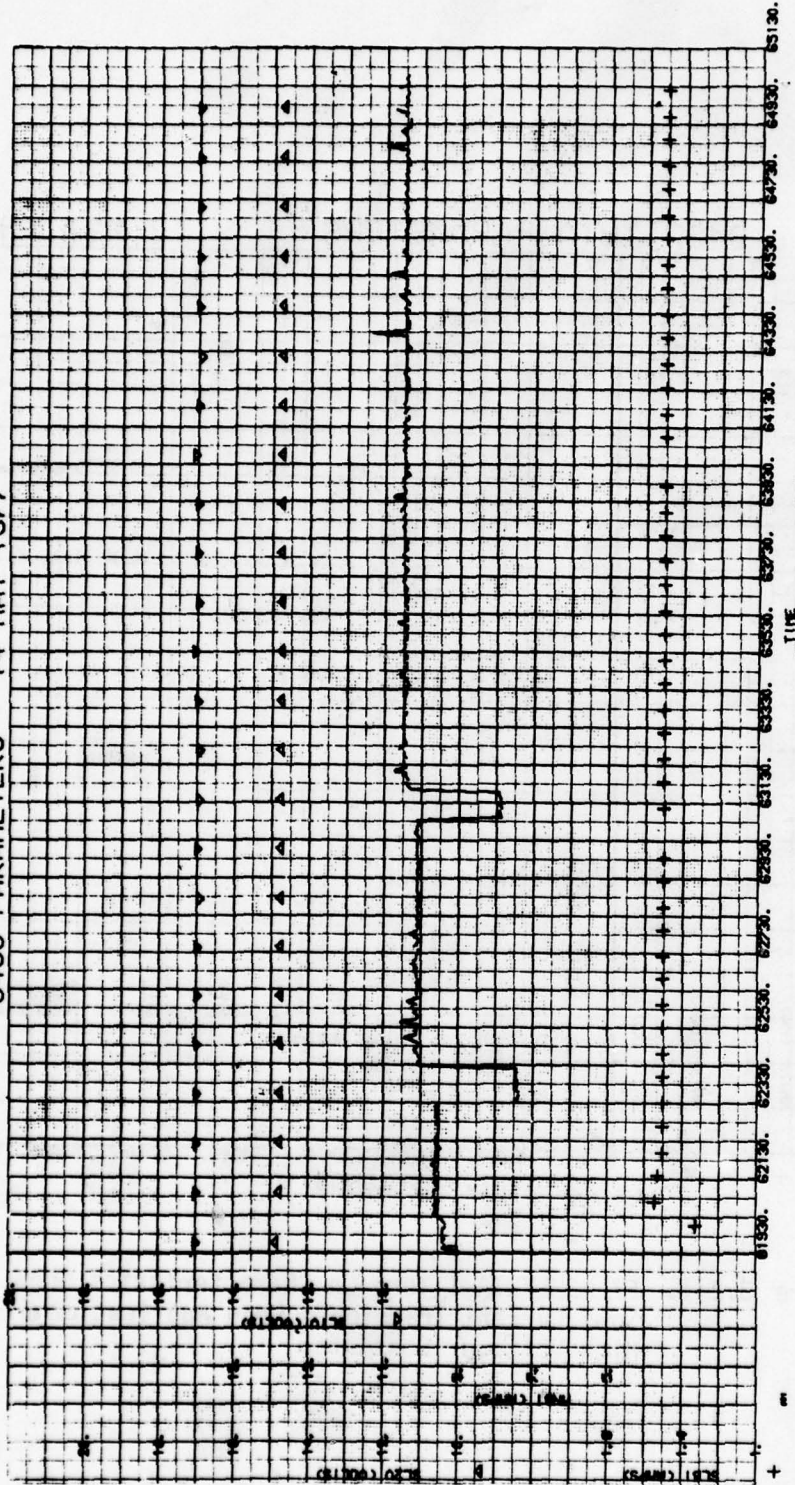
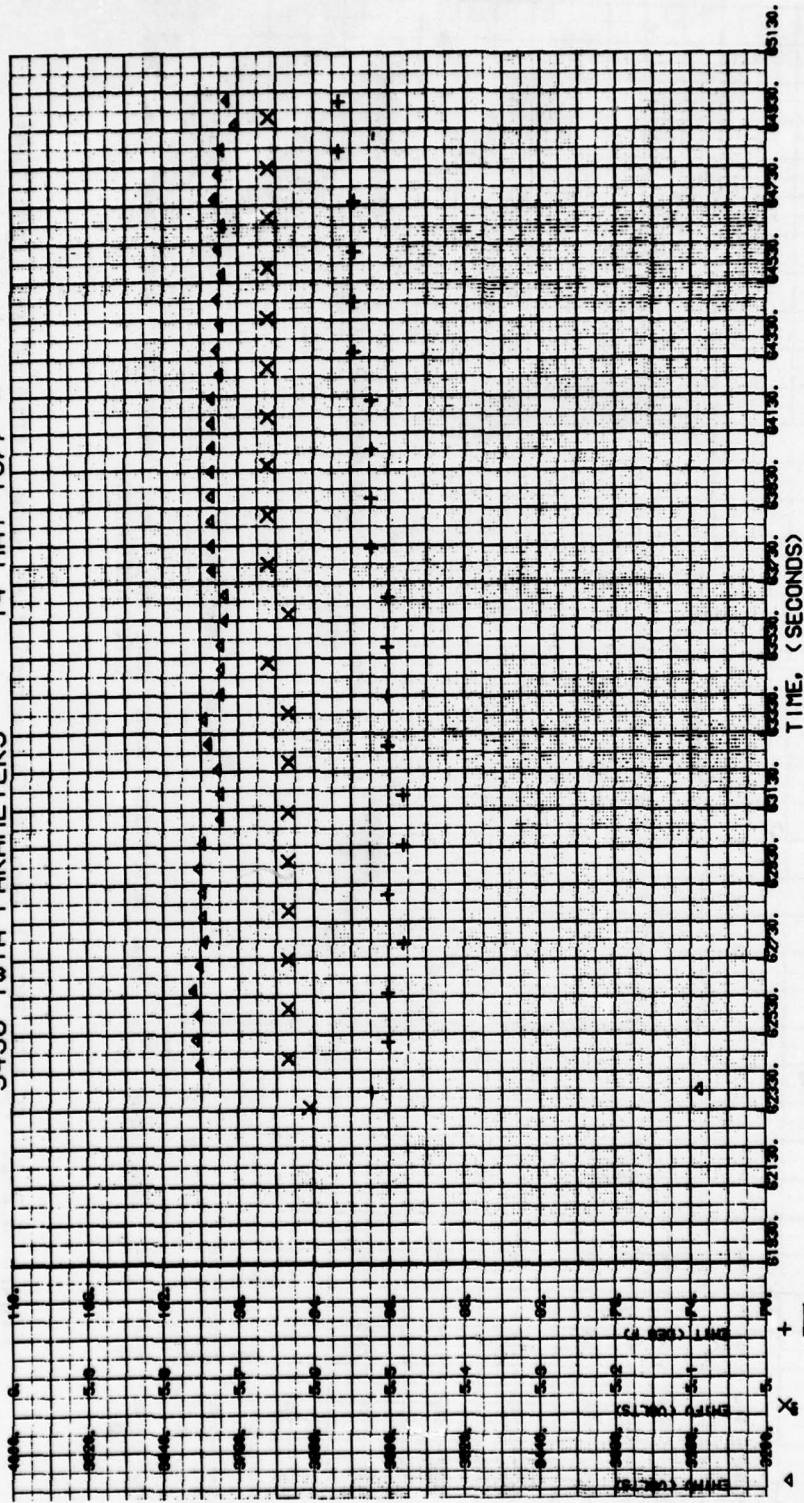
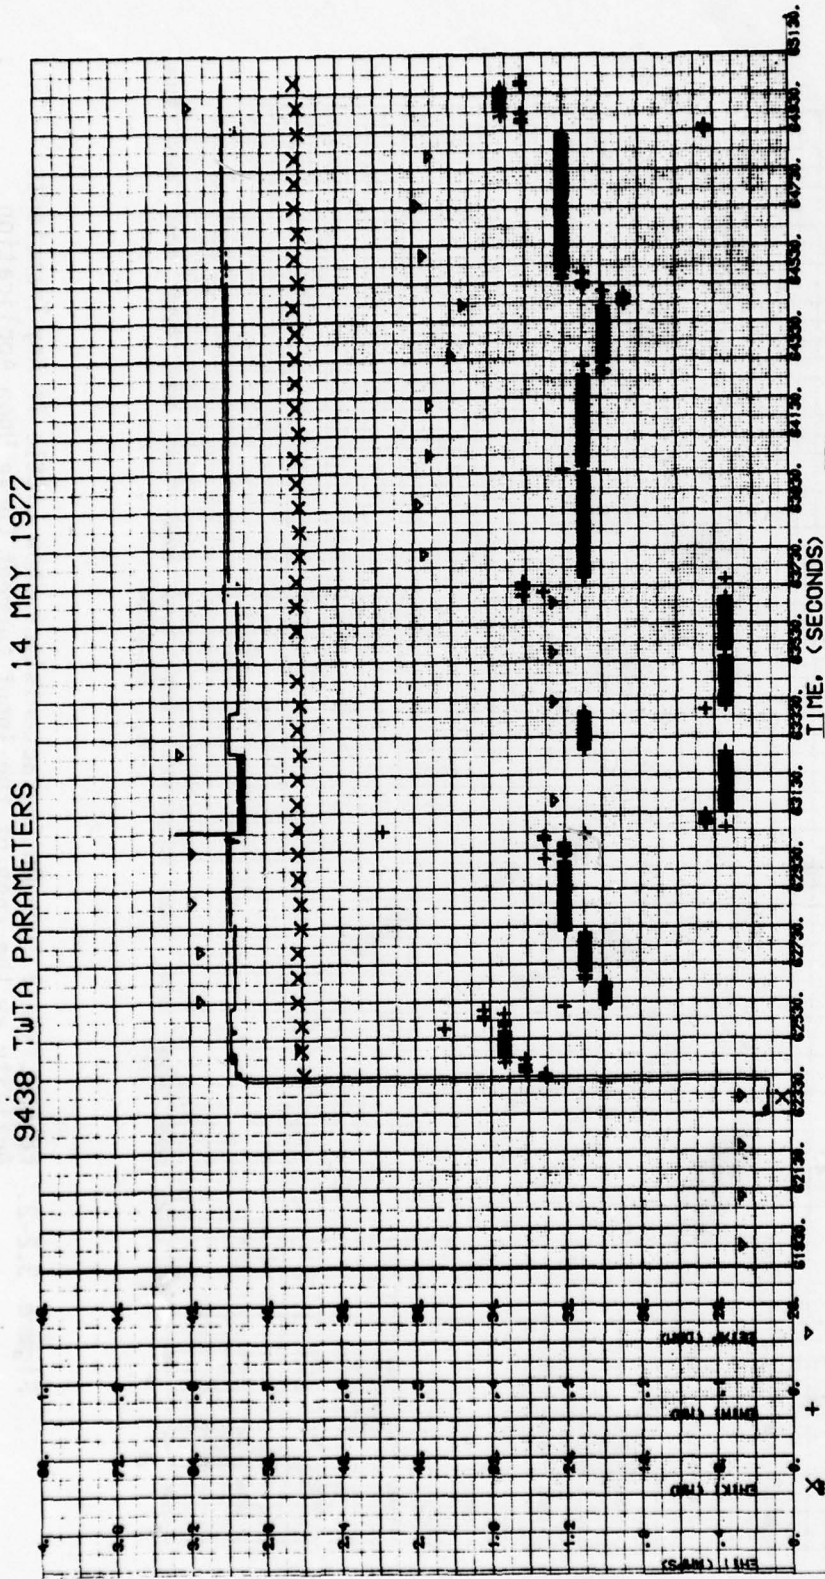
Figure 3.2-2. F8 ECHLTMTA-1 Turn On Characteristics Show Little if Any Transients Activity at the Knee of the Input Current Curve Upon Application of High Voltage to the TWT

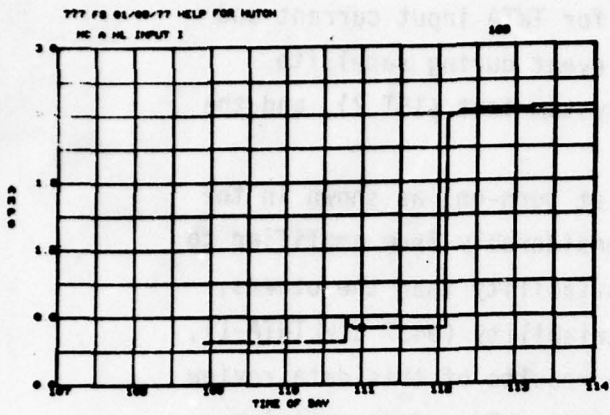
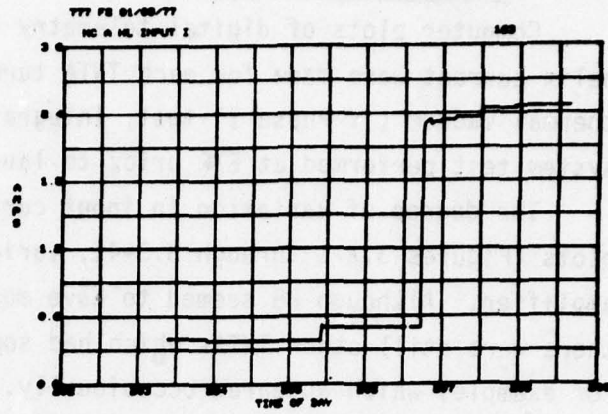
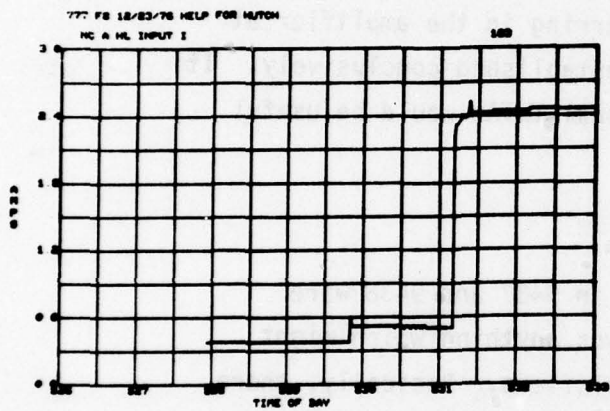
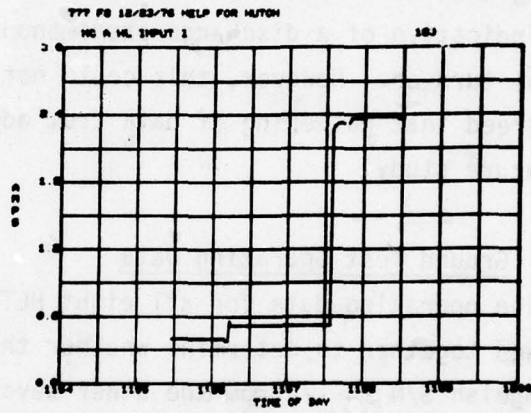
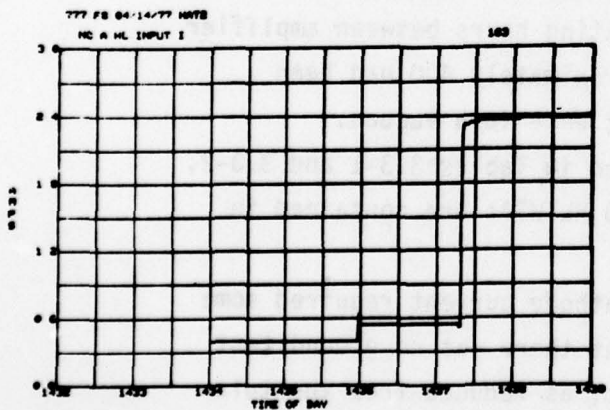
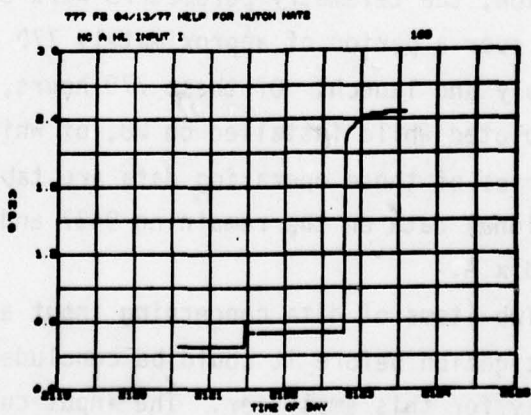
Figure 3.3-1. F8 NCHLTWTA-1 Input Current Turn On Characteristics Show Intermittent Transient Activity During Some Turn On Events

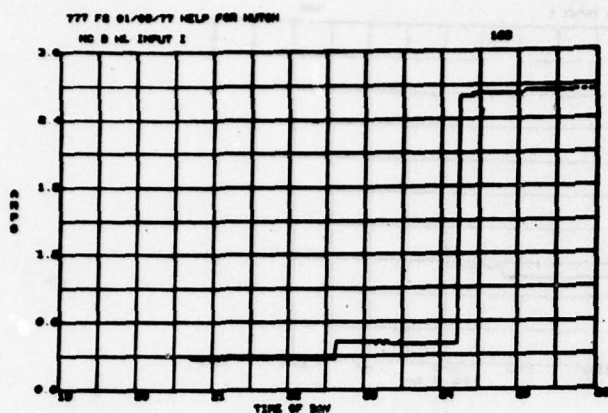
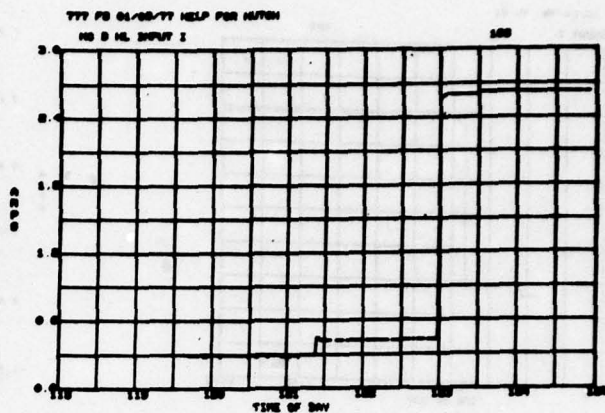
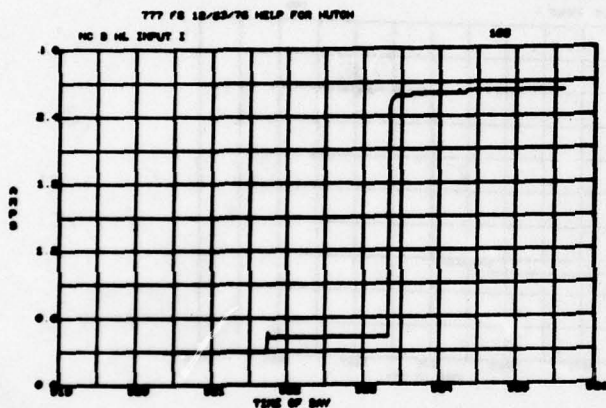
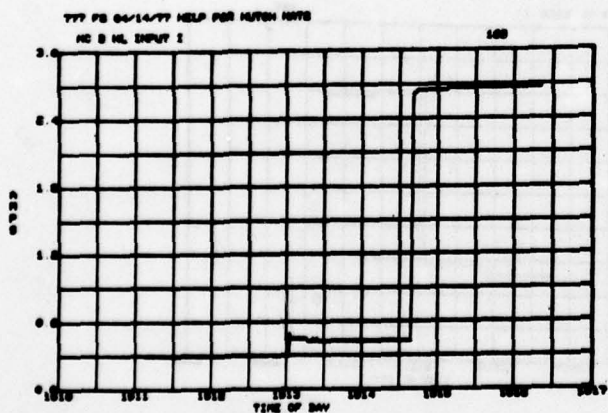
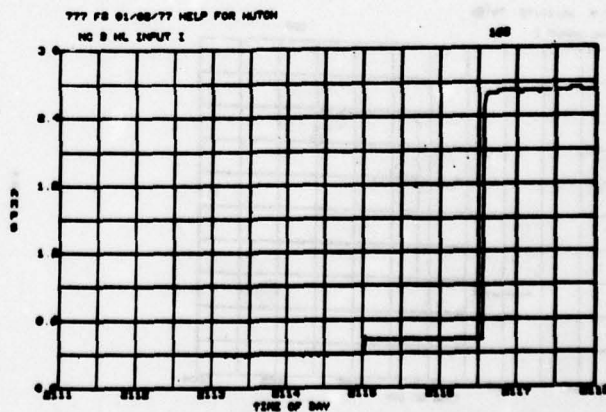
Figure 3.3-2. F8 NCHLTWA-2 Input Current Turn On Characteristics Show Little Variation Between Successive Test Startups

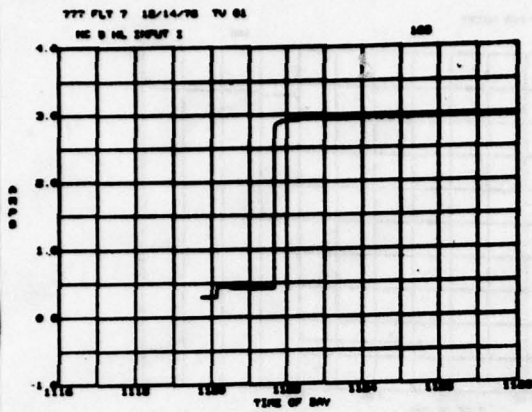
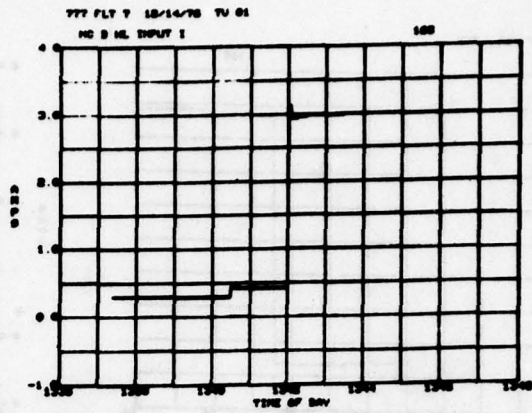
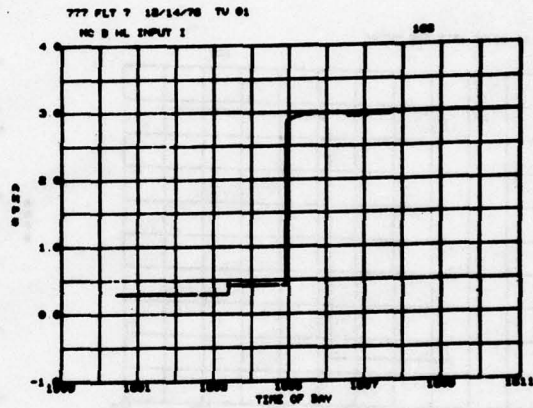
Figure 3.3-3. F7 NCHLTWTA-2 Input Current Characteristics Show Some Variation in Transient Content Between Successive Starts

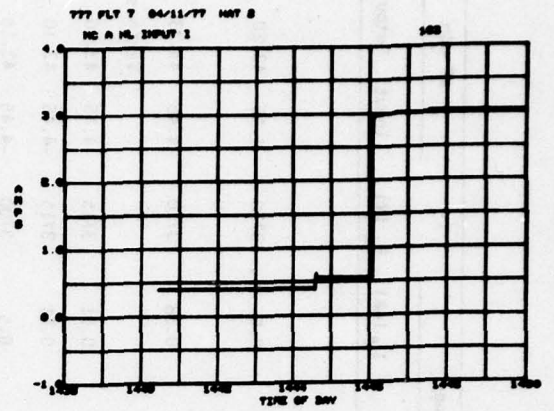
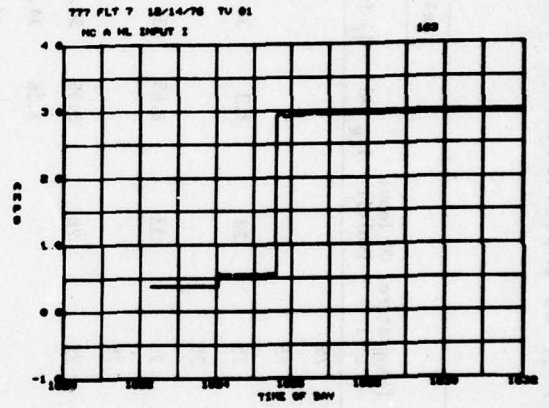
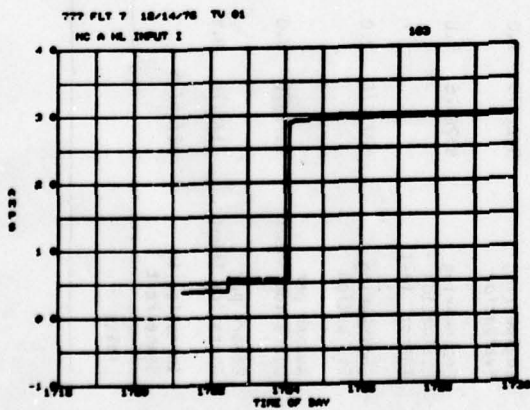
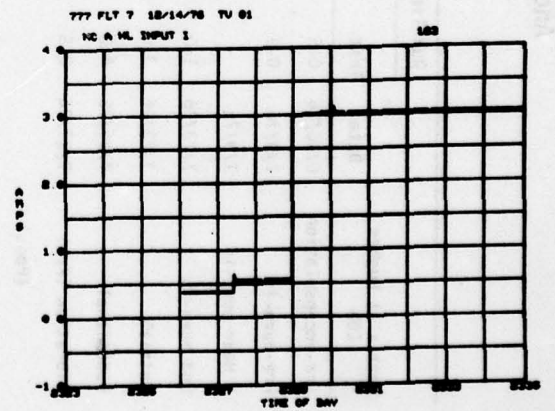
Figure 3.3-4. F7 NCHLTWTA-1 Input Current Characteristics Show Little Variation Between Successive Starts

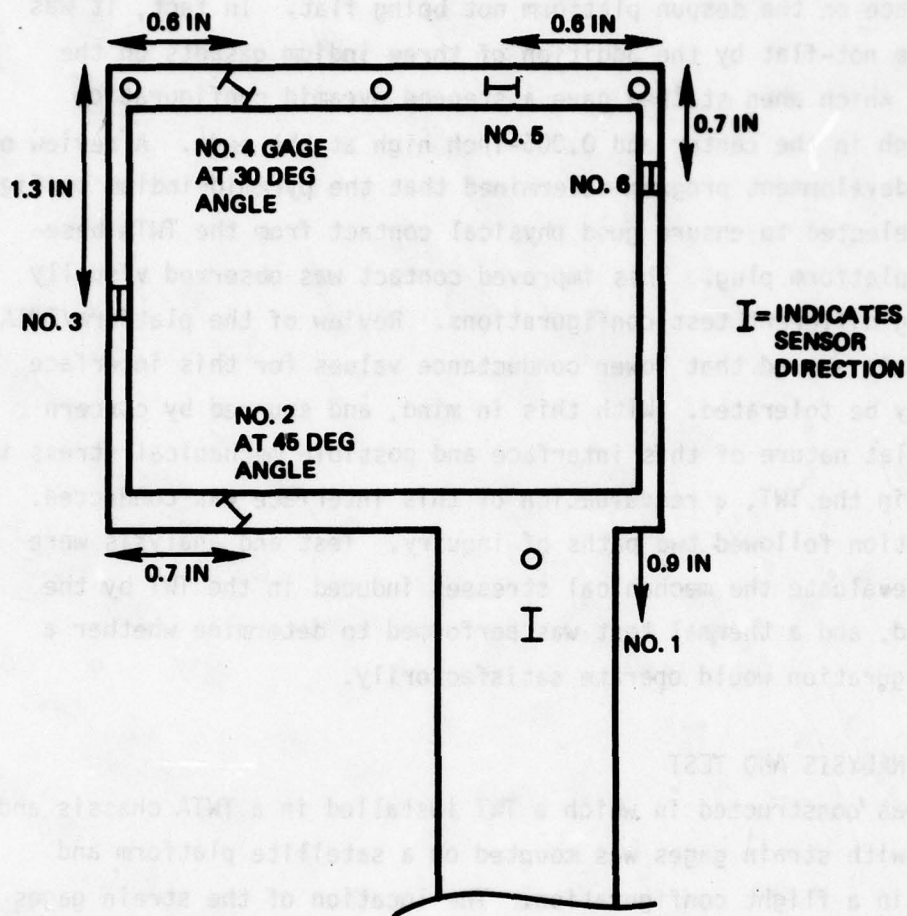
Figure 9.1-1. Strain Gage Locations were Selected to Obtain Data From Which the Mechanical Stress in the TWT Collector Assembly Could be Calculated
