9438 HIGH LEVEL TRAVELING WAVE TUBE AMPLIFIER ANOMALY. VOLUME I--ETC(U)

FINAL REPORT
9438 HIGH LEVEL TRAVELING
WAVE TUBE AMPLIFIER ANOMALY

VOLUME I

Prepared by
J. A. Durschinger
TRW, Inc.
TRW Defense and Space Systems Group
One Space Park
Redondo Beach, CA 90278

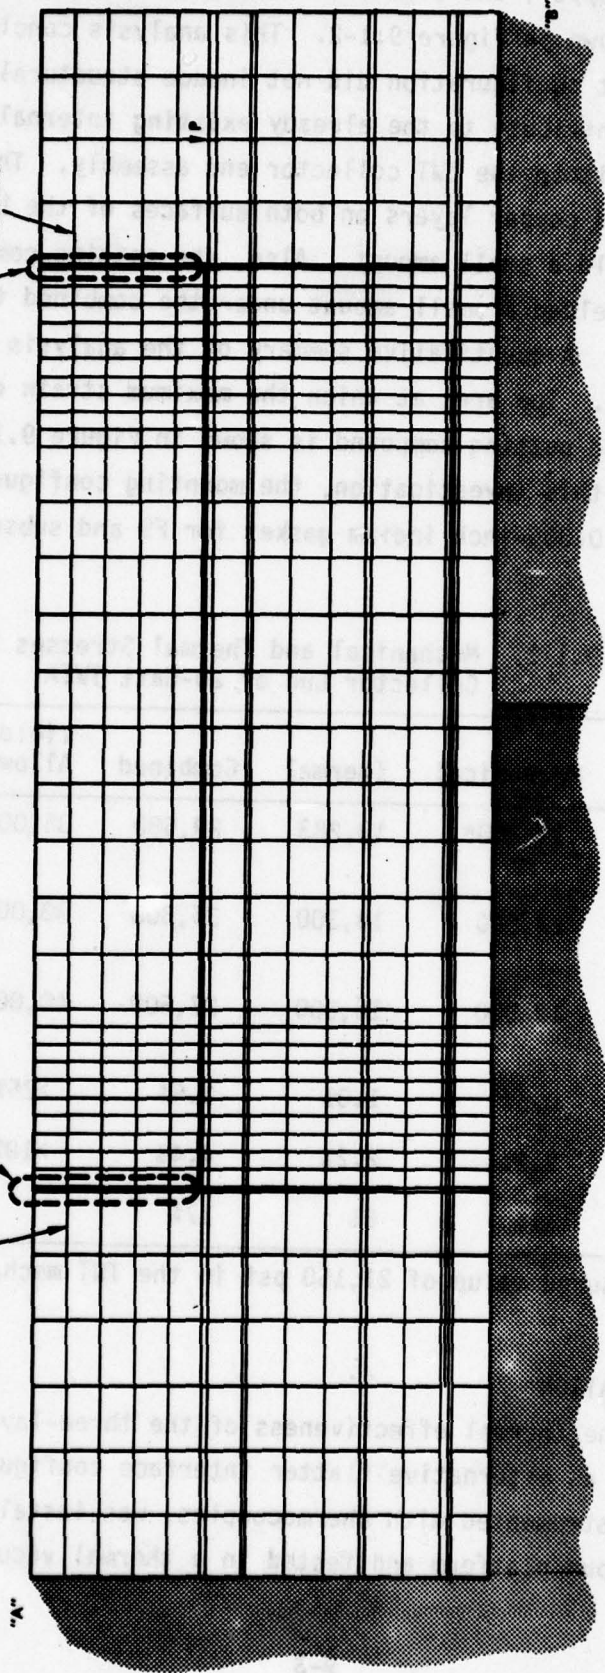
solder, beryllium, copper, and aluminum. A schematic representation of the computer model is shown in Figure 9.1-2. This analysis concluded that the stepped indium gasket configuration did not induce structural failure of the TWT. It did contribute to the already existing internal thermal stress and strains within the TWT collector end assembly. The analysis showed the solder and copper layers on both surfaces of the beryllium insulation would yield a small amount. Also, the potting compound and conformal coating yielded a small amount under the combined thermal and mechanical stresses. A quantitative summary of the analysis results are given in Table 9.1-1. The area at which the maximum strain exists in the conformal coating and potting compound is shown in Figure 9.1-2. It should be noted that after this investigation, the mounting configuration has been changed to a single 0.005-inch indium gasket for F9 and subsequent satellites.

Figure 9.1-2. The Stress Analysis Model of the Collector Assembly of the TWT Assumes the Mechanical Forces due to Mounting on the Sockets is Applied at Point P. The Model Further Assumes a Rigid Mounting Surface at Rigs A & B

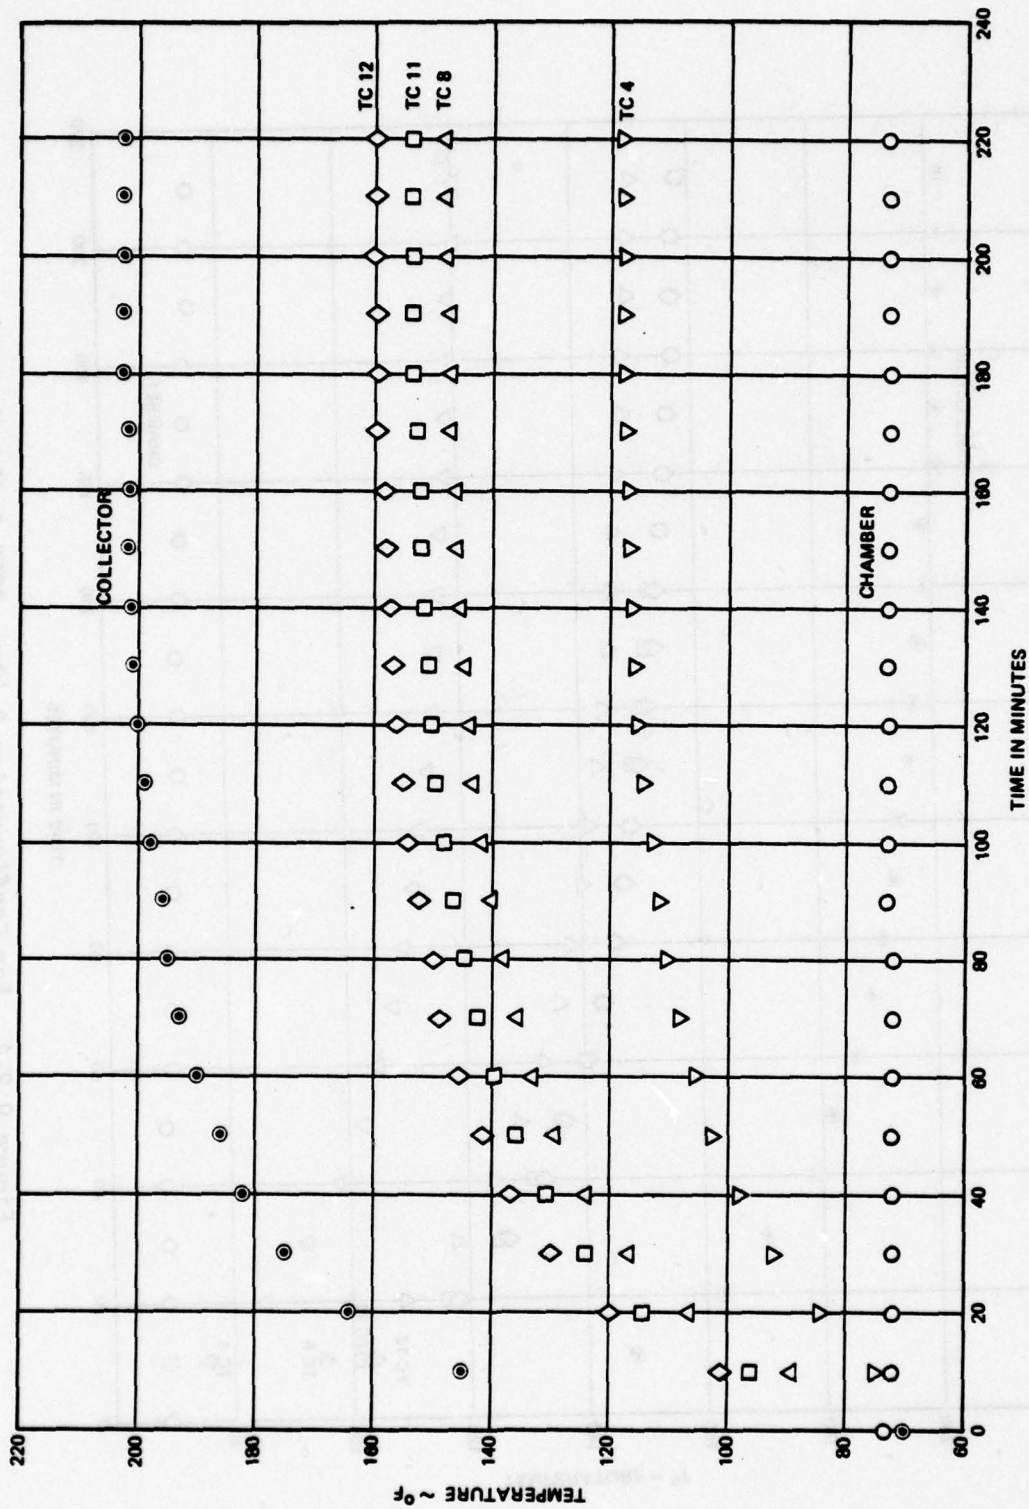
Test configuration three was the then existing flight configuration. As shown in Figure 9.2-3, the maximum collector temperature was 203°F. The platform reference temperature corresponding to a flight telemetry measurement was 113°F. It was determined from these tests that a single 0.005-inch indium gasket configuration (Configuration No. 2), where only three screws (P1, P3 and P4 in Figure 9.2-1) were installed through the platform plug into the TWT baseplate, would provide an equally good thermal interface for the TWT. This configuration was subsequently chosen for use on F9 through F12 (the remaining satellites using the 20-watt TWT). As shown in Figure 9.2-4, the maximum collector temperature was 201°F. A more detailed test report is included in Appendix D.

Figure 9.2-3. For the Reference Configuration (No. 3) the Maximum TWTA Collector Temperature was 230°F at a Chamber Temperature of 74°F

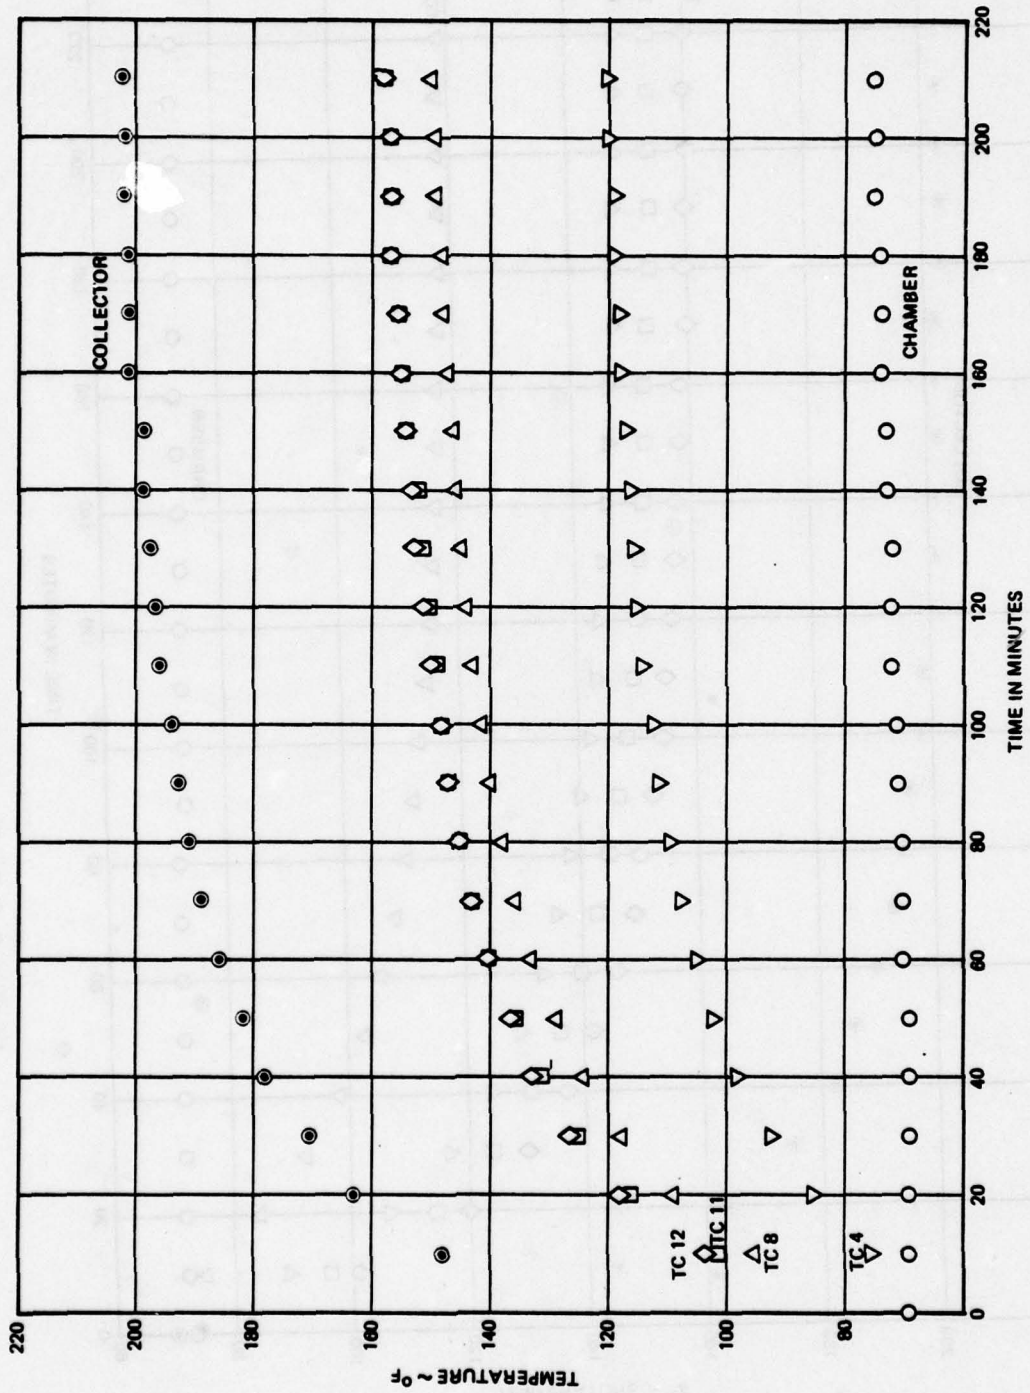
Figure 9.2-4. For Configuration 2 (One .005" Indium Gasket).
 The Maximum TMTA Collector Temperature was
 201°F at a Chamber Temperature of 74°F.
