CEEDO-TR-78-40

Premature Failure of Deep Well Anodes

THOMAS F LEWICKI

JUNE 1978

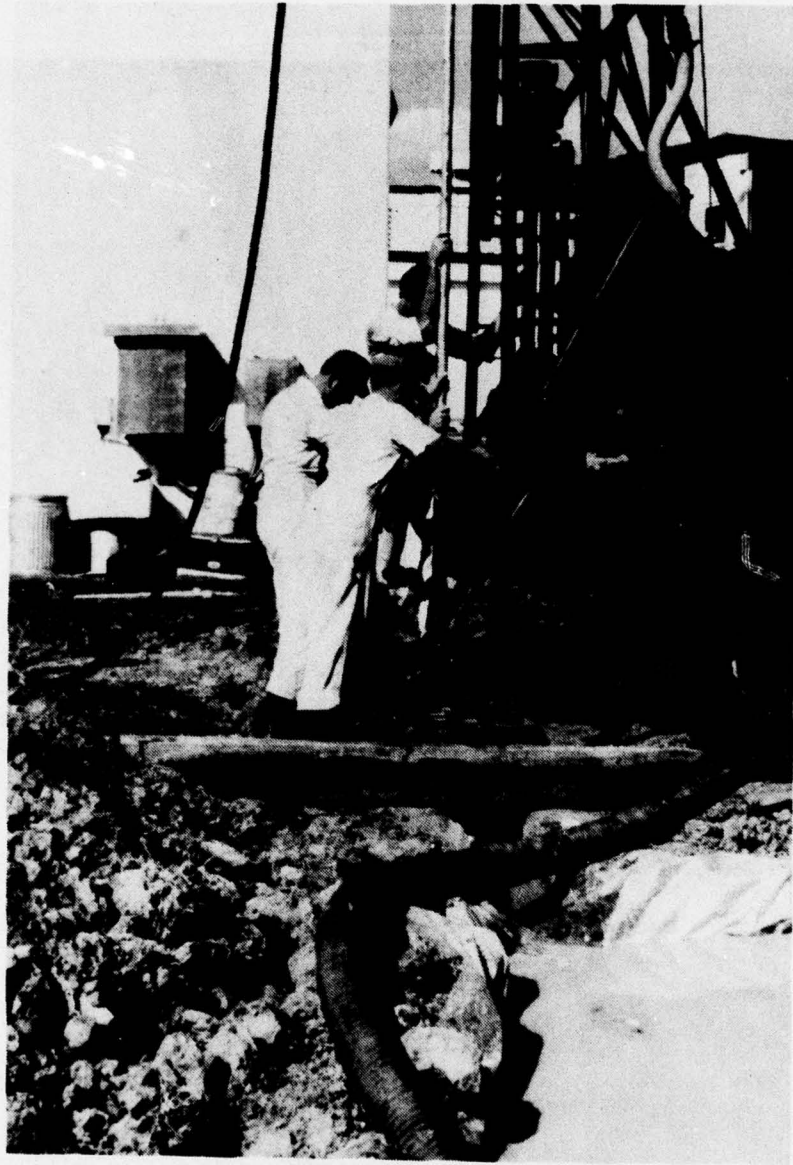
Figure 1. Fluidizing Clay in the Well

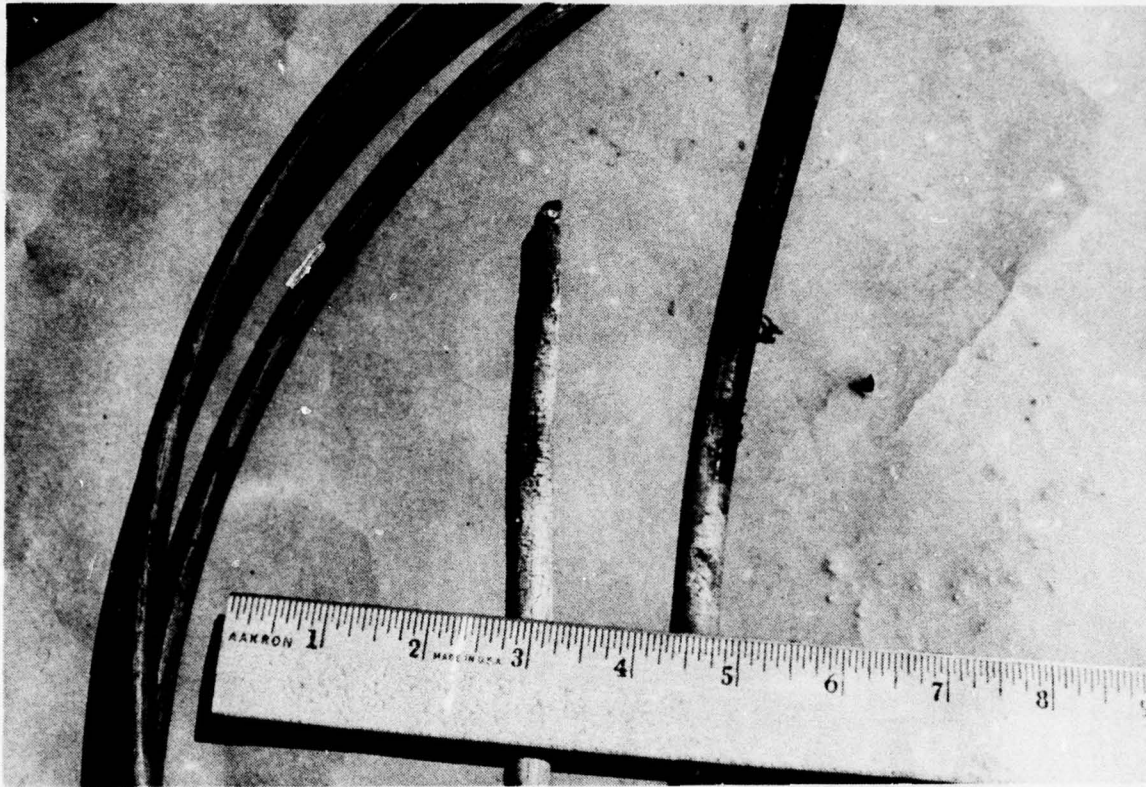
A military team from the field activities branch of the Civil Engineering Center arrived at Barksdale AFB LA on 16 June 1976 for the purpose of retrieving failed anodes and lead wire from a 250 foot deep well. The well contained 12 anodes spaced as shown in Table 1. The three foot diameter steel plate welded to a short piece of 8" casing that served as the well cap was removed. No gravel was found in the top of the well. Eight feet below ground level the well was filled with what appeared to be the original red clay. The clay in the well was fluidized by pumping drilling mud down the hole through 1-1/2 inch pipe fitted with a special point. The point had two holes drilled into it at a 45° angle so as to make the high pressure drilling mud effective in fluidizing and enlarging the backfilled hole. Working the 1-1/2 inch mud pipe into the hole went fairly easily. A total of 147 feet was fluidized during the first day (See Figure 1). Progress through the coke breeze was much slower. The mud viscosity was 48. At the end of the second day of work, the bottom of the well was reached (251 ft). We tried pulling the anode lead wires as a bundle and individually but none of the anodes would move. During the third and fourth days, we pumped mud at high pressure (400 to 500 PSI) while working the 1-1/2 inch mud pipe up and down the well. We also introduced blasts of air from a large compressor (115 PSI) down the hole through the mud pipe. Finally, with nothing left to do, we pulled the wires. All wires broke at various depths. Wire No. 1 broke 15 feet from the surface. Examination showed that the insulation had been damaged and the copper conductor had corroded in two. Wire No. 3 had been burned by the torch of the welder who cut open the well cover. Several of the wires had been damaged by the 1-1-1/2 inch mud pipe. The length of wire No. 4 retrieved was 216 ft. This means that it separated near the top of anode No. 4. The bottom end of this wire showed complete deterioration of the high molecular weight polyethylene insulation. The insulation turned white in certain areas, cracked and necked down until the copper was exposed and corroded to failure (Figure No. 2). Figure 3 shows the deteriorated insulation magnified by 10. It is obvious from the examination of the deteriorated insulation of Wire No. 4 that No. 4 anode failed because the copper conductor corroded in two after the insulation deteriorated. It is reasonable to assume that the other seven inoperative anodes failed either from mechanical damage to the lead wire insulation or from deteriorated insulation.

Figure 2. Deterioration of Insulation on Wire No. 4

1. Where chlorides are present, HALAR[®] insulated wire with a HMPE jacket for mechanical protection should be used in place of all HMPE insulation.

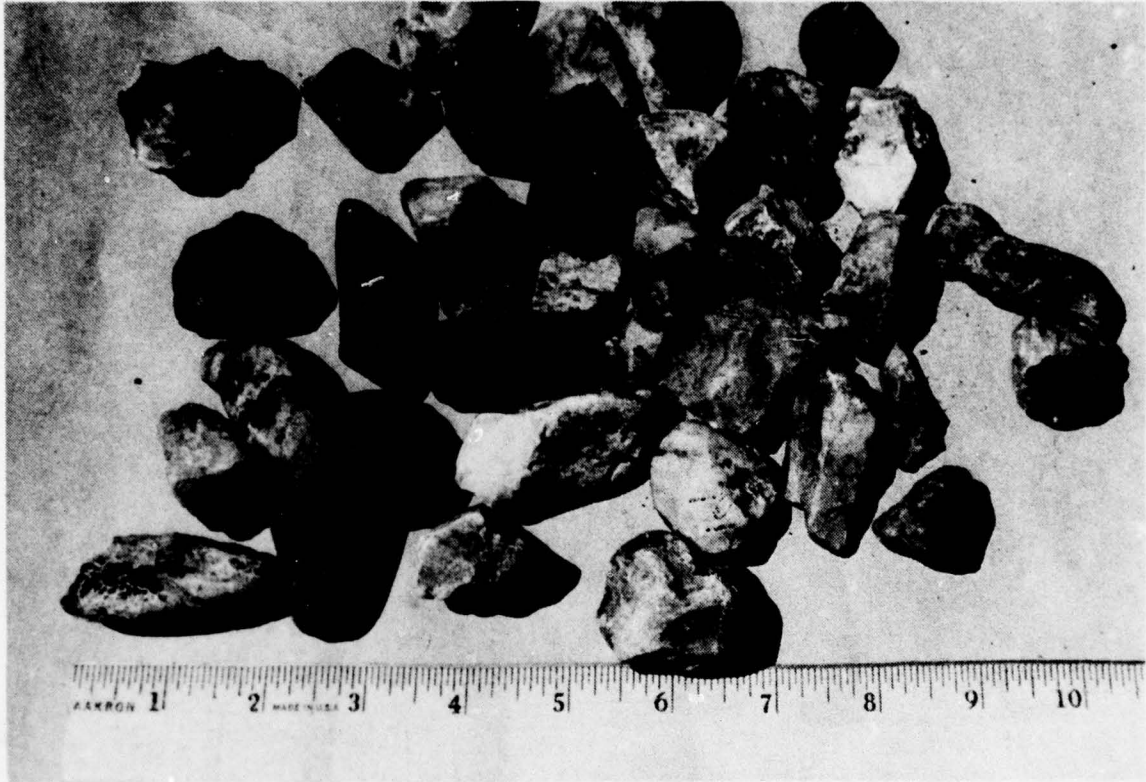
The well drilling machine was set up over the well and an effort was made to fluidize the backfill in the well similar to what was done at Barksdale AFB. Mud viscosity had to be increased above 500 in order to float out the large gravel. Pump pressure was raised as high as 500 to 550 psi. The entire column of 40 ft of large gravel was successfully removed by fluidizing with thick mud. Gravel as large as 2 inch diameter (Figure 4) was floated to the surface. After the fluidizing pipe reached the 80 ft level, 5 anodes were easily removed. Two of the five anodes had broken approximately 1/4 of the way from their bottom end (Figure 5); the other three anodes appeared to be in like new condition.

Figure 4. Large-diameter Gravel Floated Out of Well

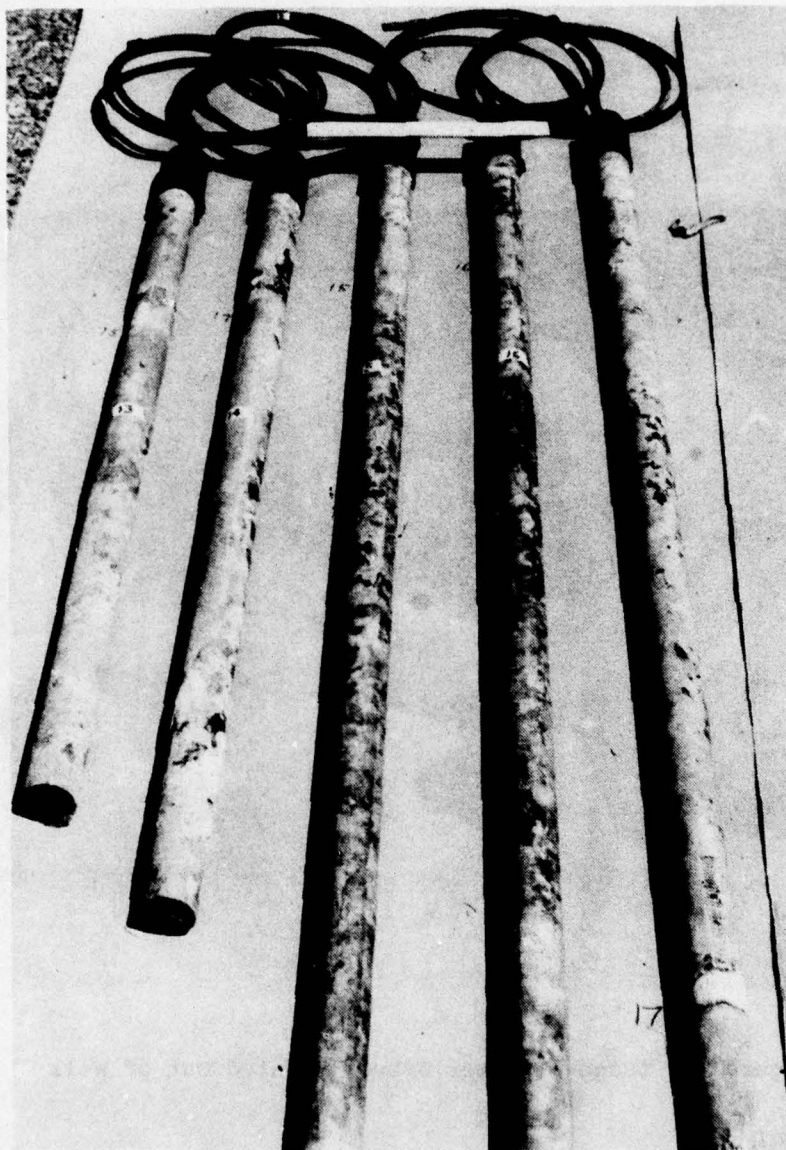
Figure 5. Anodes Taken From Well

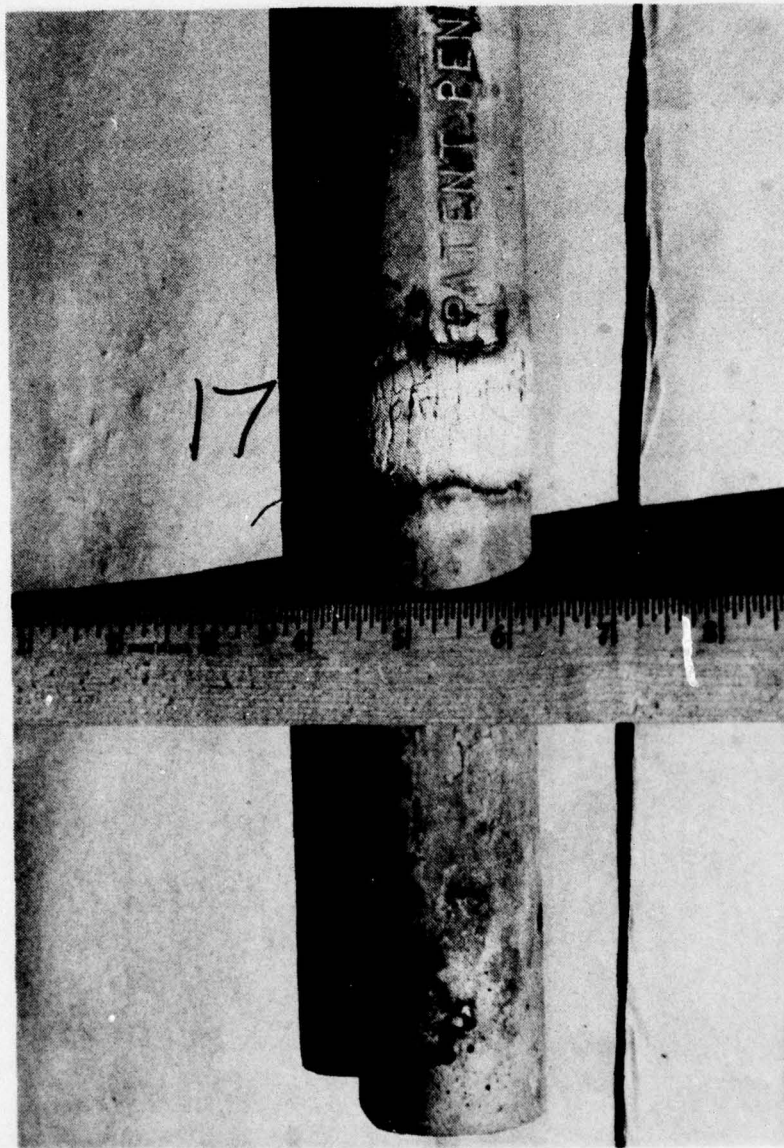
It has been suggested that the film of silica (SiO_2) that always develops on the outside of a HSCI anode can, under certain conditions, become a high resistance film. There was no evidence of this in this case. As soon as the anodes were extracted they were carefully examined. Visual examinations showed no visible oxide film. An electrical continuity test between the top end of the lead wire and the anode body showed almost zero resistance. When the anodes were placed in a water filled tub in the laboratory with a small voltage applied, current output was high, indicating low resistance between the anode and the water. Resistivity of the water in the lab test was 6800 ohm-cm whereas the resistivity of the water in the well at Little Rock is 6200 ohm-cm. It is the author's opinion that the only cause for such low current output was gas blockage between the anode and the coke breeze. Figures 6 and 7 show sections of the anodes where the worst corrosion damage occurred.

Figure 6. Corrosion Damage

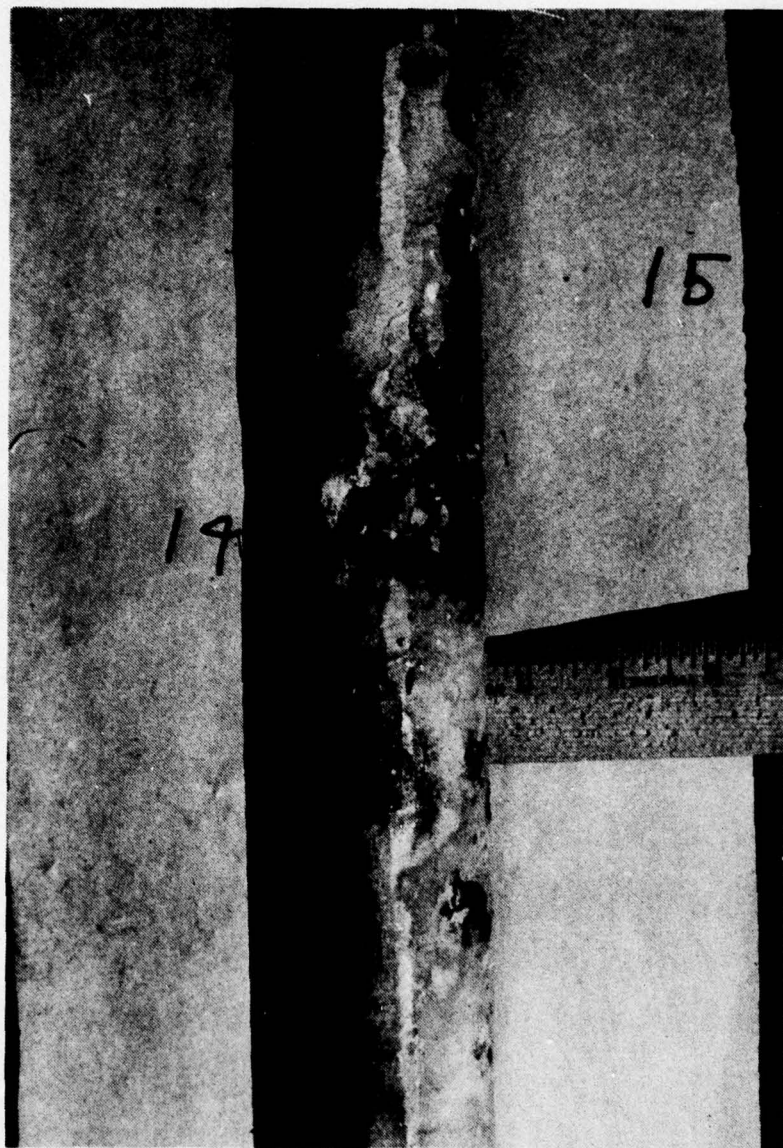
Figure 7. Worst Corrosion Damage Found at Little Rock AFB

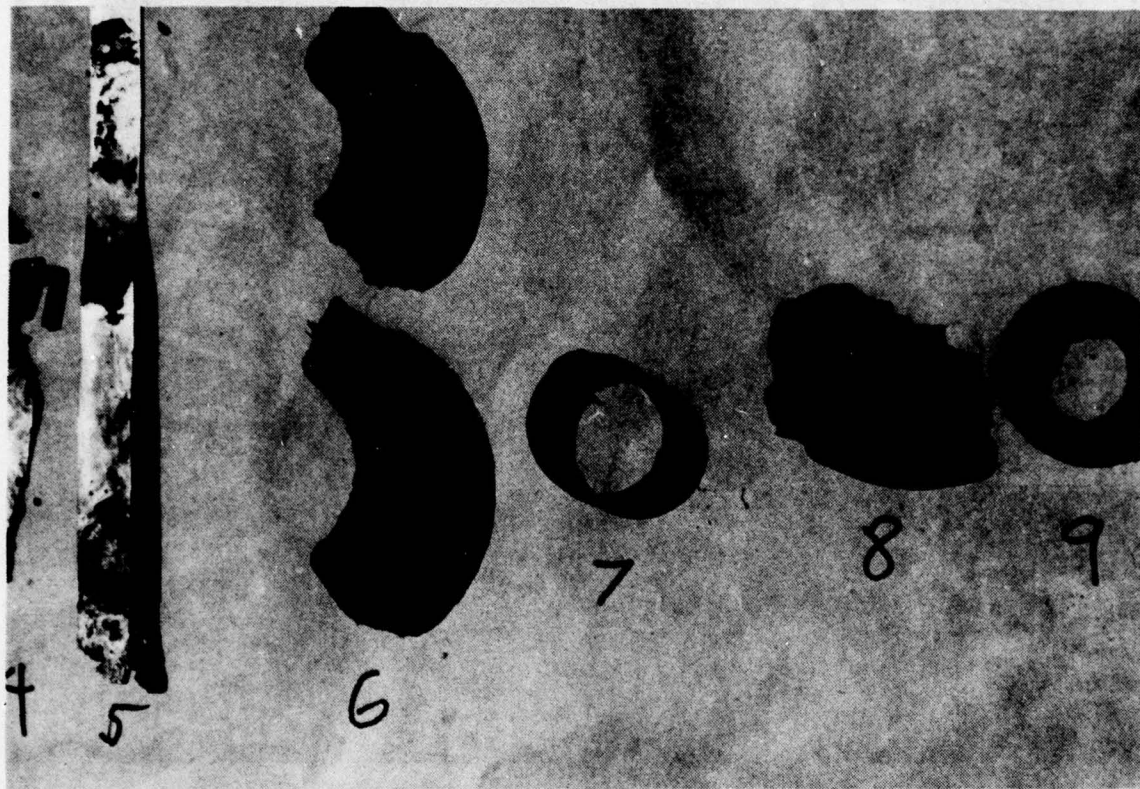
Figure 8. Items Retrieved From Anode Bed

a. In Figure 8 from left to right, stainless steel bands that held anodes to support pipe, wooden spacers that were placed around anodes, plastic insert from insulated union (7), parts of an insulated union with most of the steel corroded away (8 and 9). These parts were designed to hold the anodes only until the backfill was in place and their deterioration is to be expected.

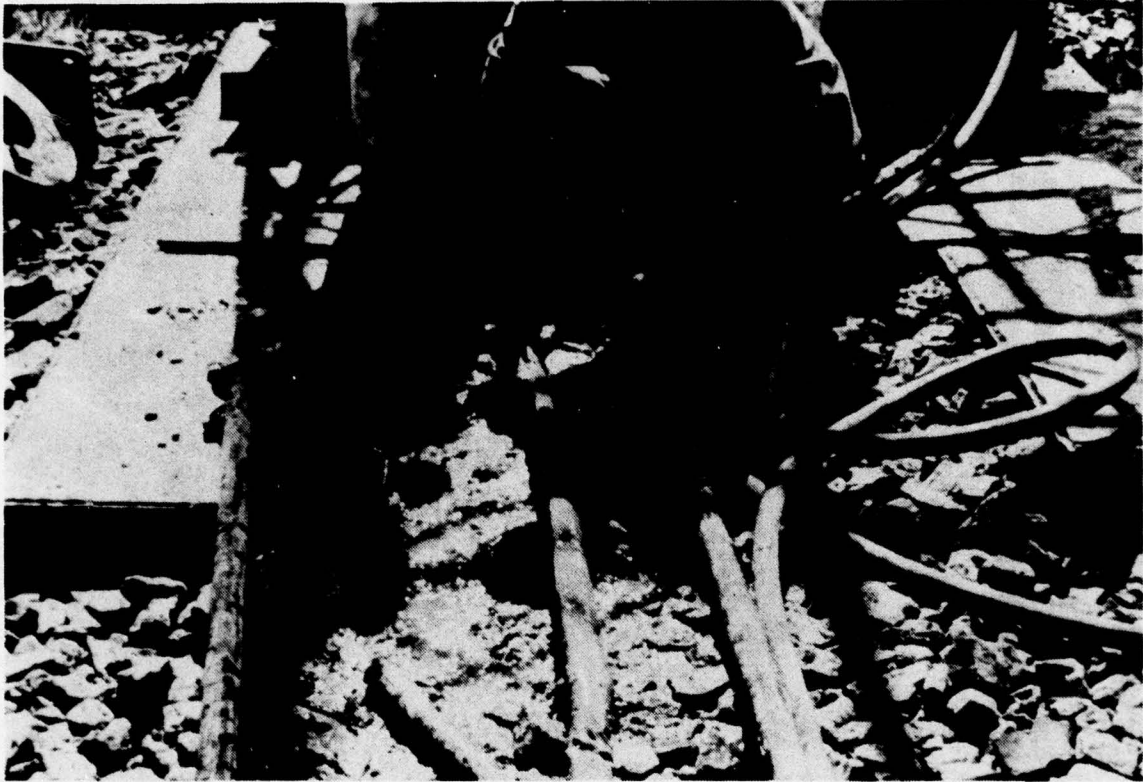
Figure 9. Technician Holding Flattened Plastic Vent Pipe

b. In Figure 9, a technician is shown holding a flattened 1-1/2 inch plastic vent pipe. This pipe had holes drilled in it throughout the area where anodes were installed. The top 15 feet of the vent pipe was normal but below that point the pipe gradually flattened and below the 20 ft level the plastic pipe had been squeezed completely flat. It is suspected that the coke breeze plugged the holes in the plastic pipe and the pressure of the water and coke breeze flattened the pipe. This indicates that vent pipes are not effective unless the minimum particle size of coke breeze is larger than the holes in the pipe.

2. Vent pipes should not be used unless the minimum particle size of the anode backfill is larger than the holes in the vent pipe.

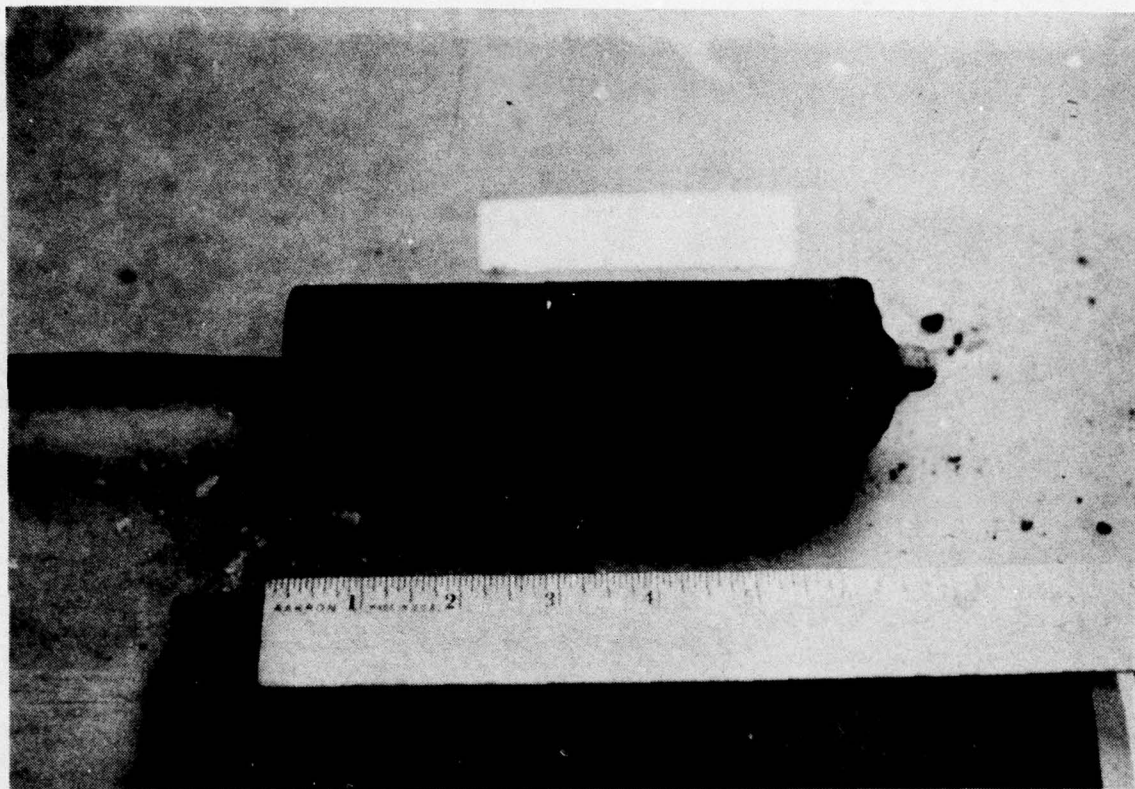
b. The high silicon cast iron anodes suffered less weight loss and corrosion damage than the graphite anodes. Condition of anodes after test can be seen in Figure 16 through 19. Figures 16 through 18 show the condition of graphite anodes, whereas Figure 19 shows the condition of the high silicon cast iron anodes.

Figure 17. Corrosion Damage to Graphite Anode, Drum 2

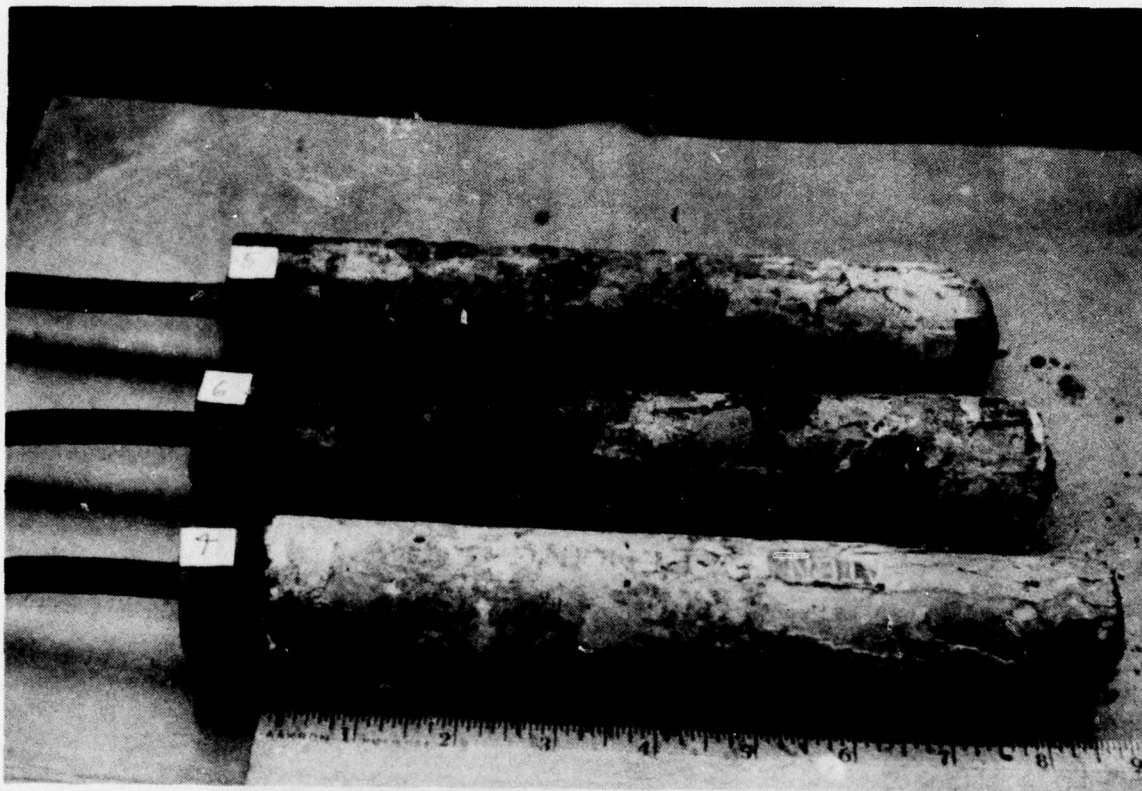
Figure 19. Corrosion Damage to High Silicon Cast Iron Anodes

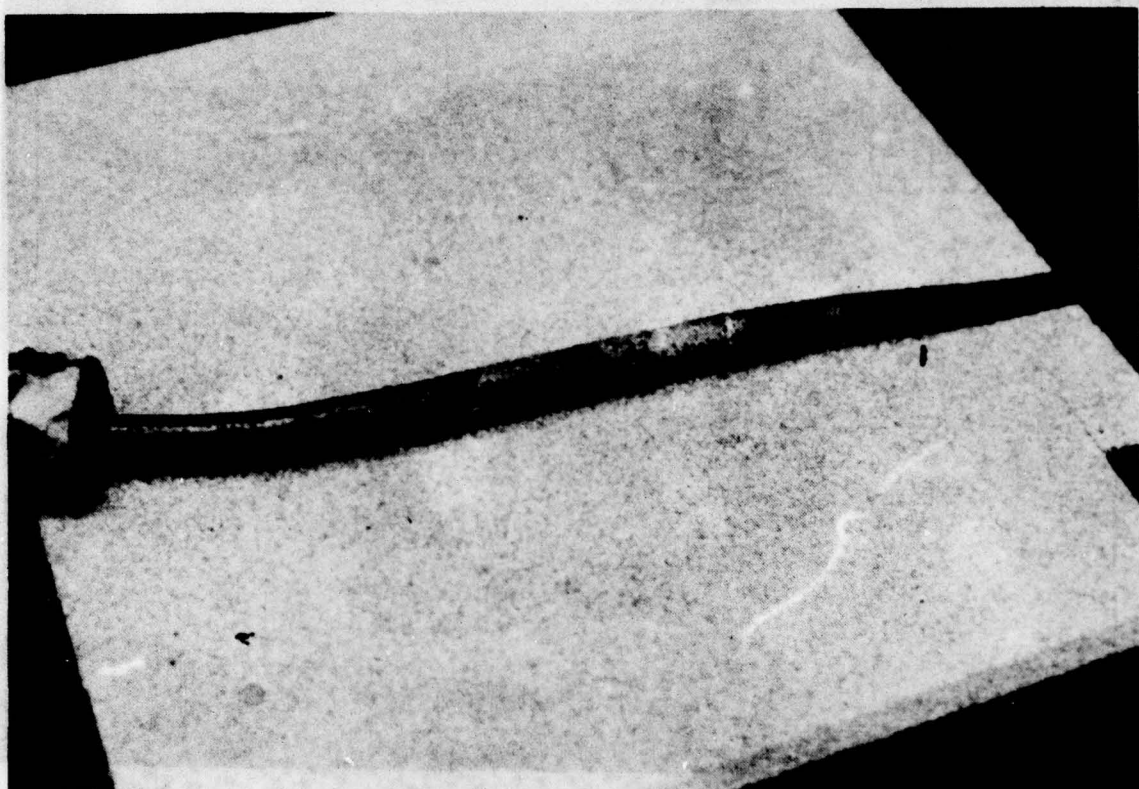
Figure 21 shows the blistering damage on the cast iron anode lead taken from the PVC "W" cell containing coke breeze after 42 days of operation. The HMPE insulation also started to turn white similar to the deteriorated insulation retrieved from the well at Barksdale AFB. Figure 22 shows the blisters with greater magnification. True size can be determined by comparing with the magnified lead from a pencil in the upper right corner.

Figure 21. Blistering Damage on Cast Iron Anode Lead
