**WEST CARROLL TOWNSHIP WATER  
AND SEWER AUTHORITY DAM  
(BAKERTON DAM)**

**PHASE I INSPECTION REPORT  
NATIONAL DAM SAFETY PROGRAM**

**JUNE 1978**

NDI No PA 436

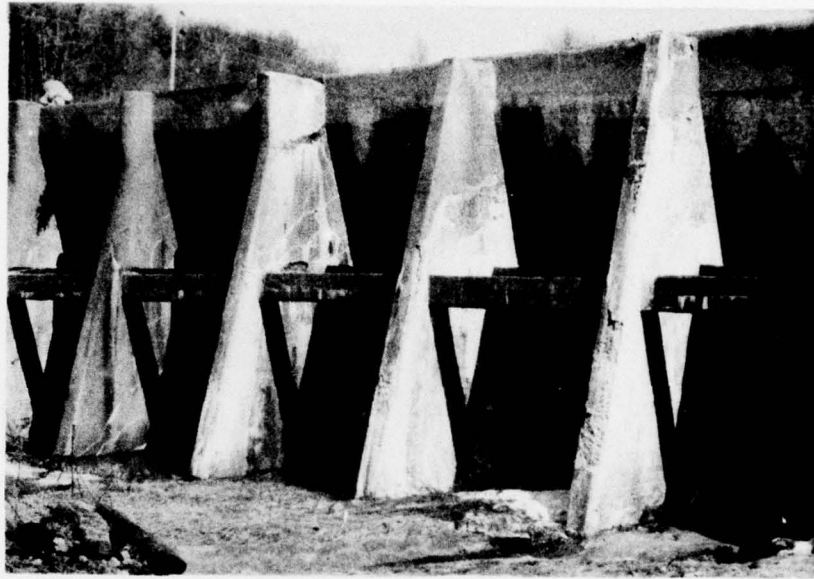
(2) Concrete structure: Based on our observations the concrete and guniting is disintegrating in many locations. There are wet spots and leakage coming through the deck slabs in many locations, but this has been happening ever since the structure was filled with water. There is a slight separation between the deck slab and baffle for the low flow spillway. This separation appears to have been caused by ice build-up. This area was completely blocked with ice during our initial field inspection on March 8, 1978. The concrete in this region, the top of baffle and the top of the concrete buttress, are lightly reinforced, but the failure of this top section in our opinion would not lead to total collapse of the structure. The loss of the steel reinforcing section due to the continuous corrosion conditions over the years and the existing strength of the concrete could become factors at peak flood conditions. The steel reinforcing that we observed showed no major loss of section. The concrete structure at this time shows no outside sign of distress, but the question arises as to what's the condition of the steel reinforcing and concrete that's covered with earth. The right portion of the structure has had sulfurized water permeating through the earthen embankment and weep holes possibly since it was constructed or for some time. The reason for this condition is that during construction a seam of coal at elevation 1810 was unexpectedly uncovered. This area was of much concern at the time, but it was finally decided by the engineers and inspector (from DER records) that the material was impervious enough so the core wall was not extended into the coal laden material. The major area of concern is the differential in earth pressure at several buttresses. The buttresses are not reinforced for the lateral forces which are presently being generated from

GENERAL VIEW OF CENTER SECTION OF DAM  
SHOWING CONDITION OF CONCRETE DAM

(1) The Owner retain a competent consulting engineering firm to make a feasibility study and cost analysis to determine whether the existing dam is economically feasible to repair, or should it be replaced by another dam downstream from the existing facilities. The study should be completed as soon as possible, with immediate action concerning the remedial solution to follow in the near future.

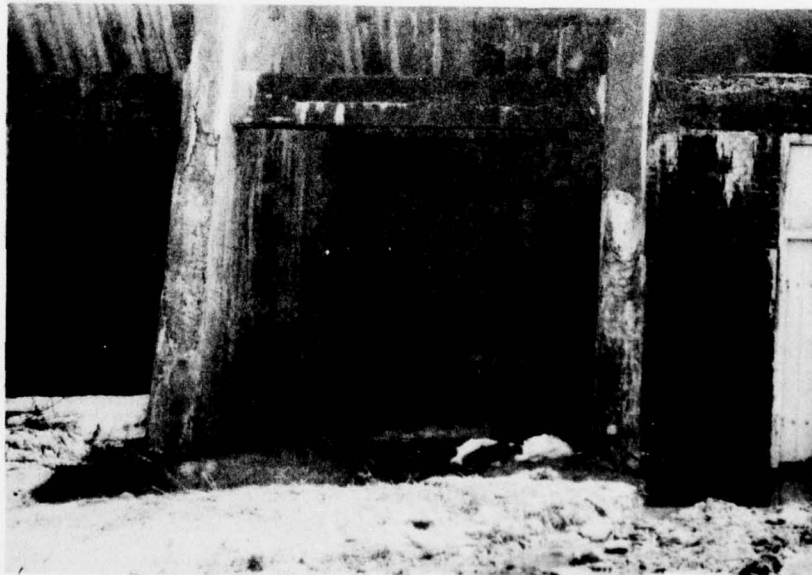
GENERAL VIEW OF TYPICAL BAY OF DAM
