**LAKE HERITAGE PROPERTY OWNER DAM  
(LAKE HERITAGE)**

**PHASE I INSPECTION REPORT  
NATIONAL DAM SAFETY PROGRAM**

NDI No. PA 334

Lake Heritage Property Owners Dam  
Pennsylvania  
Adams County  
Plum Run  
April 5 & 6, 1978  
Inspection Team - EADS

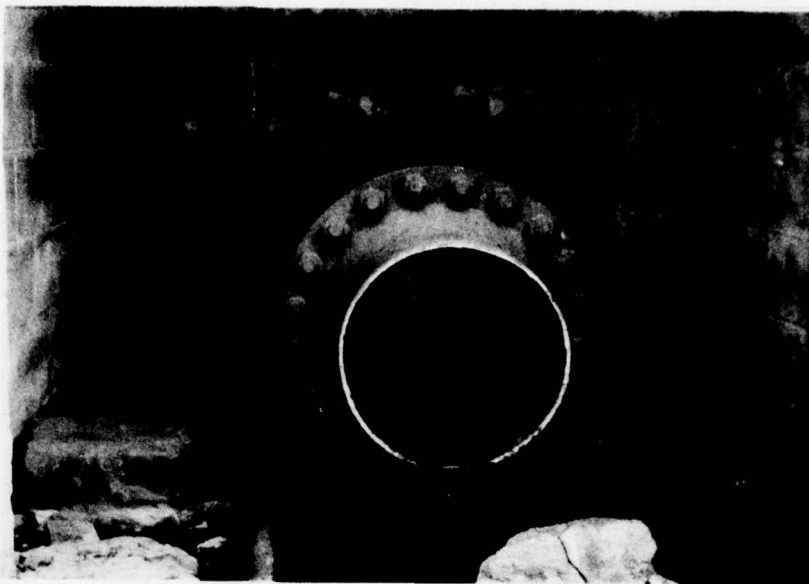
DOWNSTREAM END OF OUTLET PIPE, SHOWING  
15" DISCHARGE PIPE & 16" PLUG VALVE DOWNSTREAM  
FROM 24" GATE VALVE

1. The Owner retain a competent engineer to make an hydrologic and hydraulic analysis of Lake Heritage to determine the capacity of the spillway and the frequency of flood that the dam can pass without overtopping. The study should also consider and make recommendations for decreasing the overtopping potential of the dam, as well as develop a rating curve for the outlet pipe due to the plug valve being installed downstream from the gate valve.

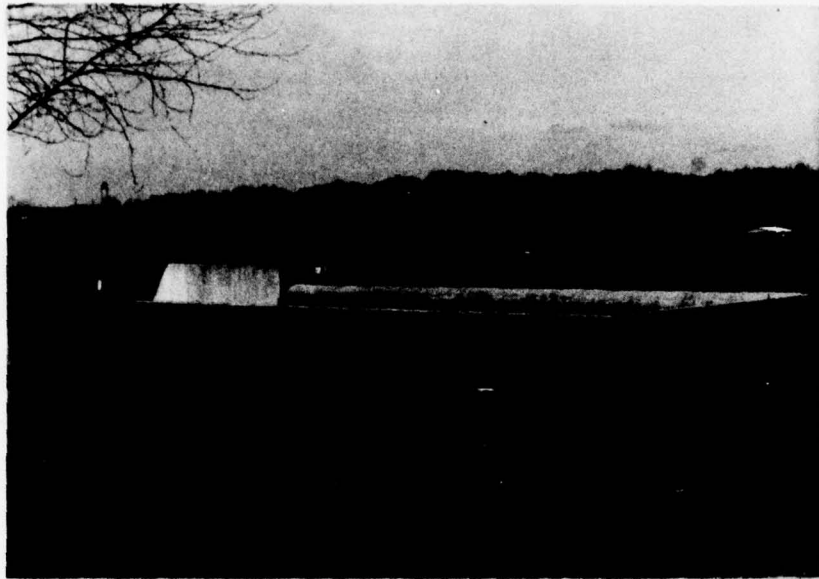
VIEW OF DAM SPILLWAY, LOOKING SOUTHWEST

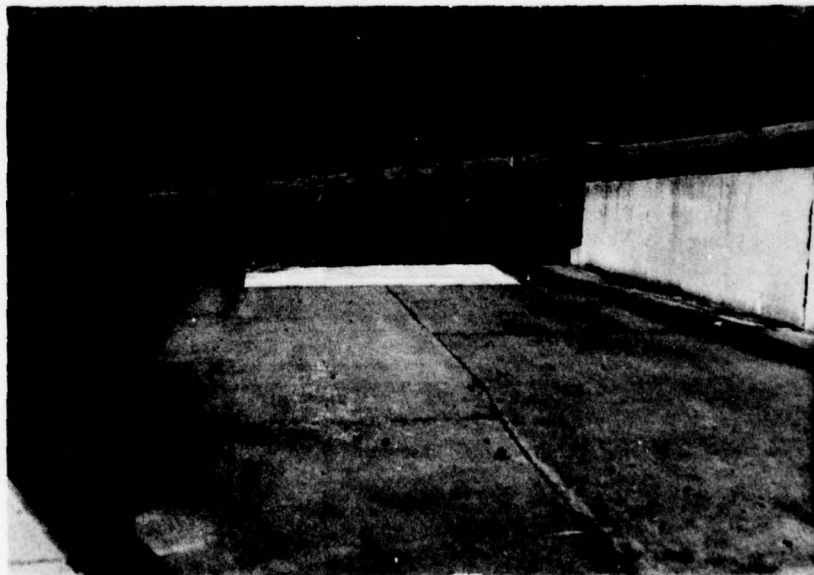
VIEW LOOKING DOWN SPILLWAY, WITH  
OUTLET CHANNEL TO LEFT-CENTER
