National Dam Safety Program. Dalton  
Run Dam (NDS-I.D.-232), Ohio River Basin,  
Dalton Run, Somerset County, Pennsylvania  
Phase I Inspection Report.

PHASE I REPORT  
NATIONAL DAM INSPECTION PROGRAM

NAME OF DAM: Dalton Run Dam  
STATE LOCATED: Pennsylvania  
COUNTY LOCATED: Somerset  
STREAM: Dalton Run, tertiary tributary of Conemaugh River  
DATE OF INSPECTION: April 24 and May 4, 1978

DALTON RUN DAM  
NDS I.D. NO. 232  
APRIL 24, 1978

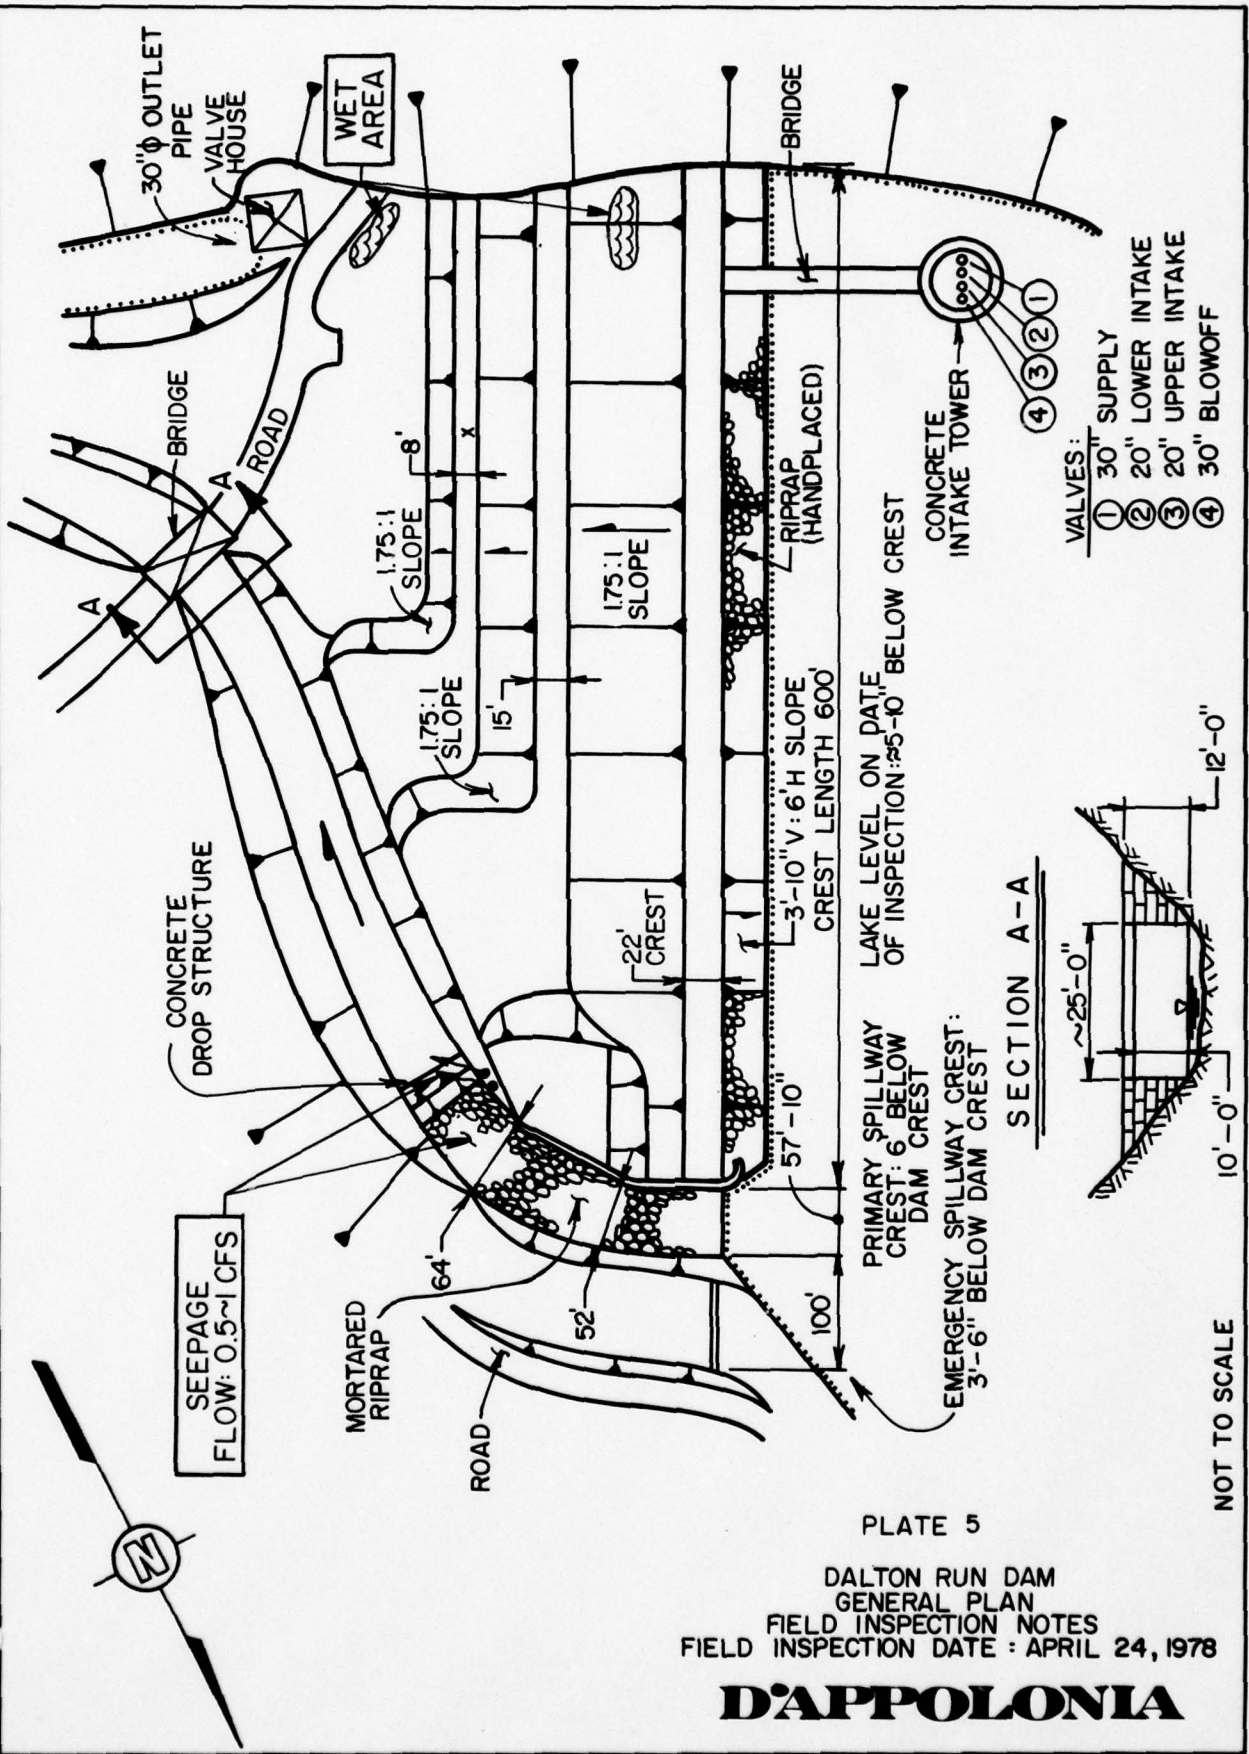
PLATE 5

Two wet areas were observed (Plate 5), one at the toe near the valve house and a second on the embankment adjacent the right abutment. No perceivable seepage was associated with these wet areas.

DALTON RUN DAM  
 GENERAL PLAN  
 FIELD INSPECTION NOTES  
 FIELD INSPECTION DATE: APRIL 24, 1978

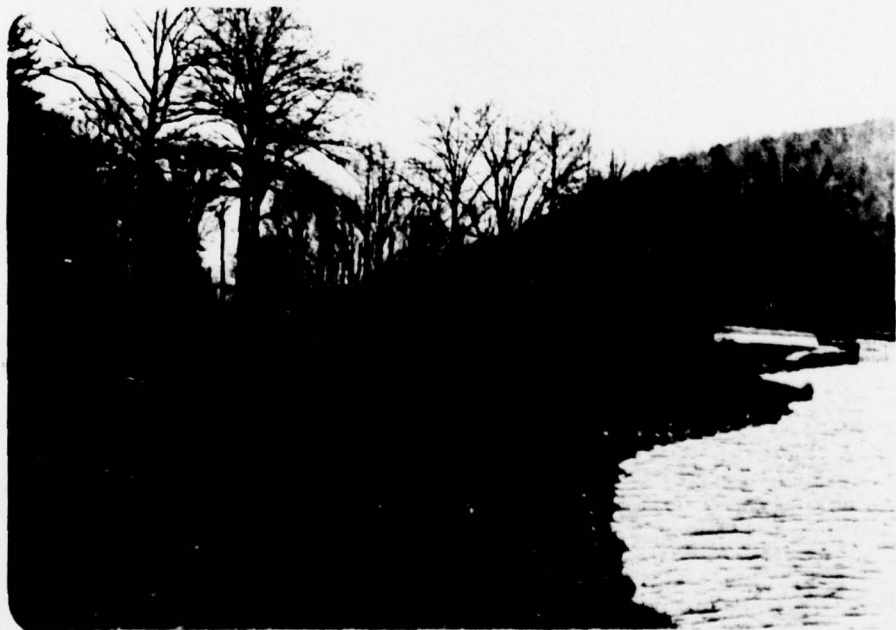
Photograph No. 2  
Emergency spillway crest.

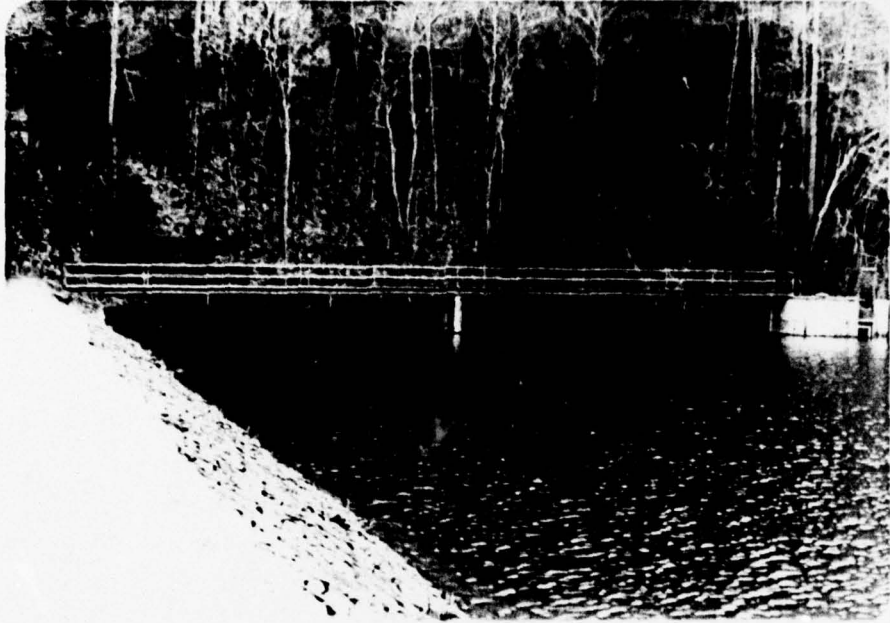
Photograph No. 3  
Access bridge to intake tower.

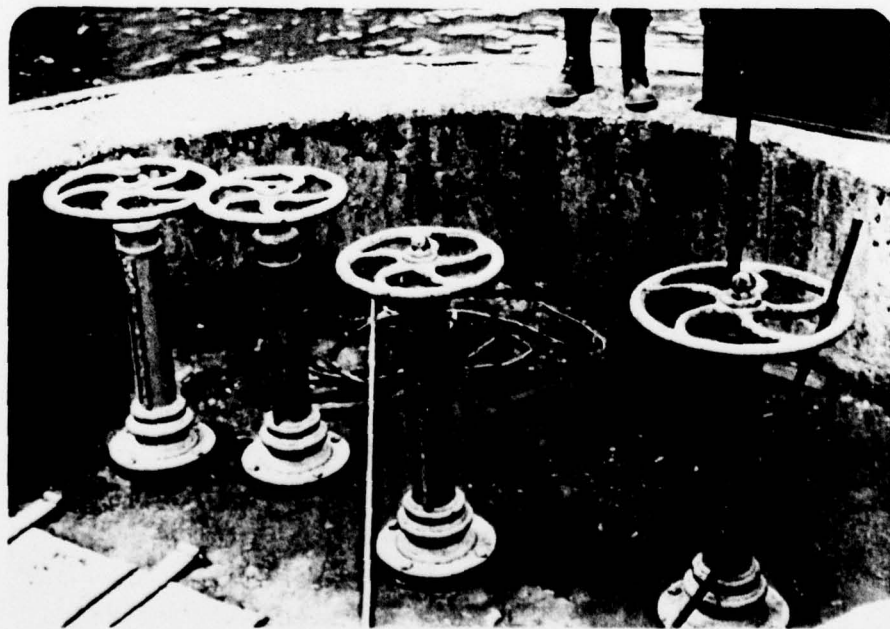
Photograph No. 4  
Valve controls on intake tower.

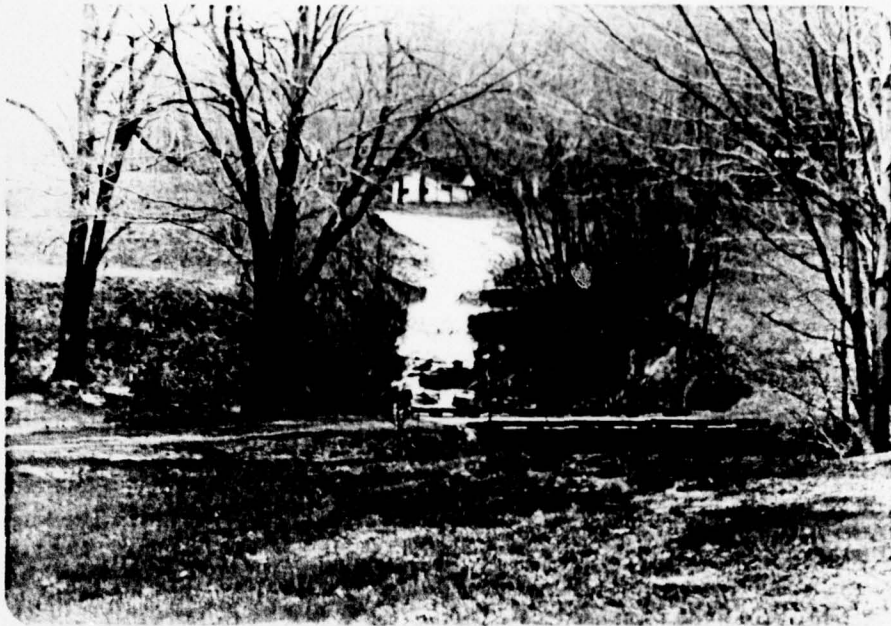
Photograph No. 5

1. The spillway discharge channel was found to show signs of surficial and internal erosion. Various seeps at the lower end of the channel indicated that water is passing beneath the grouted stone paving. Flow from one of the seepage areas located on the right side of the channel approximately 25 feet below the crest of the dam was estimated to be in the range of 0.5 to 1.0 cfs. Flow was also observed coming up through the grouted stone paving of the discharge channel.

Spillway discharge channel. Note bridge on foreground.  
Bridge to gate house (Bridge No. 1).

1. The owner should evaluate the adequacy of the spillway discharge channel lining in view of the existing underseepage condition and undertake necessary repairs.
2. The owner should also evaluate the extent of corrosion and the structural adequacy of the blow-off pipe.
3. In view of "inadequate" spillway capacity, it is recommended that during periods of high runoff the owner should provide around-the-clock surveillance and have contingency plans in the event of overtopping to warn the inhabitants of the flood plain downstream.

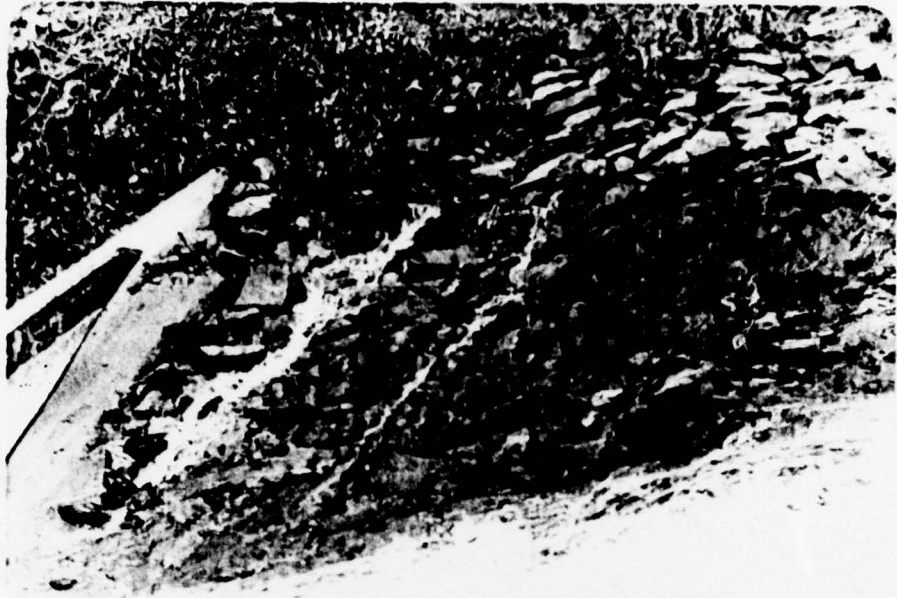
Photograph No. 7

3.2 Evaluation. In general, while the condition of the embankment is considered to be good, the condition of the spillway discharge channel is considered to be poor, with indications of internal erosion. As far as can be assessed from the downstream end, the condition of the outlet pipe also appears to be poor due to corrosion. Further evaluation of the condition of the drainpipe is required.

Seepage on the right bank (looking downstream) of spillway discharge channel.

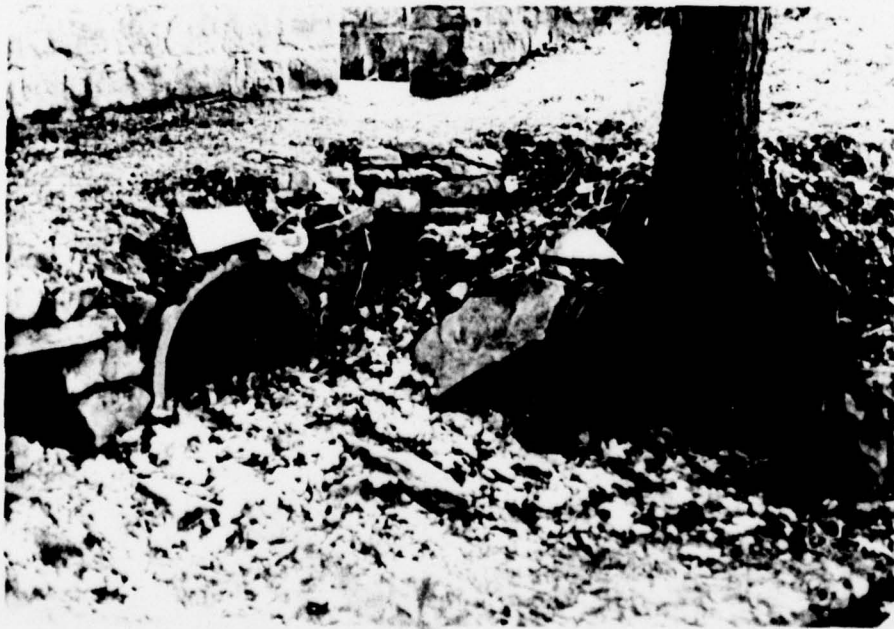
Photograph No. 8

2. The outlet end of the blow-off pipe was inspected and found to be significantly corroded.
3. Orange-colored water was observed in the outlet pipe discharge channel suggesting acid mine drainage from the adjacent hillside.

Outlet end of "blow-off" pipe.

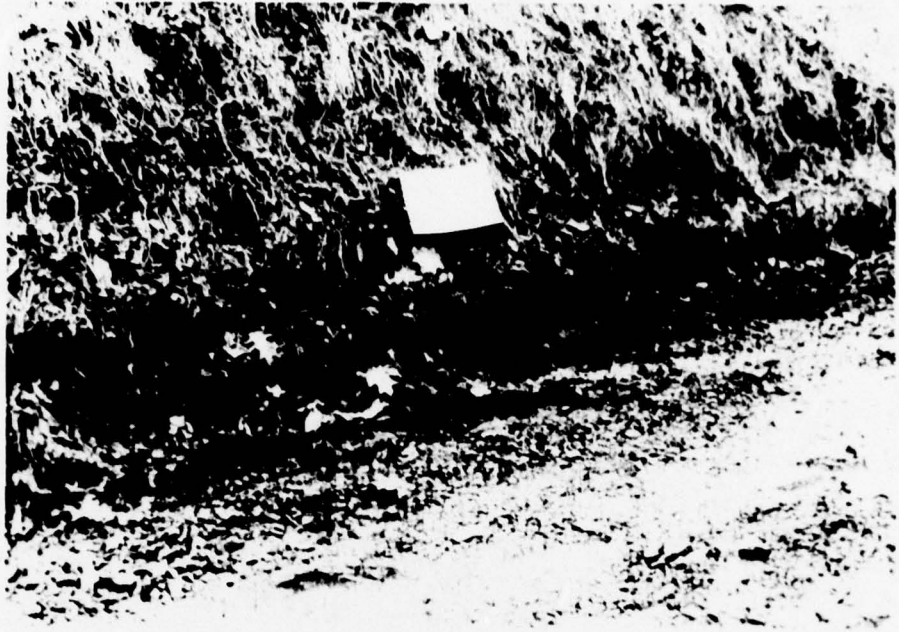
Photograph No. 9

Wet area at the toe. (See Plate 3 for location.)

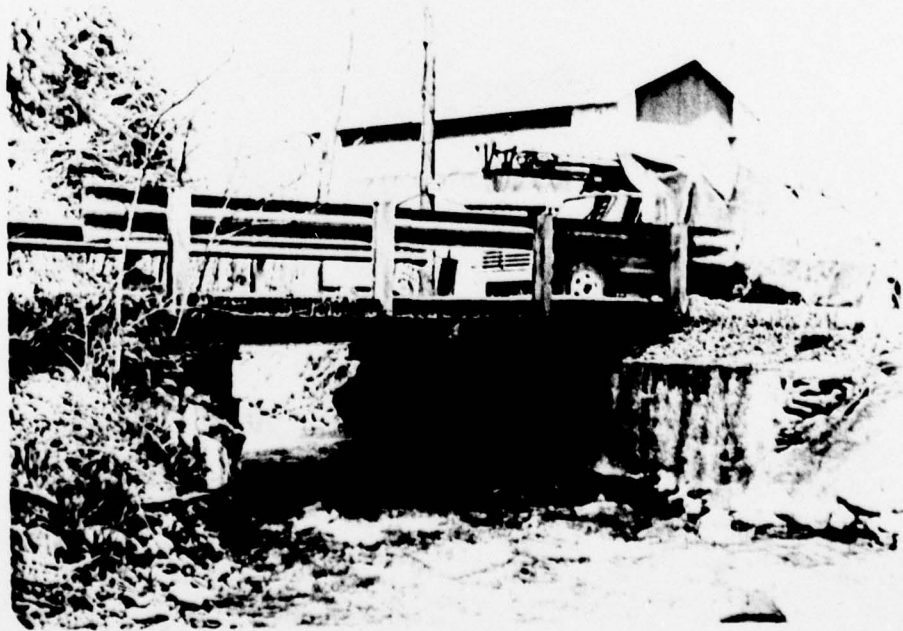
Photograph No. 10

Bridge on Dalton Run Road (Bridge No. 2).

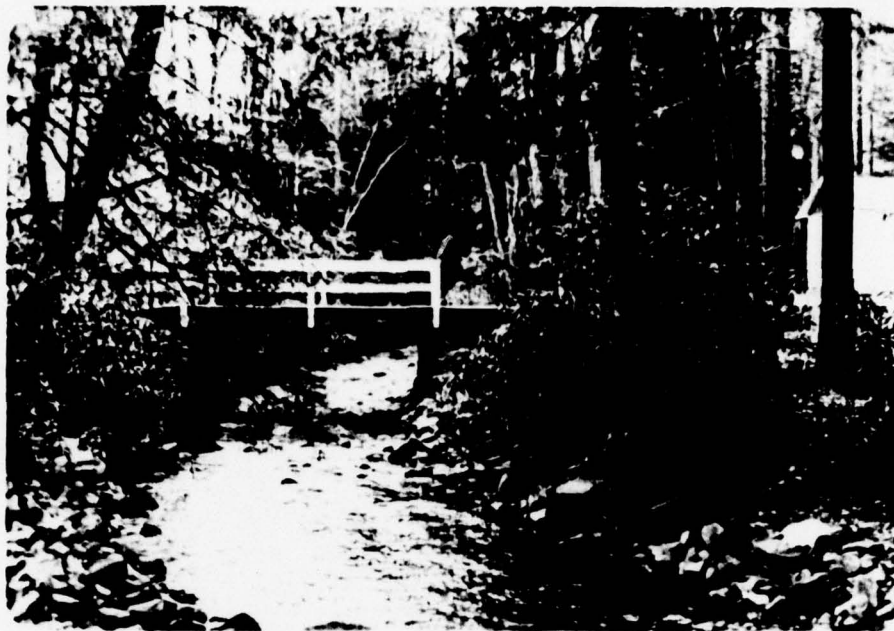
Photograph No. 11  
Private bridge (Bridge No. 3)

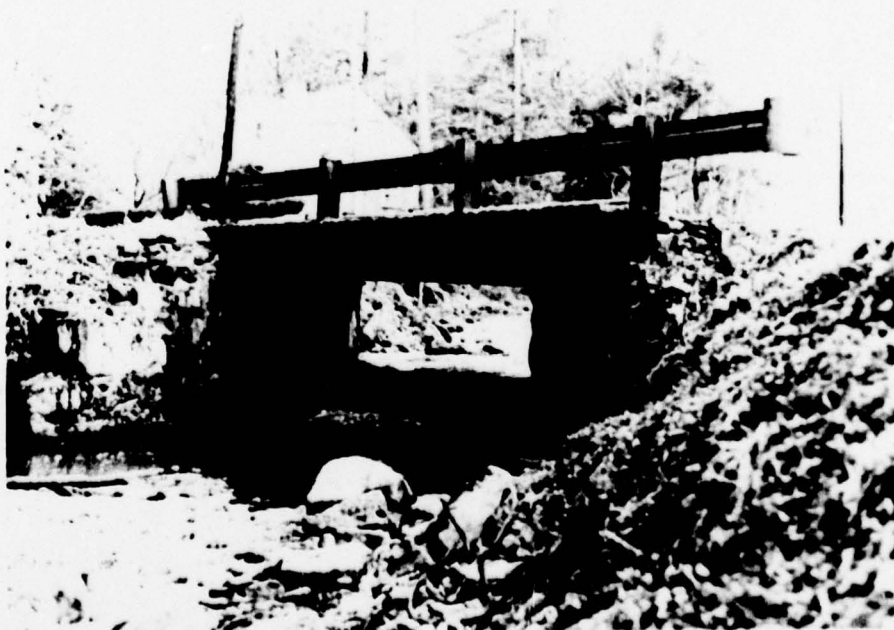
Photograph No. 12  
Bridge on Dalton Run Road (Bridge No. 4).

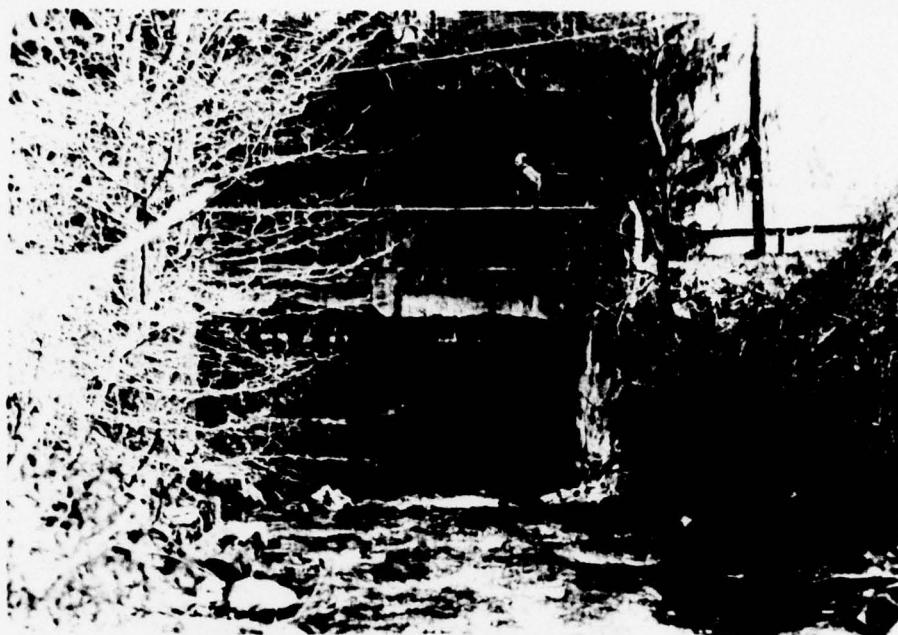
Photograph No. 13  
Bridge No. 5.

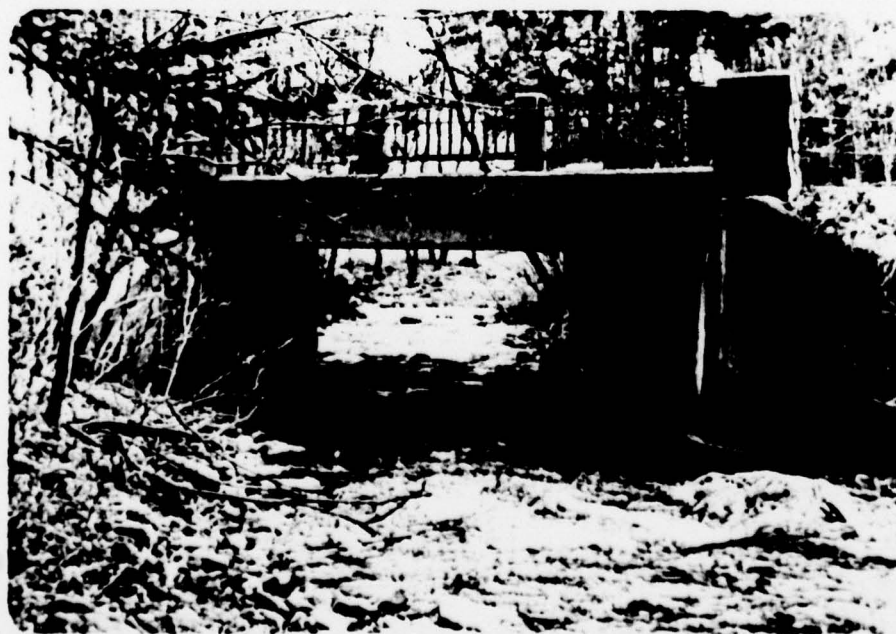
Photograph No. 14  
Bridge on County Road (Bridge No. 6).
