**WATER COMPANY 4,
NDI Pa-507.**

**PHASE I INSPECTION REPORT,
NATIONAL DAM INSPECTION PROGRAM.**

2 June 1978

PHASE I INSPECTION REPORT
NATIONAL DAM INSPECTION PROGRAM
CITIZEN'S WATER COMPANY DAM #4
NDI# PA-507, PENNDER# 63-3

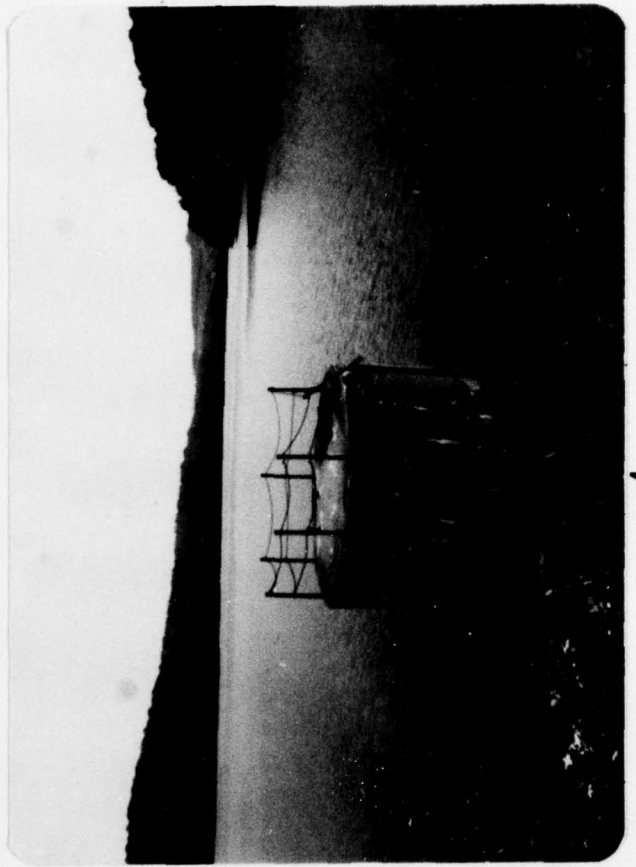
PHOTOGRAPH 4 Close-up view of the outlet controls at Dam #4. The gates are reportedly kept open and flow is said to be regulated at the treatment plant.

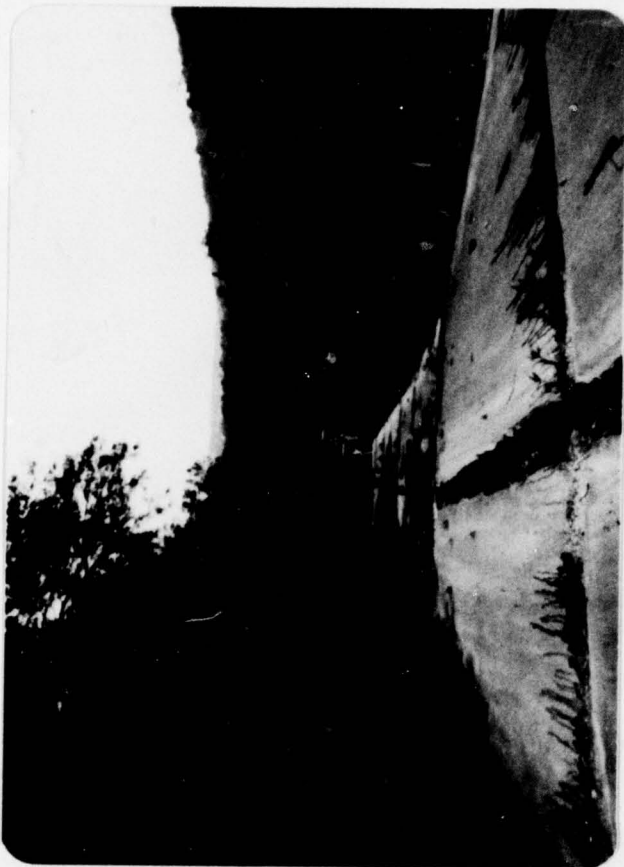
6

1. Spillway. The upper two-thirds of the spillway including the wingwalls and channel floor appeared to be in fair to good condition. Joints and popouts have been sealed with bitumen. The bottom third of the spillway chute above the stilling basin is in poor condition with random spalling and severe scaling evident. Leakage through the left spillway wall appears to be causing some concrete deterioration. The ogee portion of the spillway and plunge pool walls appear to be in good condition (see Photographs 5 and 6).

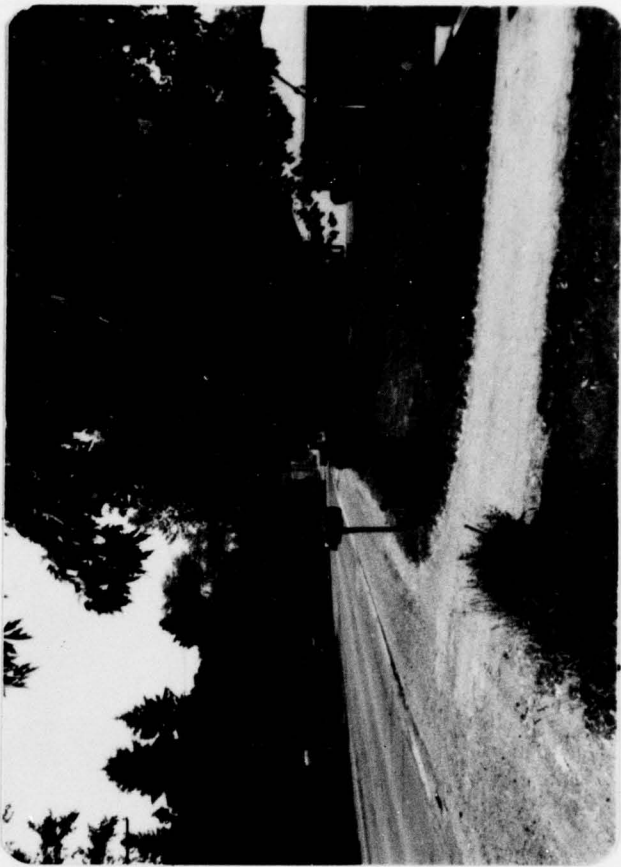
5. Downstream Channel. The downstream channel is a relatively flat, broad floodplain of Chartiers Creek. Vegetation within the floodplain is sparse consisting chiefly of shrubs and grasses. Approximately 2,000 feet downstream of the dam is a small community containing about 20 homes along PA Route 18. Many of these dwellings would be affected by a sudden failure of the embankment. Other dwellings in the community of Franklin Farms are also located within the Chartiers Creek floodplain approximately 6,000 feet from the dam. However, as the floodplain is quite wide in this area, the effects of a sudden breach appear minimal. Based on the above observation, the hazard rating for the facility is "high" (see Photograph 8).

PHOTOGRAPH 8 View of a residential area located approximately 2,000 feet downstream of the dam.

c. the owner adapt their proposed emergency contingency plan for maintaining a safe potable water supply to include a warning system in the event of an emergency embankment condition.

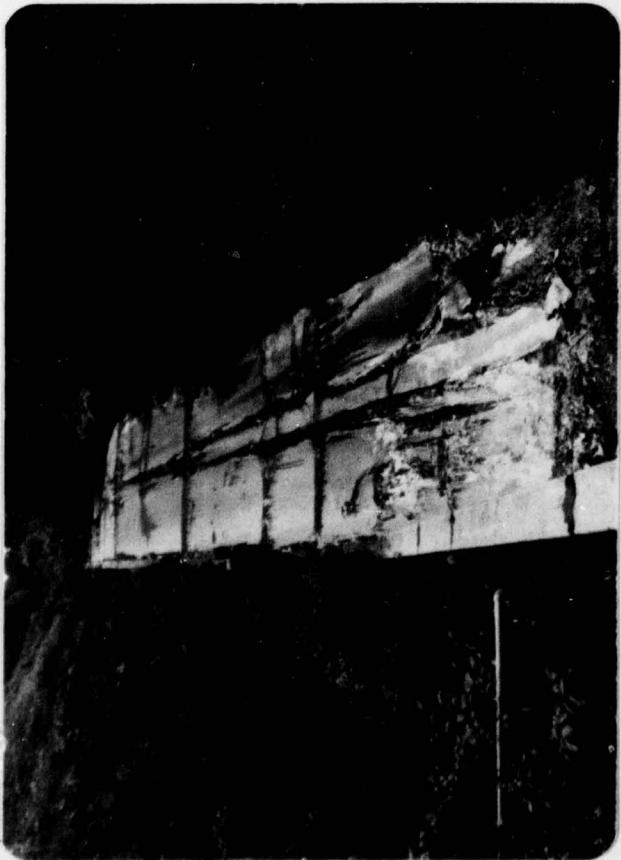
The lower third of the spillway chute has deteriorated and is in need of remedial maintenance. Seepage through and under the spillway near the embankment bench level should also be investigated and controlled.

Fair to good condition in upper two-thirds. Joints and popouts have been filled with bitumen. Flow surface in reasonably good condition. Seep through left side of spillway at wall causing concrete deterioration. Bottom third in poor condition with spalling and severe scaling evident. Plunge pool walls in good condition.

PHOTOGRAPH 5 View of the spillway at Dam #4 taken from the plunge pool area. Note the deteriorated condition of the structure near the entrance to the plunge pool.

a. the owner investigate and initiate remedial repair of the deteriorated spillway section. The investigation should include an assessment of the seepage source(s) within and adjacent the spillway with possible remedial schemes to direct the seepage through the underlying drainage system.

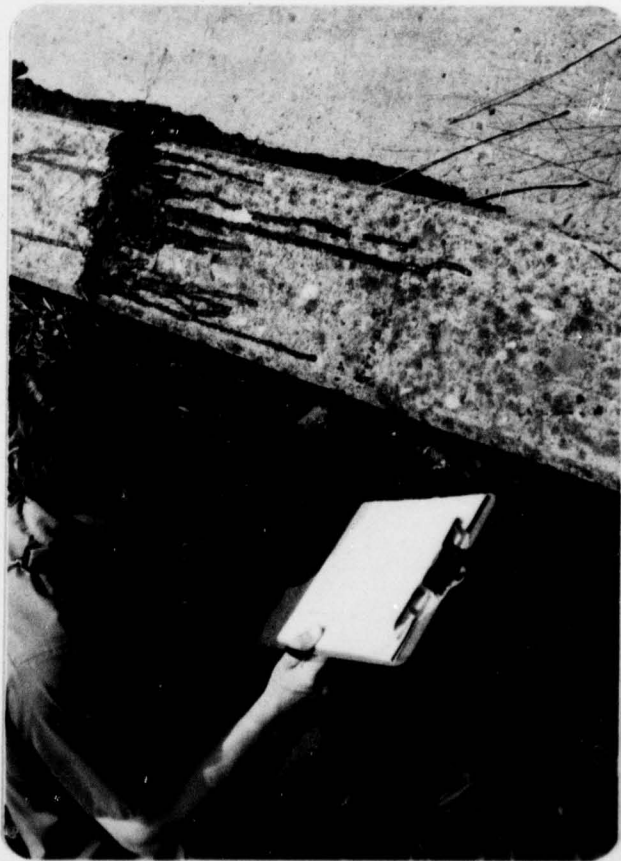
b. Embankment. The dam embankment appears to be in good condition. There is no evidence of any cracking or sloughing. Settlement of the embankment crest was found to be minimal not exceeding approximately 4 inches. The upstream slope is covered with a well graded slag with maximum particle size of about 6 inches. Minor slope erosion was evident in a few areas on the upstream slope indicating that the protection provided by this riprap material is questionable. The downstream slope contains a 3.5-foot wide bench drained with a stone gutter located approximately 25 feet below the dam crest. No indications of seepage through the embankment slope were observed during the field investigation. However, a seep was observed adjacent the right spillway wingwall with flow emanating about 10 feet below the bench (visually estimated to be 5 gpm). Leakage is also visible through the spillway slab slightly above this level indicating the source of the seep may originate in the abutment (see Photograph 7).

Flow along spillway at junction of embankment. Flow apparently originates 10 feet below bench and is visually estimated to be approximately 5 gpm. Leakage is also visible through spillway indicating the source of the above seep may originate underneath the spillway.

PHOTOGRAPH 7 View of seepage emanating adjacent the spillway sidewall approximately 10 feet below the embankment bench level.
