2 QUEMAHONING DAM

(NDI I.D.NO: 740)

PHASE I INSPECTION REPORT  
NATIONAL DAM INSPECTION PROGRAM

1275p D'APPOLONIA CONSULTING ENGINEERS  
10 DUFF ROAD  
PITTSBURGH, PA. 15235

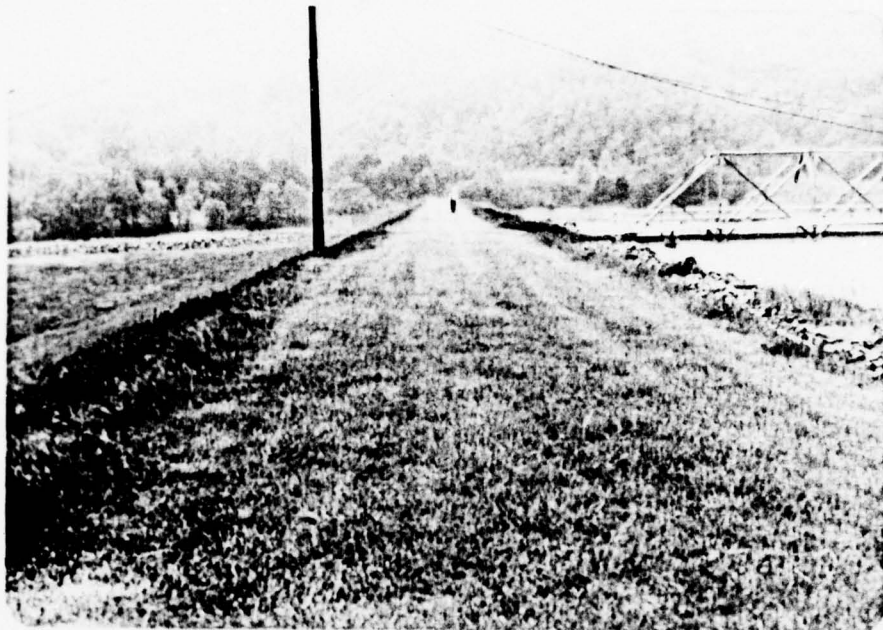
Photograph No. 1  
Crest (looking east).

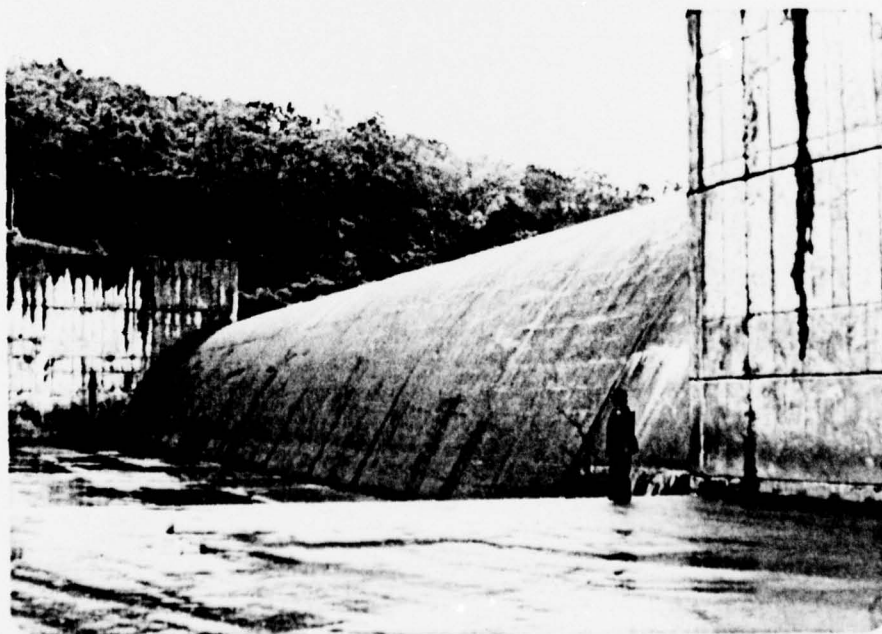
Photograph No. 4  
Side channel spillway crest.
