② BEAR GAP NO. 6

## ④ PHASE I INSPECTION REPORT

⑤ NATIONAL DAM INSPECTION PROGRAM

by  
BERGER ASSOCIATES, INC  
CONSULTING ENGINEERS  
HARRISBURG, PA

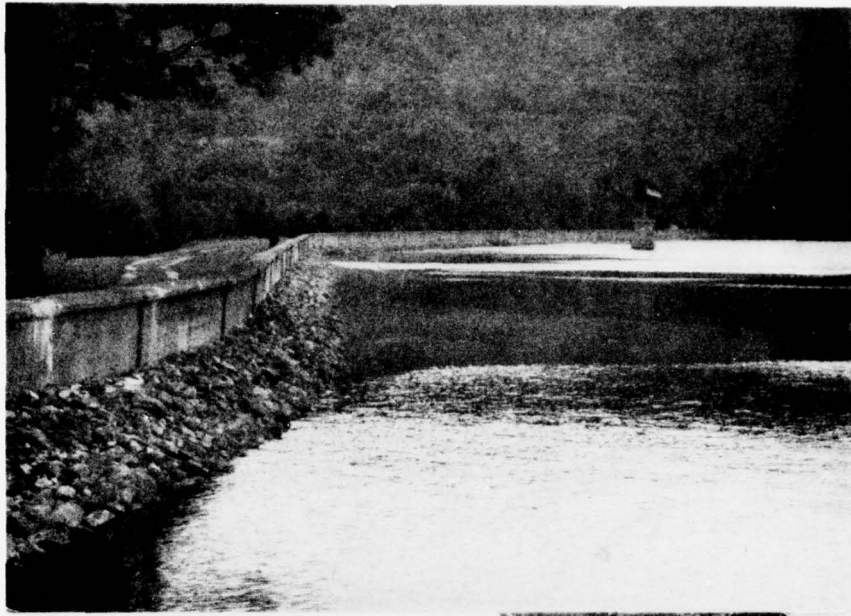
Dam  
Looking North

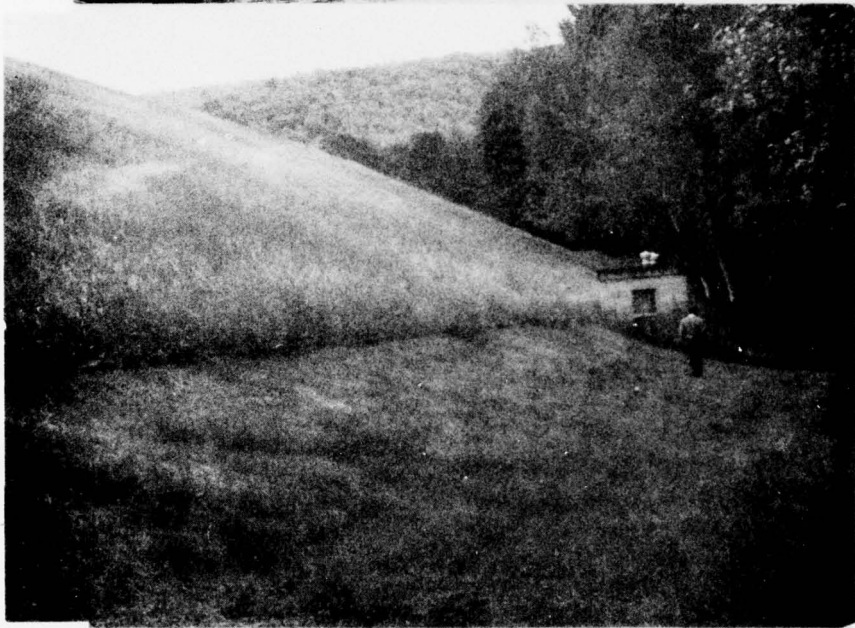
There were no visual indications of undue embankment stresses or sloughage. Except for a small amount of seepage near the left abutment just above the roadway leading to the valve house (Appendix D, Plate VII) the embankment was in good condition. A small amount of leakage was also detected about 50 feet beyond the toe of the dam, north of the valve house and located in a wooded area.

Downstream Slope  
and Valve House

1. The owner shall make a detailed hydrologic and hydraulic analysis for these facilities and improve the spillway capacity to meet the requirements found by this analysis.
2. The owner shall monitor the seepage occurring at this dam. If seepage increases or if turbidity is discovered in the seepage water, or embankment sloughage is detected, immediate remedial measures shall be taken.

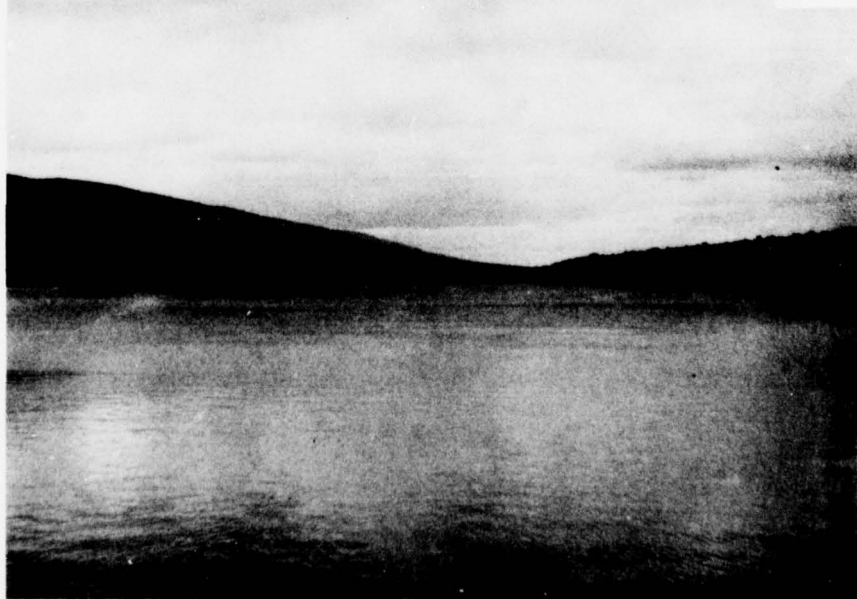
Reservoir

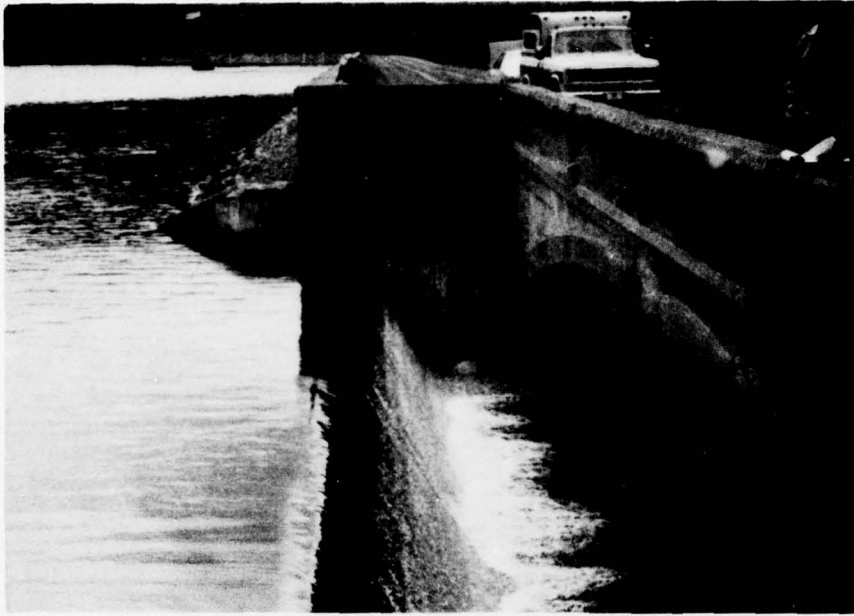
The appurtenant structures all appear to be in good condition. An arch bridge is located across the spillway just below the ogee section (Appendix D, Plate IV). The spillway had been heavily damaged during tropical storm Agnes in June, 1972. The damage started about 200 feet downstream from the ogee section. The spillway chute was redesigned and construction was completed in 1975. Photographs on Plate IV and V show the new spillway channel and energy dissipators.

Spillway

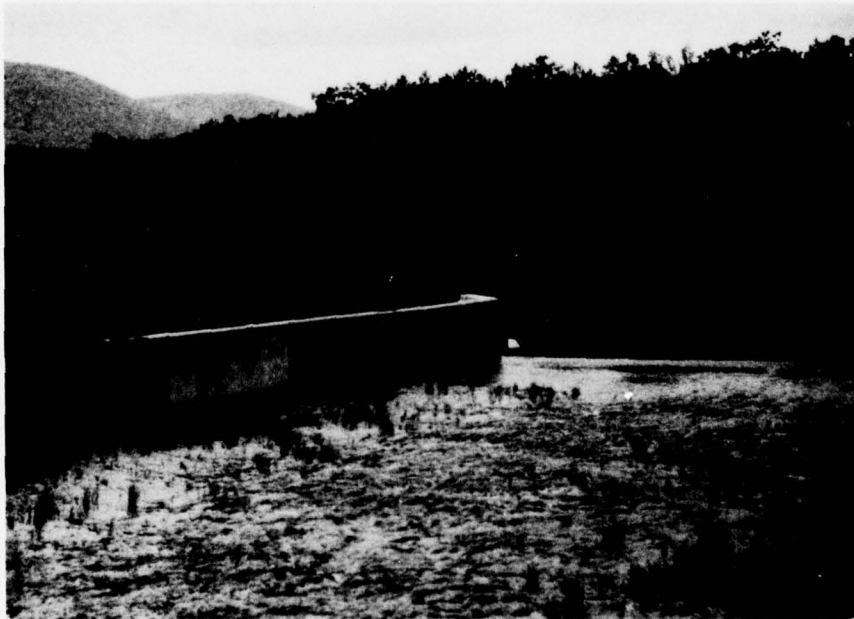
Visual observations indicate no present stability or stress problems in any of the appurtenant structures. A small amount of spalling has occurred on the spillway walls near the spring line of the arch bridge.

Spillway  
Below Bridge

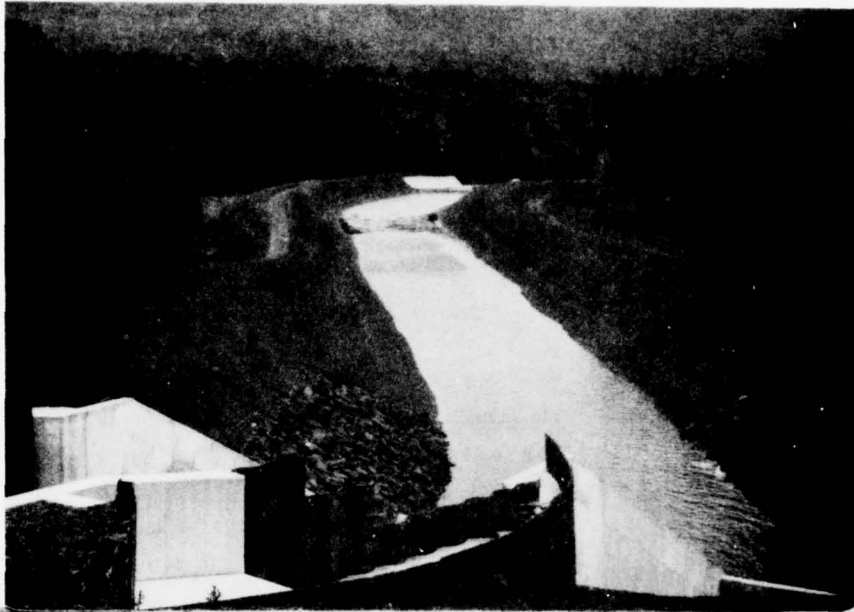
Spillway  
Channel

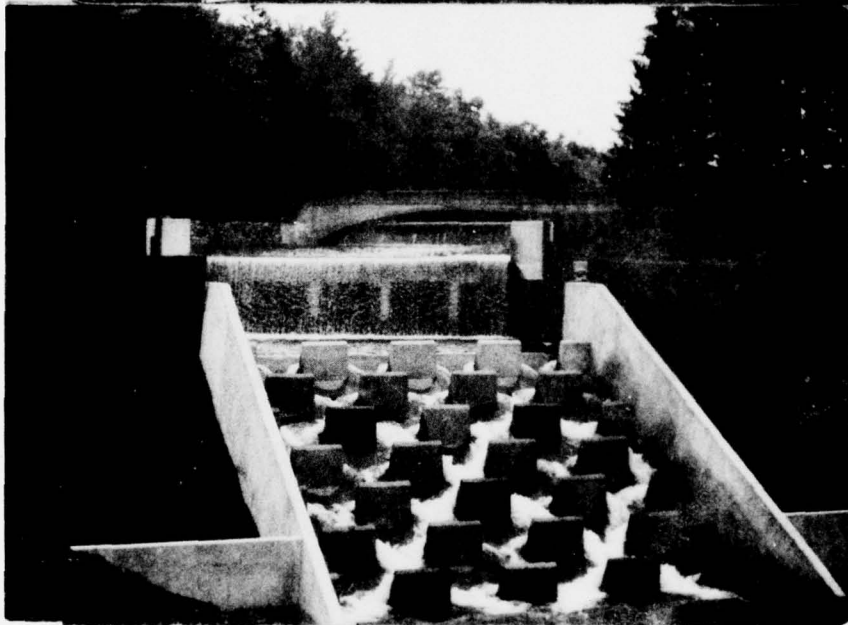
Energy  
Dissipators

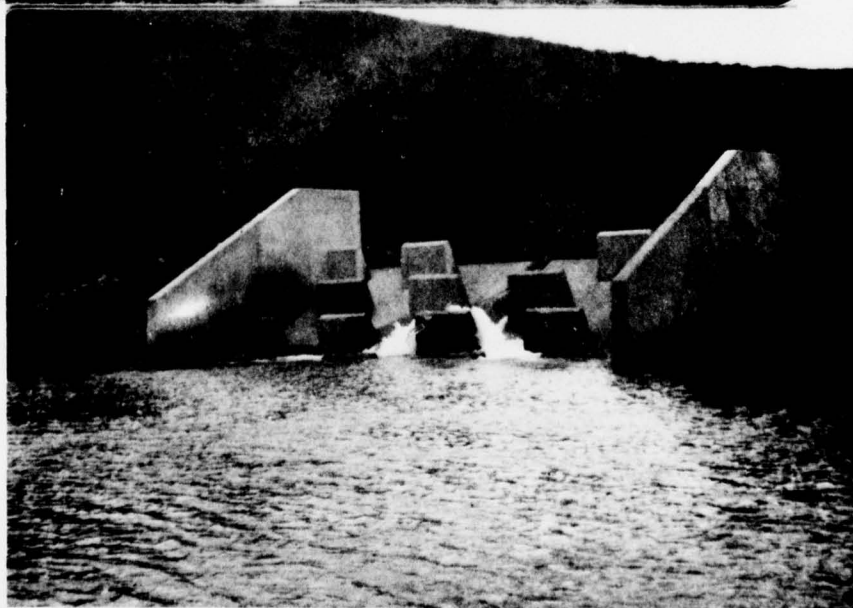
End of  
Spillway
