Name Of Dam: RURAL RETREAT DAM

Location: WYTHE COUNTY, VIRGINIA

Inventory Number: VA 19701

PHASE I INSPECTION REPORT

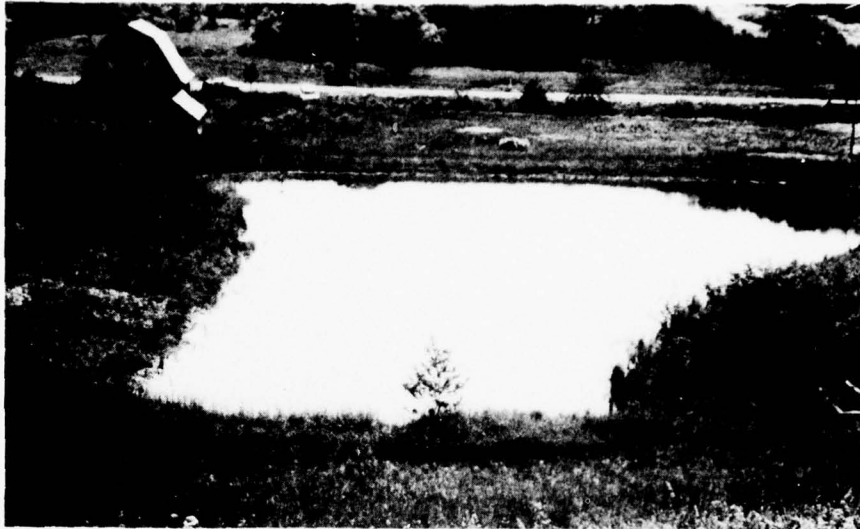
The minnow pond had well-vegetated slopes with no apparent seepage or sloughing. A 6-inch iron pipe was found exiting from the embankment at the base of the dam, leading to the minnow pond. Although evidently some type of drainage pipe, it was completely dry. The pipe was not shown on the plans.

MINNOW POND BELOW DAM AS VIEWED FROM THE CREST.

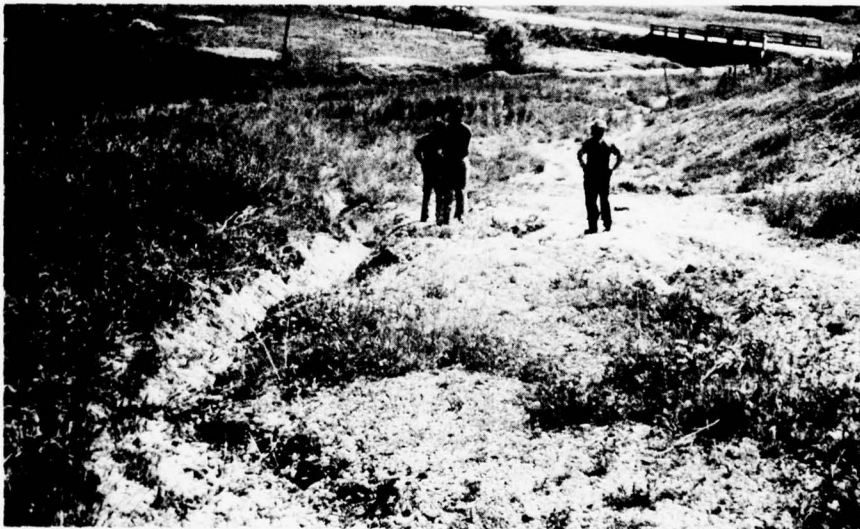
The spillway was found to have a capacity sufficient to pass 62 percent of a PMF. Although this is inadequate according to the Corps of Engineers' guidelines, it is not considered "seriously inadequate." The primary fault with the spillway is that it is not designed with sufficient consideration of the erosive capacity of a high velocity discharge. There is a good chance that under a large discharge flow severe erosion would occur.

SPELLWAY CHUTE SHOWING EROSION ON LEFT SIDE.

b. Spillway Protection: The spillway should be protected against erosion and slope instability. It is recommended that the owner enlist the services of a consultant to design an erosion resistant covering for the spillway crest and chute. The spillway capacity was not found to be "seriously inadequate", but future consideration should be given to enlarging it to meet the PMF design flood criteria. This work should be carried out in conjunction with the recommendation of paragraph b.

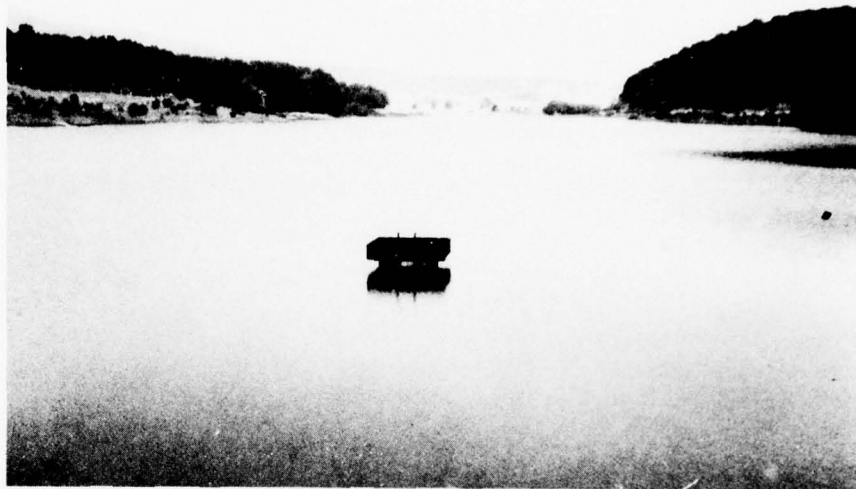
DROP INLET INTAKE STRUCTURE June 1978

The intake is a tower in the reservoir. Inflows pass over the top and through a 30-inch discharge pipe. Water level appeared to be about 15 inches below the overflow level. The hand operated gate stem was missing the wheel.

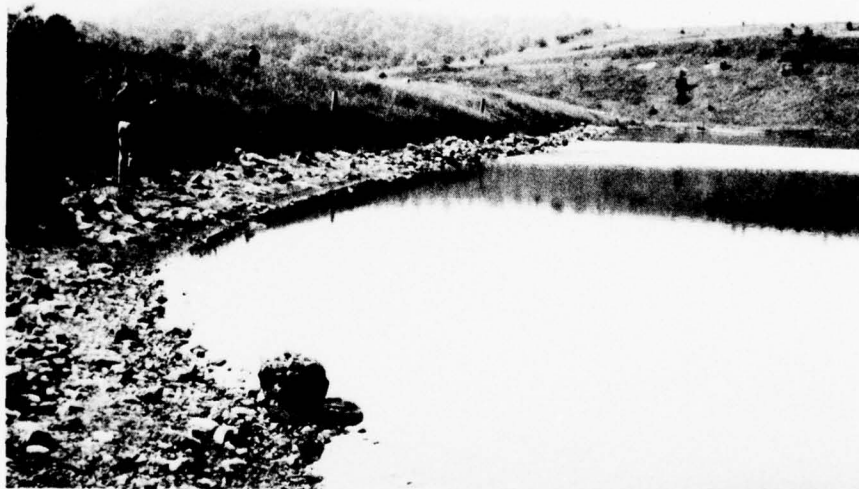
3.1 Findings: The downstream slope of the dam has well established vegetation, including several small trees (approximately 10 to 15 feet high) near the left abutment, and one tree at the dam center, near the one-third point along the slope. In addition to the trees, several holes burrowed by animals were also seen in the abutment area. A complete failure of the riprap along the shoreline has resulted in severe erosion of the upstream face.

7.1 Dam Assessment: The visual inspection revealed several deficiencies which are primarily the result of poor maintenance. However, more serious is the deficiency in design reflected by the riprap failure and the spillway.

UPSTREAM FACE OF DAM SHOWING RIPRAP FAILURE
AND SEVERE EROSION OF THE SLOPE June 1978

c. Slope Repair: The upstream slope should be repaired and new riprap installed on the slope. This should be done within 90 days.
