Name Of Dam: GATEWOOD DAM
Location: PULASKI COUNTY, VIRGINIA
Inventory Number: VA 15503

PHASE I INSPECTION REPORT

NATIONAL DAM SAFETY PROGRAM

AUGUST, 1978

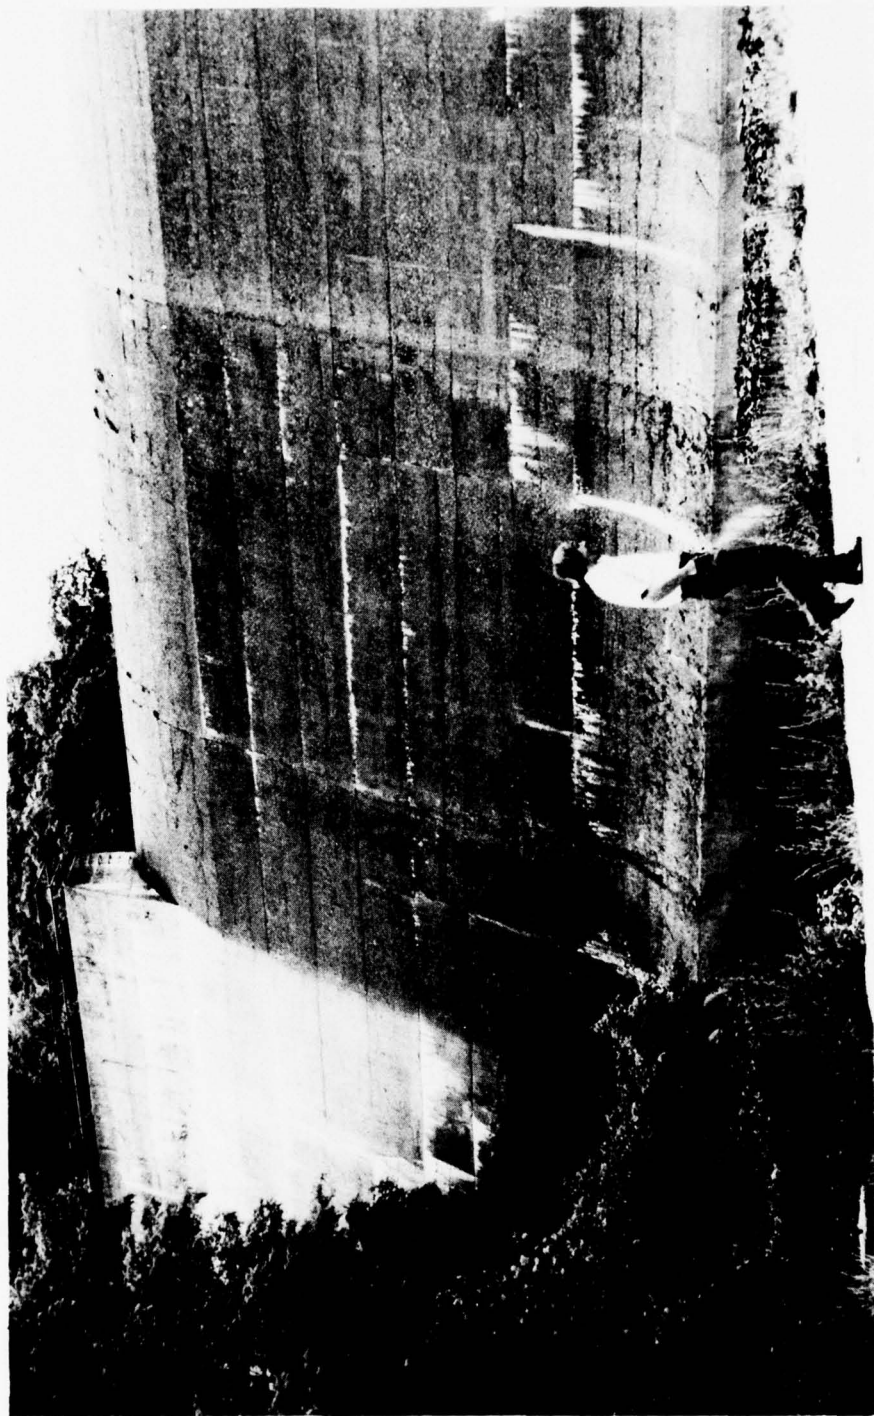
OVERVIEW OF GATEWOOD DAM

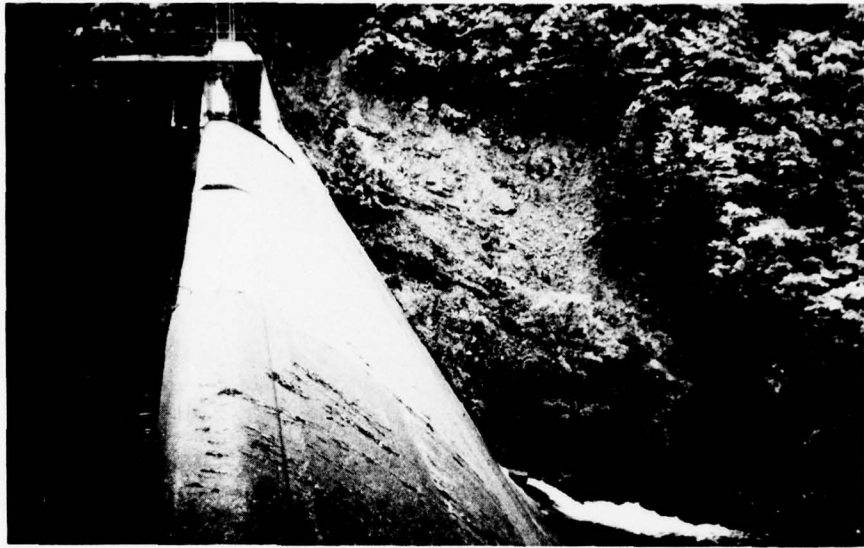
VIEW OF THE DAM CREST AND GATE TOWER

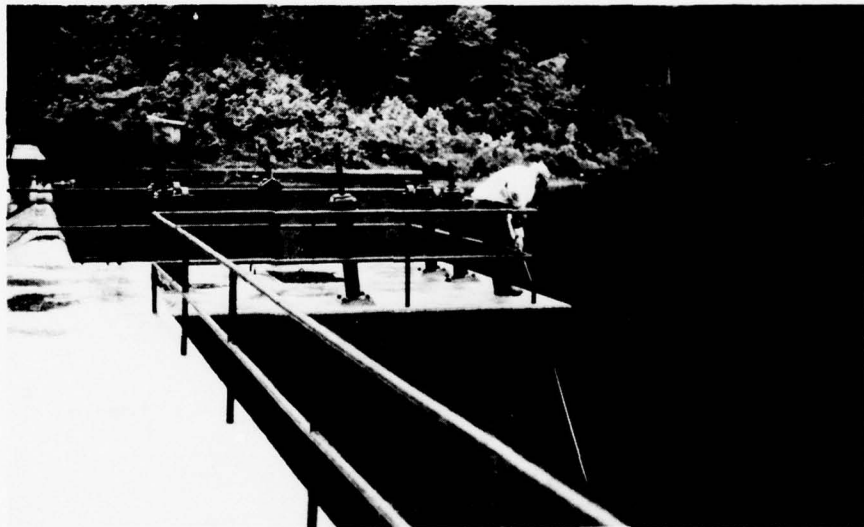
GATE TOWER AND OPERATING DECK

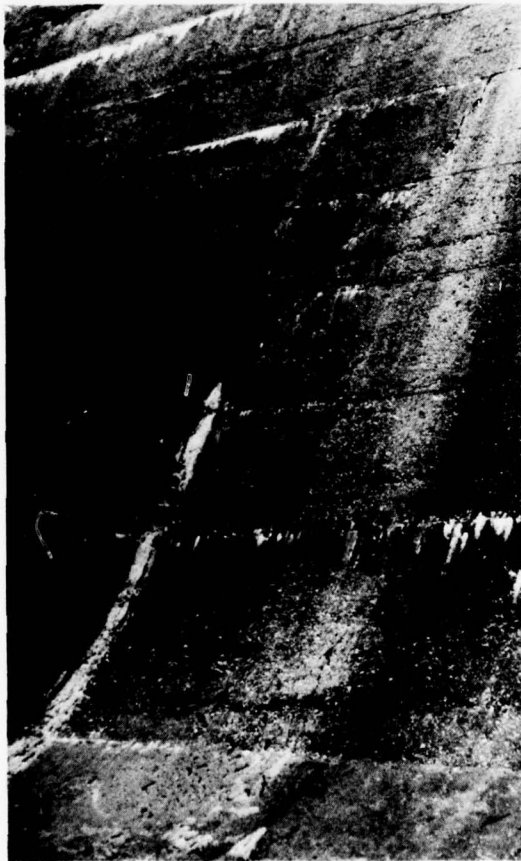
them. The crack starts at a vertical joint, runs diagonally upward across three lifts, and ends at the vertical construction joint of the upper lifts. No seepage was observed from the crack but stains on the concrete indicated that seepage has occurred in the past. The crack is shown in Appendix II.

TRANSVERSE CRACK ON THE FACE
OF THE DAM

VISUAL EXAMINATION OF	OBSERVATIONS	REMARKS OR RECOMMENDATIONS
STRUCTURAL CRACKING	<p>A transverse crack running through three concrete lifts was observed below the left end of the spillway. The crack starts five lifts below the crest at a level where the vertical construction joint between monoliths was offset. It then runs downward and intersects another vertical joint.</p>	
VERTICAL AND HORIZONTAL ALIGNMENT	<p>All concrete surfaces appeared straight or built to the proper contour. No bulging or sagging was observed.</p>	
MONOLITH JOINTS	<p>Efflorescent deposits on face of dam indicates seepage above joints. Because of wet weather conditions, it could not be determined if any seepage was actually coming through the joints. The worst area was near the left side of the dam where deterioration of the concrete is also visible, but signs of seepage are also visible at the base of the dam for the entire length.</p>
