Name Of Dam: HOGAN DAM

Location: PULASKI COUNTY, VIRGINIA

Inventory Number: VA 15504

PHASE I INSPECTION REPORT

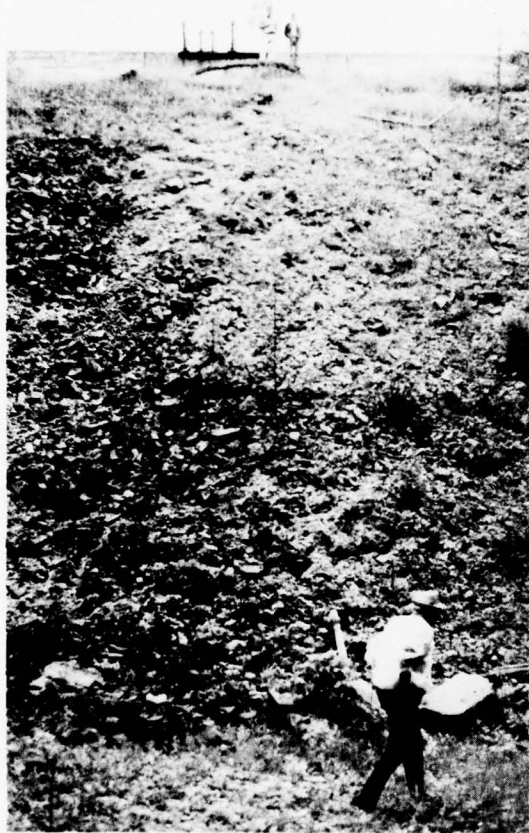
FACE OF DAM FROM DOWNSTREAM TOE

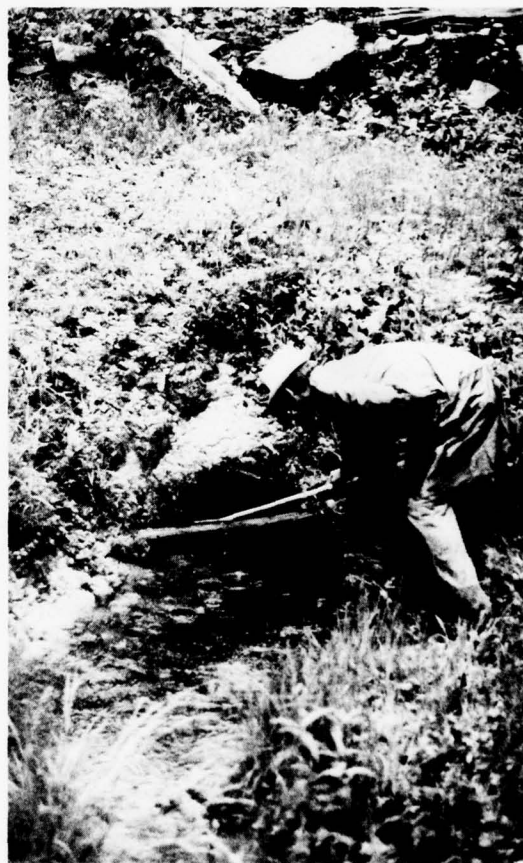
RESERVOIR OUTLET

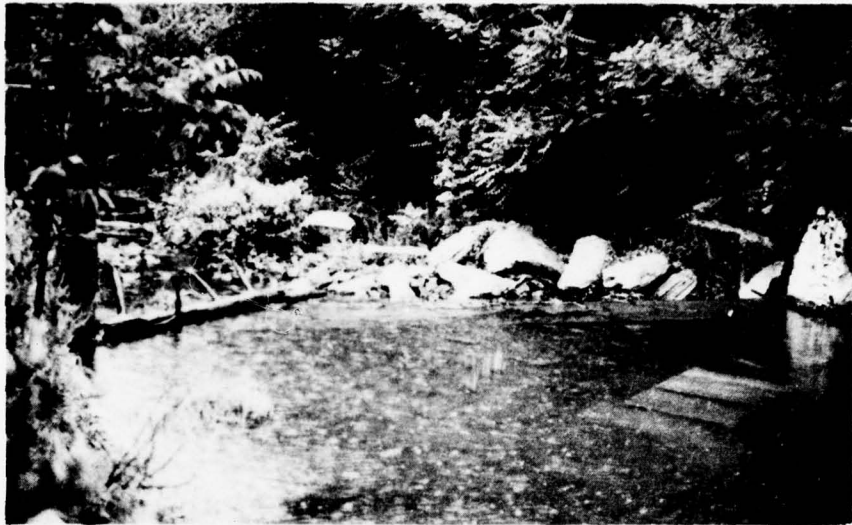
VIEW OF SPILLWAY CREST, LOOKING DOWNSTREAM

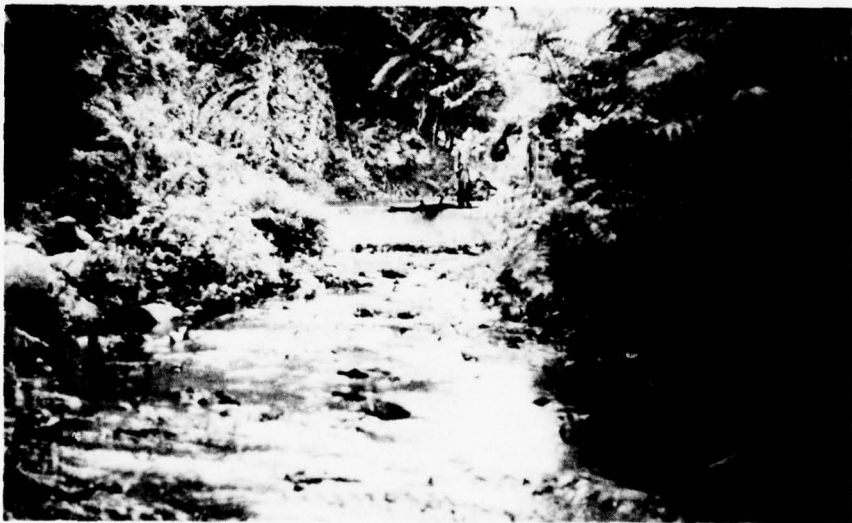
LOOKING UPSTREAM TOWARD SPILLWAY CREST

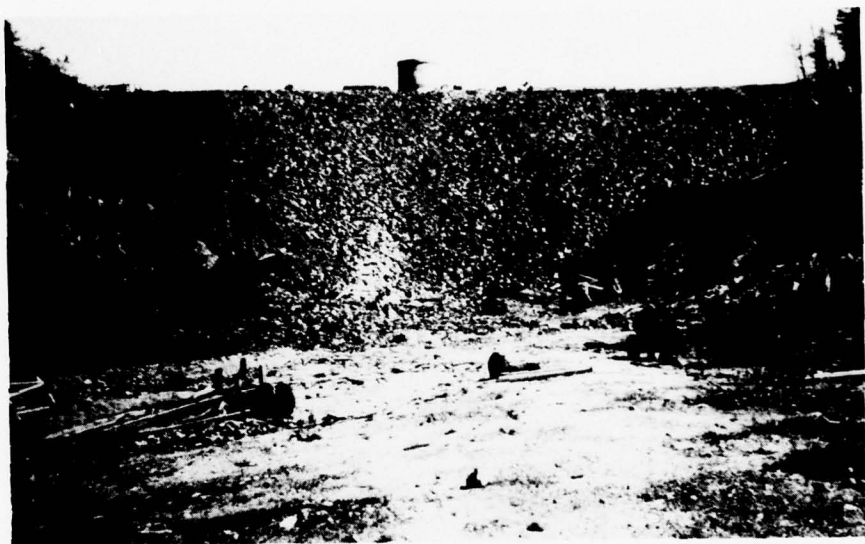
HOGAN DAM AS IT APPEARED DURING ORIGINAL CONSTRUCTION
