Name Of Dam: LOWER NORTON RESERVOIR

Location: WISE COUNTY, VIRGINIA

Inventory Number: VA 19507

PHASE I INSPECTION REPORT NATIONAL DAM SAFETY PROGRAM

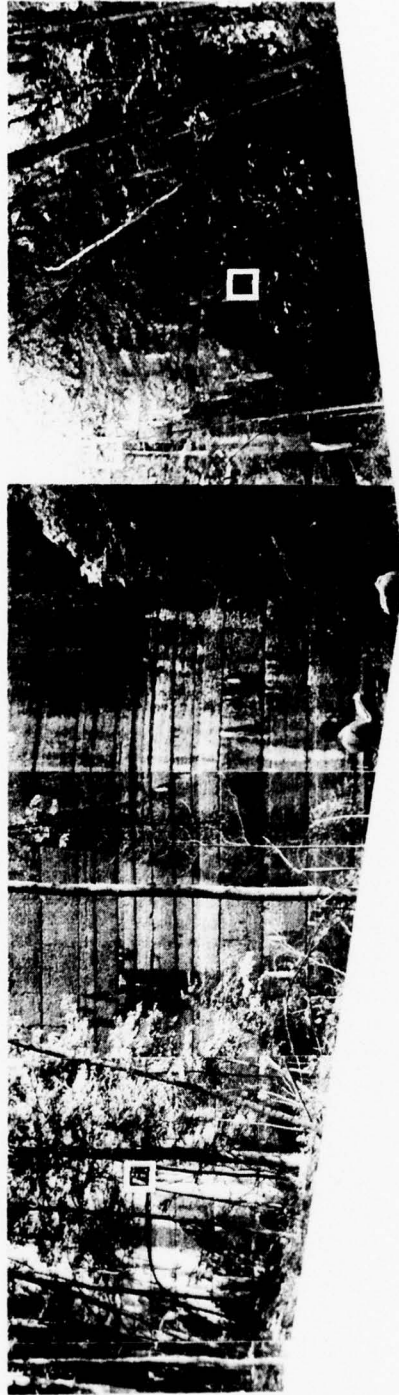
MOSAIC OF DOWNSTREAM FACE - NOTE 3 SEEPAGE AREAS INDICATED BY WHITE SQUARES

Significant quantities of leakage were observed at various locations on the downstream face of the dam. Three of the locations were practically within or near the overflow section, at the horizontal construction joints, and were between 12 feet and 47 feet below the top of the overflow crest. Seepage at each of two of the locations, which were at mid-height of the dam, was approximately 120 to 140 g.p.m. Seepage at the top most location was approximately 30 to 35 g.p.m., while that at the lowest was hardly 15 g.p.m. Several other very small leaks, all at the joints, also were noticed.

The leaks must be monitored and stopped soon; otherwise, they may excessively erode the concrete and corrode the reinforcement.

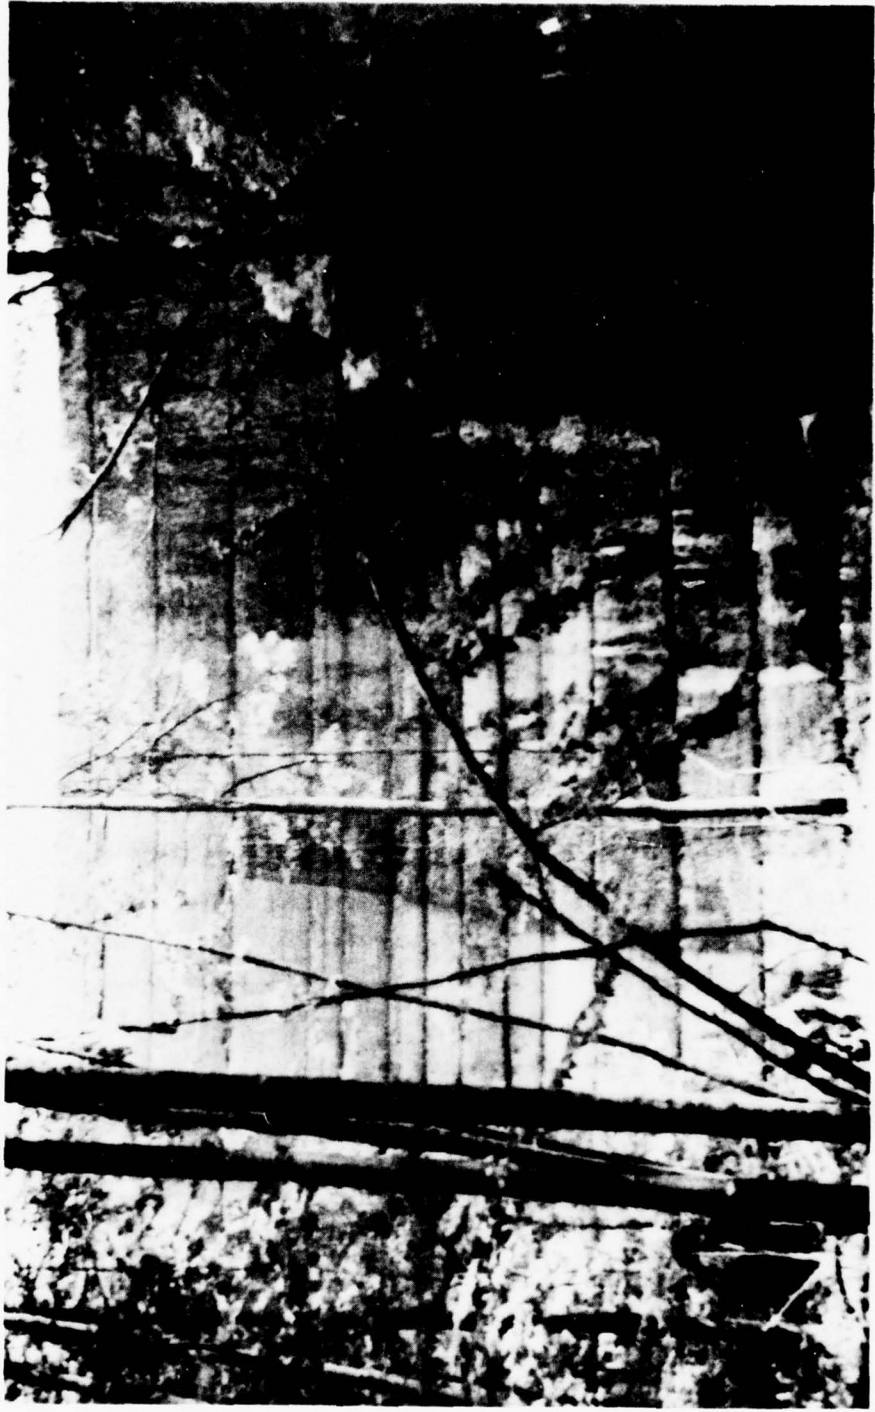
3.1.2 Dam: It appears from the form-work impressions that the dam was constructed in horizontal lifts of 5 feet or less. Significant leakage of water was noticed at at least three different places. It appears that water is coming out of the construction joints. Three of these leakage spots were in the central overflow section of the dam. There were areas of severe scaling of the concrete, and erosion at horizontal joints was common.

3.2 Evaluations: The foundation and the abutments of the dam appear to be in sound condition, posing no imminent hazard. The concrete in the dam shows areas of scaling and spalling, and erosion at the construction joints. The leaks at the construction joints can create serious erosion problems resulting in progressively increasing the size of the holes and, consequently, increasing the leakage making it more difficult to repair as time passes. Therefore, the holes should be closed and the leakage stopped in the next six months. The tree growth at the abutments can undermine the safety of the abutments by decomposition of the rock strata resulting in deterioration of its load-bearing capacity.

DOWNSTREAM FACE OF ARCH
NOTE: SEVERE SCALING OVER AREAS AND GENERAL JOINT EROSION

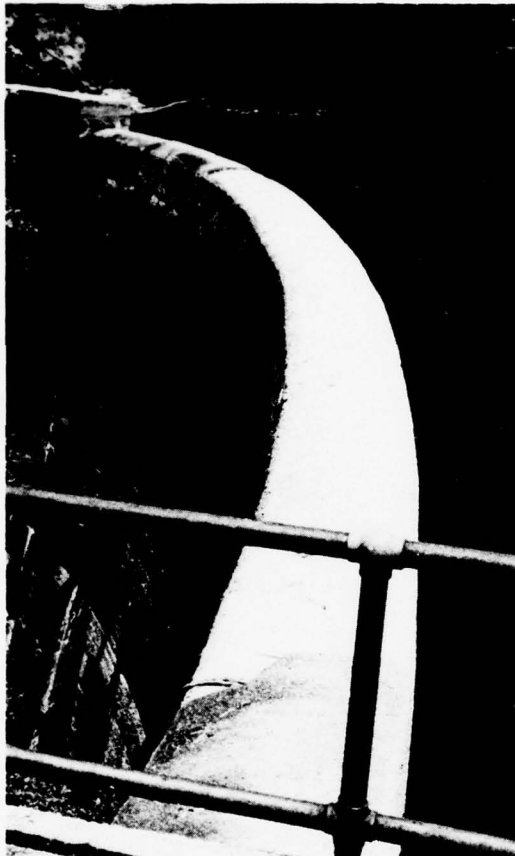
The dimensions of the overflow section of the dam generally agreed with the drawings. There was some spalling of concrete on the spillway crest except for 10-foot sections on both ends of the structure.

VIEW OF SPILLWAY CREST - NOTE
SEPARATION OF TOP LAYER ALONG
ENTIRE CENTER PORTION AND
VEGETATION EMBRACING RIGHT
SIDE OF DAM

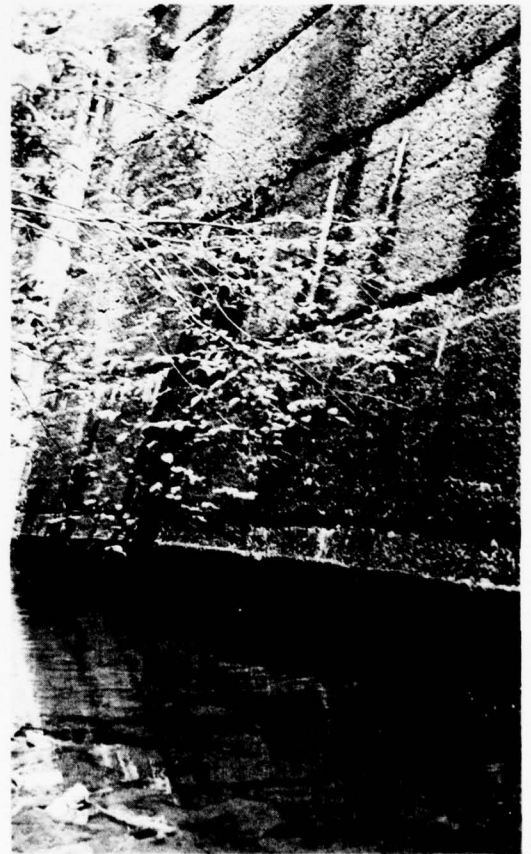
DETAIL OF DOWNSTREAM BASE - NOTE
SEVERE CONCRETE SCALING, ESPECIALLY
AT CONSTRUCTION POINTS

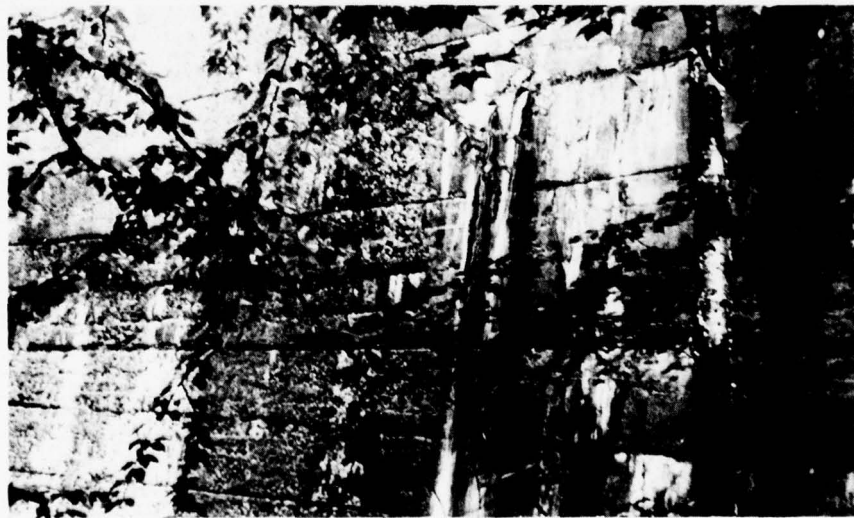
CLOSE-UP OF LEAK AREA IN FACE OF DAM
NOTE: CONCRETE EROSION AROUND LEAK

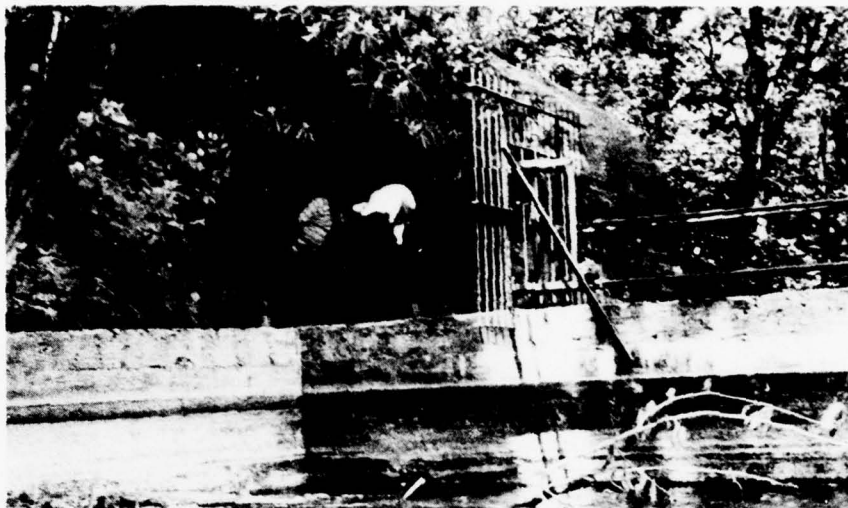
6.3 Evaluation: There is inadequate information available for a meaningful stability analysis of this dam. The excessive tree growth in the vicinity of the abutments could result in deterioration of the strength and integrity of the abutment rock.

LEFT ABUTMENT - NOTE LEDGE ROCK
BEDDING AND GROWTH OF TREES

Abutments consist of fine to medium grained sandstone strata dipping approximately 20 degrees at the left abutment and sloping approximately 50° (±10°) to the horizontal. Excessive growth of trees at the both abutments was noticed. No visible leakage at the junctions was noticed. The slopes at the abutments were apparently stable.

The trees, which can deteriorate the abutment rocks, should be removed.

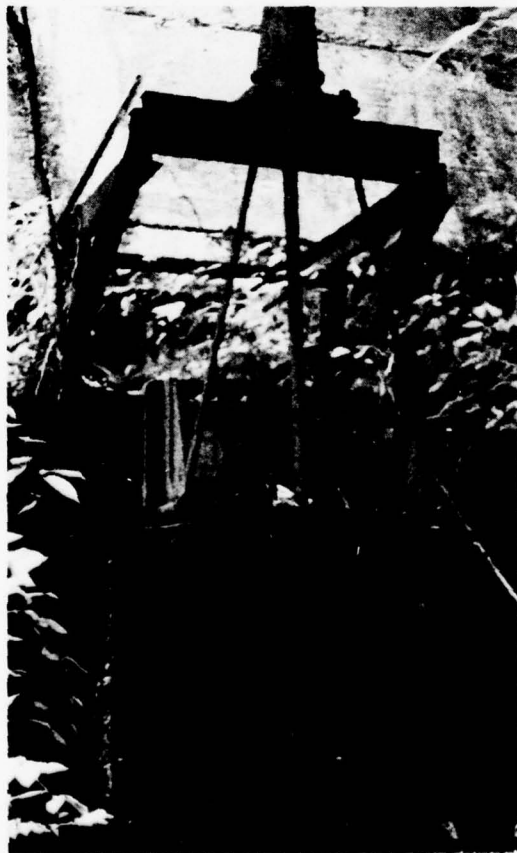
Although the available drawings do not show it, a sluice gate about 3 feet in diameter was installed above the downstream grade to the left of the overflow section, apparently to drain the reservoir. This valve is rusted and filled with sediments; therefore, it is not operational. The handwheel has been removed from this valve.

The sluice gate (about 3 feet in diameter) to drain the reservoir is inoperable (see Photographs in Appendix II). The available drawings (see Appendix I) do not show this gate.

THREE-FOOT DIAMETER SLUICE GATE -
OPERATING WHEEL HAS BEEN REMOVED.
