Name Of Dam: WOODSTOCK

Inventory Number: VA 17104

PHASE I INSPECTION REPORT NATIONAL DAM SAFETY PROGRAM

MICHAEL BAKER, JR., INC.

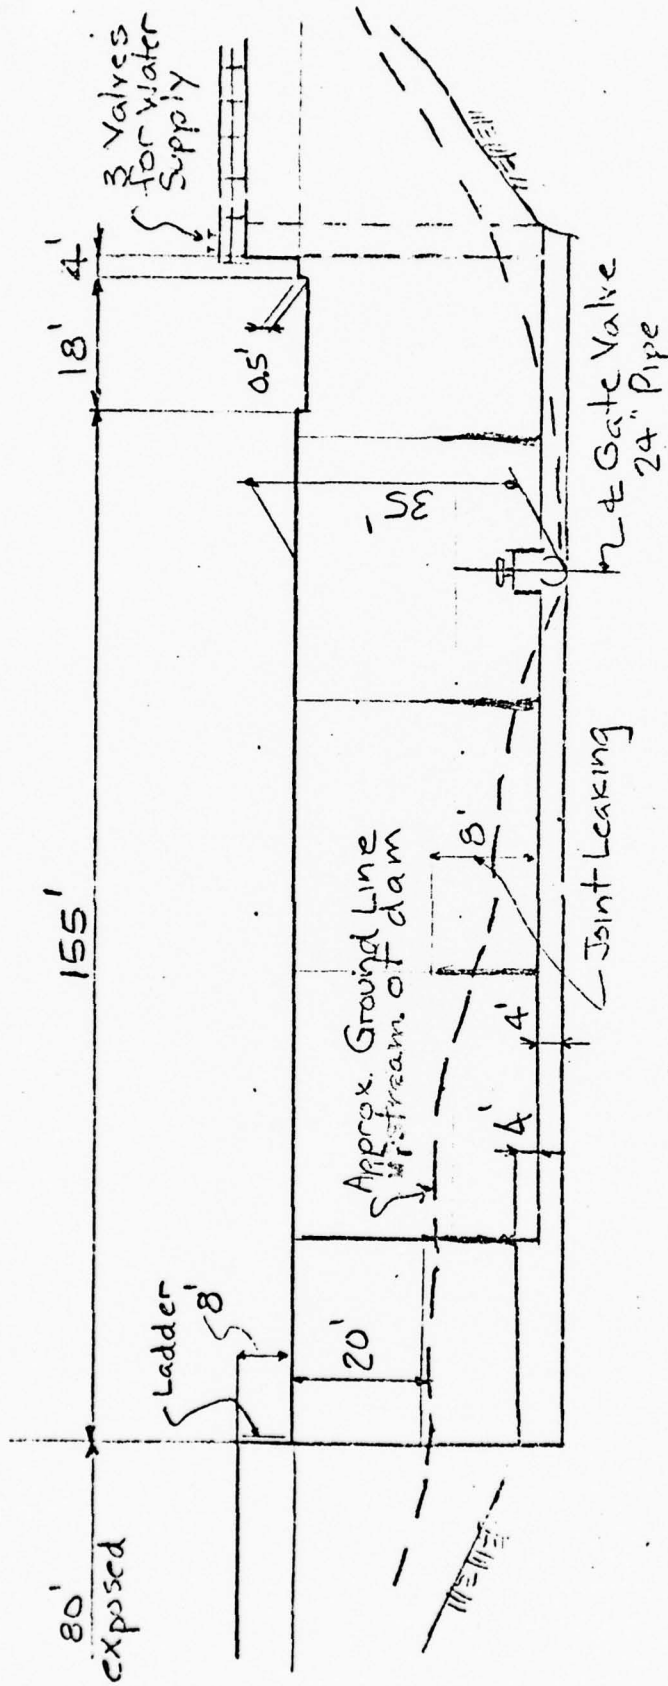
WOODSTOCK - ELEVATION OF DOWNSTREAM FACE
 (AS SKETCHED FROM FIELD MEASUREMENTS)

Plate 4 is a sketch of the measured dimensions of the dam. It shows that the bottom of the spillway is at the same elevation from end to end and does not follow the abutment slopes as indicated on the original plans. It does, however, correspond to the as-built foundation elevations shown on Plate 2.

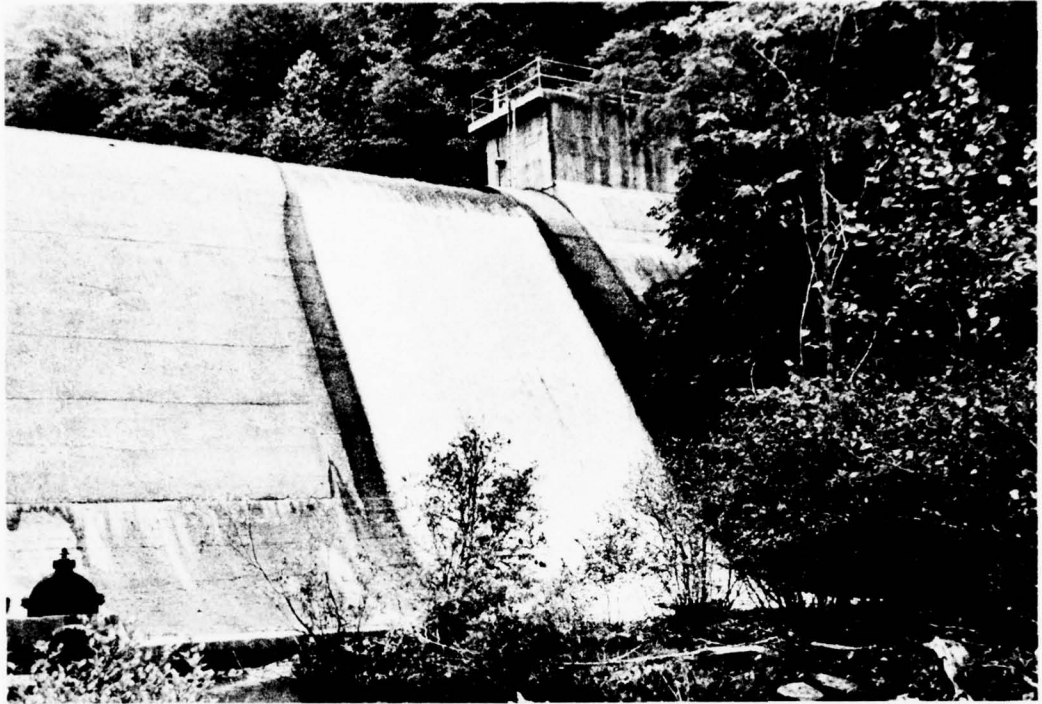
PHOTO 1
Left Downstream Face of Dam

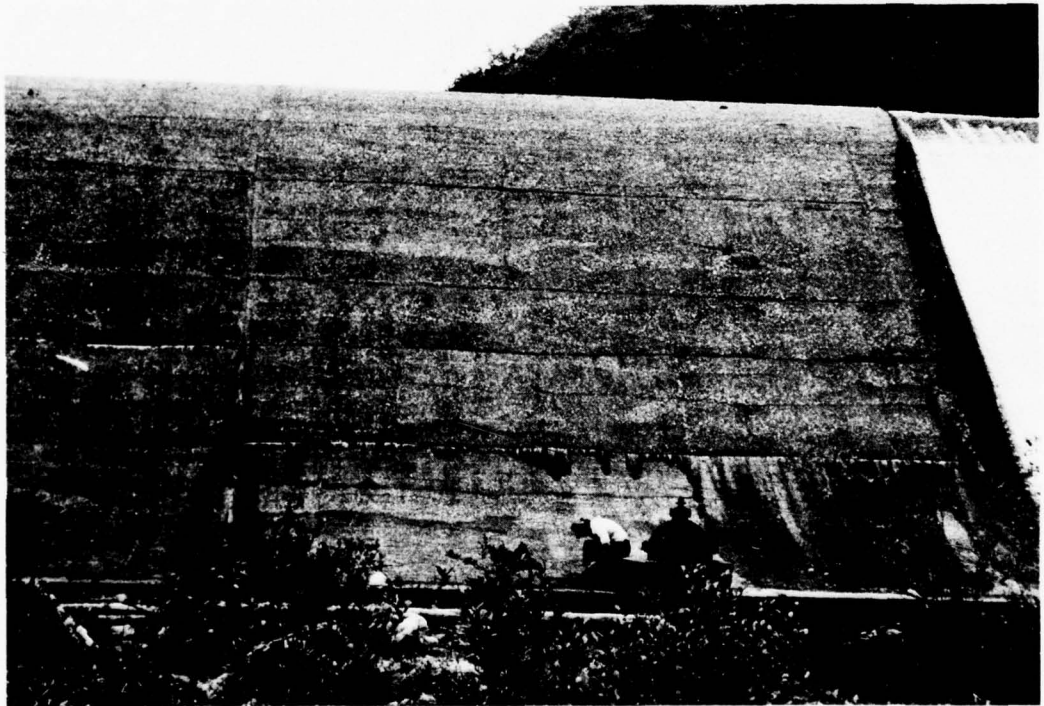
PHOTO 2
Center Downstream Face of Dam

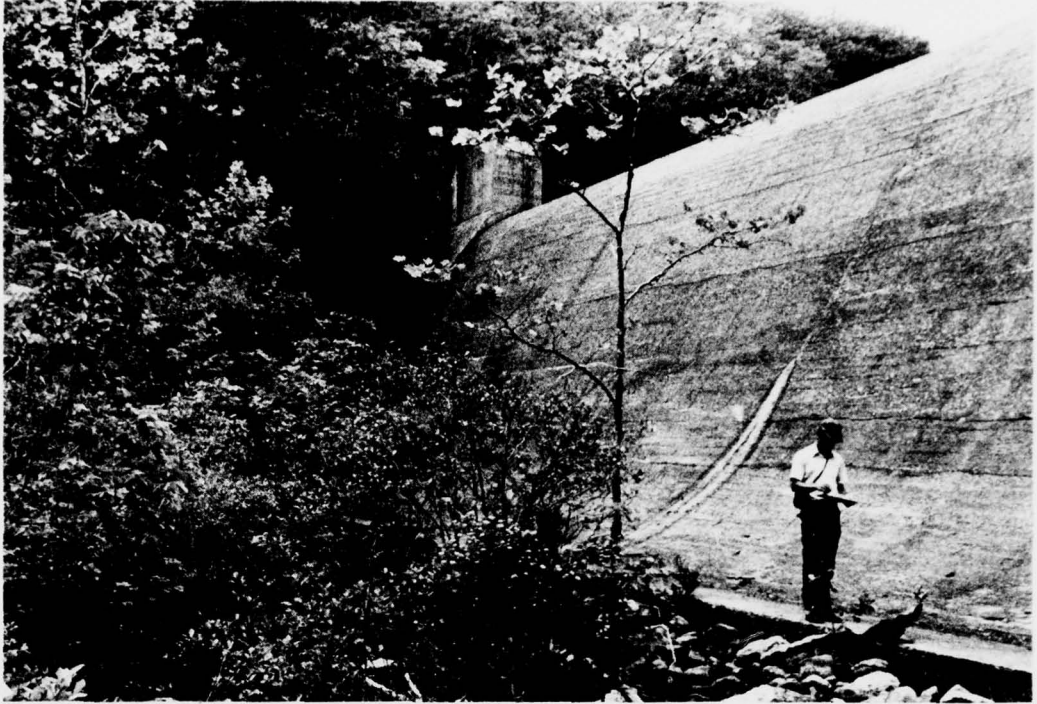
PHOTO 3
Right Downstream Face of Dam

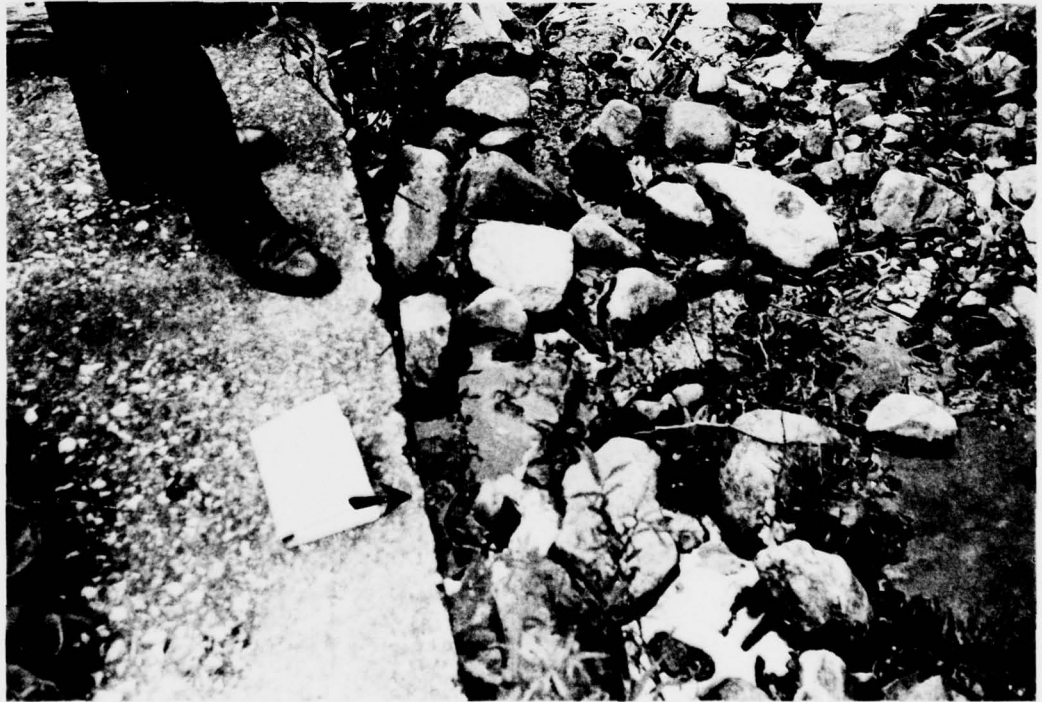
PHOTO 4
Clear Seepage at End of Spillway Bucket

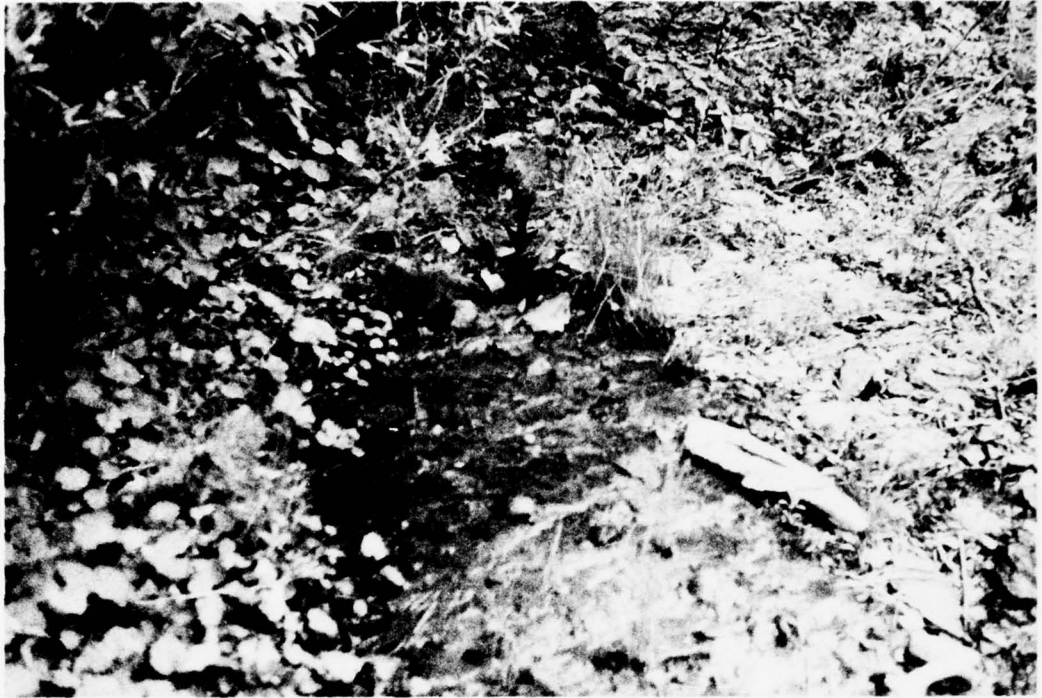
Case II was considered because of the clear seepage observed 36 feet downstream of the spillway bucket. Uplift pressure at the toe of the analyzed section was increased proportionally. Case III was the P.M.F. condition with an assumed tailwater elevation of 1225.0 or five feet above the bottom of the spillway. Lack of cross sections and downstream gradients precluded the calculations of tailwater in the Phase I investigation. The tailwater necessary to move the resultant force to the middle one-third of the spillway foundation was calculated to be 13 feet for the P.M.F. case.

PHOTO 5
Clear Seepage 36' Downstream of Spillway

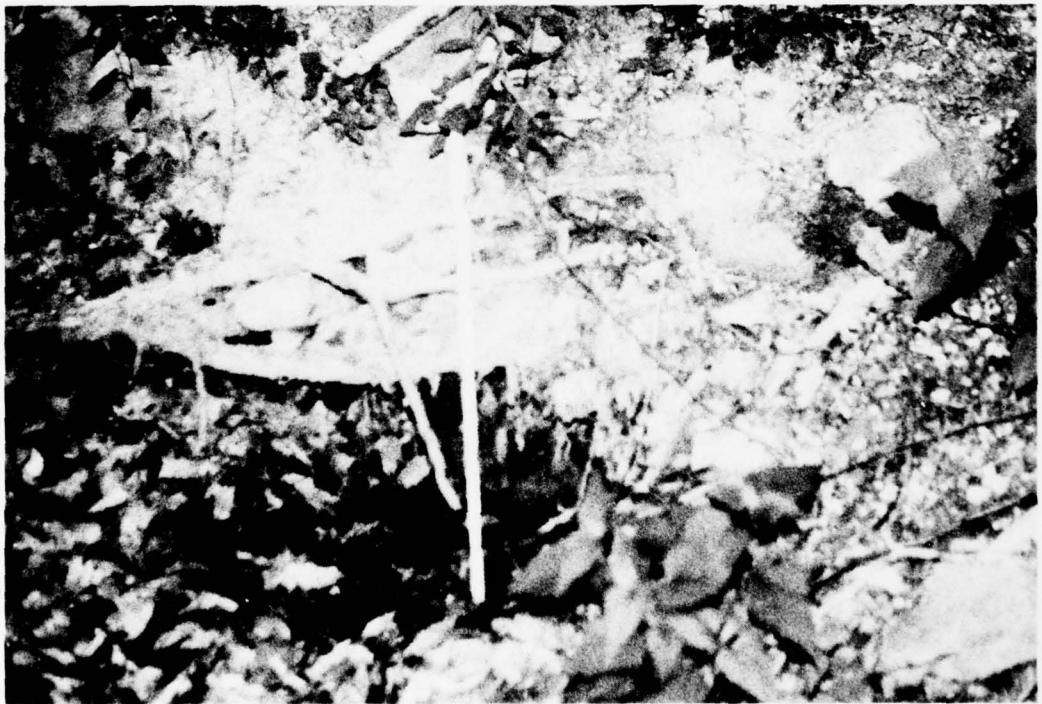
- 6) At the toe of the non-overflow section between Stations 2+80 and 2+90¹ (100 g.p.m.). (Photo 6). This area coincides with the location of the 12 inch cast-iron pipe outletting from the intake tower. No serious erosion was observed.

- 3.2.2 Appurtenant Structures: Further investigation is required to determine if the 12 inch outlet pipe is leaking or if the clear seepage at this point originates in the backfill for the pipe.
- 3.2.3 Reservoir Area: Does not require further investigation.
- 3.2.4 Downstream Channel: Does not require further investigation.

PHOTO 6
Clear Seepage at Toe of Spillway Below Intake Tower (appx. 100 g.p.m.)

- 1) Determination of actual seepage pressures below the dam. This can be obtained with piezometers.
- 2) Determination of the cause of the 100 g.p.m. clear leak in the left downstream abutment and repair of the leak.
- 3) Further analysis should be made of the marginal calculated stability of the spillway. This includes a determination of the tailwater elevation during the P.M.F.
- 4) Patching the clear leak in the intake tower above the highest slide gate by maintenance personnel during the next scheduled maintenance visit. No remedial treatment of the clear leaking vertical joints in the spillway is
