Name Of Dam: LOWER NORTH RIVER NO. 80

Location: ROCKINGHAM COUNTY, STATE OF VIRGINIA

Inventory Number: VA 16501

PHASE I INSPECTION REPORT

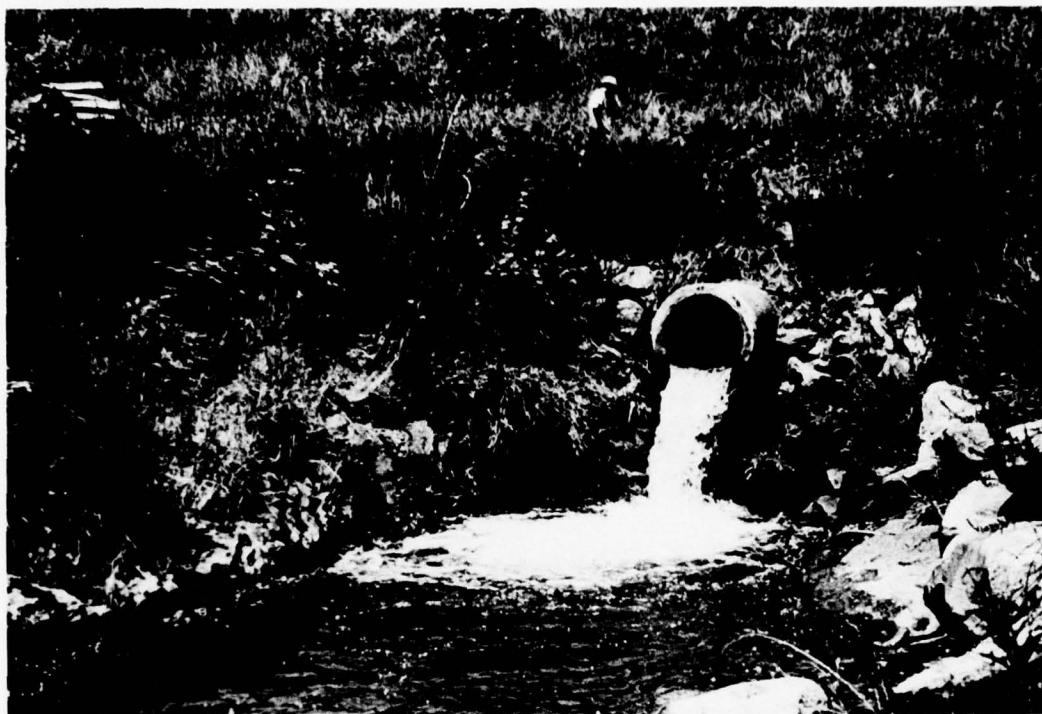
3.1.2 Dam: A small clear seep (person in Photo 1 is standing at location of clear seep) was noted on the downstream face of the dam at an elevation of 1526.5 located approximately ten feet to the right of the outlet pipe. Flow at the time of the visual inspection was estimated at less than one-half g.p.m. However, a six inch wide by two inch deep erosion channel, which indicates possible higher intermittent flows, had formed immediately below the origin of the clear seep. A fifteen feet by three feet marshy area is also present about one or two feet in elevation immediately down slope of this clear seep. This marshy area may be related to the above clear seep.

PHOTO 1. Principal Spillway Outlet - Stilling Basin

- 7.2.1 Clear Seep: Immediately, the owner should set up and maintain a regular observation schedule of inspecting the clear seep, during higher reservoir levels, to determine its source, prevent erosion and prevent a worsening condition from going unobserved. If as a result of these periodic inspections it is found that the flow is originating from the reservoir, then an in-depth investigation including a test boring program and piezometers is recommended. An inverted filter may be needed to prevent piping if the source of the clear seep is determined to be the reservoir.

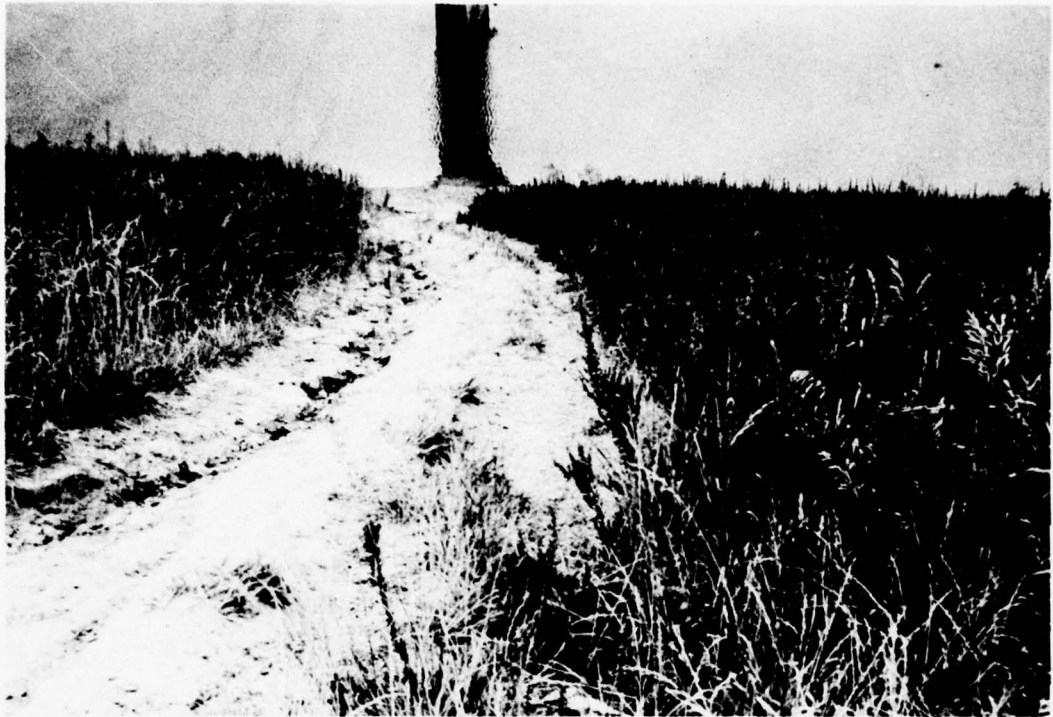
Minor erosion damage was observed during the visual inspection. A ten feet wide shallow eroded footpath was observed leading from the dam crest to the water edge down the center of the upstream side of the dam (see Photo 3 and Overall View of Dam). Minor erosion is also occurring along the downstream dam abutments due to runoff. Riprap had not been placed on the erosion control (wave dissipation) berm at normal pool level on the upstream embankment (see Photo 2). Consequently, this berm has eroded slightly due to water level fluctuations, wave action and pedestrian traffic.

PHOTO 3. Erosion on Footpath - Dam Crest to Water Edge

- 1) The small trees growing on the embankment should be removed.
- 2) The footpath on the upstream face of the dam should be repaired and reseeded, or a type of stairway should be constructed to prevent future damage.
- 3) The erosion channels along the downstream dam abutments should be filled and reseeded.

upstream face of the dam should be graded and reseeded or a type of stairway should be constructed to prevent future damage. Also, the erosion channels along the downstream dam abutments should be filled and reseeded. These items can be accomplished through the annual maintenance program.

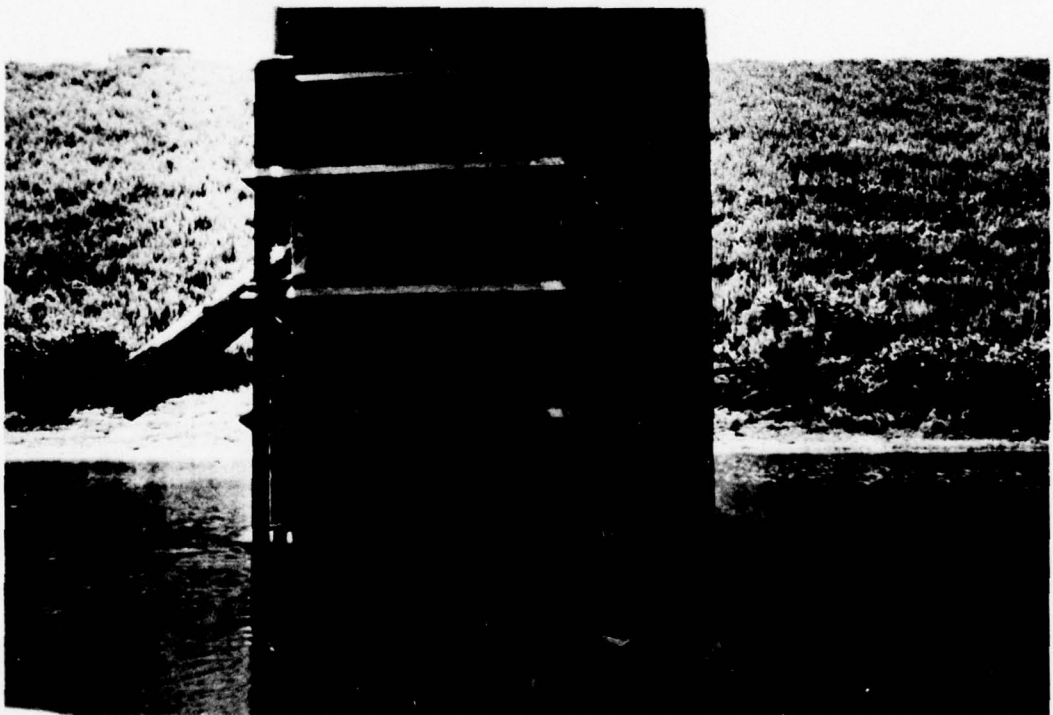
PHOTO 4. Debris in Low Stage Trash Rack

- 3.2.2 Appurtenant Structures: The trash rack should be inspected; and debris should be removed periodically from it, particularly during the heavy rainfall seasons. The upper handrail section on the riser access ladder should be replaced.
- 3.2.3 Reservoir Area: The reservoir area does not require further investigation.
- 3.2.4 Downstream Channel: The downstream channel does not require further investigation.
