Name Of Dam: LOWER NORTH RIVER NO. 83

Location: ROCKINGHAM COUNTY, STATE OF VIRGINIA

Inventory Number: VA 16503

PHASE I INSPECTION REPORT
NATIONAL DAM SAFETY PROGRAM

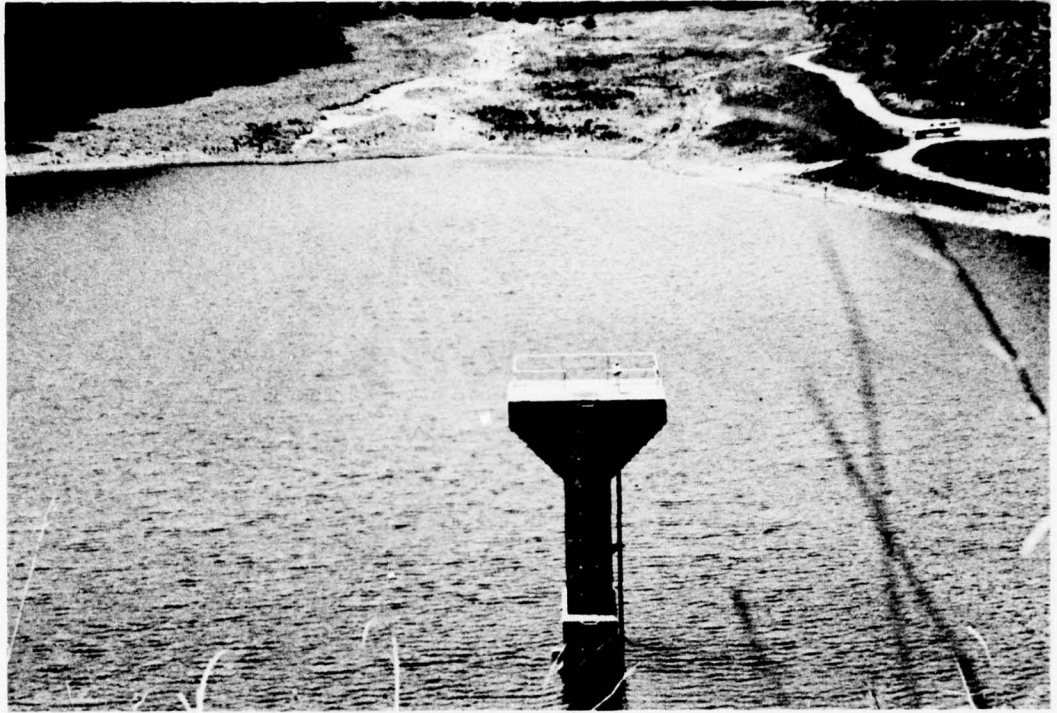
PHOTO 1

3.1.4 Reservoir Area: No serious deficiencies were observed in the reservoir area (see Photo 1).

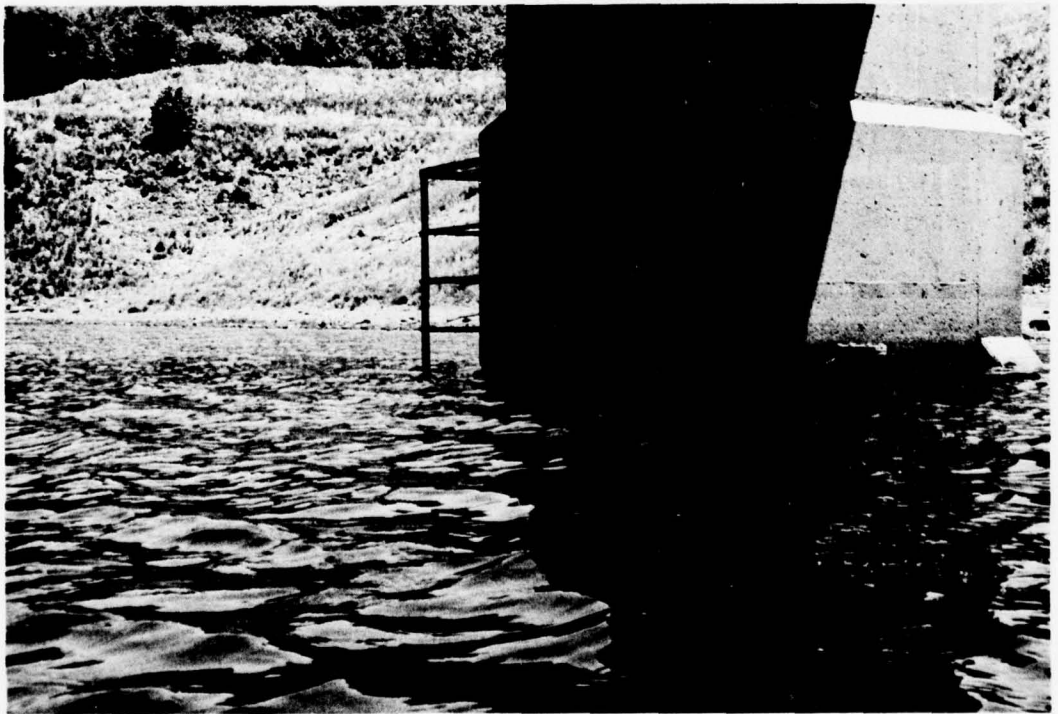
PHOTO 2

3.1.3 Appurtenant Structures: At the time of inspection, some debris was lodged in the low stage trash rack at normal pool (see Photo 2). This debris should be removed as soon as possible, and thereafter periodically in the future, to prevent clogging of the inlet or damage to the trash rack.

- 7.2 Recommended Remedial Measures: The riser inlet and trash rack should be cleaned of debris, and it should continue to be cleaned frequently in the future. Riprap should be placed around the outlet conduit and cradle to prevent further erosion. The cracking and spalling of the 36 inch concrete outlet pipe should also be repaired.

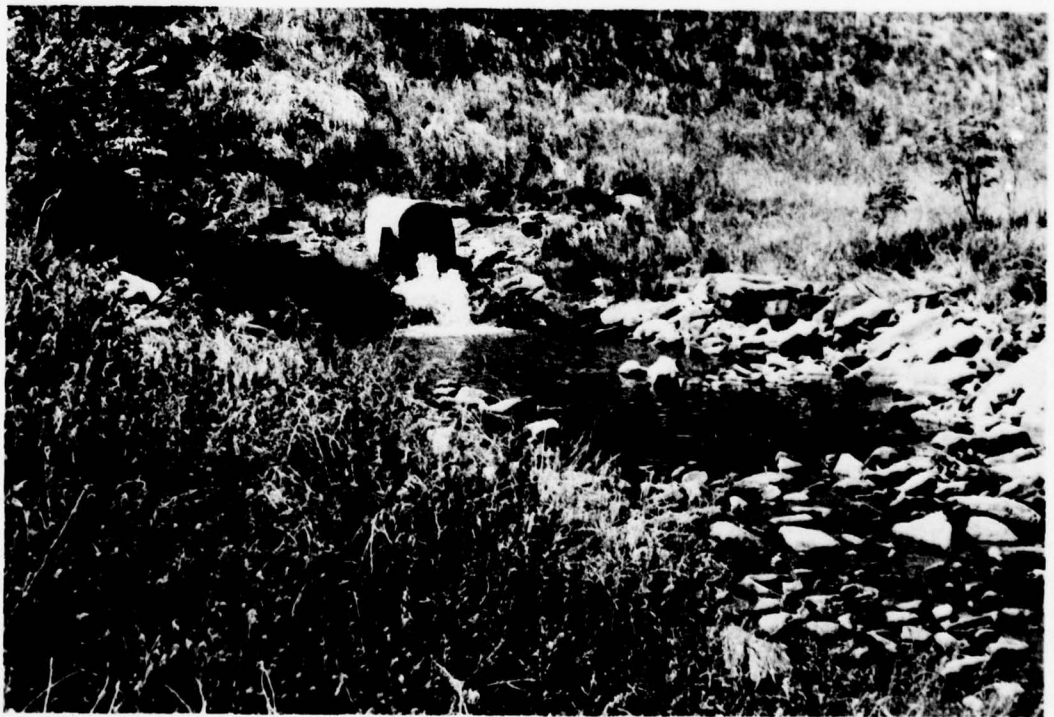
PHOTO 4

3.1.5 Downstream Channel: The stilling basin and outlet channel are functioning properly, and the riprap as placed is in good condition (see Photo 4).
