Name Of Dam: TALBOTT DAM

Location: PATRICK COUNTY

Inventory Number: VA 14101

# PHASE I INSPECTION REPORT NATIONAL DAM SAFETY PROGRAM

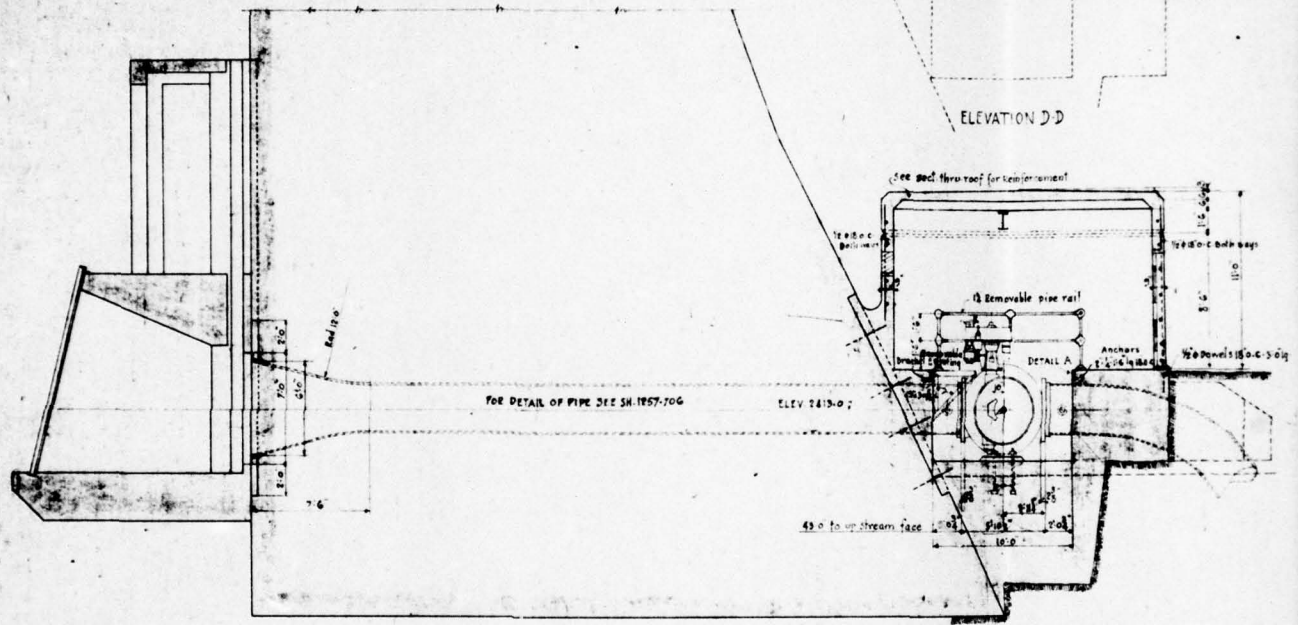
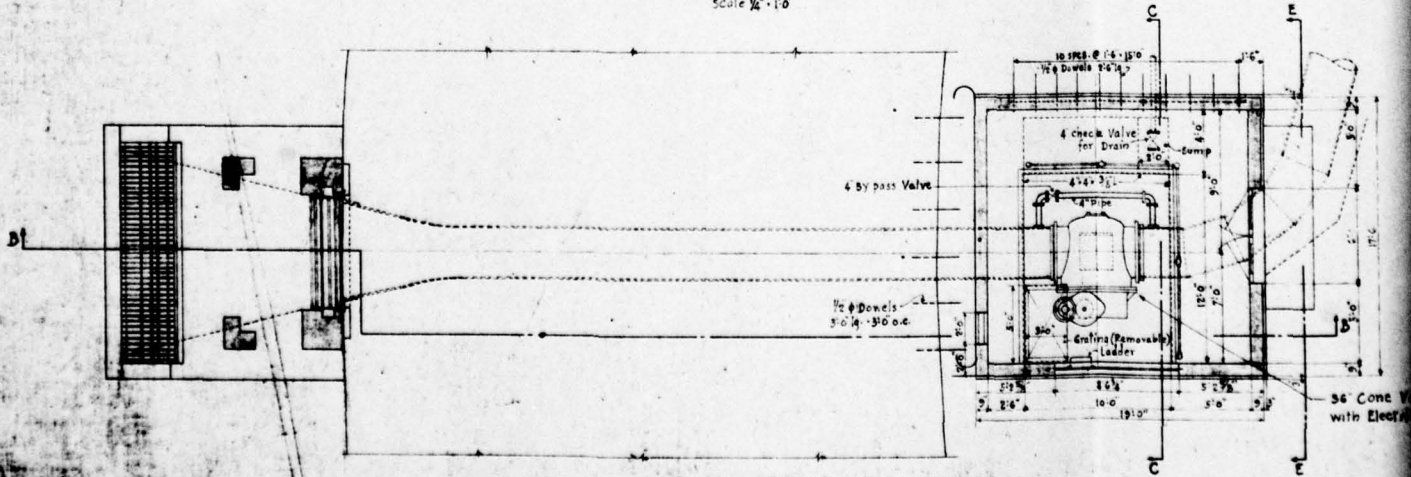
1. 6" Valves & Piping were found in lieu of 4" shown.
2. Two 36" inch Tandem Butterfly Valves were found in lieu of one 36" inch valve as shown.

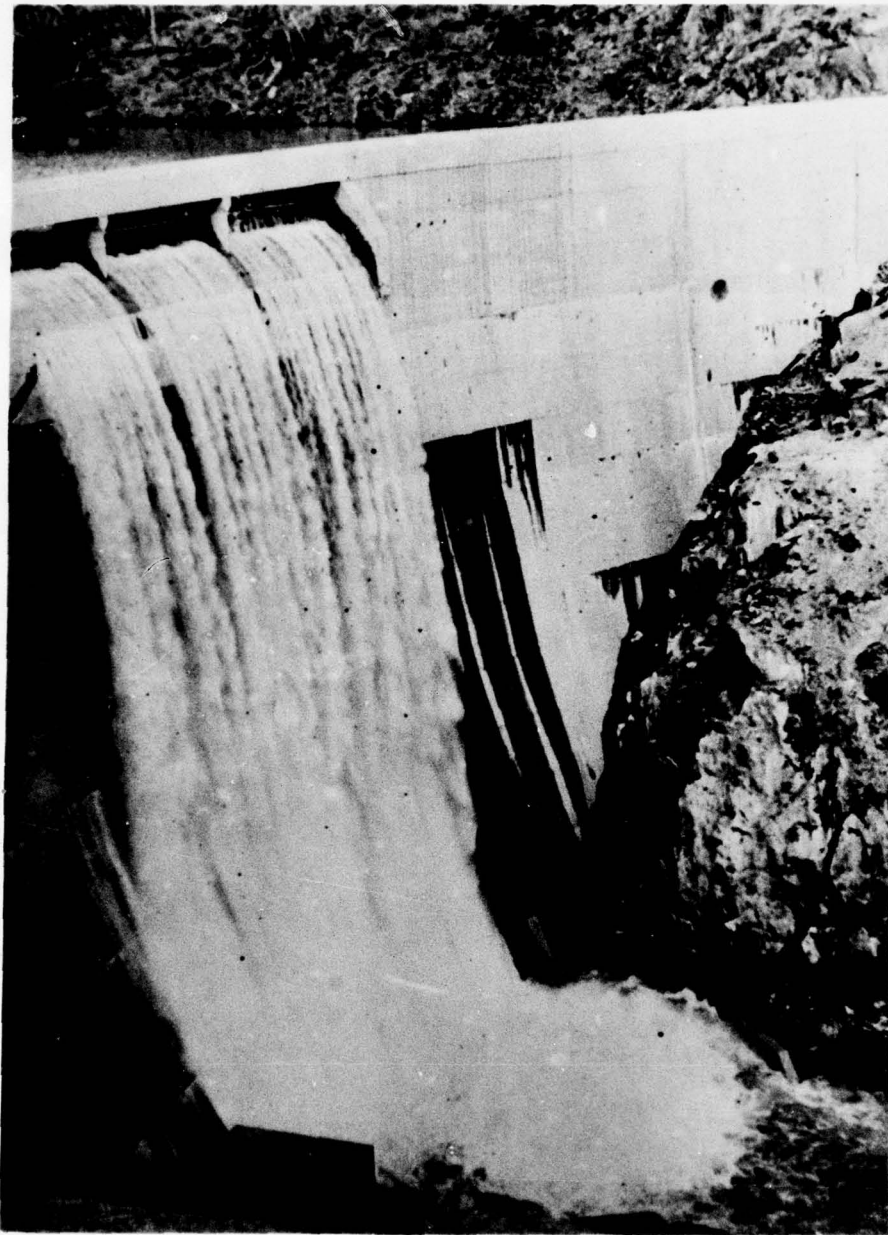
PHOTO 1

TALBOTT DAM---PHOTO PRIOR TO 1940  
NOTE SEEPS THROUGH DAM

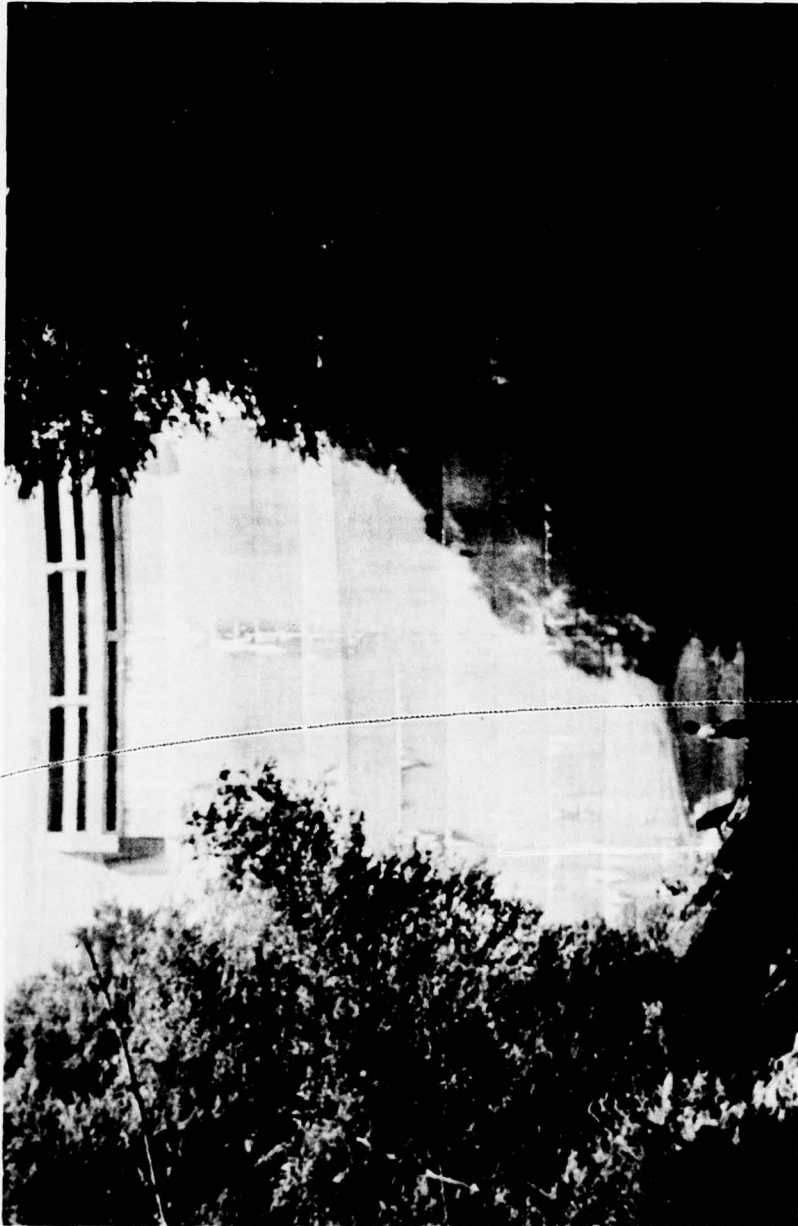
PHOTO 2

The dam is in good condition. Seepage has occurred through an estimated 30 to 40% of all construction and monolith joints leaving calcium deposits on the face at the dam. A 1/2-inch horizontal crack, 30 feet long and 4 lifts from the top of the dam was found starting at the contact between the left abutment and downstream face of the dam. Seepage through the crack was estimated to be 1 gallon per minute. Based on visual observation, the crack does not warrant serious concern at this time, however, further investigation is required.

TALBOTT DAM---TAKEN FROM STREAM  
BED DOWNSTREAM FROM DAM-NOTE WHITE CALCIUM  
DEPOSITS FROM SEEPAGE THROUGH CONSTRUCTION JOINTS

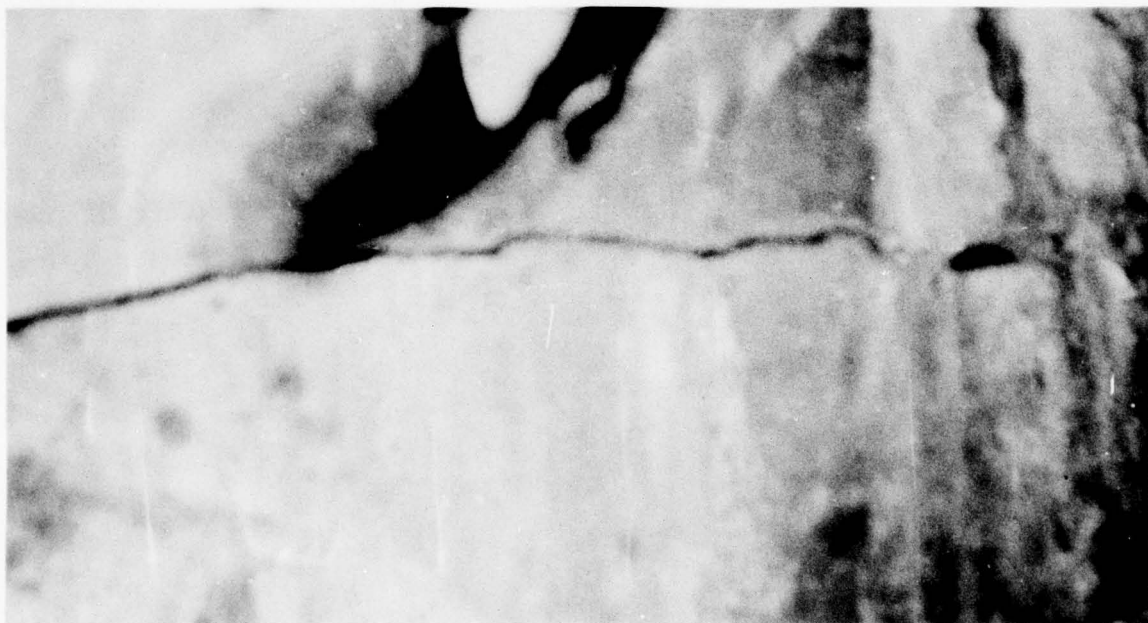
PHOTO 6

3.2.1 Dam and Abutments: The results of the 27 July 1978 inspection are recorded in Appendix III. At the time of the inspection, the pool elevation was 2527.2, 7.8 feet below the elevation of the spillway. The outlet works were not releasing flow. Only minor seepage was noted on the face of the dam. There were some areas of calcium deposits showing areas of past seepage that are not currently active. A horizontal crack, approximately 1/2 inch wide and 30 feet long, is located at the bottom of the fourth lift from the top of the dam, beginning at the left abutment on the downstream face. The concrete above the crack is displaced approximately 1/8 inch. The crack is seeping at a rate estimated to be 1 GPM.

TALBOTT DAM-CRACK AT LEFT ABUTMENT  
EXTENDING 30 FT. FROM ABUTMENT/ROCK CONTACT  
4 LIFTS BELOW WALKWAY

b. Engage the services of a Professional Engineer to perform a structural stability analysis under all loading conditions. The 1/2" crack at the left abutment should be evaluated when the structural investigation is accomplished. Structural analysis should be completed within 6 months.
